Condition Assessment Report

CTF - Bldg A
3500 Pennsy Drive
Hyattsville, MD 20785

Inspection Date: Thursday, June 12, 2014

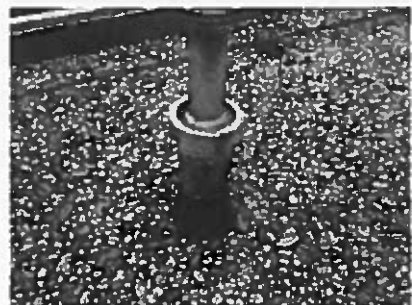
Hot stack

Associated Defect: #6 - Flashing damage or deterioration (EA)

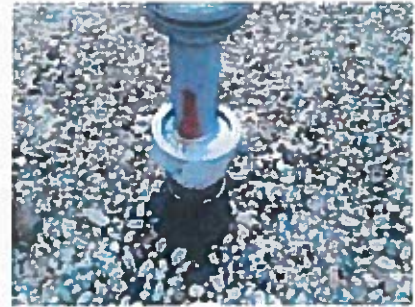
Hot stack

Associated Defect: #11 - Flashed penetration defects

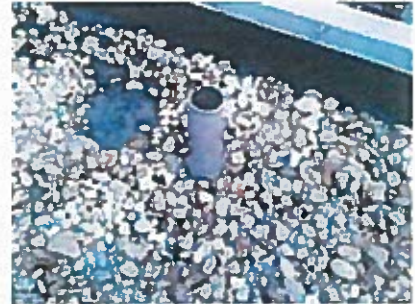
Plumbing vent

Associated Defect: #3 - Boot defect

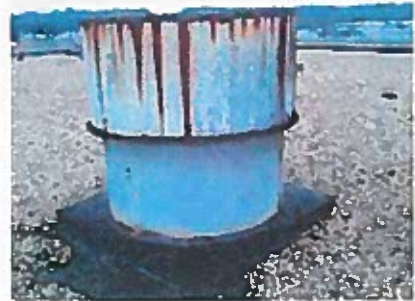
Exhaust fan/Extractor vent

Associated Defect: #14 - Flashing damage or deterioration (EA)

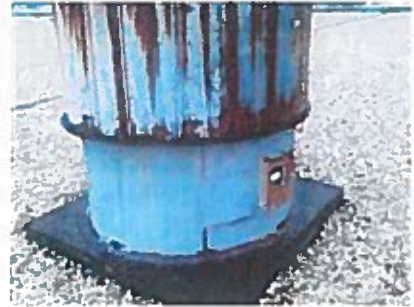
Exhaust fan/Extractor vent

Associated Defect: #17 - Flashing damage or deterioration (EA)

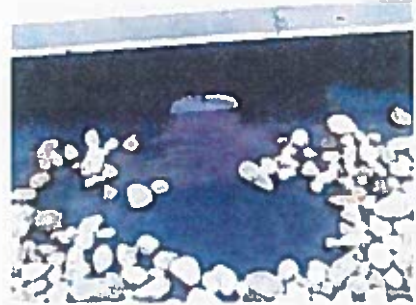
Overflow scupper

Associated Defect: #9 - Scupper metal deterioration or damage

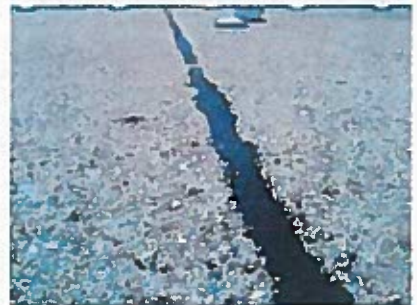
Expansion joint

Associated Defect: #12 - Flashing damage or deterioration (EA)

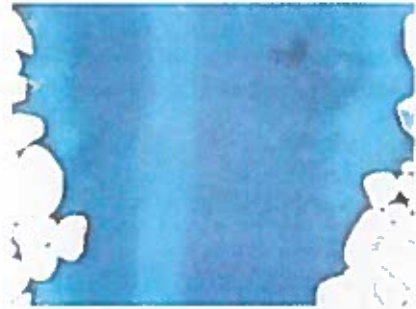
Control joint

Associated Defect: #21 , #22 - Flashing damage or deterioration (EA)

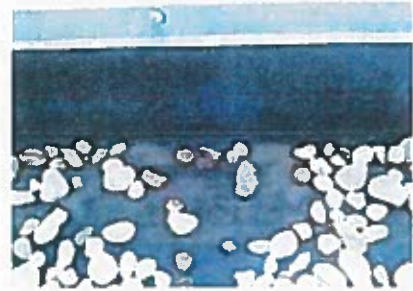
Parapet membrane flashing

Associated Defect: #20 - Flashing wrinkle/movement

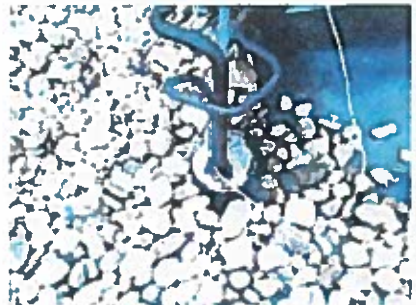
**Electrical line penetration**

Associated Defect: #31 - Pitch pan defect

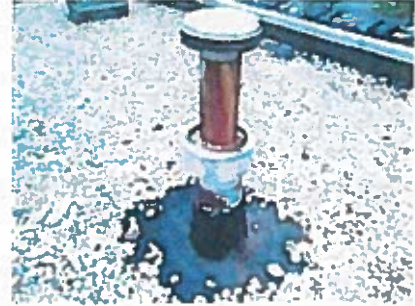
Metal flue

Associated Defect: #35 - Metal flashing defects (EA)

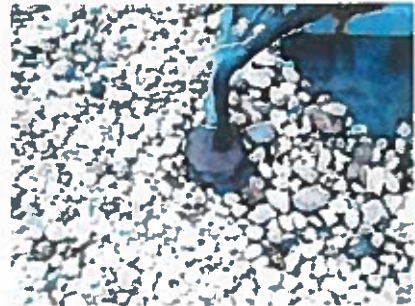
**Electrical line penetration**

Associated Defect: #37 - Pitch pan defect

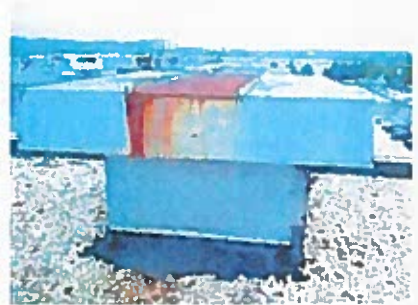
Mechanical vent

Associated Defect: #38 - Flashing damage or deterioration (EA)

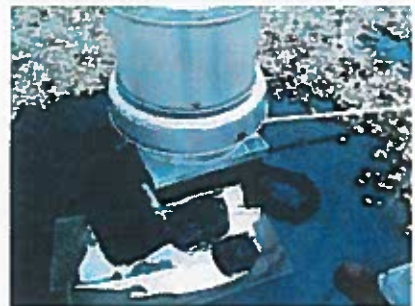
Associated Defect: #40 - Flashing damage or deterioration (EA)

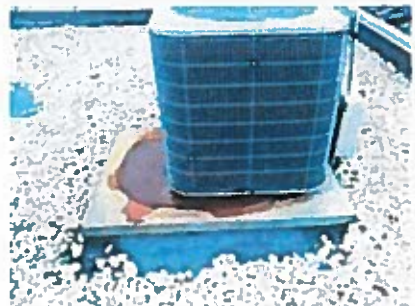
Associated Defect: #36 - Flashing wrinkle/movement

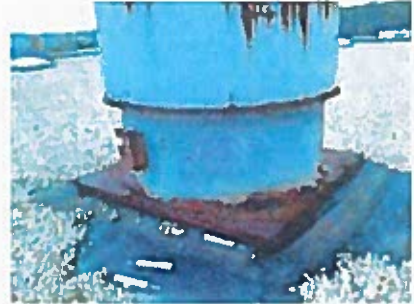
Associated Defect: #39 - Flashing damage or deterioration (EA)

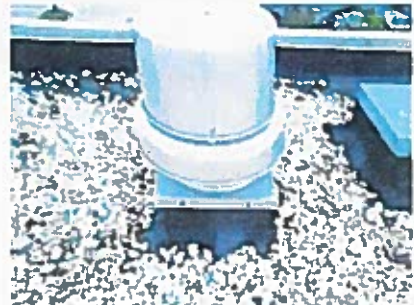
Associated Defect: #33 - Flashing damage or deterioration (EA)

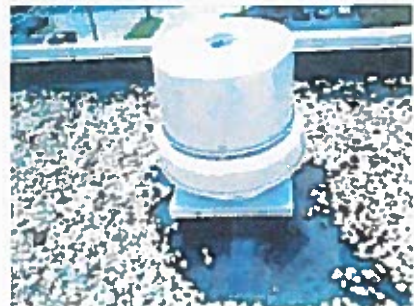
Associated Defect: #34 - Flashing damage or deterioration (EA)

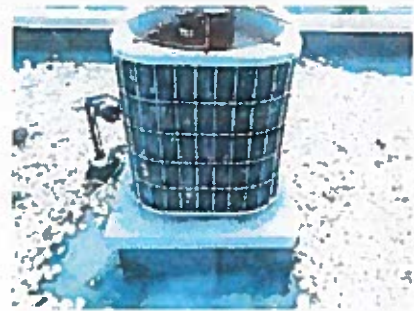
Associated Defect: #30 - Flashing damage or deterioration (EA)

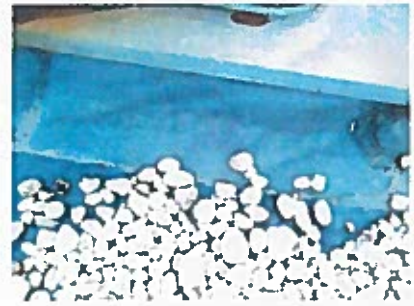
**Refrigeration unit**

Associated Defect: #29 - Flashing wrinkle/movement

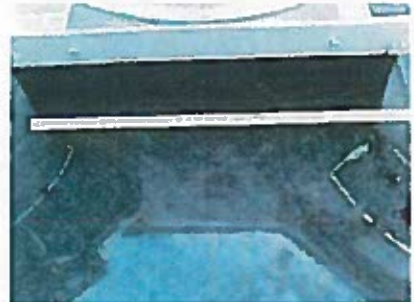
**Exhaust fan/Extractor vent**

Associated Defect: #27 , #28 - Flashing damage or deterioration (EA)

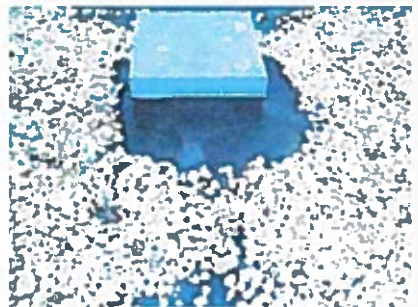
Abandoned

Associated Defect: #32 - Point defect - see notes
