Condition Assessment Report

C94 Alexandria Yard Revenue Collection Facility
3301 Eisenhower Avenue
Alexandria, VA 22314

Inspection Date: Friday, June 20, 2014

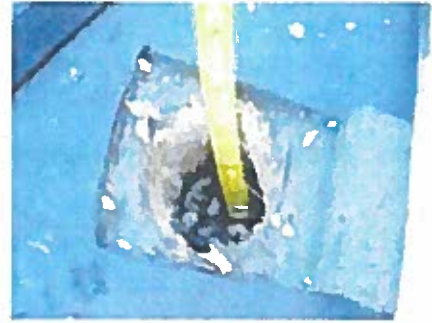
Core test
60 mil EPDM, 3"polyiso, asphalt, concrete deck

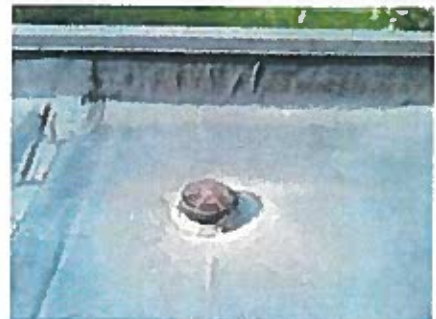
Field drain

- Size: 4"
- Material: Cast iron w/ strainer

Associated Defect: #10 - Clogged drain

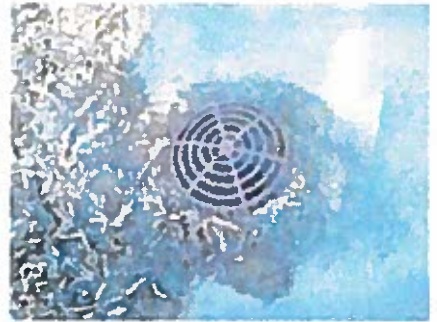
Field drain

- Size: 4"
- Material: Cast iron w/ strainer

Associated Defect: #9 - Clogged drain

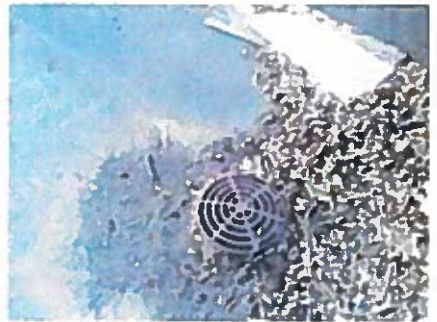
Field drain

- Size: 4"
- Material: Cast iron w/ strainer

Associated Defect: #8 - Clogged drain

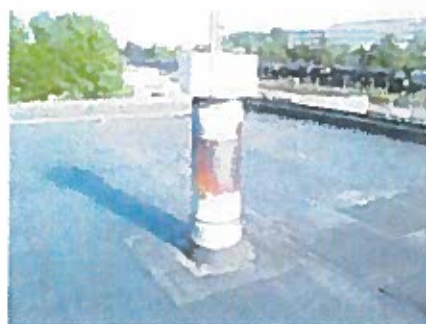
Hot stack

- Diameter: 12"
- Flashing: Membrane
- Base height: 8"
- Length: 48"
- Width: 12"
- Material: Metal

Associated Defect: #12 - Metal flashing defects (EA)
