ELECTRICAL AND DATA CABLE INSTALLATION

Washington Metropolitan Area Transit Authority

Contract Number FQ17021

**Mezzanine Inspection Reports
Part 1a
Orange and Blue Lines**

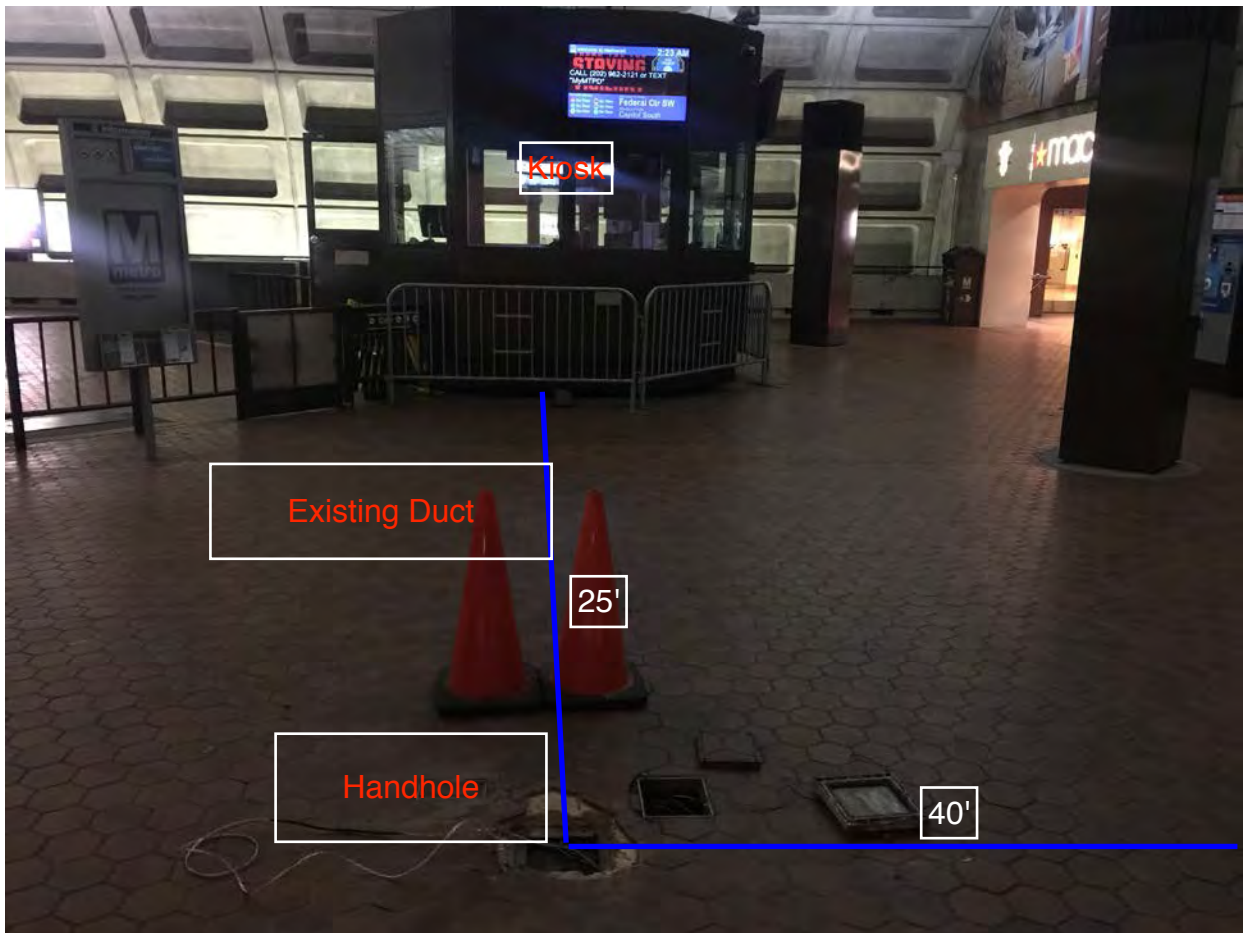
Photo #1 - Existing duct run on mezzanine floor.

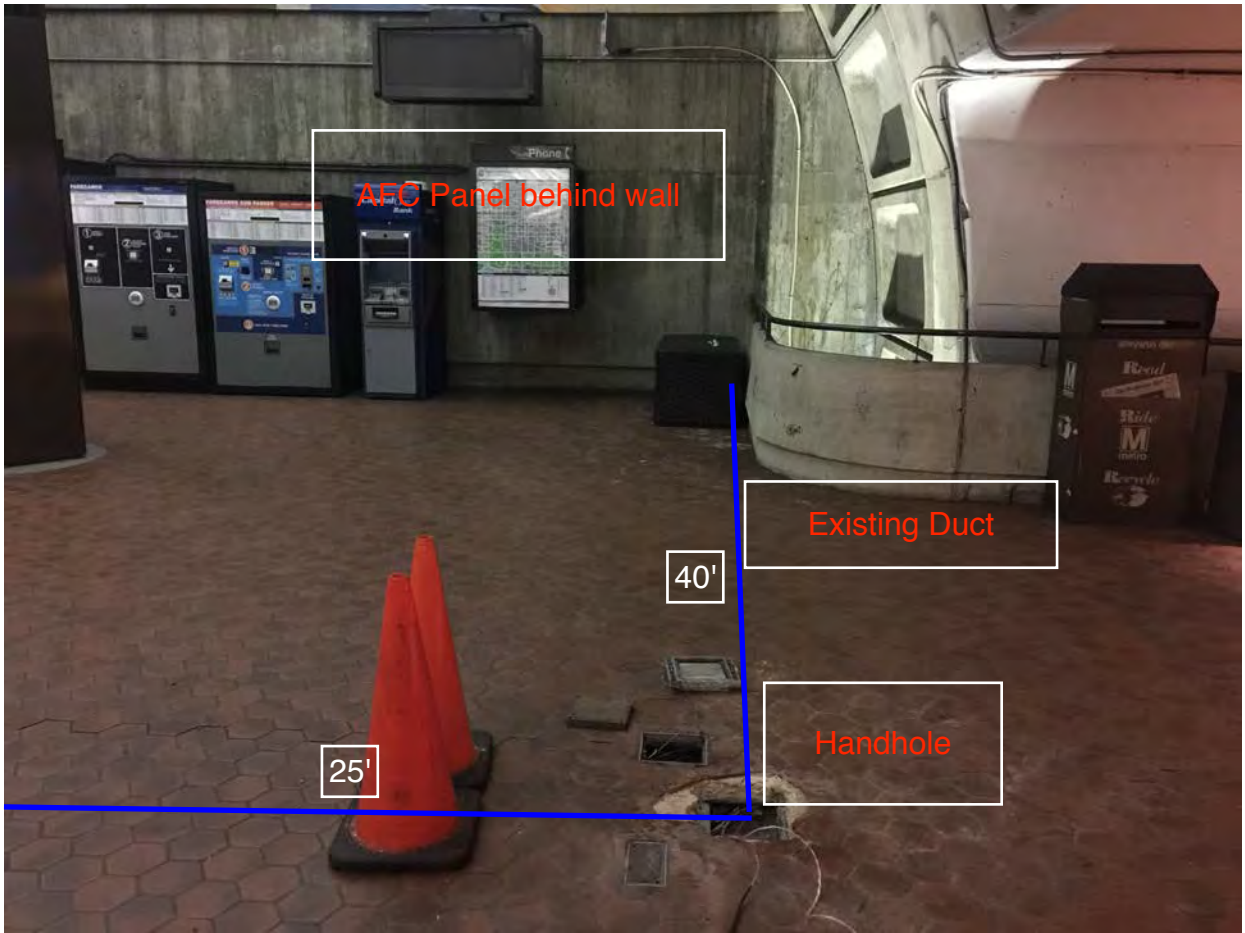
Photo #2 - Existing duct run on mezzanine floor.

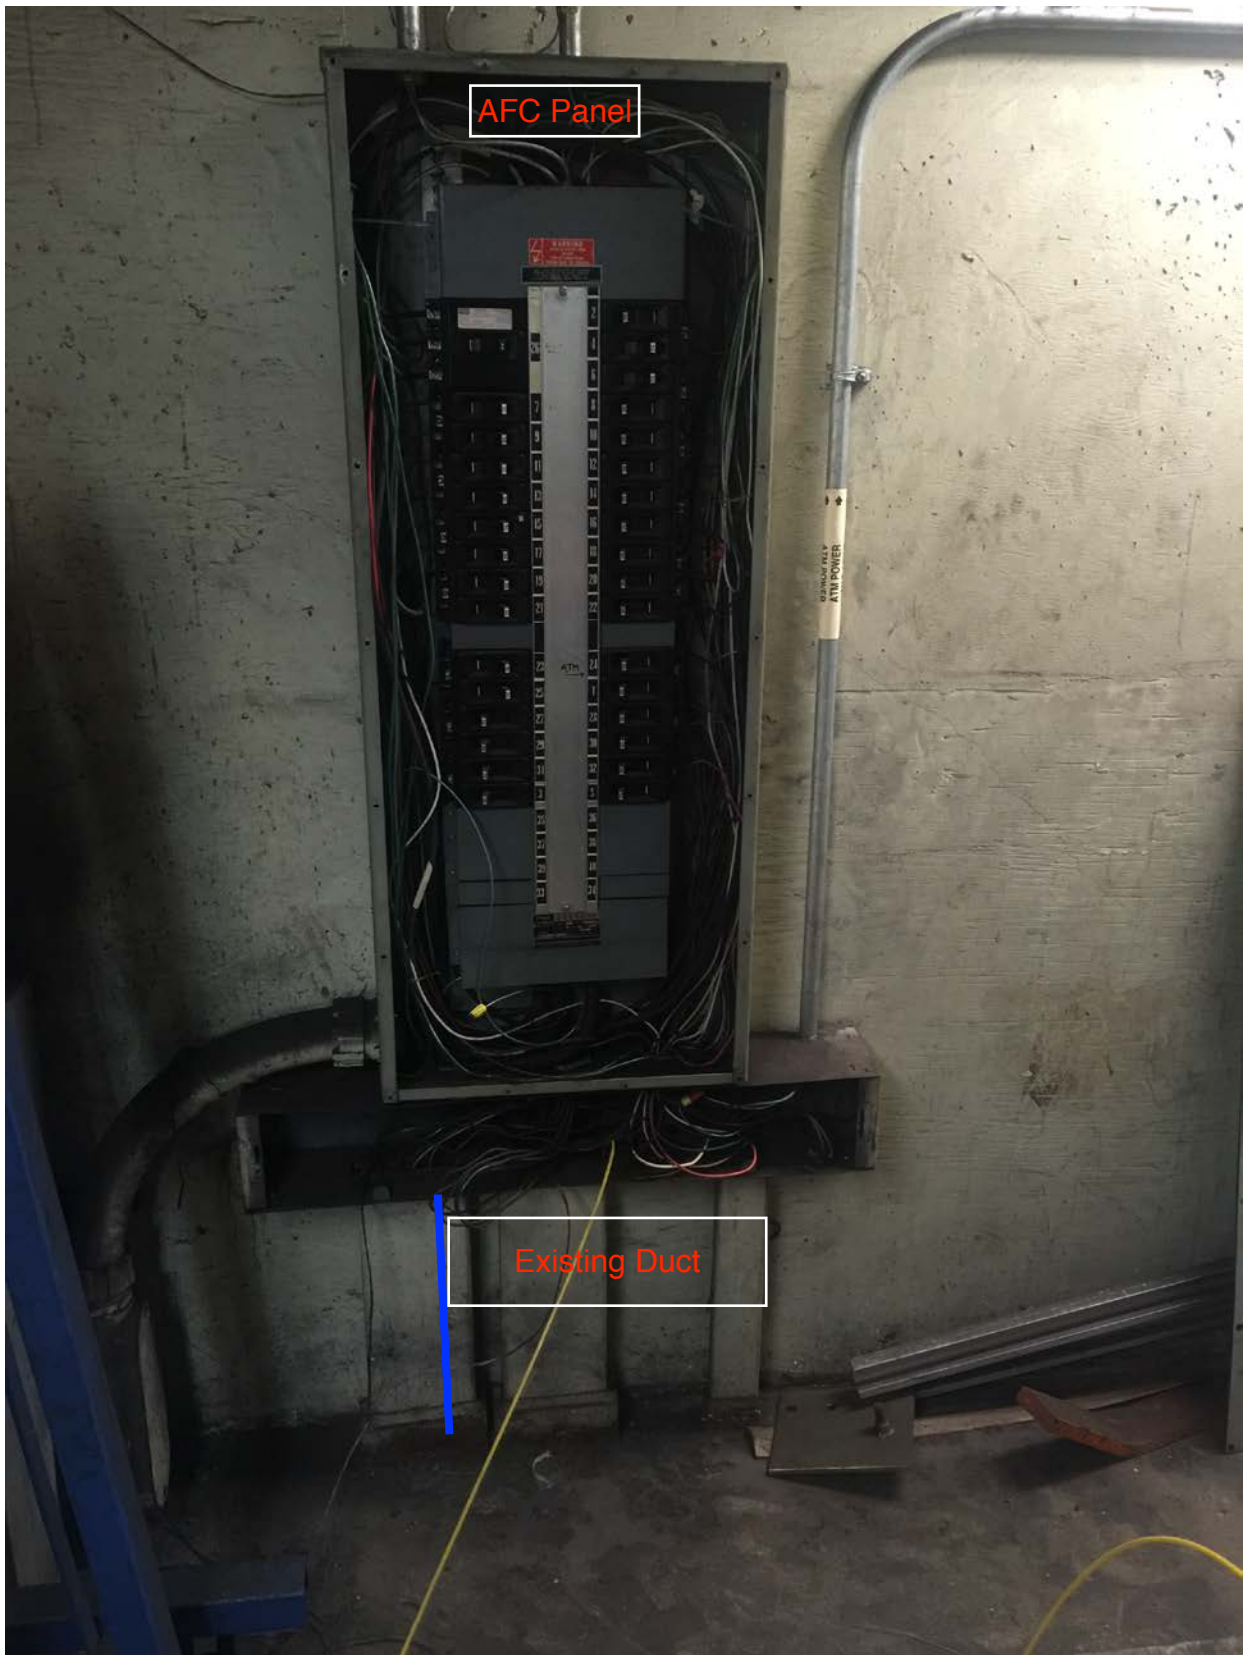
Photo #3 - AFC Panel and duct connection in Room N206.

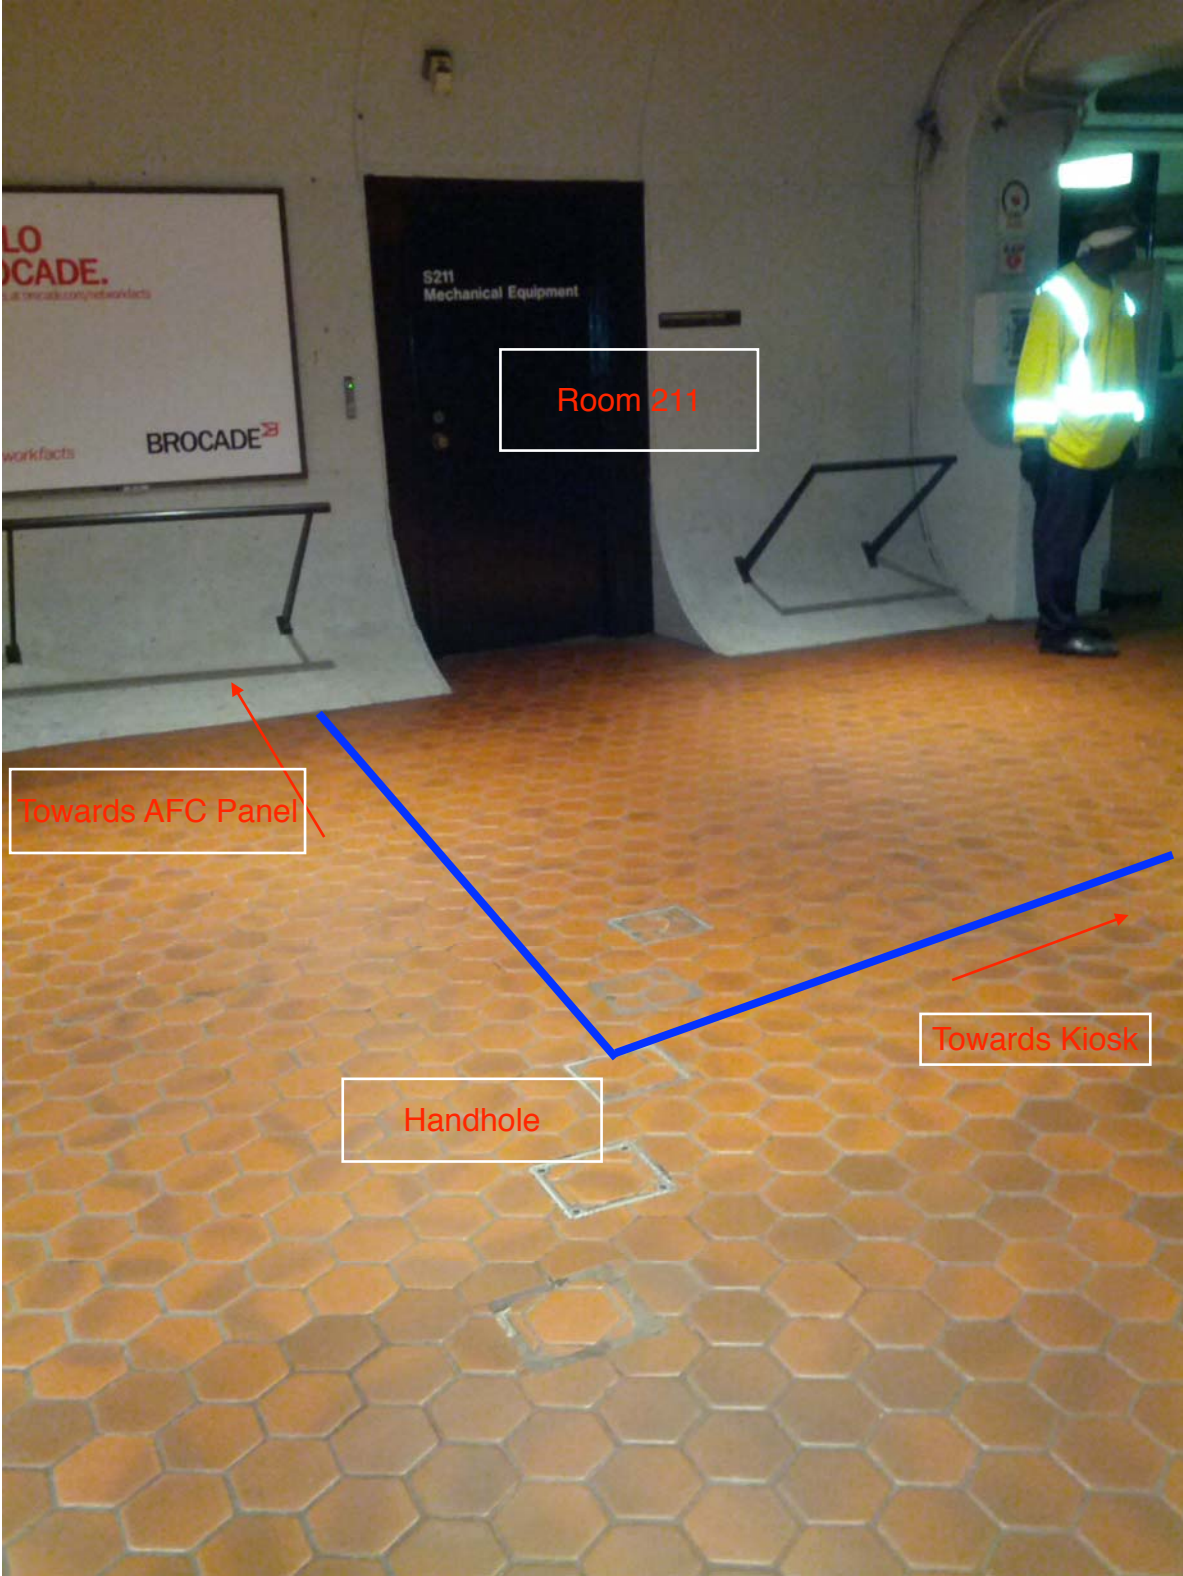
Photo #1 – Handholes located on Mezzanine Level outside Mechanical Room Room 211

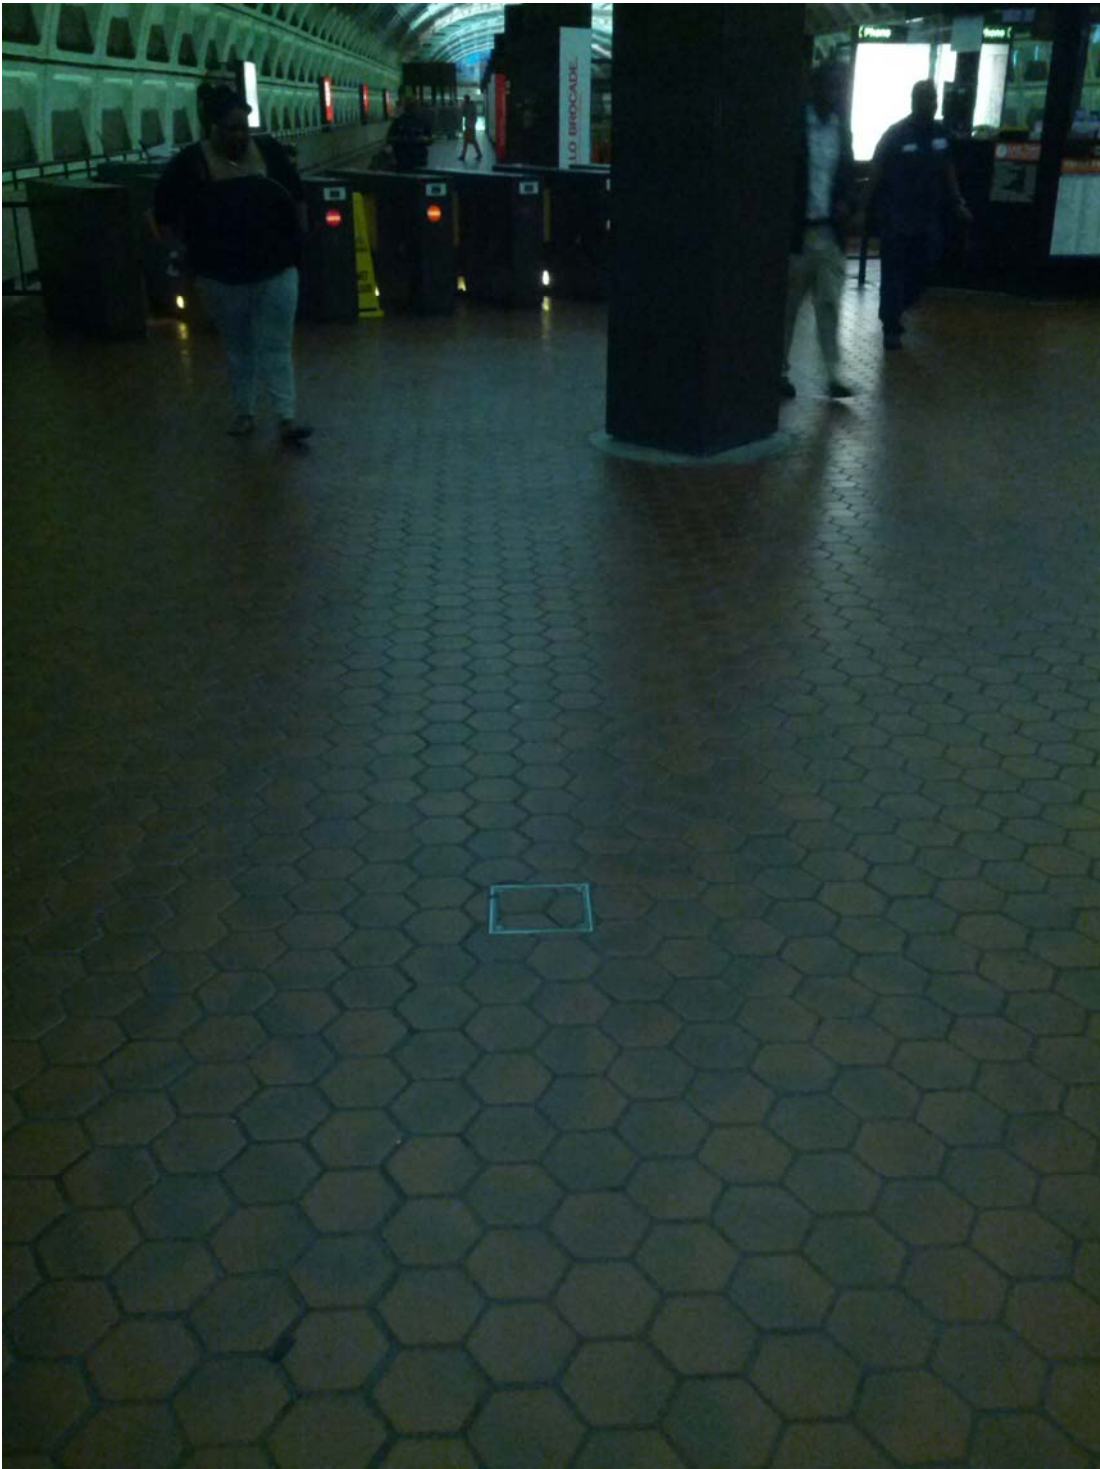
Photo #2 – Kiosk and faregates on mezzanine level.
