Mezzanine Inspection Report (Scoping)

Date: 1/21/2015	Station Name: C02 McPherson Square (East)	Mezzanine #: 036	Completed By: Mike Butler
------------------------	--	-------------------------	----------------------------------

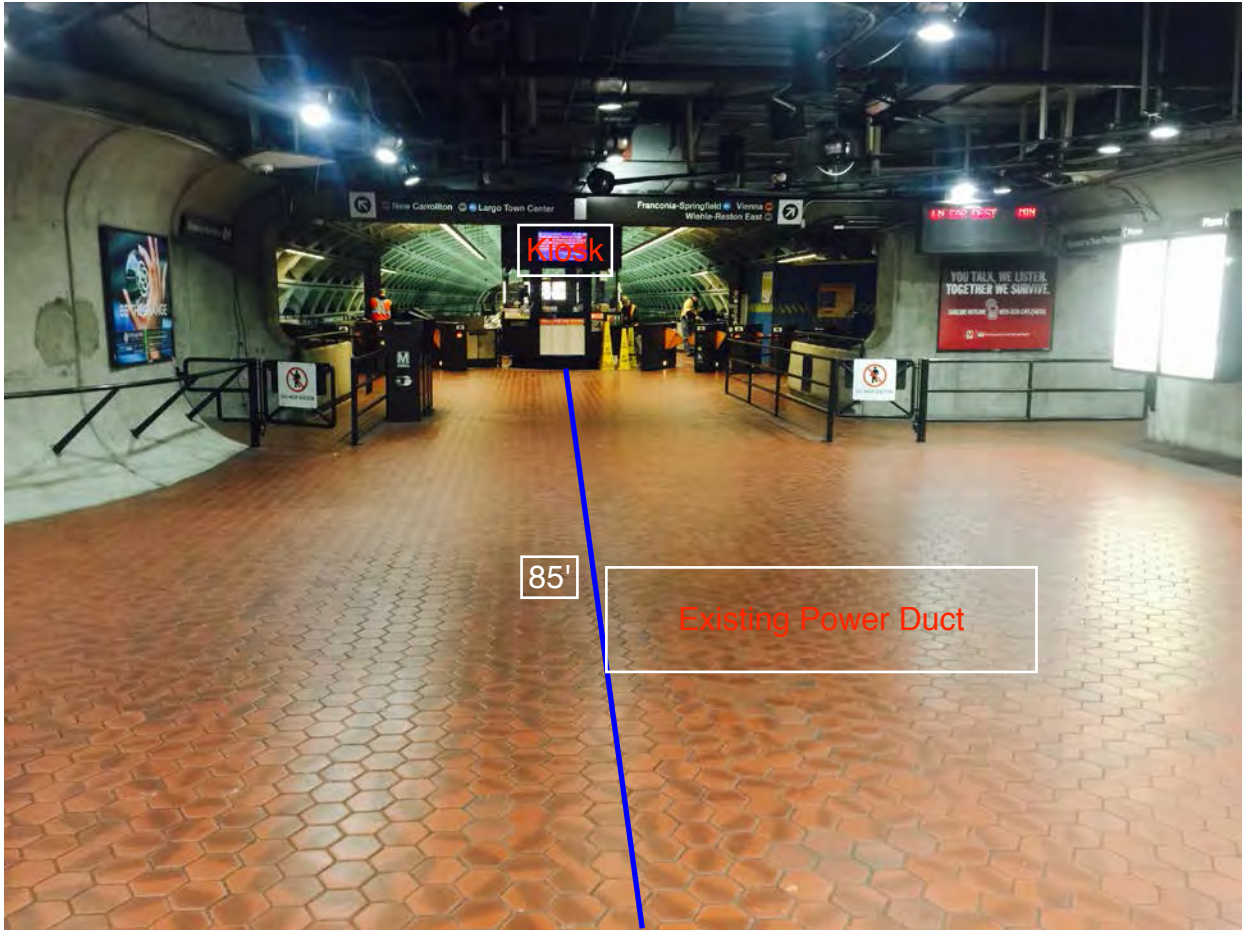
Photo #1 - Existing power duct run on mezzanine floor.

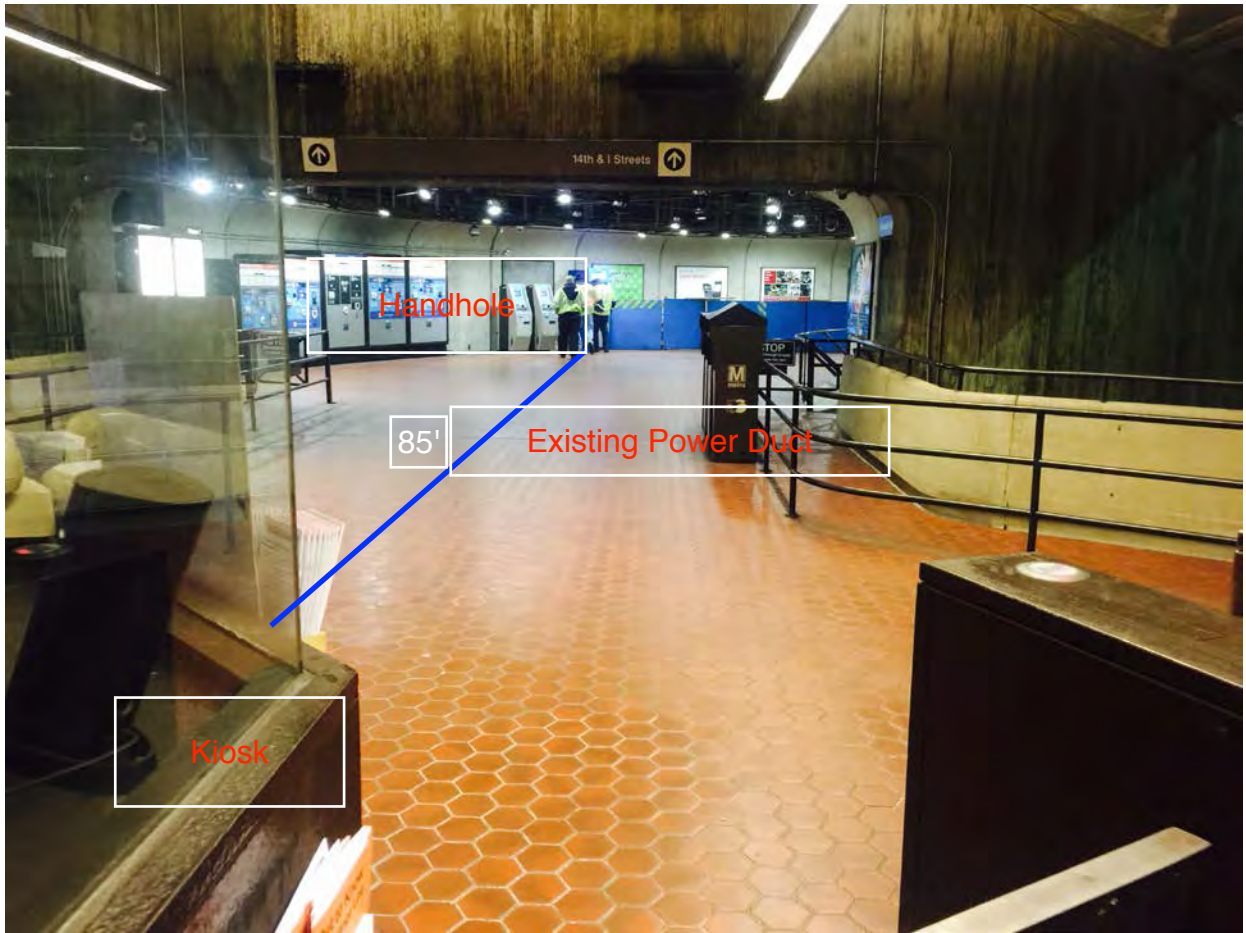
Photo #2 - Existing power duct run on mezzanine floor.
