Mezzanine Inspection Report

Date: 06/15/15	Station Name: C02 McPherson Square	Mezzanine #: 037	Completed By: Mike Butler
-----------------------	---	-------------------------	----------------------------------

15-NEPP-01
IN - FLOOR DUCT INSPECTIONS
C02 McPherson Square
PROPOSED POWER RUN

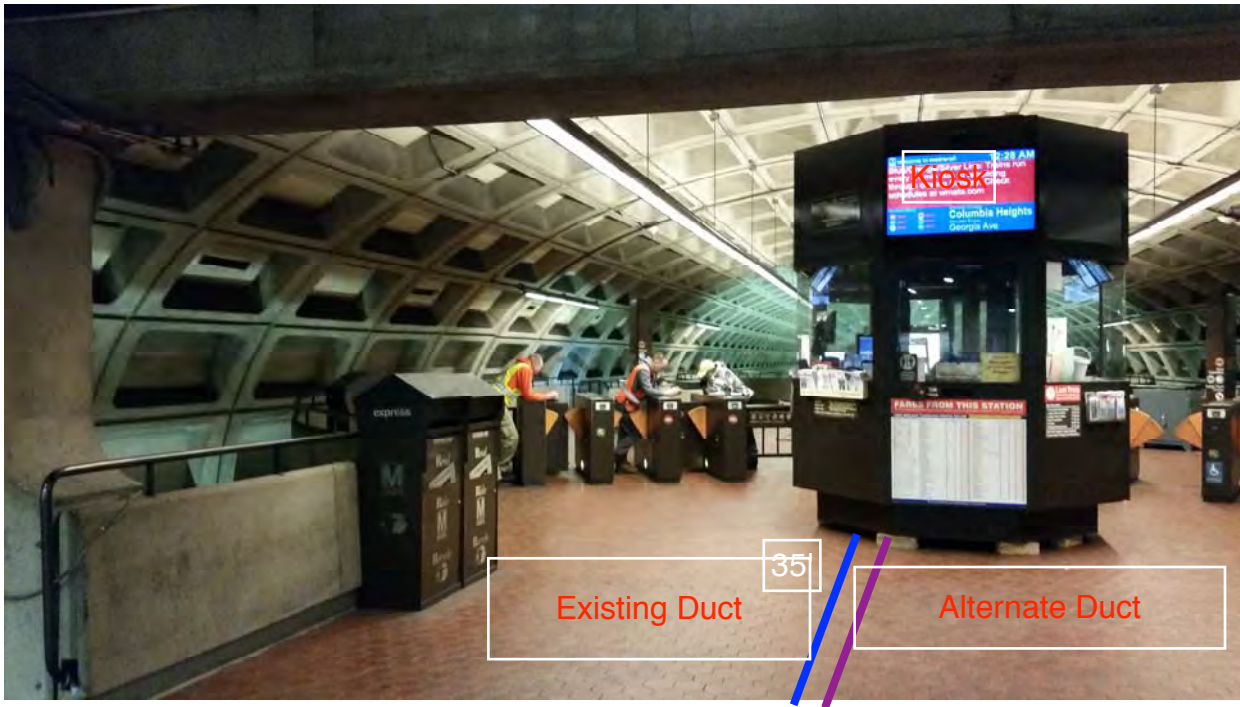
NEPP-02: Video scoping and pull string installation was attempted in an alternate duct that runs parallel with existing power duct from Kiosk to AFC Panel. Video scoping was completed from Kiosk to an in-floor access panel, and from AFC Panel to the same in-floor access panel. However, it was not possible to install pull string due to access issues to the in-floor access panel. A fare vending machine (Express Vendor #37; SN:FV1880) is currently blocking access to the in-floor access panel and will need to be moved to complete the pull string installation. The alternate duct appears to be in good condition and is at minimal capacity. The alternate duct leads to Panel NMWW-1A (Room 212), which is adjacent to the existing AFC Panel NWMM-1B. Panel NWMM-1A could be used as a potential power source for the new wires, or the new NEPP wires could be routed to AFC Panel NMWW-1B.

Photo 1 – Existing and alternate duct layout on mezzanine floor

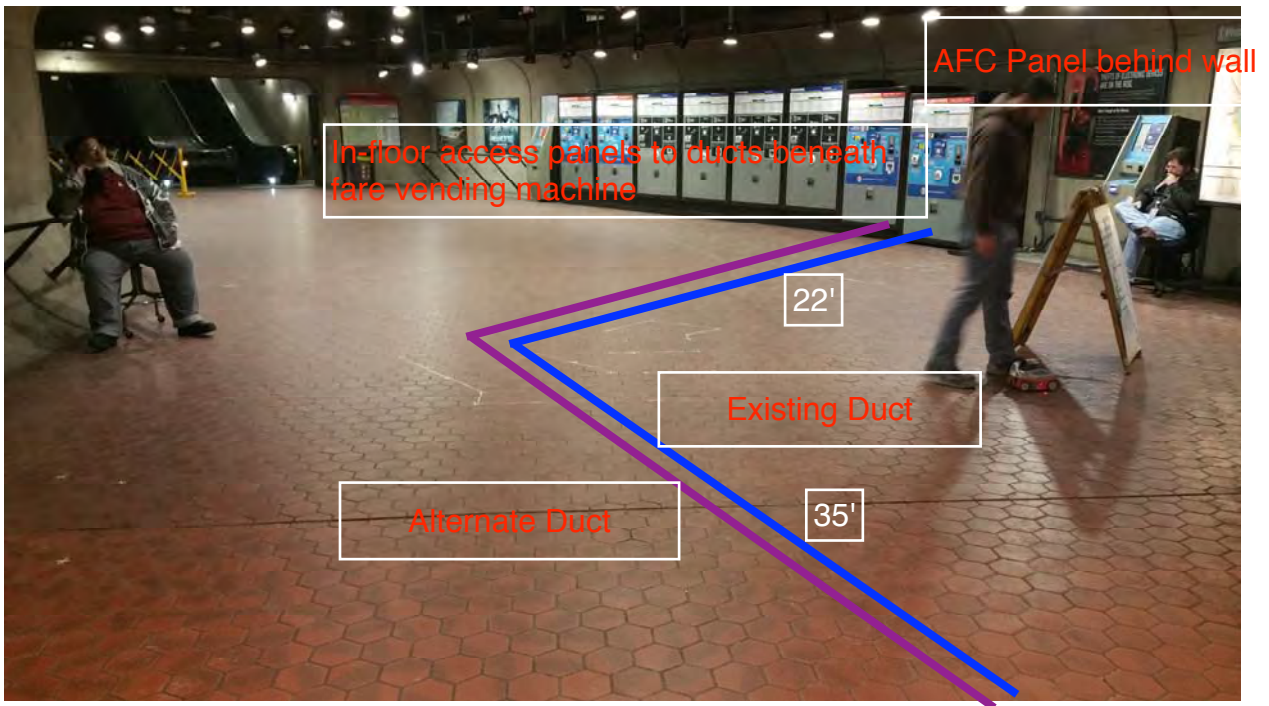
Photo 2 – Existing and alternate duct layout on mezzanine floor

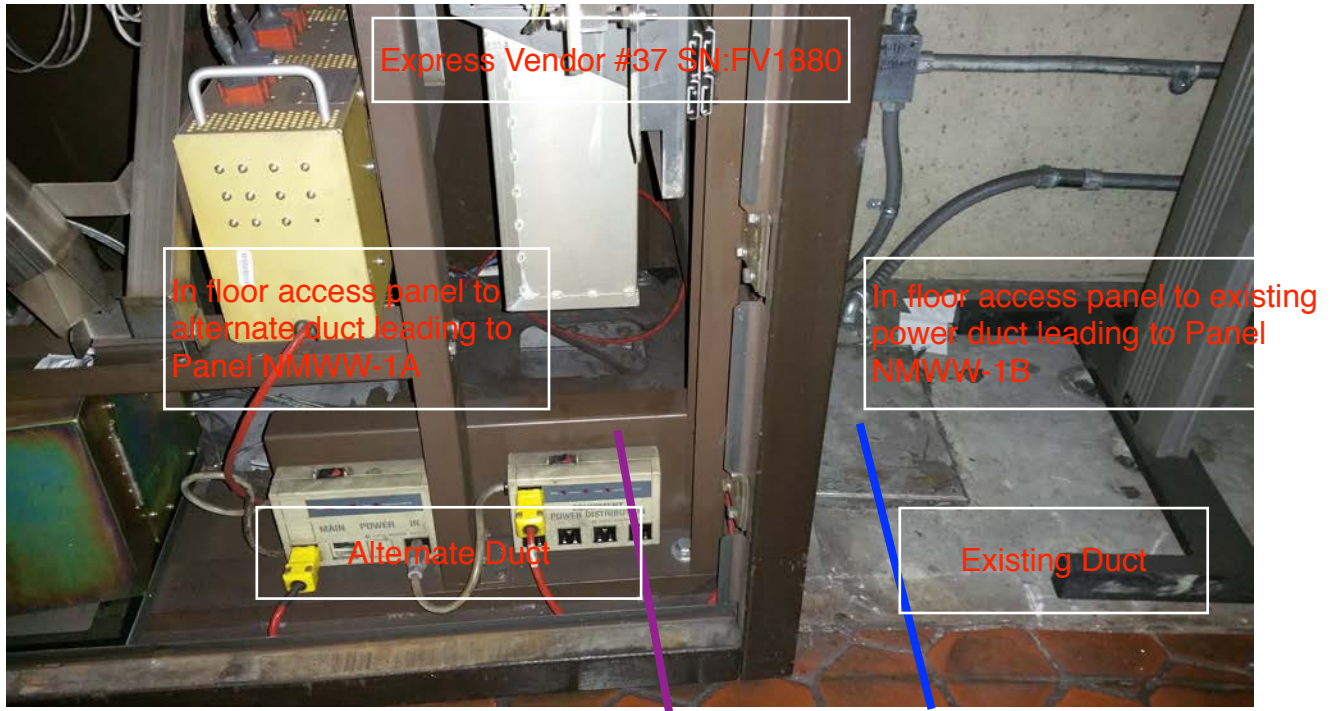
Was pull string installed?	No	Could not gain access to in-floor access panel, which prohibited the installation of pull string. Fare vending machine needs to be moved temporarily to allow access. There are no other obstructions in duct run.
Were there any obstructions or blockages? Provide details of type and specific location.	No	
Is the duct / conduit at capacity? Provide additional details about the dimensions of duct / conduit and number of wires.	No	6" walker duct with 5 wires.
Observations / Issues / Next Steps		
<ul style="list-style-type: none"> - The alternate duct was video scoped up to the in-floor access panel from Kiosk and AFC Panel sides; however it was not possible to scope across the in-floor access panel due to multiple crossing wires. The in-floor access panel is currently inaccessible due to a fare vending machine blocking access. - Pull string installation in alternate duct between Kiosk, In-floor Access Panel and AFC Panel (NMWW-1A) should be possible if the in-floor access panel is made accessible by moving the fare vending machine. - The alternate duct is at minimal capacity and in good condition, therefore viable for further use. - It should be noted that the alternate duct leads to Panel NMWW-1A (Room 212), which is adjacent to the existing AFC Panel NWMM-1B. Panel NWMM-1A could be used as a potential power source for the new wires, or the new NEPP wires could be routed to AFC Panel NMWW-1B.

Photo 3 – In floor access panels for existing and alternate ducts (beneath fare vending machine)

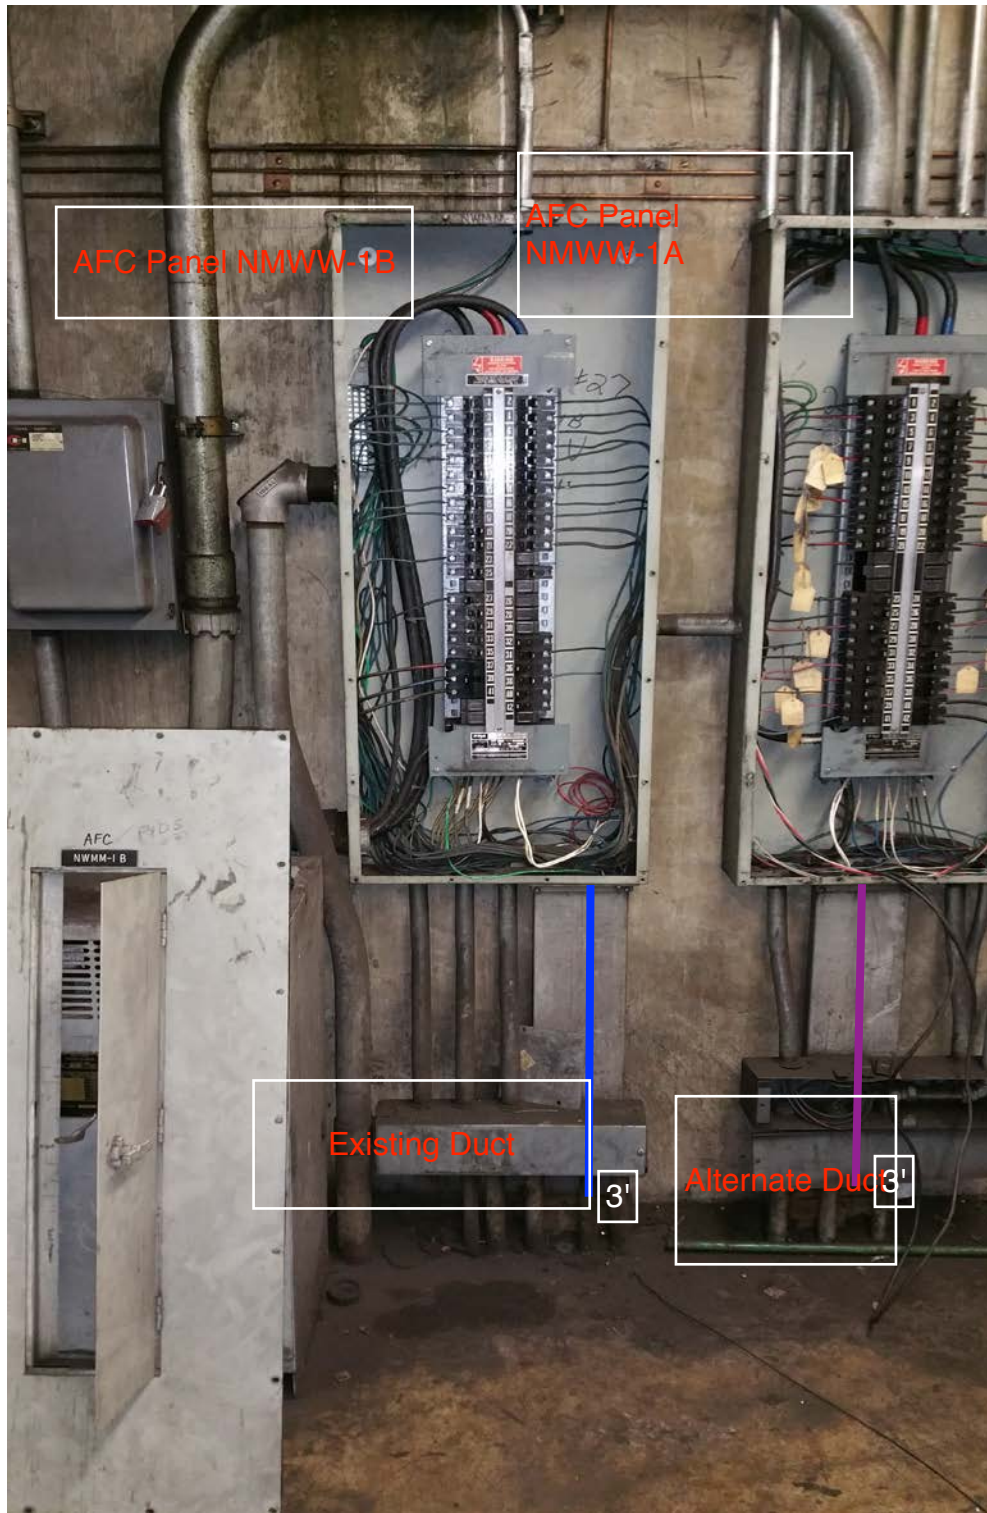
Photo 4 – AFC Panels NMWW-1B and NMWW-1A

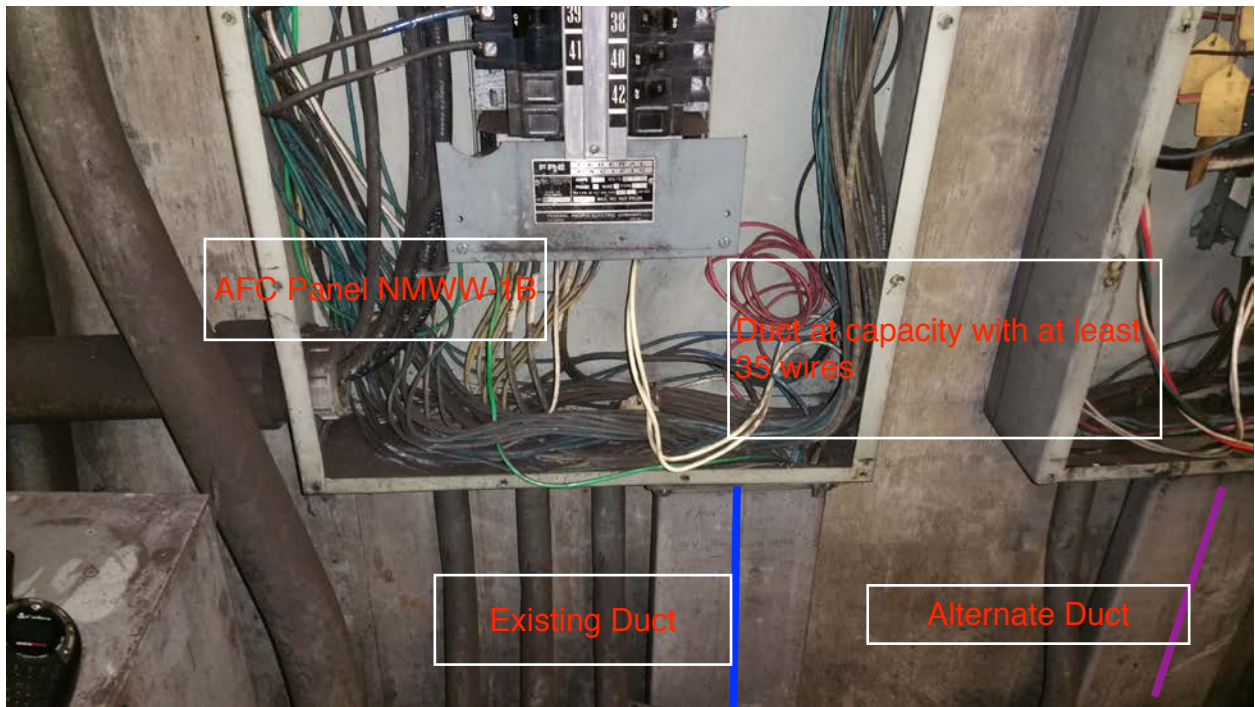
Photo 5 – AFC Panel NMWW-1B

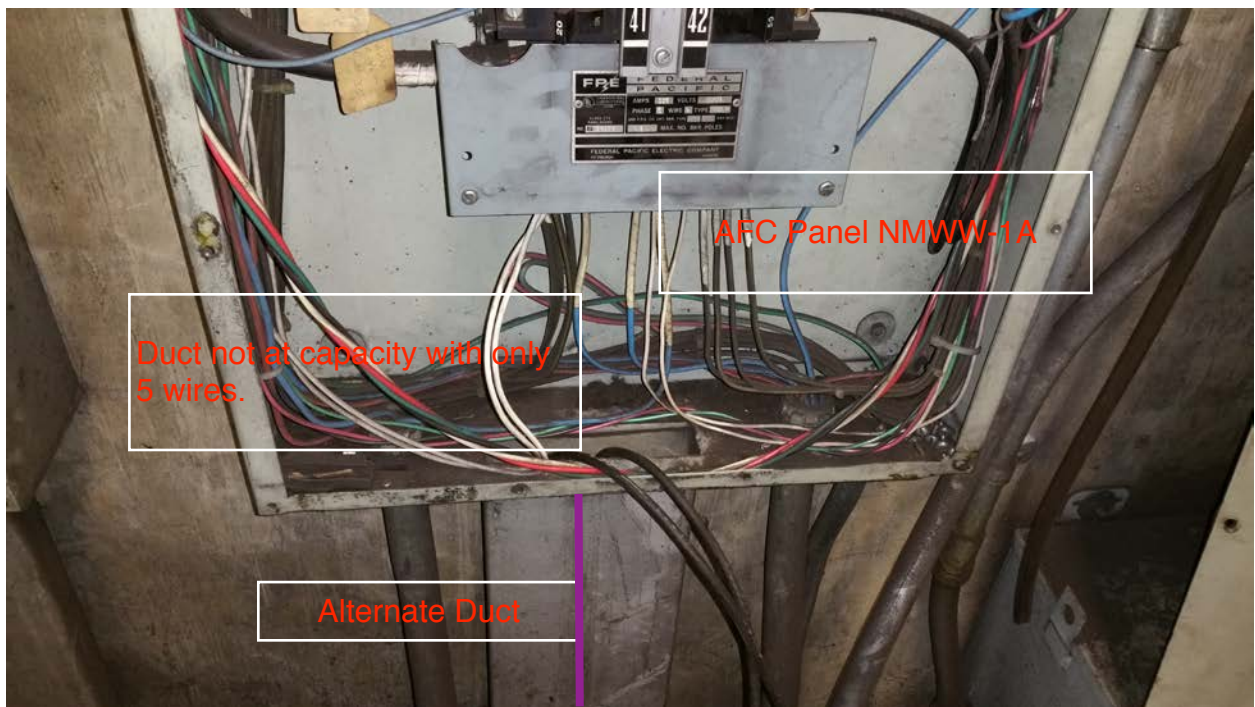
Photo 6 – AFC Panel NMWW-1A
