Mezzanine Inspection Report REVISION 3

Date: 03/11/2015 Station Name: Farragut West – C03 Mezzanine #: 038 Completed By: Mike Butler

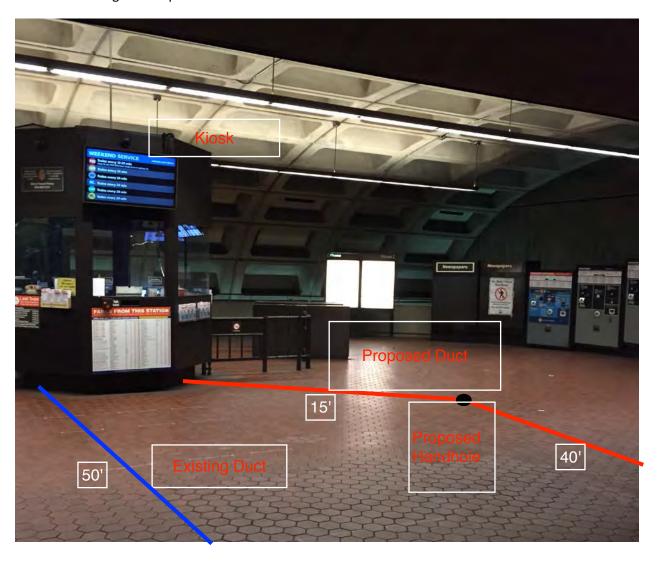
Photo #1: Existing and Proposed Duct from Kiosk

Scanning was completed at this mezzanine. A proposed duct is recommended to run from the southeast face of the kiosk and continue parallel to the existing ducts, hugging as close to the wall as possible. Handholes are proposed at the bend locations. The duct will transition from duct to overhead conduit at the third handhole, adjacent to the existing recycle bins. The proposed conduit will run vertically up the side wall to the core drill location where it will pass through the wall into Room 201. Once inside Room 201, the conduit will run along the inside wall towards the AFC Panel.

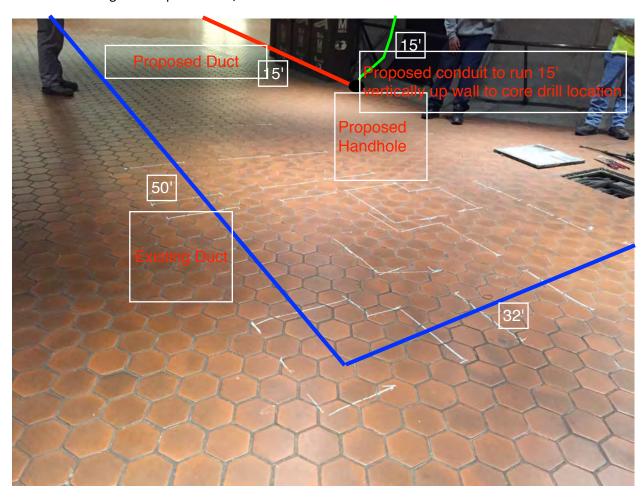
Photo #2: Existing and Proposed Duct/Conduit on mezzanine floor

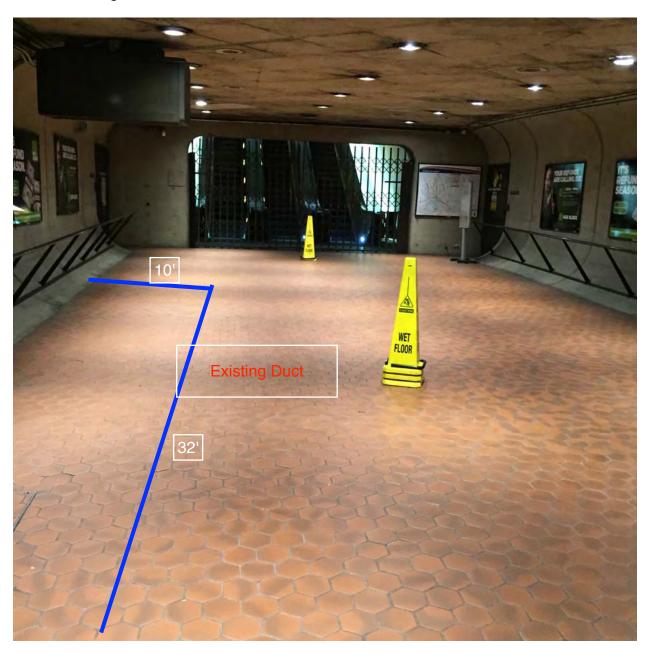
Photo #3: Existing duct on mezzanine floor

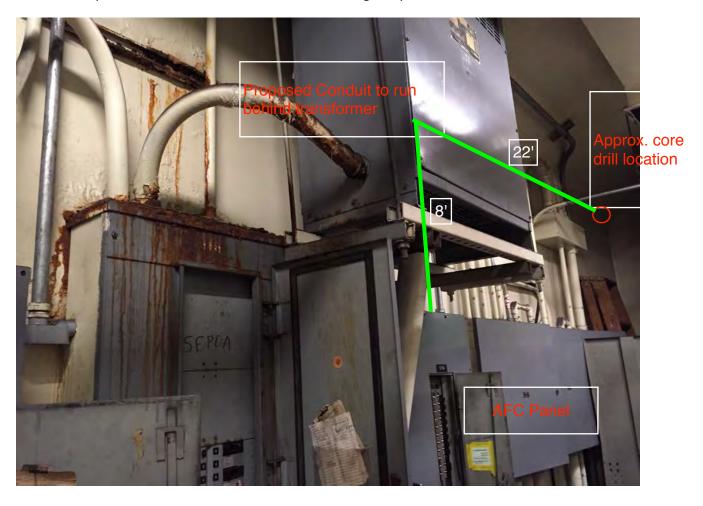
Photo #4: Proposed Conduit from core drill location feeding AFC panel SEMA in room 201

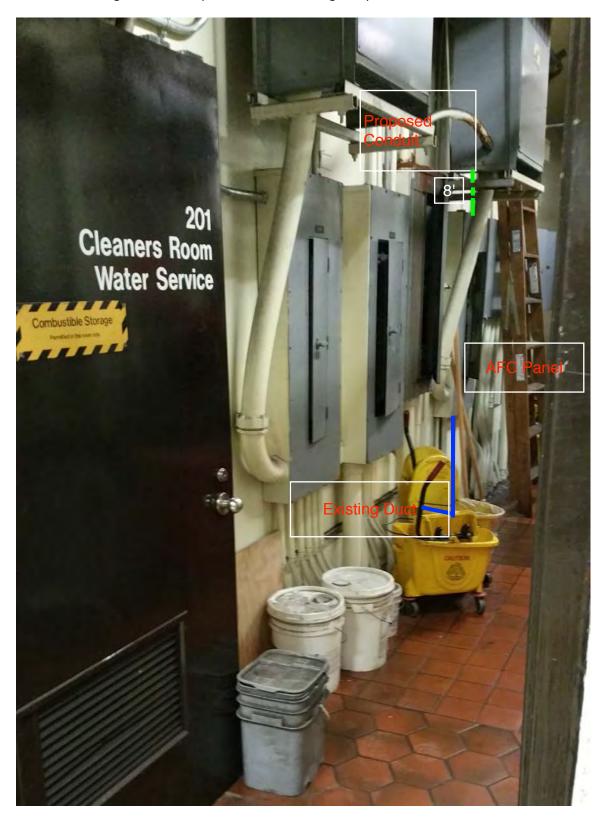
Photo #5: Existing Duct and Proposed Conduit feeding AFC panel SEMA in room 201
