# Mezzanine Inspection Report

Date: 02/13/2015	Station Name: Foggy Bottom – C04	Mezzanine #: 040	Completed By: Mike Butler
------------------	----------------------------------	------------------	---------------------------

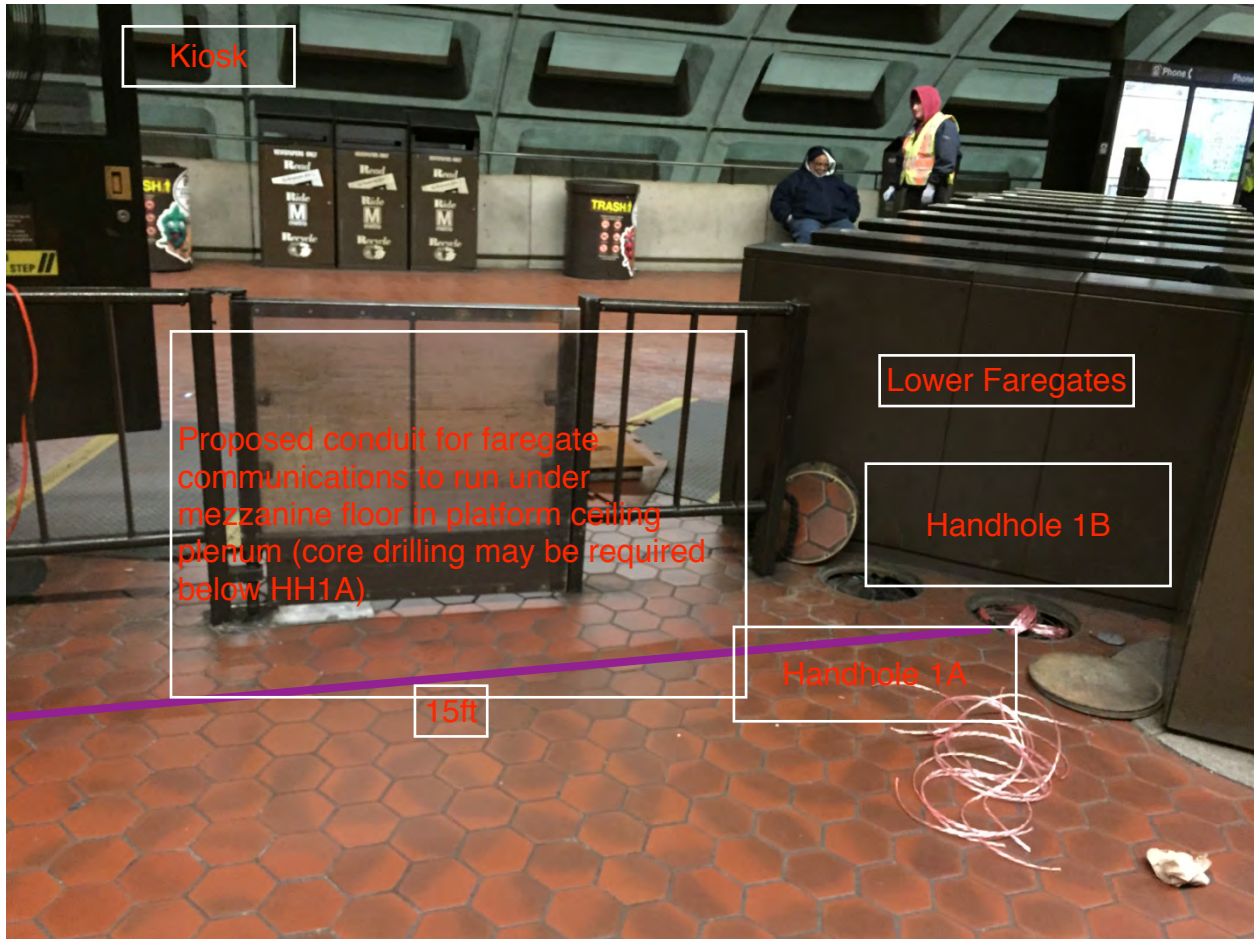
Photo #1 – Proposed conduit run from Kiosk to Handhole 1A for lower faregate array communications run

A proposed conduit is also recommended between Kiosk and Handhole 1A. The proposed conduit will run vertically down from the Kiosk to ceiling plenum at platform level. It will then continue along ceiling plenum until it reaches Handhole 1A where it will rise up and core drill through ceiling.

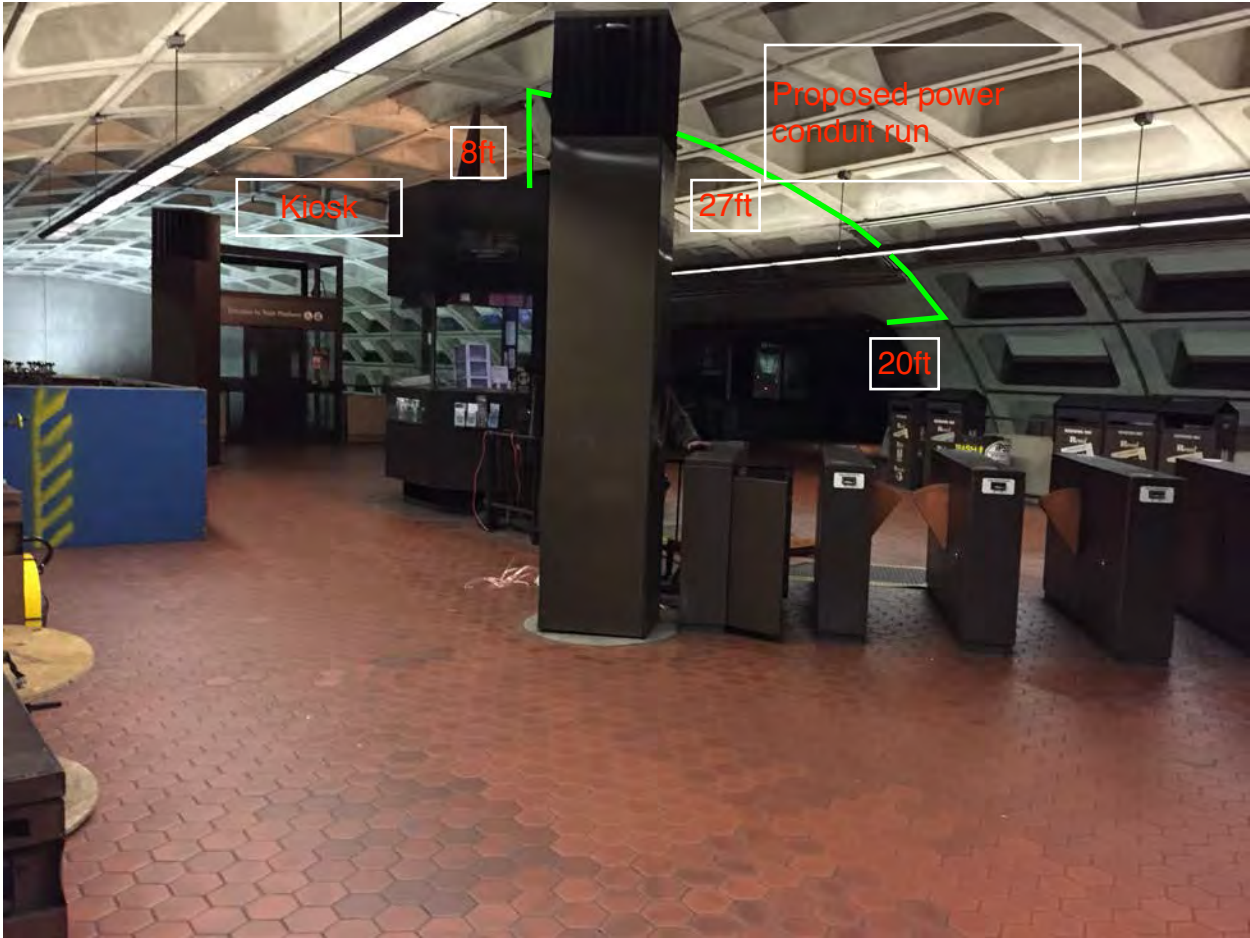
Photo #2 – Proposed conduit run from kiosk along mezzanine ceiling and wall

Scanning was completed at this mezzanine. The mezzanine floor is congested with existing in-floor ducts, and there is no feasible in-floor duct option. An overhead conduit run is proposed between the Kiosk and AFC Panel. The proposed conduit will rise up vertically from kiosk and run along the vaulted ceiling until it reaches mezzanine passageway. The overhead conduit will then run through the ceiling plenum above the mezzanine passageway. Once the proposed conduit reaches the passageway's outer wall, it will core drill through the wall into Room C204 and feed into AFC Panel.
