## Mezzanine Inspection Report

<b>Date:</b> 3/19/2015	<b>Station Name:</b> C05 - Rosslyn (Old)	<b>Mezzanine #:</b> 041	<b>Completed By:</b> Mike Butler
------------------------	--	-------------------------	----------------------------------

## Mezzanine Inspection Report (Scoping)

<b>Date:</b> 3/13/2015	<b>Station Name:</b> C05 - Rosslyn	<b>Mezzanine #:</b> 113	<b>Completed By:</b> Mike Butler
------------------------	------------------------------------	-------------------------	----------------------------------

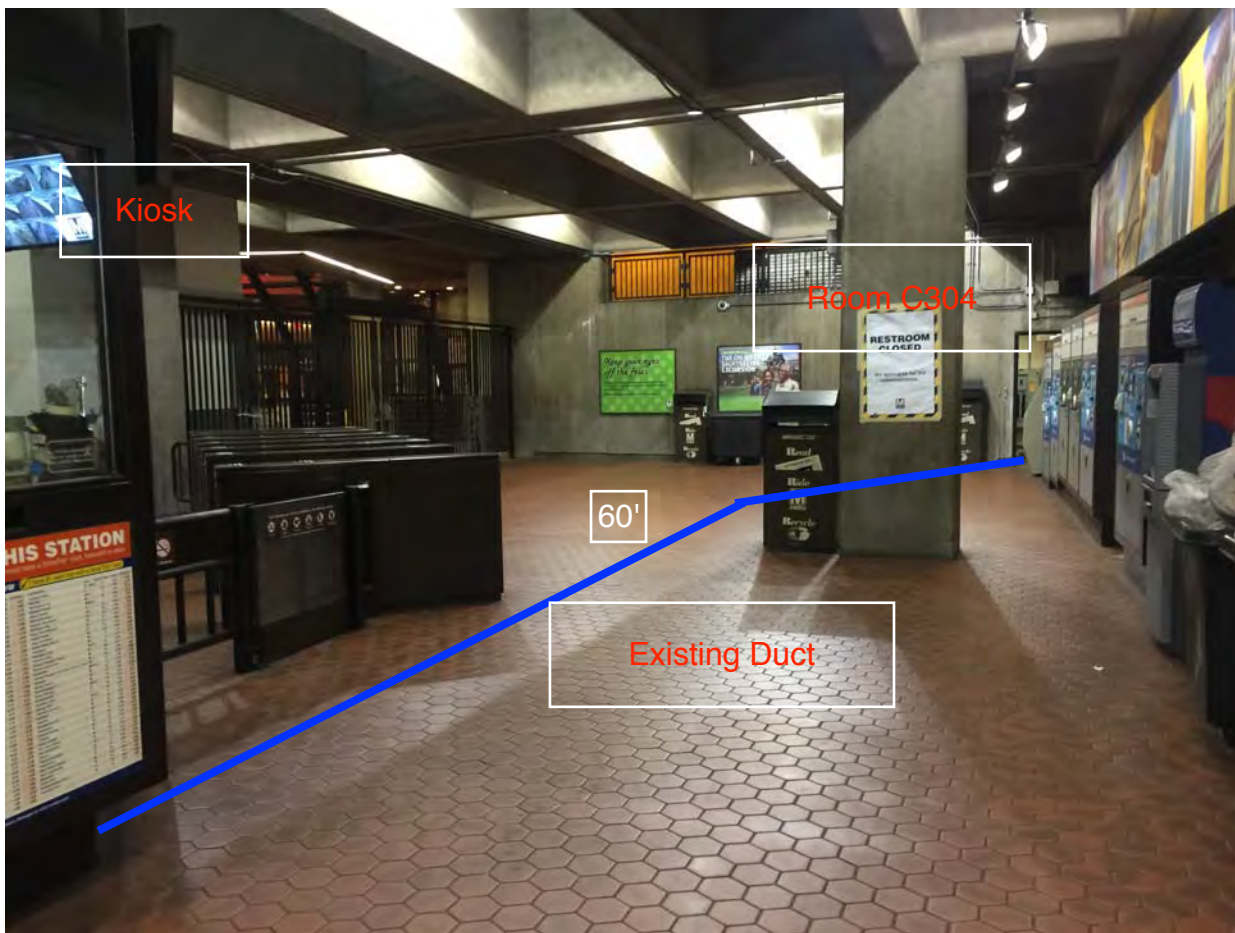
Photo 1 – Existing duct run from Kiosk to AFC panel

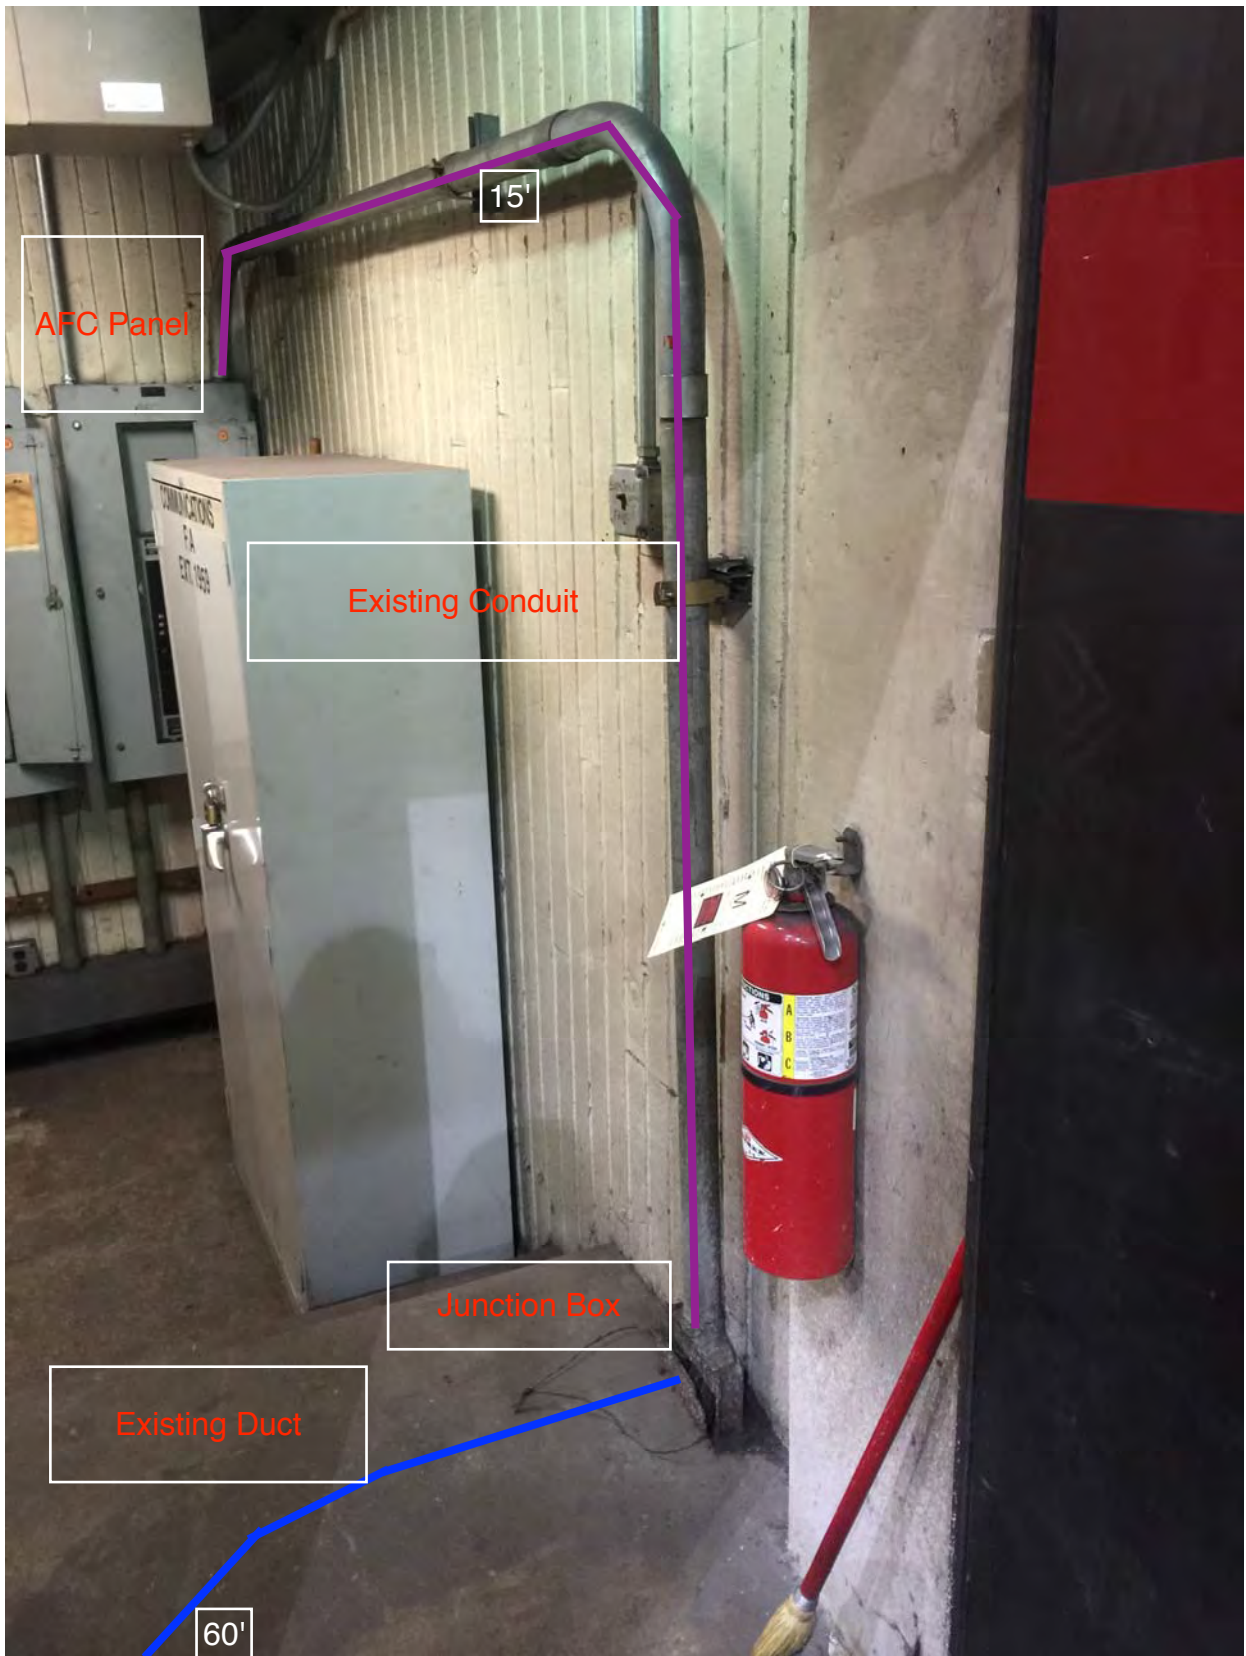
Photo 2 – Existing duct / conduit transition at Junction Box, and AFC Panel.

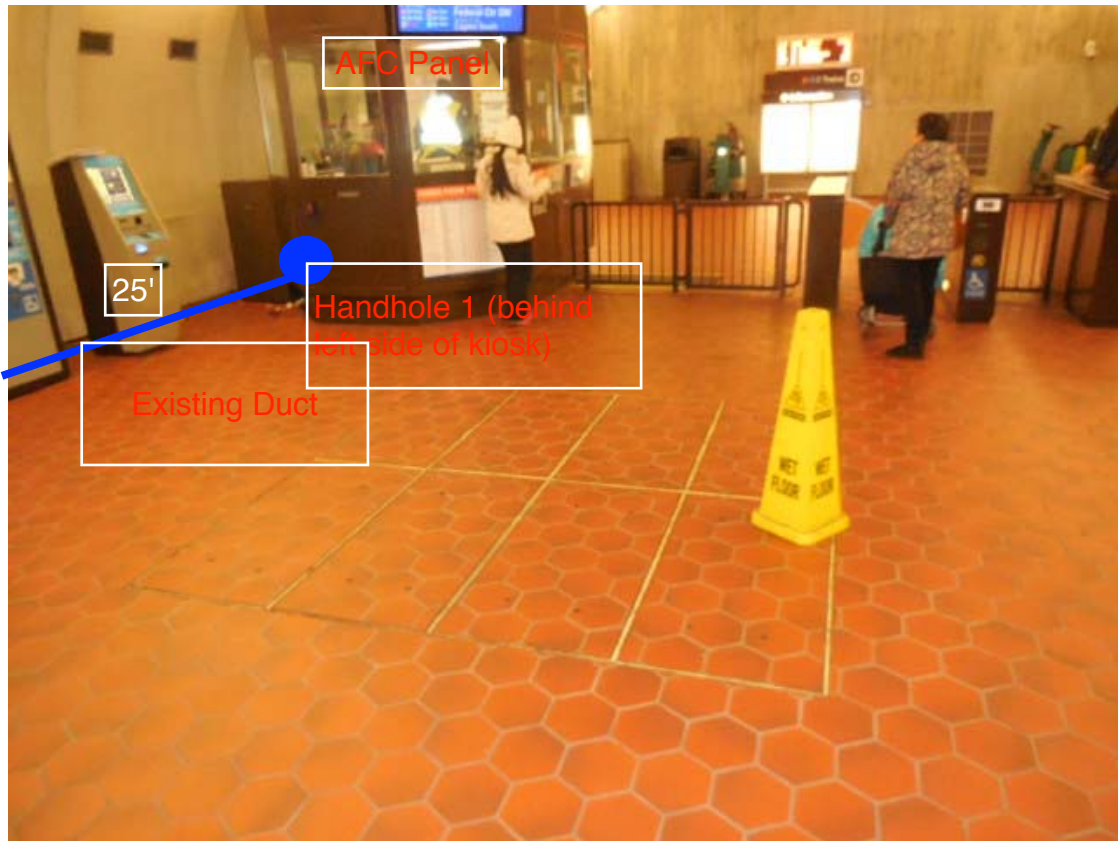
Photo 1 – Existing duct layout on mezzanine floor.

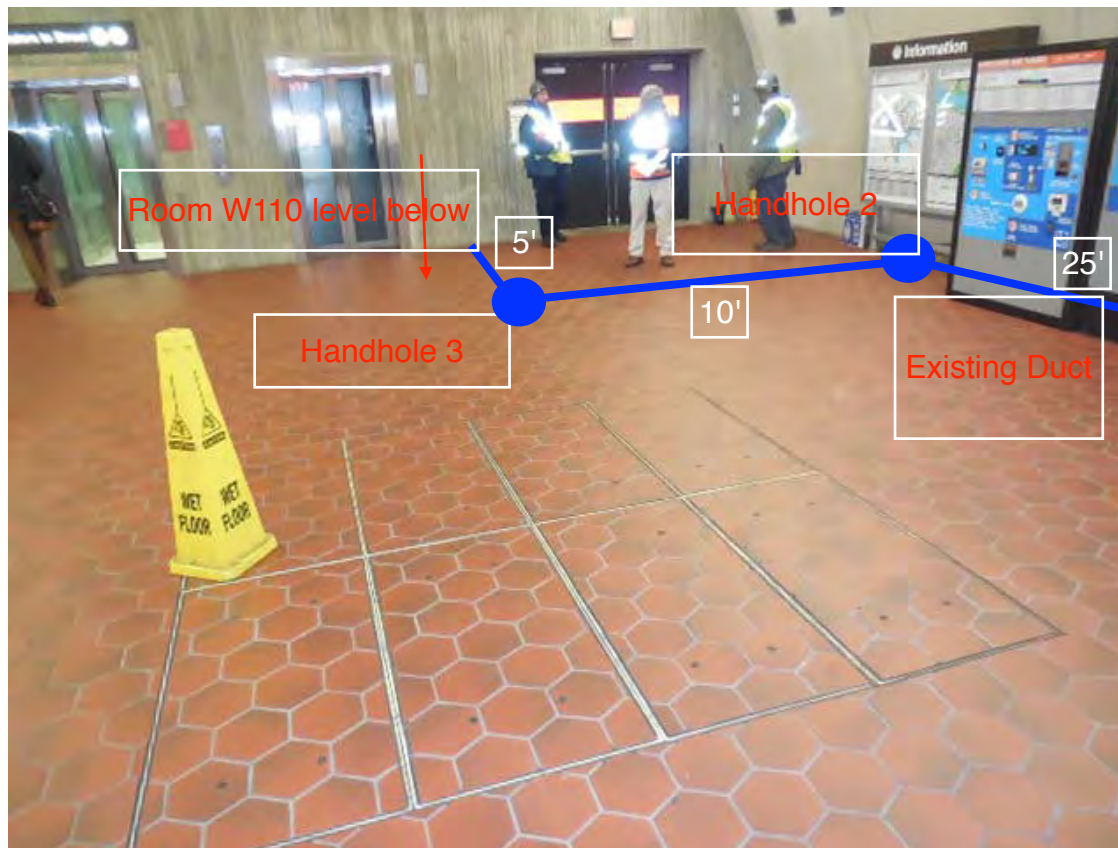
Photo 2 – Existing duct layout on mezzanine floor.

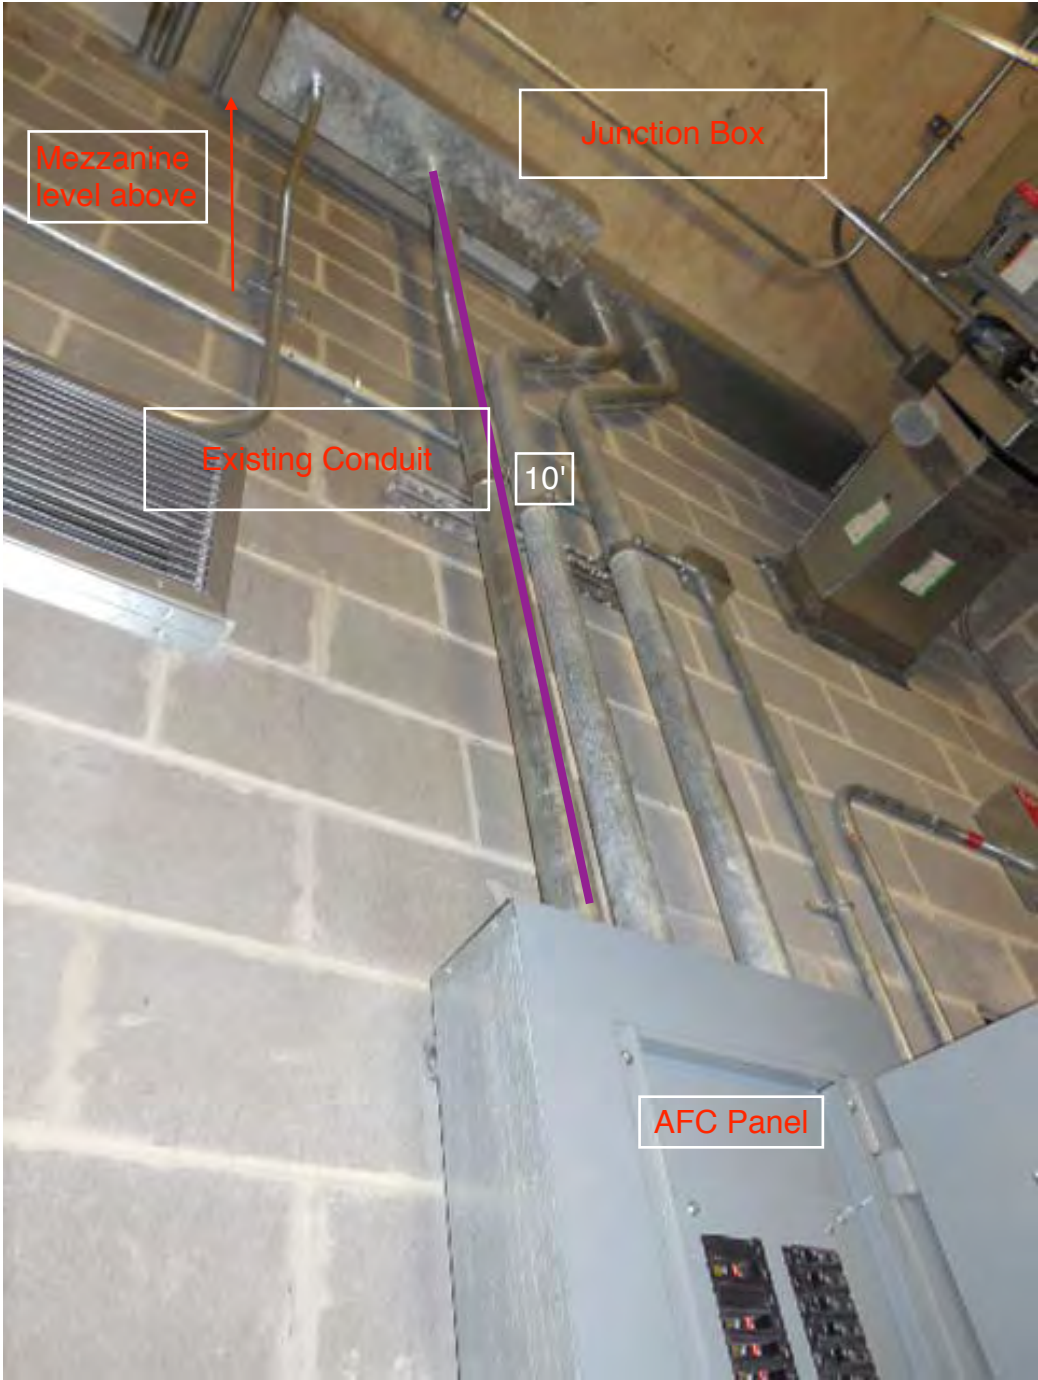
Photo 3 – Junction box and conduit feeding AFC Panel in Room W110.
