Mezzanine Inspection Report (Scoping)

Date: 02/09/2015	Station Name: C06 Arlington Cemetary	Mezzanine #: 042	Completed By: Zach Fitzwater
Summary			
<p>Video scoping and pull string installation complete for communication duct in upper and lower faregate arrays. Video scoping complete in the power duct in the lower faregate array. Video scoping only partially completed in power duct for upper faregate array due to tangled wires near the kiosk and at the 45 degree bend to faregates. Pull string was installed in vacant 2" power conduit from kiosk to AFC panel.</p> <p>Scanning is not required for this mezzanine.</p>			
Scoping of Faregate Array(s)			
Task	4	Yes/No	Notes
Communications Duct – Upper Faregate Array (5-Gates)			
Was video scoping completed for the entire duct run?		Yes	Refer to WMATA Arlington Cemetary 3inch Upper Comm Faregate.avi and WMATA Arlington Cemetary 6inch Upper Comm Faregate.avi files.
Were pull strings installed at all faregates in the array?		Yes

Mezzanine Inspection Report

Date: 06/21/15	Station Name: D01 – Federal Triangle	Mezzanine #: 053	Completed By: Mike Butler
----------------	--------------------------------------	------------------	---------------

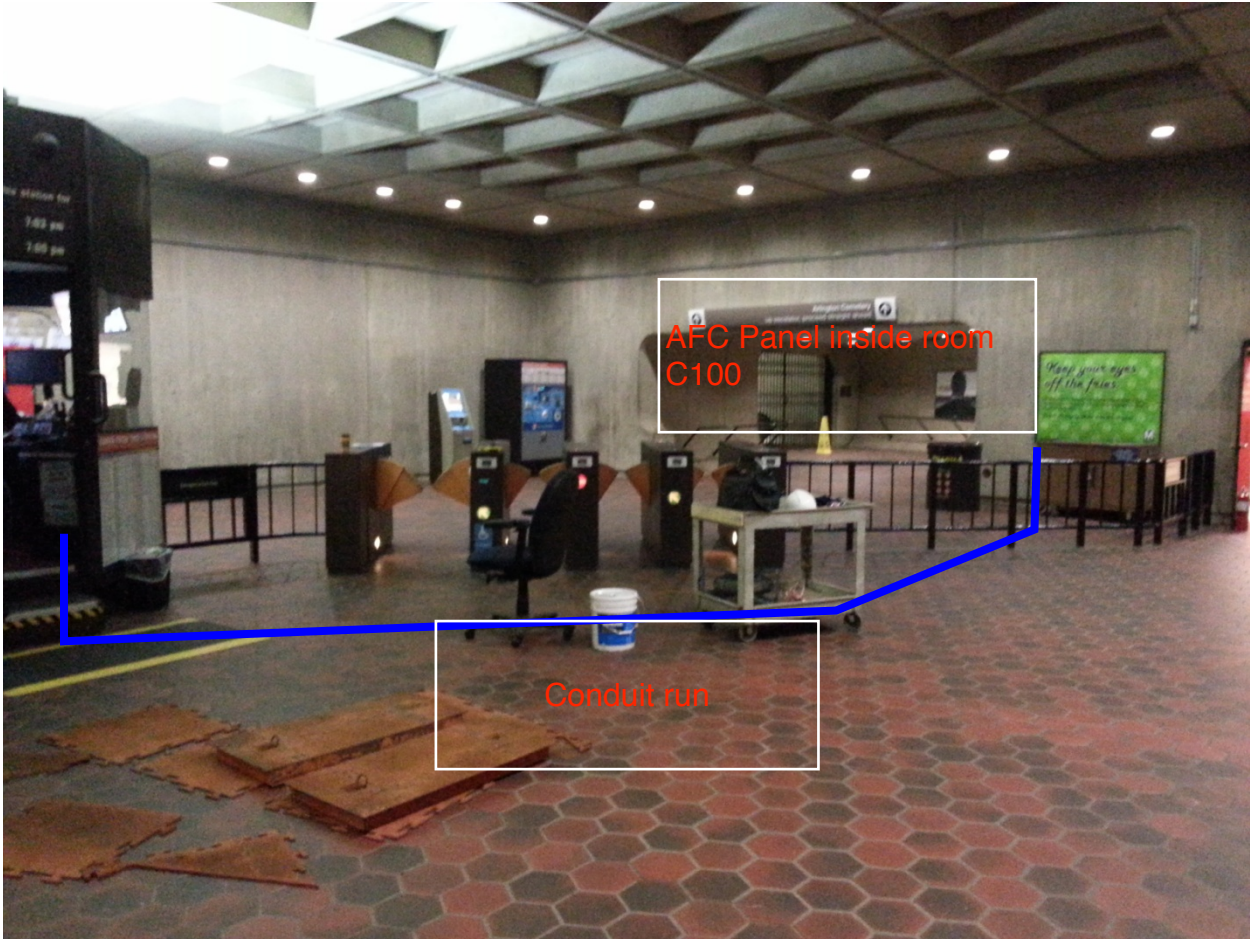
Photo #1 – C06 Arlington Cemetery: Kiosk to outside wall of Room C100

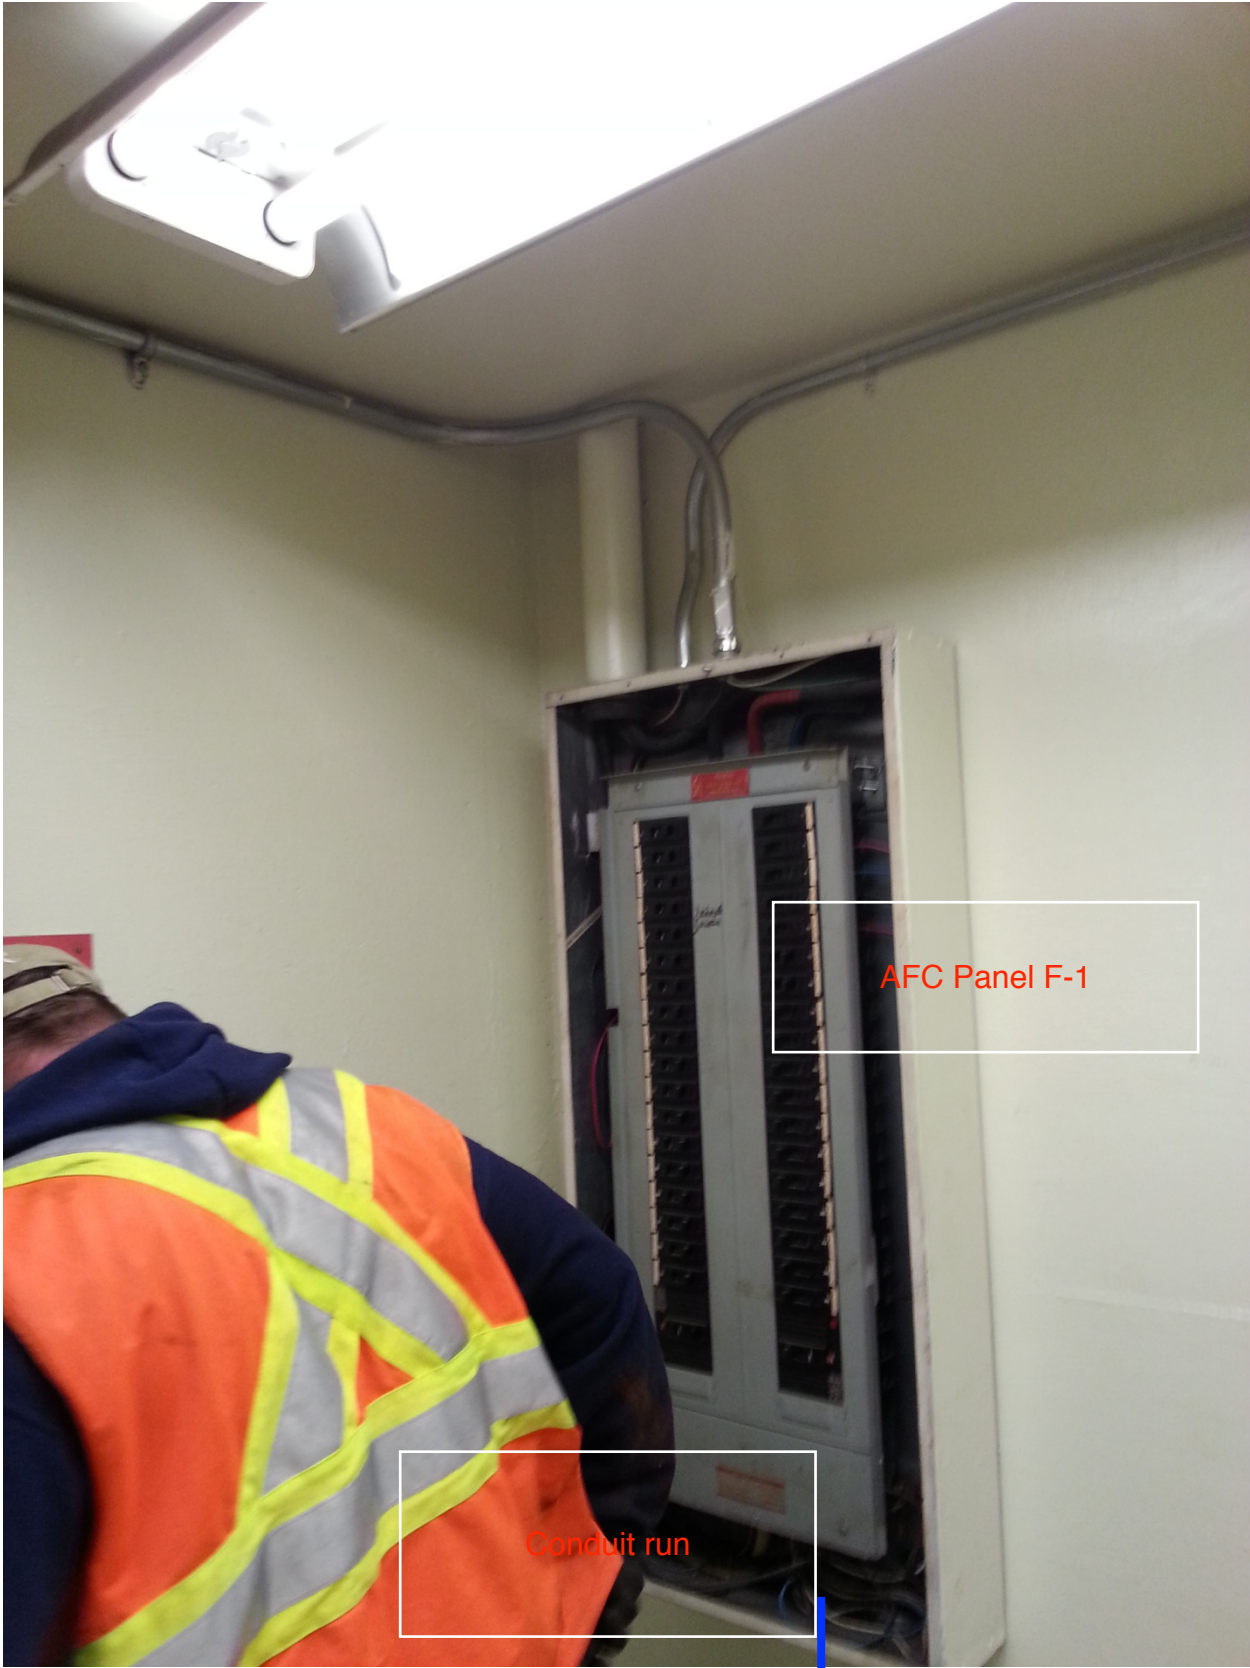
Photo #2 – C06 Arlington Cemetery: AFC Panel F-1

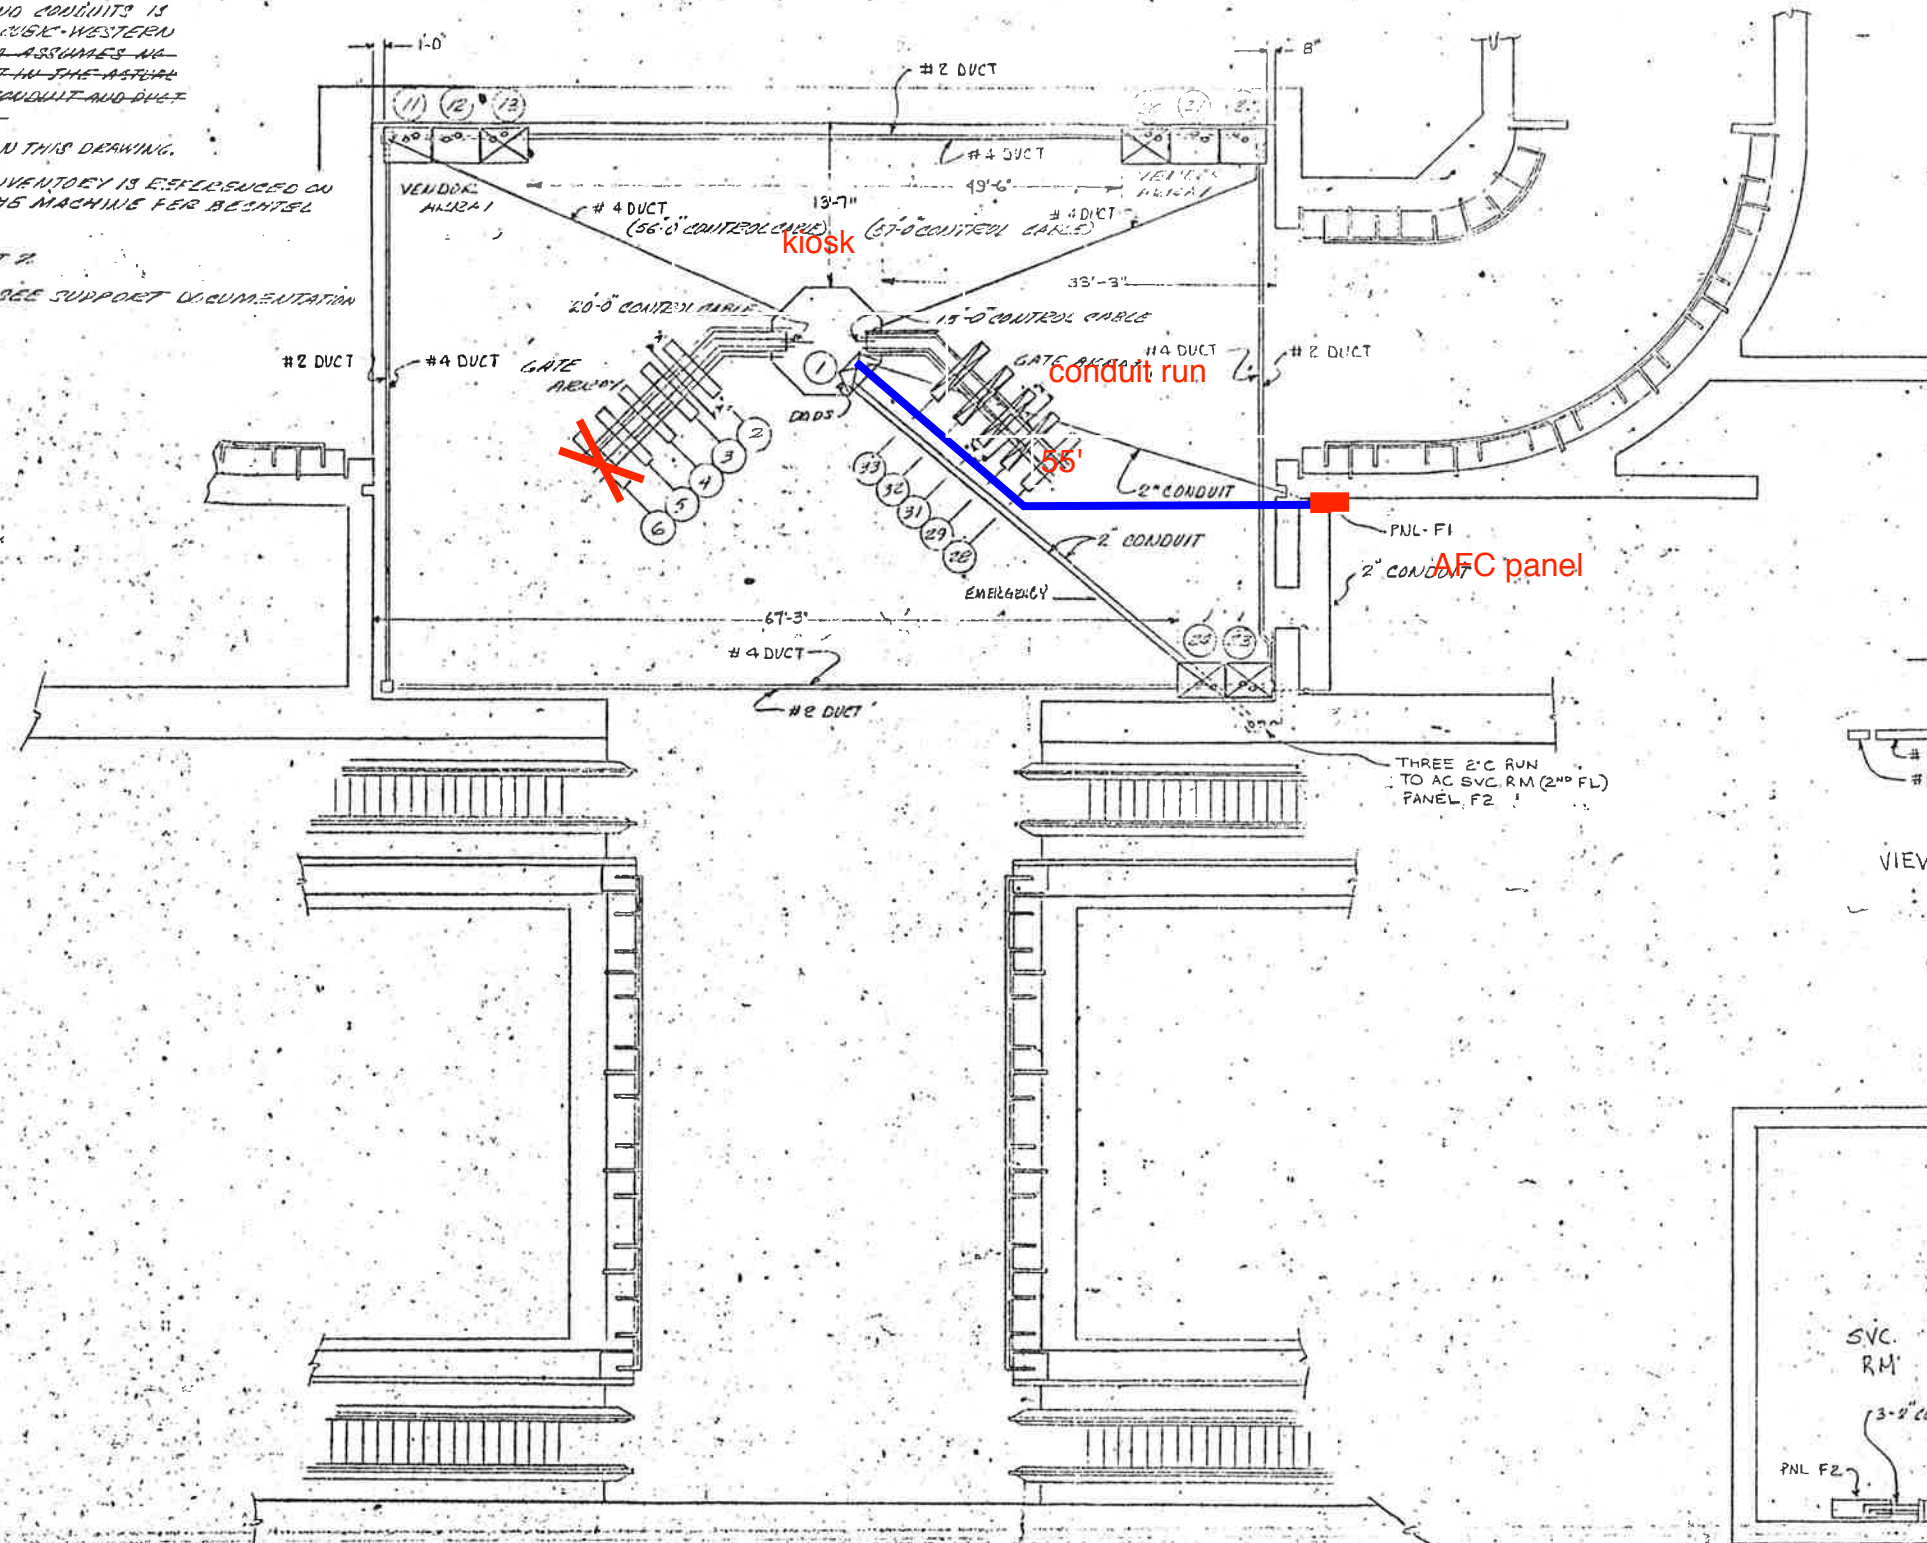
VIEW 'A-A'

- 1) No of conductors for power
- 2) Note 1 Not acceptable
- 3) Fence should be depicted in gate area.

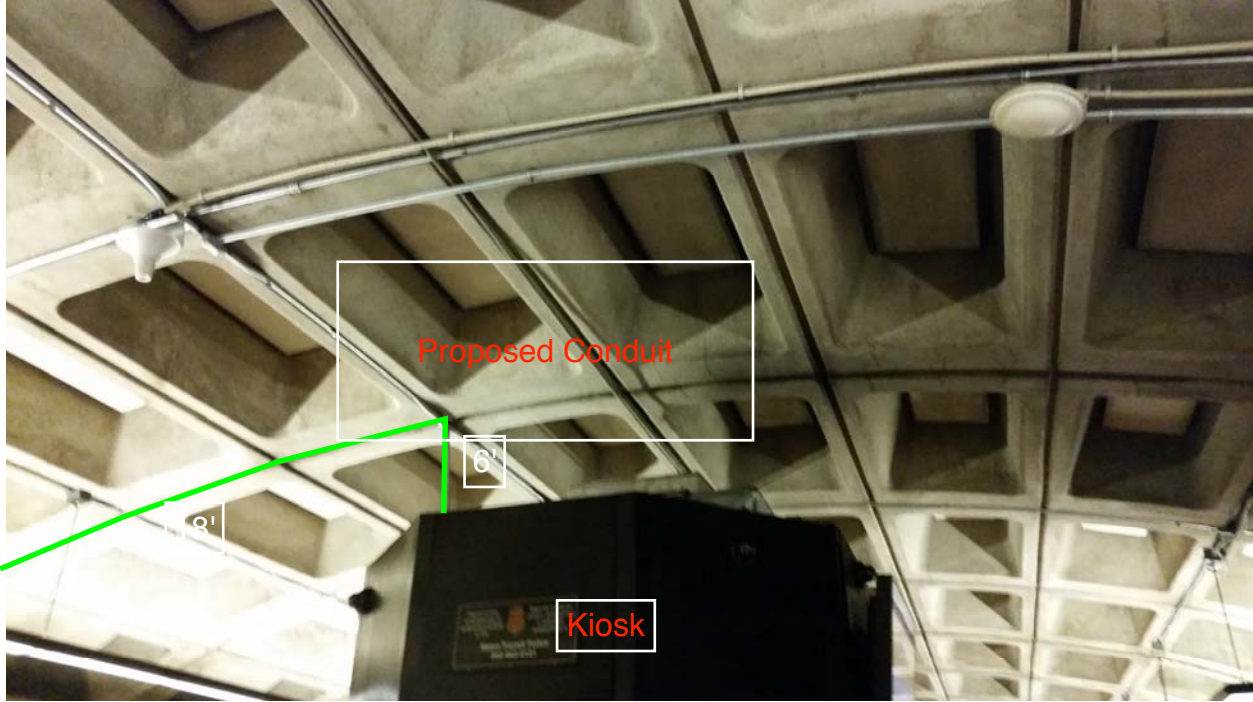
Photo 1 – Proposed overhead conduit in mezzanine.

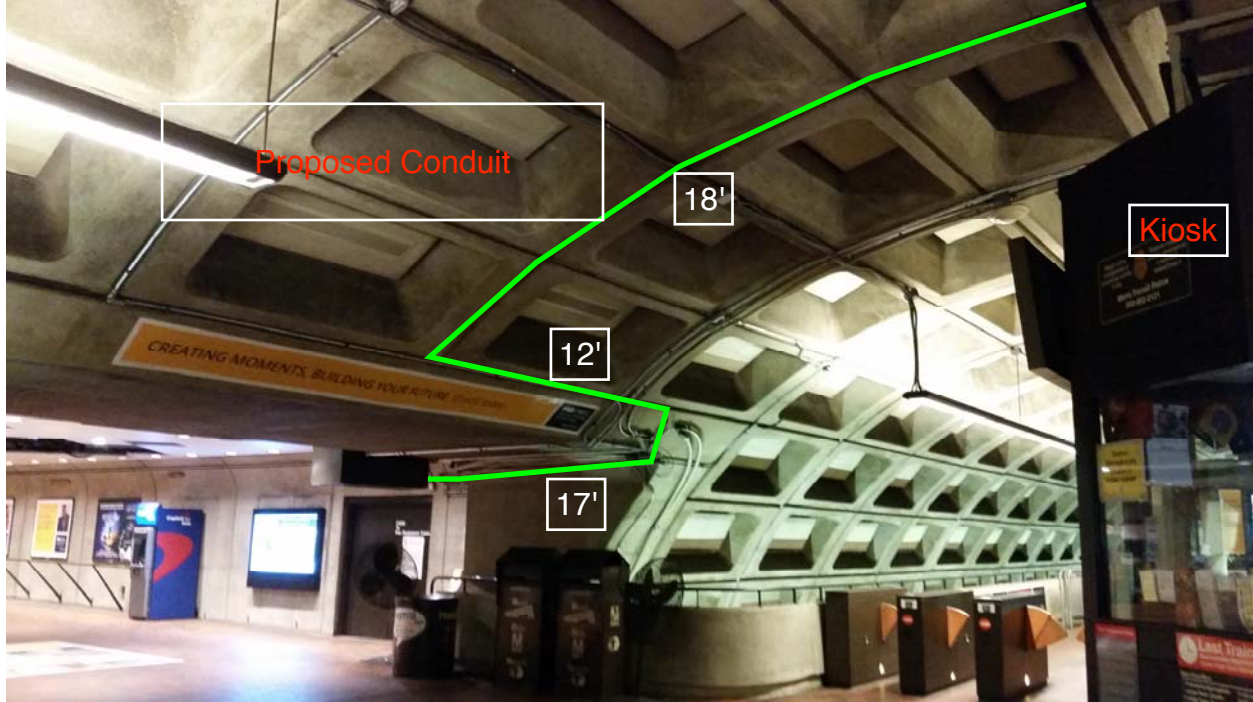
Photo 2 – Proposed overhead conduit in mezzanine.

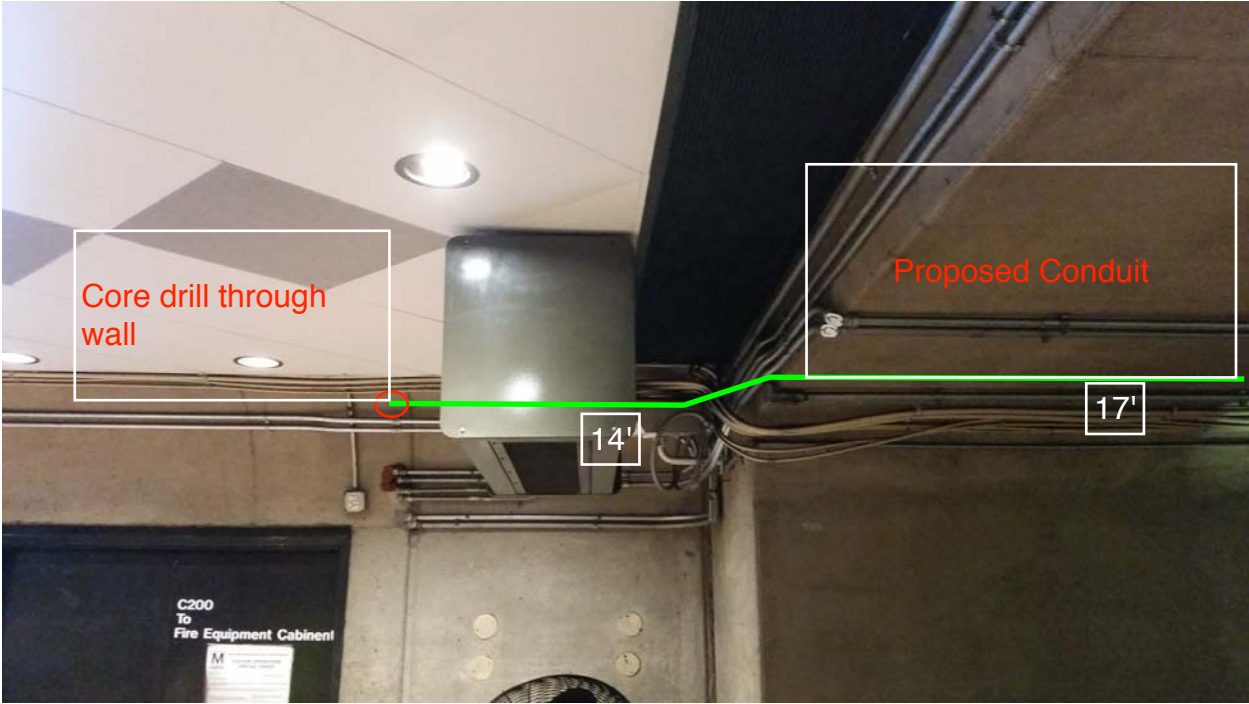
Photo 3 – Proposed overhead conduit in mezzanine.

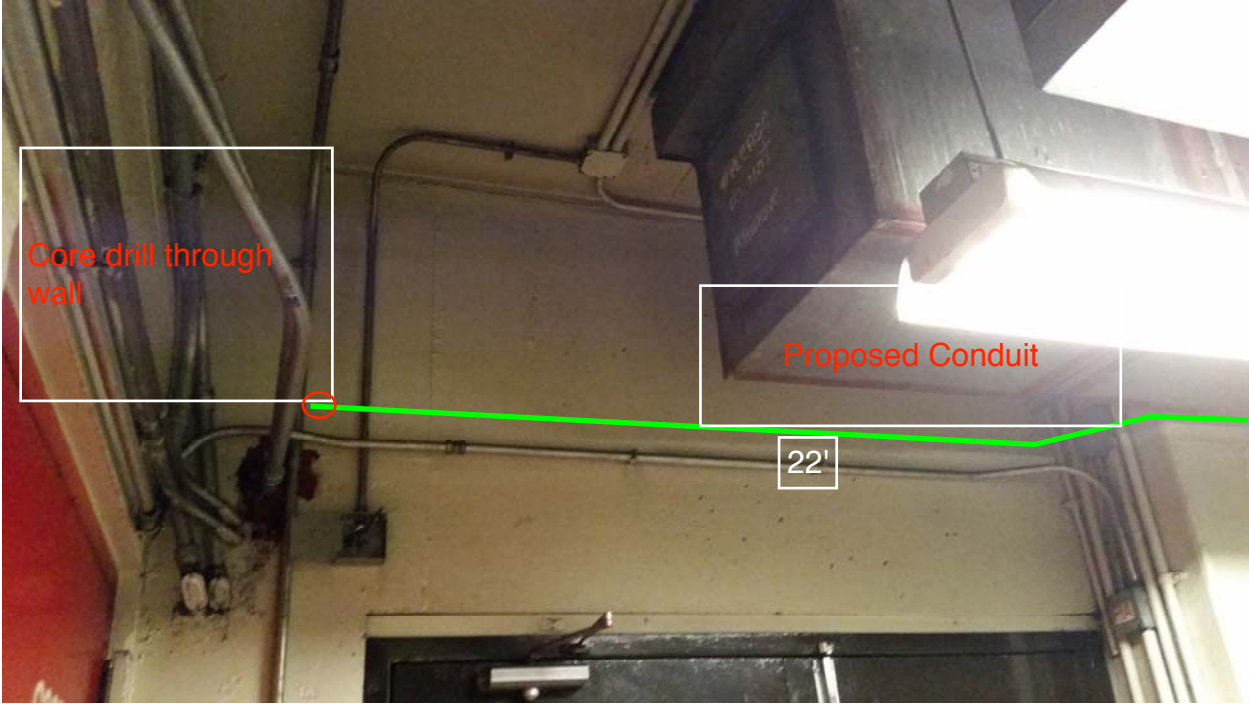
Photo 4 – Proposed overhead conduit in Room C200.

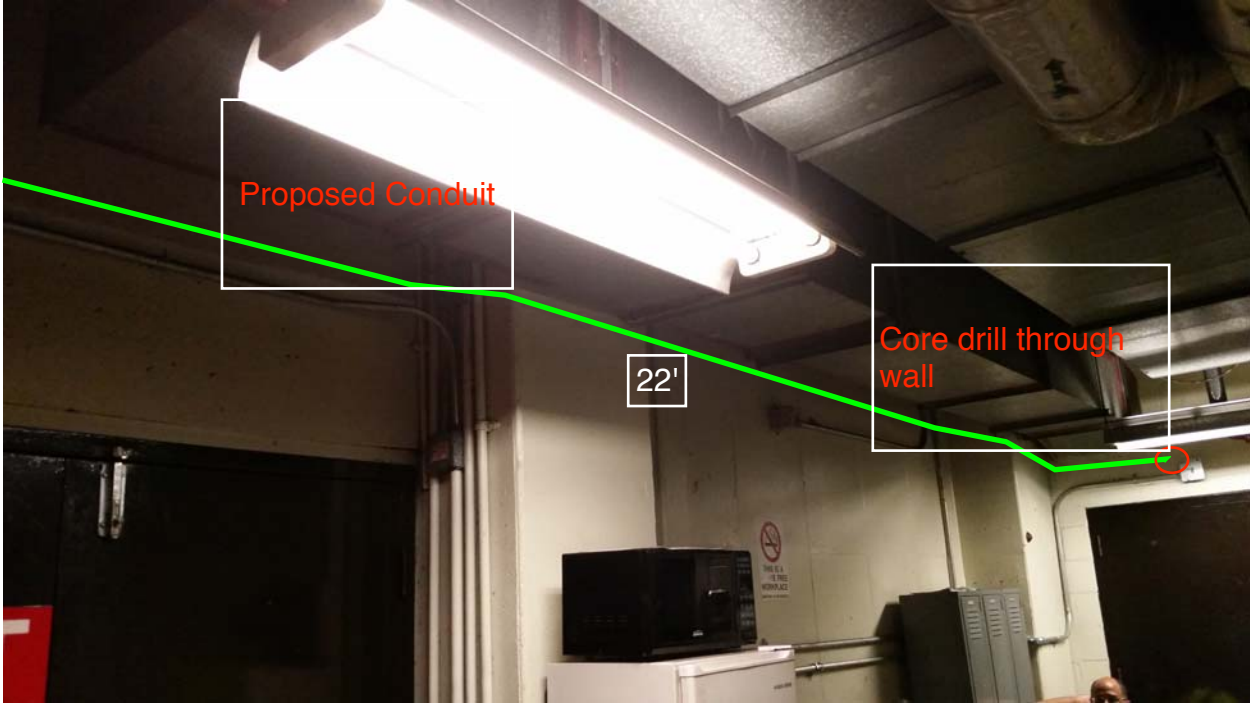
Photo 5 – Proposed overhead conduit in Room C200.

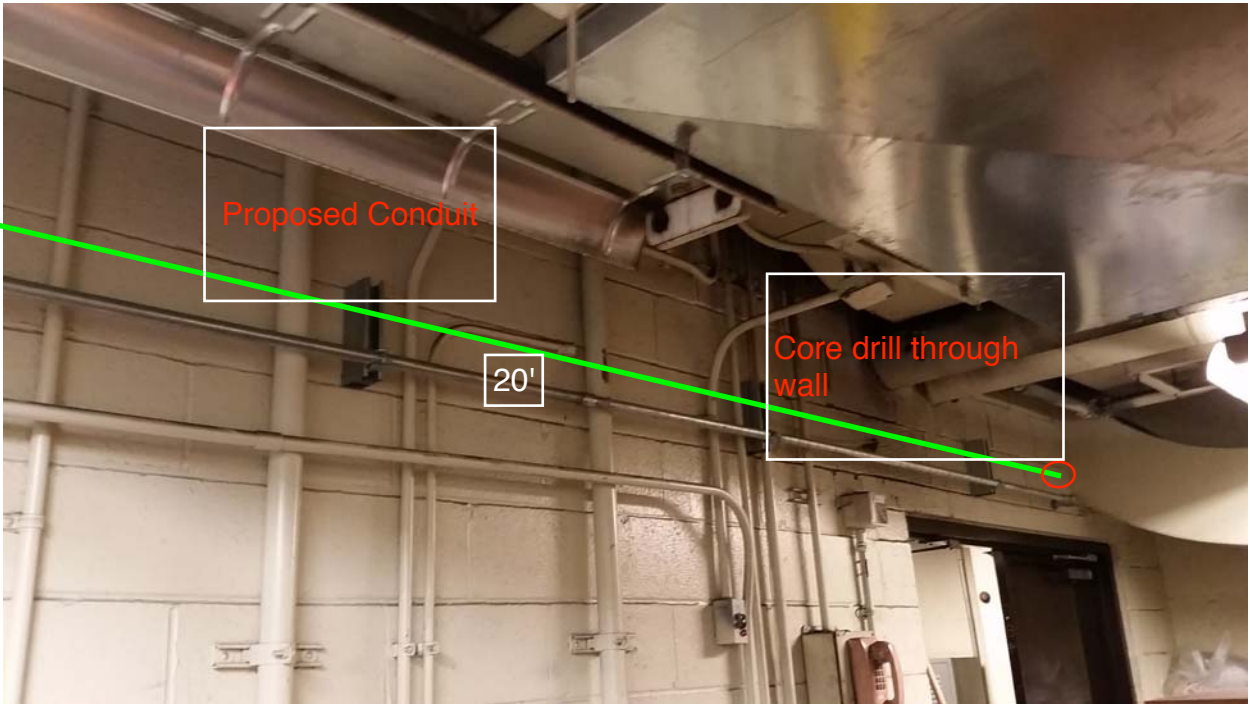
Photo 6 – Proposed overhead conduit in Room C206.

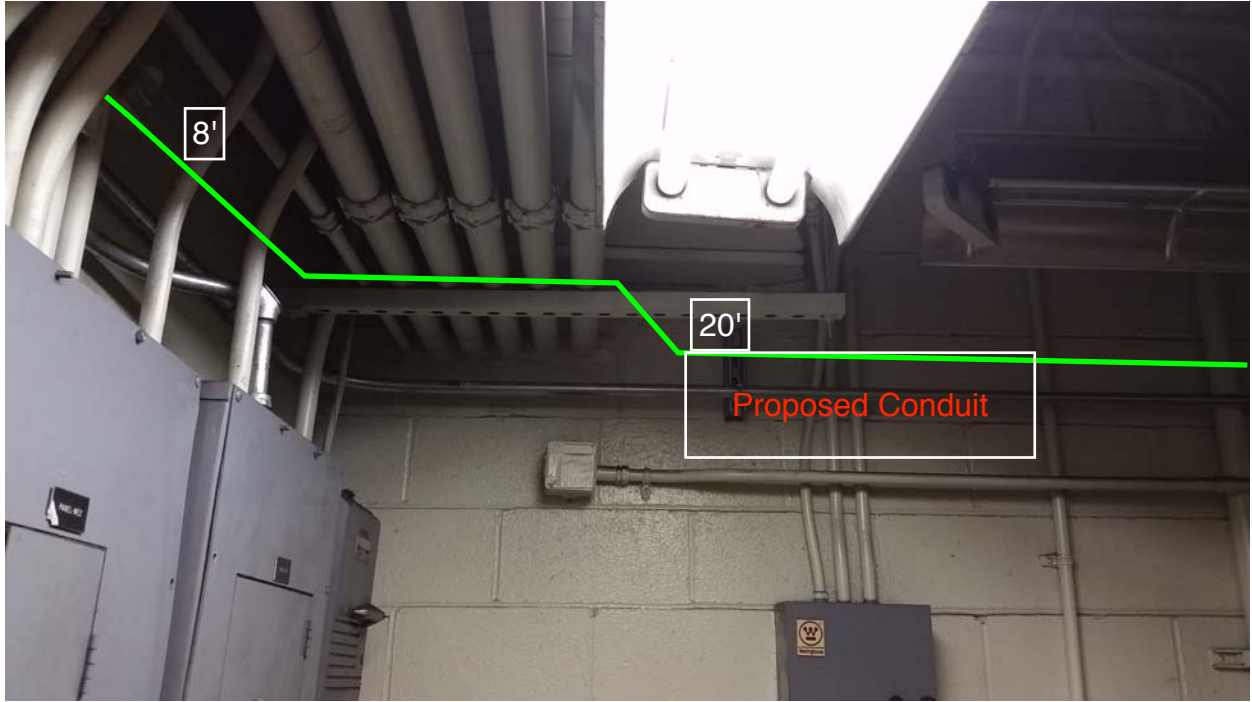
Photo 7 – Proposed overhead conduit in Room C206.

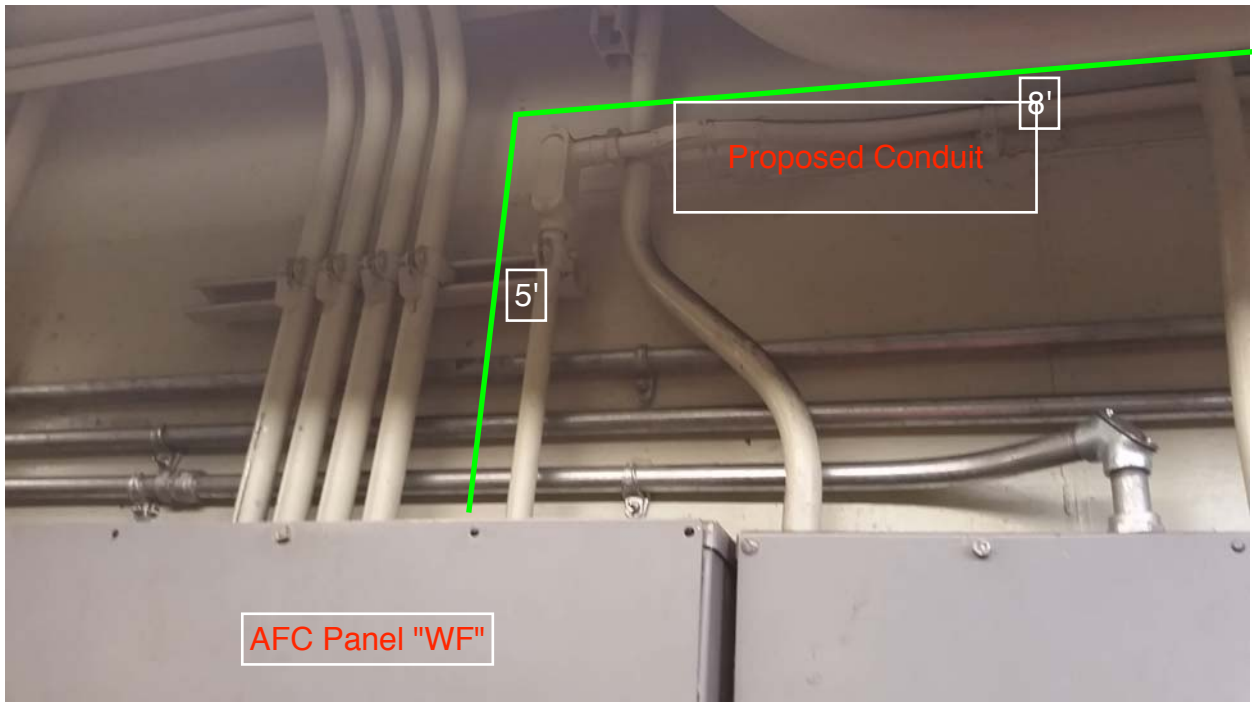
Photo 8 – Proposed overhead conduit in Room C206.

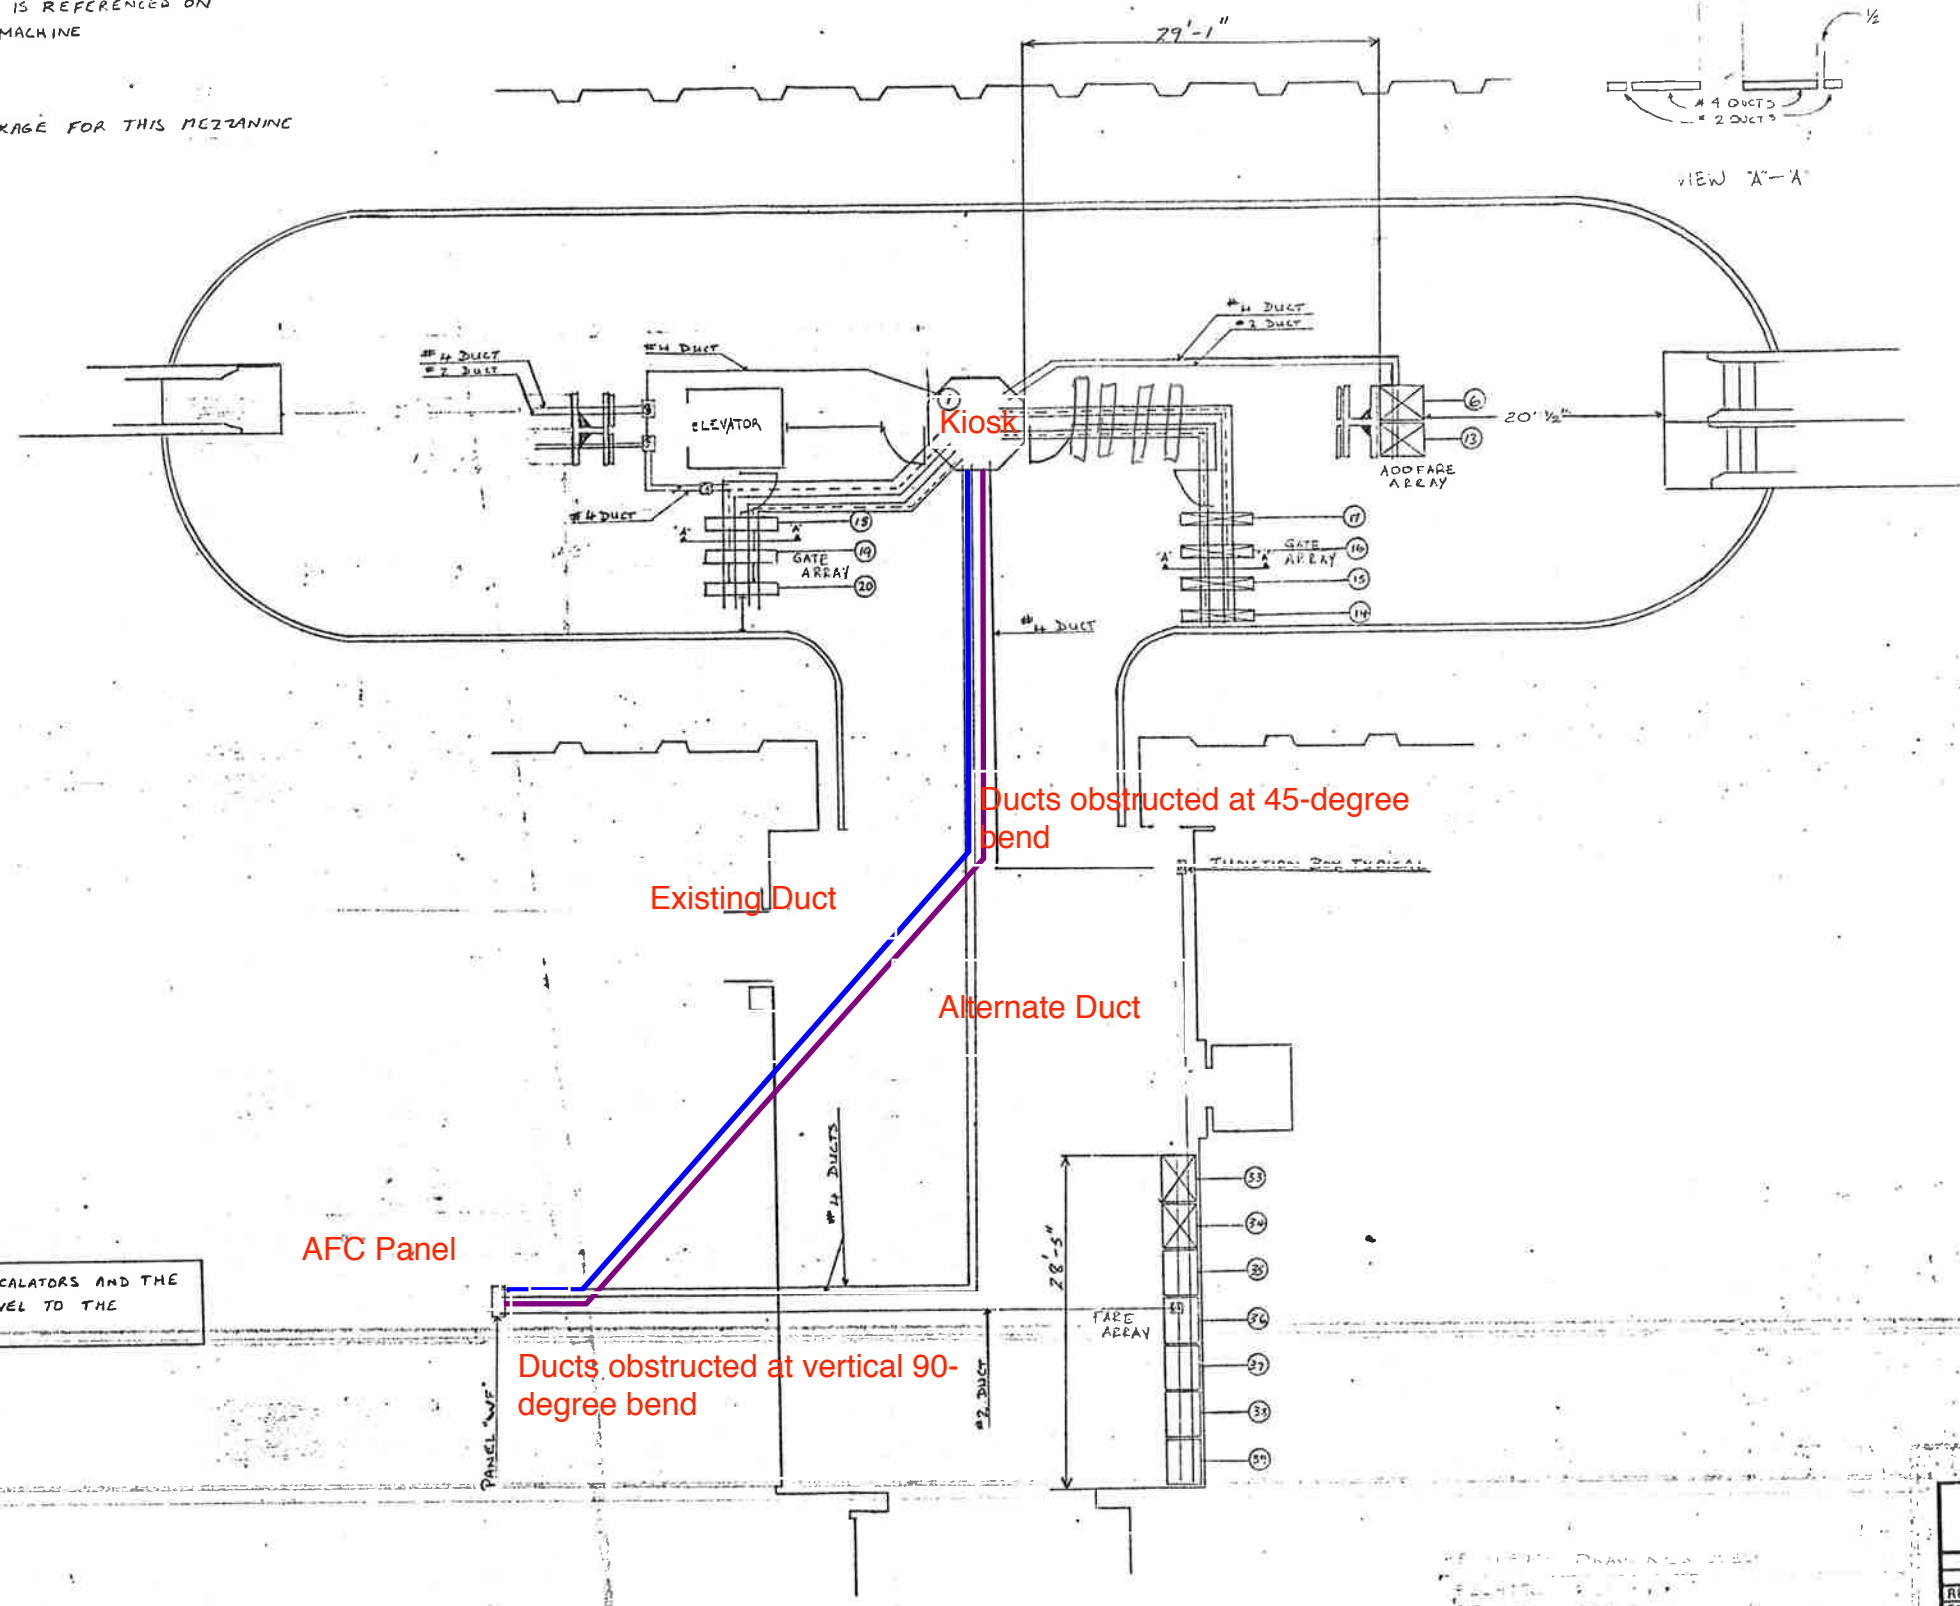
EXISTING DUCT LAYOUT

Ducts obstructed at 45-degree bend
 Existing Duct
 Alternate Duct
 AFC Panel
 Ducts obstructed at vertical 90-degree bend

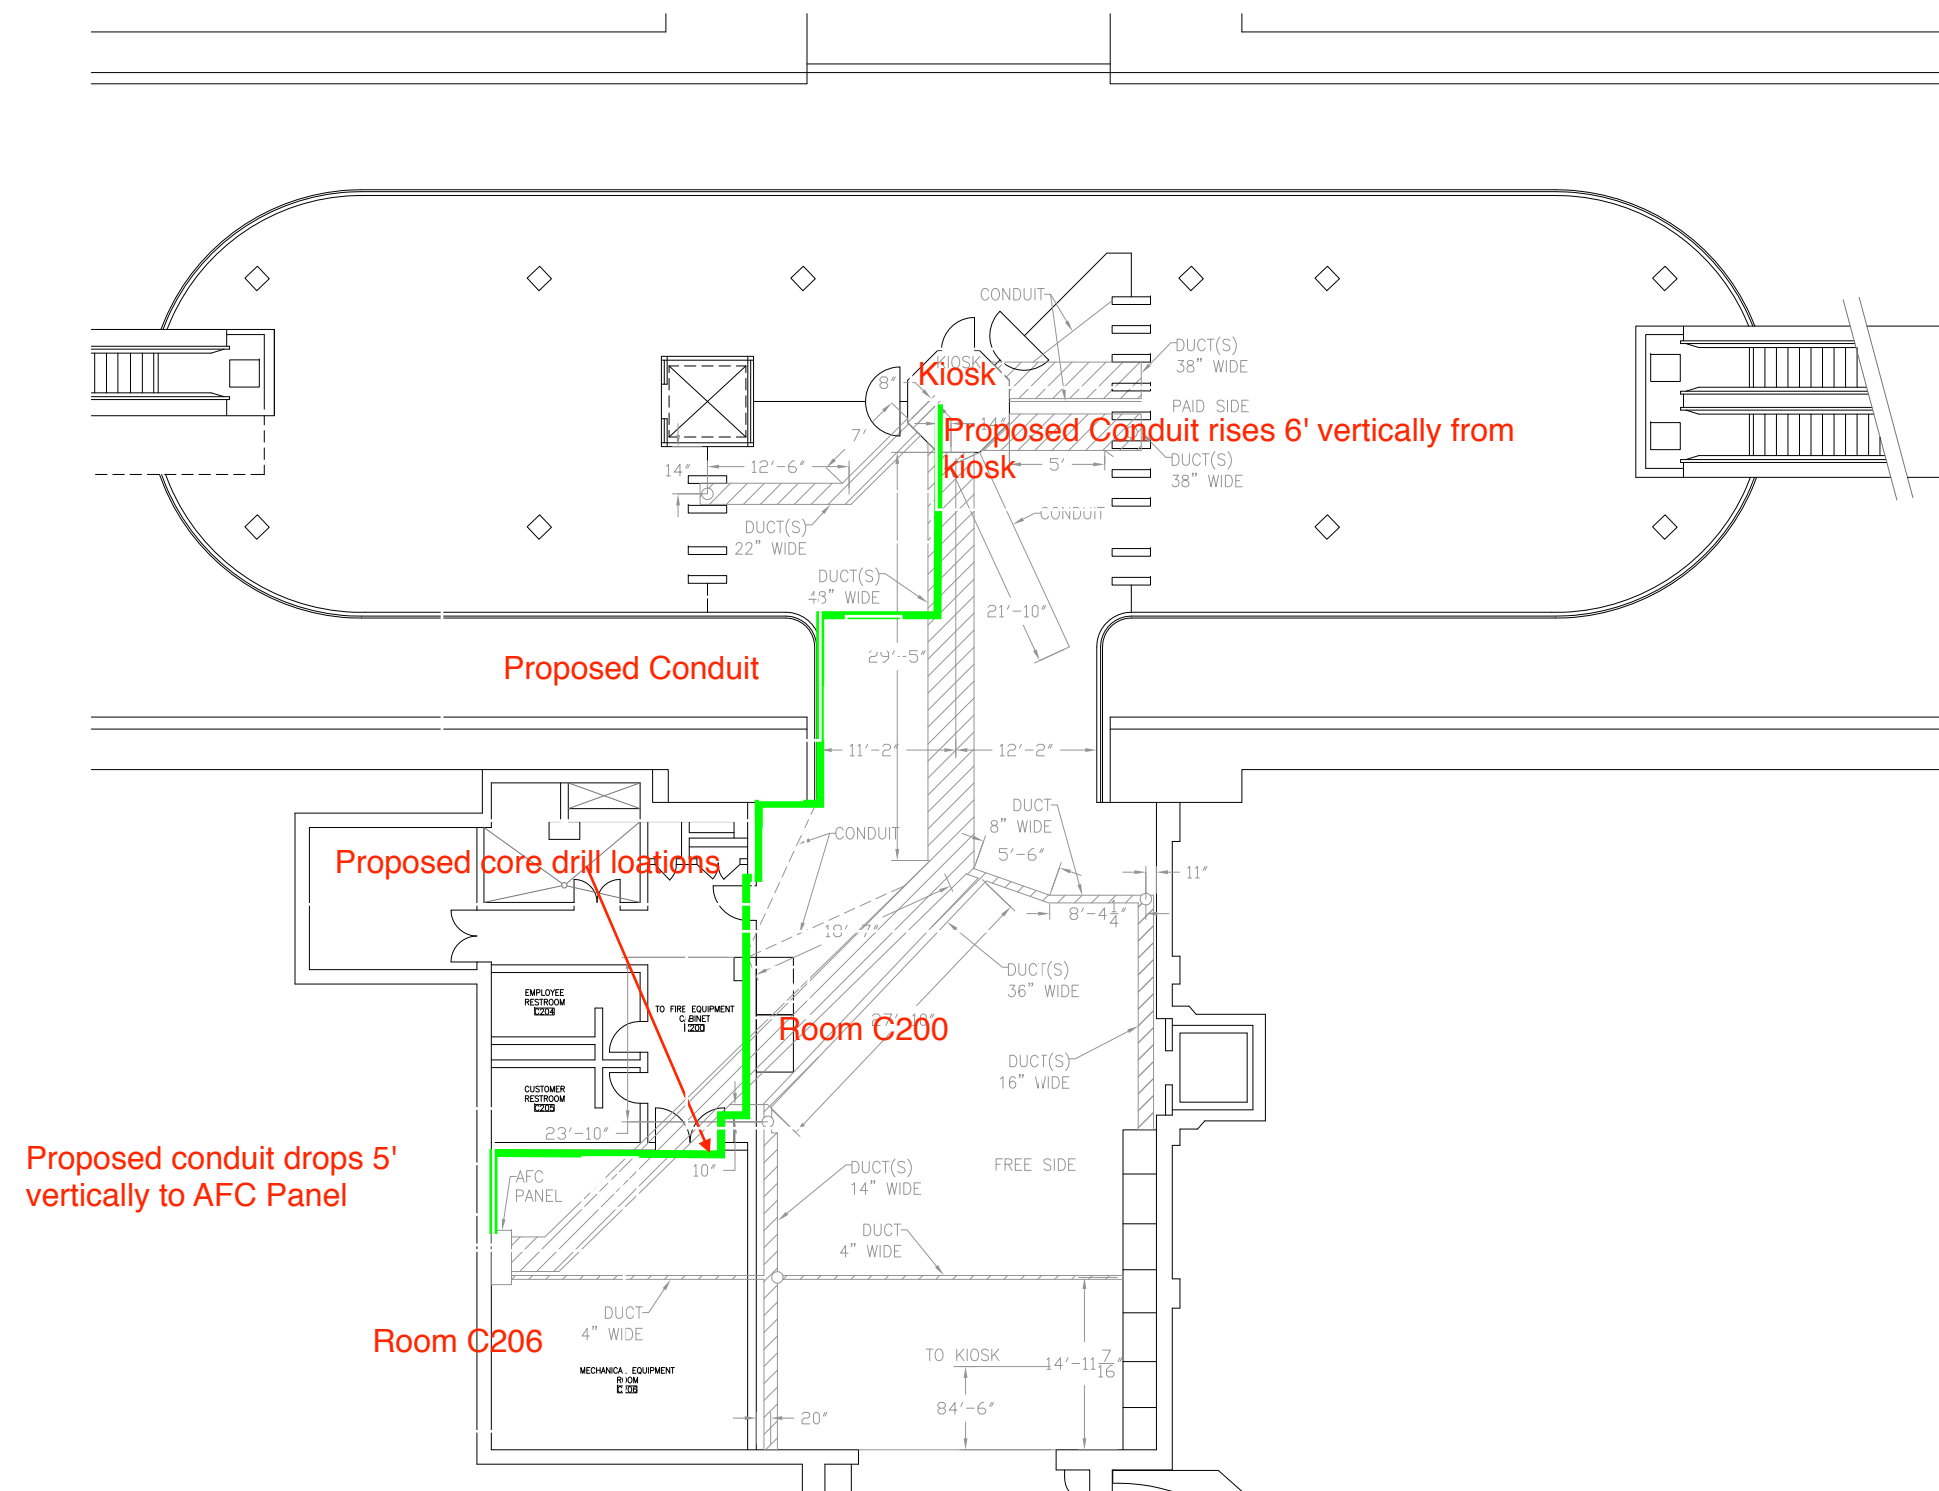
15-NEPP-01
IN - FLOOR DUCT INSPECTIONS
D01 Federal Triangle
PROPOSED POWER RUN
SCALE
NOT TO SCALE

Scanning was completed at this mezzanine to identify a proposed power route between the Kiosk and AFC Panel. The scanning results showed that the mezzanine floor is congested with existing ducts/conduits and there is no clear route to run a proposed duct from the Kiosk to AFC Panel. However, an alternate duct running parallel to existing power duct was identified.

NEPP-02: Video scoping and pull string installation was attempted in an alternate duct that runs parallel with the existing power duct from the Kiosk to the AFC Panel. Scoping and rodding was attempted from both the Kiosk and AFC Panel, however obstructions were encountered. Video scoping showed that the duct is in bad condition and heavily corroded. An overhead conduit is proposed from the Kiosk to AFC Panel - refer to attached photos and drawings for further information.
