Mezzanine Inspection Report (Scoping)						
Date: 01/08/2015	e: 01/08/2015 Station Name: D02 Smithsonian North Mezzanine #: 054 Completed By: Zach Fitzwater					
	Summary					
Summary Video scoping was completed for the communication and power ducts in the faregate arrays. Pull strings were successfully installed in the communication ducts for the faregate arrays. Video scoping was completed and pull string installed in the power duct between the Kiosk , Handhole 1, Handhole 2, Handhole 3 and the AFC Panel. Scanning is not required at this mezzanine.						
		Scoping o	of Faregate Array(s)			
	Task	Yes/No		Notes		
Communications Duo	ct – Upper Faregate Array (7 G	ates)				
Was video scoping co run?	ompleted for the entire duct	Yes	Refer to WMATA Smith	sonian North 6inch Upper Comm Videos.avi file.		
Were pull strings inst array?	alled at all faregates in the	Yes				
Were there any obstru details of type and sp	uctions or blockages? Provide ecific location.	No	Minor dust and debris

Mezzanine Inspection Report (Scoping)						
Date: 01/07/15	01/07/15 Station Name: D02 Smithsonian South Mezzanine #: 055 Completed By: Zach Fitzwater					
Summary						
Scoping and pull sting installation

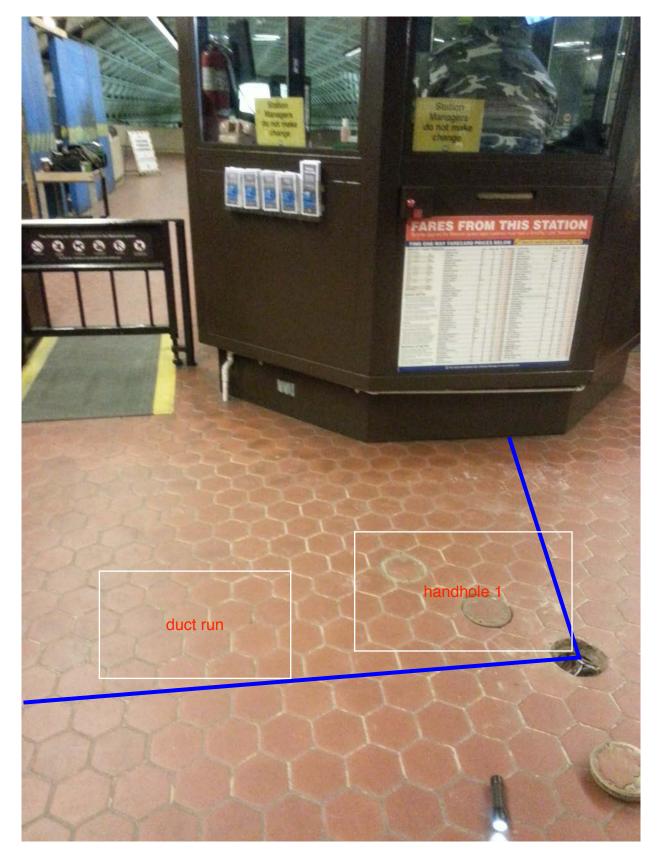
Photo #1 – D02 Smithsonian North: Kiosk to handhole 1

Scoping of Power Duct - Kiosk to AFC Panel						
Task Yes/No			Notes			
Kiosk to Handhole 1 (5')		1				
Was video scoping completed for the entire duct conduit run?	Yes					
Was pull string installed?	Yes					
Were there any obstructions or blockages? Provid details of type and specific location.	e No	Minor dust and debris				
Is the duct / conduit at capacity? Provide additiona details about the dimensions of duct / conduit and number of wires.	l No	6" duct – inside the	wires congested at small handhole openings, but there is room ducts			
Handhole 1 to Handhole 2 (45')						
Was video scoping completed for the entire duct conduit run?	Yes	Tangle of wires at handhole 2 prevented last 1' of scope. Refer to WMATA Smithsonian North Power HH1 to HH2 Videos.avi file.				
Was pull string installed?	Yes					
Were there any obstructions or blockages? Provid details of type and specific location.	e No	Minor dus	Minor dust and debris

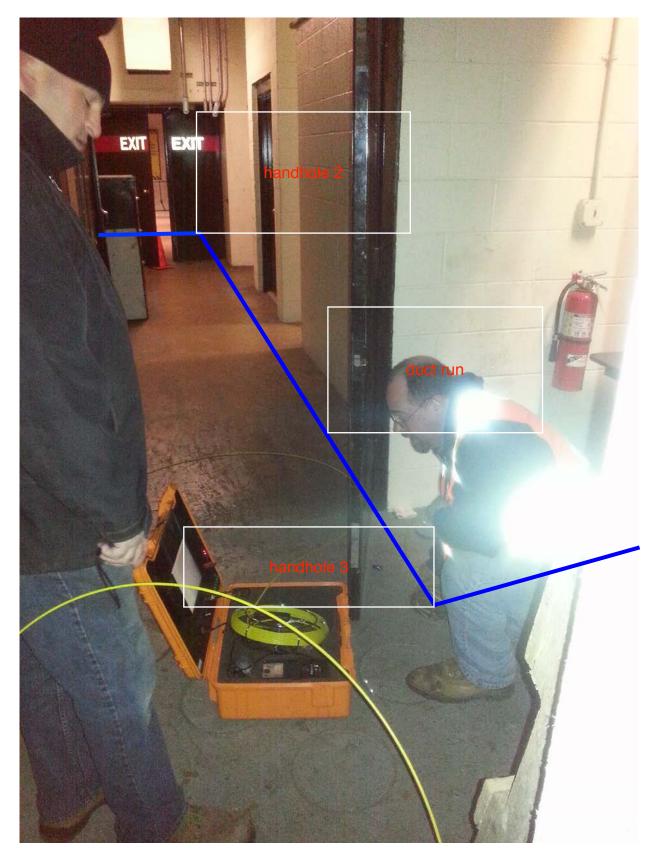
Photo #3 – D02 Smithsonian North: Handhole 2 to handhole 3

Is the duct / conduit at capacity? Provide additiona details about the dimensions of duct / conduit and number of wires.	l No	6" duct – wires congested at small handhole openings, but there is room inside the ducts				
Handhole 2 to Handhole 3 (45')						
Was video scoping completed for the entire duct conduit run?	Yes	Tangle of wires at handhole 2 prevented last 1' of scope. Refer to WM Smithsonian North Power HH3 to HH2 to HH3 to AFC Videos.avi file.				
Was pull string installed?	Yes					
Were there any obstructions or blockages? Provid details of type and specific location.	e No	Minor dust and debris				
Is the duct / conduit at capacity? Provide additiona details about the dimensions of duct / conduit and number of wires.	l No	6" duct – wires congested at small handhole openings, but there is room inside the ducts				
Handhole 3 to AFC Panel (25')						
Was video scoping completed for the entire duct conduit run?	Yes	Refer to WMATA Smithsonian North Power HH3 to HH2 to HH3 to AFC Videos.avi file.

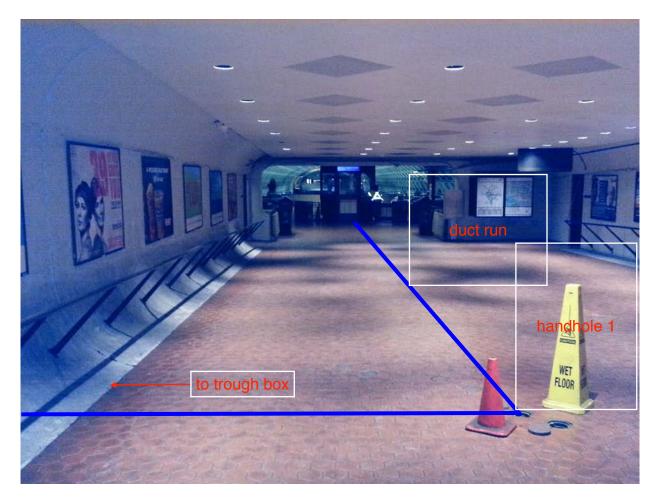
Photo #1 – D02 Smithsonian South: Kiosk to Handhole 1

Scoping of Power Duct - Kiosk to AFC Panel						
Task Yes/No			Notes			
Kiosk to Handhole 1 (90 foot run)						
Was video scoping completed for the entire duct / conduit run?	Yes	Refer to WMATA Smithsonian South 6inch Power Handhole to Kiosk Video.avi file.				
Was pull string installed?	Yes Pull string already installed in run					
Were there any obstructions or blockages? Provide details of type and specific location.	No	Minor dust				
Is the duct / conduit at capacity? Provide additional details about the dimensions of duct / conduit and number of wires.	No	6" duct les	s than 10 wires			
Handhole 1 to Trough box (20 foot run)						
Was video scoping completed for the entire duct / conduit run?	Yes Refer to WMATA Smithsonian South 6inch Power Handhole to Trough Video.avi file.					
Was pull string installed?		Pull string	already installed in run			
Were there any obstructions or blockages? Provide details of type and specific location.	No
