Mezzanine Inspection Report					
Date: 01/29/15 Station Name:	D03 L'Enfant P	laza (West)	Mezzanine #: 056	Completed By: Mike Butler	
Summary					
Video scoping and pull string installation was completed for communication ducts in upper / lower faregate arrays; respective power ducts were also video scoped. Pull string installation was completed in power duct between Kiosk, Handhole and Junction Box. Pull string was also installed in conduit between Junction Box and AFC Panel. However, video scoping of power duct between Kiosk and AFC Panel could not be completed due to wire congestion; it was confirmed that the duct / conduit are at capacity and an alternate power route is needed.					
Scanning of the mezzanine was condunct a clear path for proposed duct in the				AFC Panel. The scanning results showed that there is ed power route:	
<b>Option 1</b> : Core drill through the floor beneath Kiosk and run a proposed conduit vertically down into a proposed junction box in the ceiling plenum at platform level. The proposed conduit will then run across the ceiling plenum from the proposed junction box to the head wall at the end of the platform. The proposed conduit will then run through s

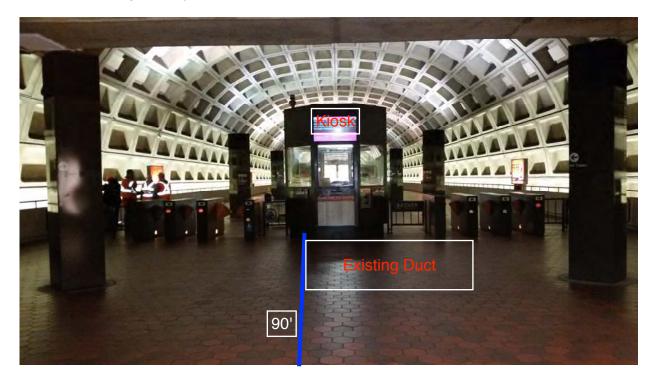
Photo #1: Existing duct layout on mezzanine floor

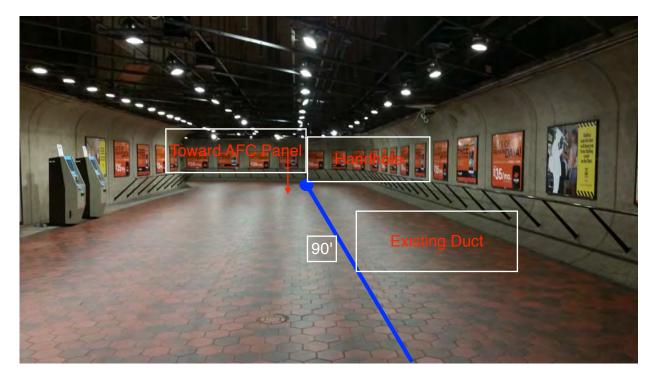
Photo #2: Existing duct layout on mezzanine floor

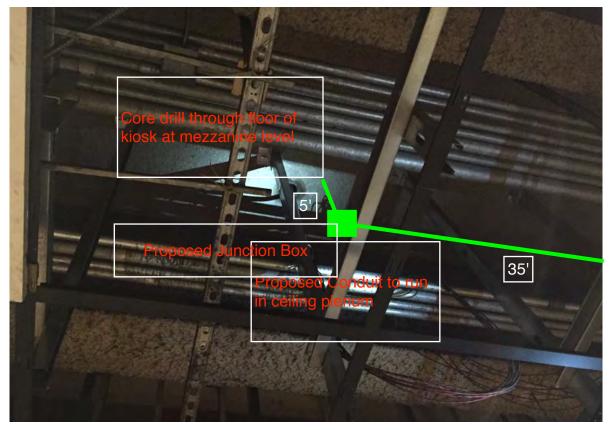
Photo #3: Proposed conduit options at platform level (Option 1 and Option 2 are the same at this location.

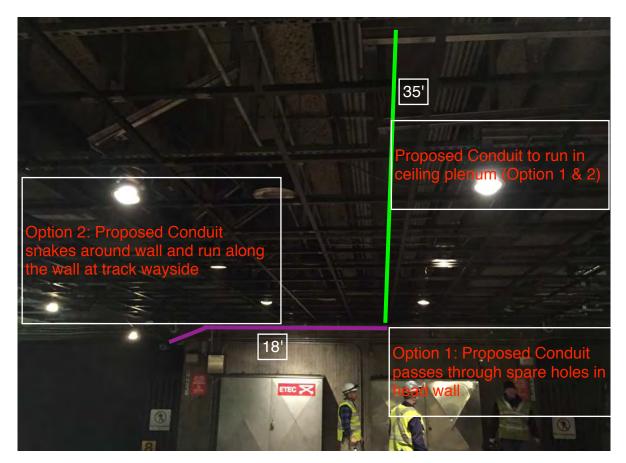
Photo #4: Proposed conduit options at platform level

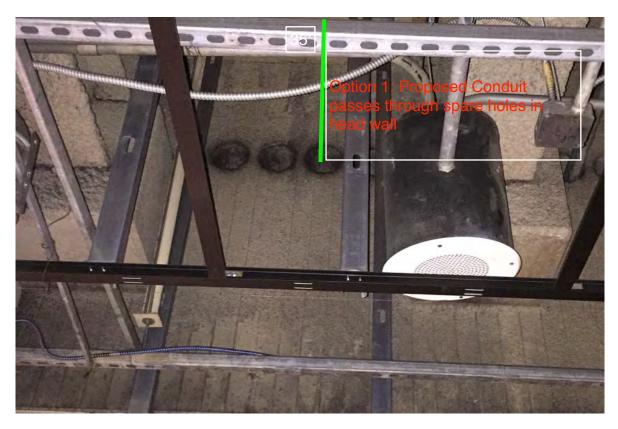
## Photo #5: Proposed conduit Option 1 at platform level

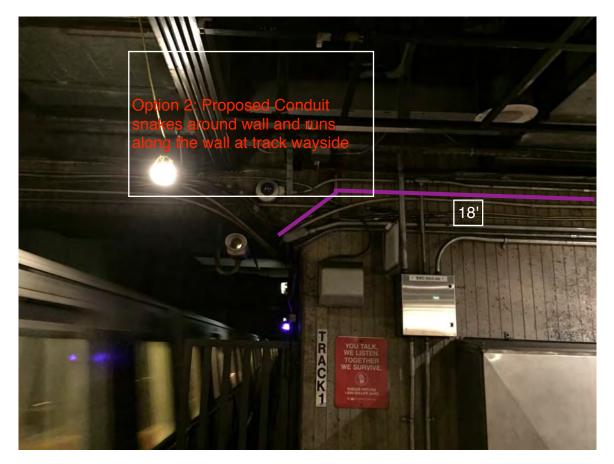
Photo #6: Proposed conduit Option 2 at platform level

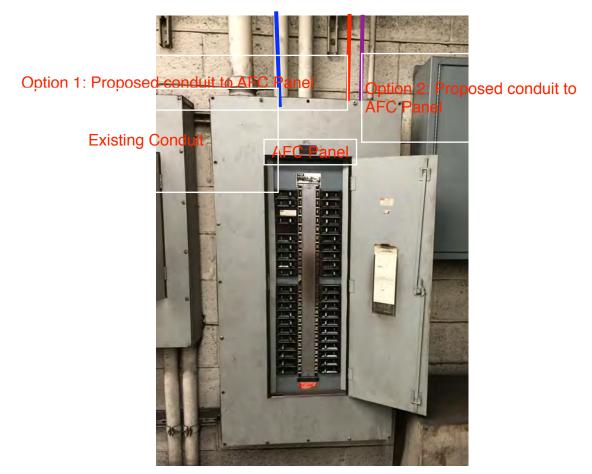
Photo #7: Existing and proposed conduit options inside Room W104

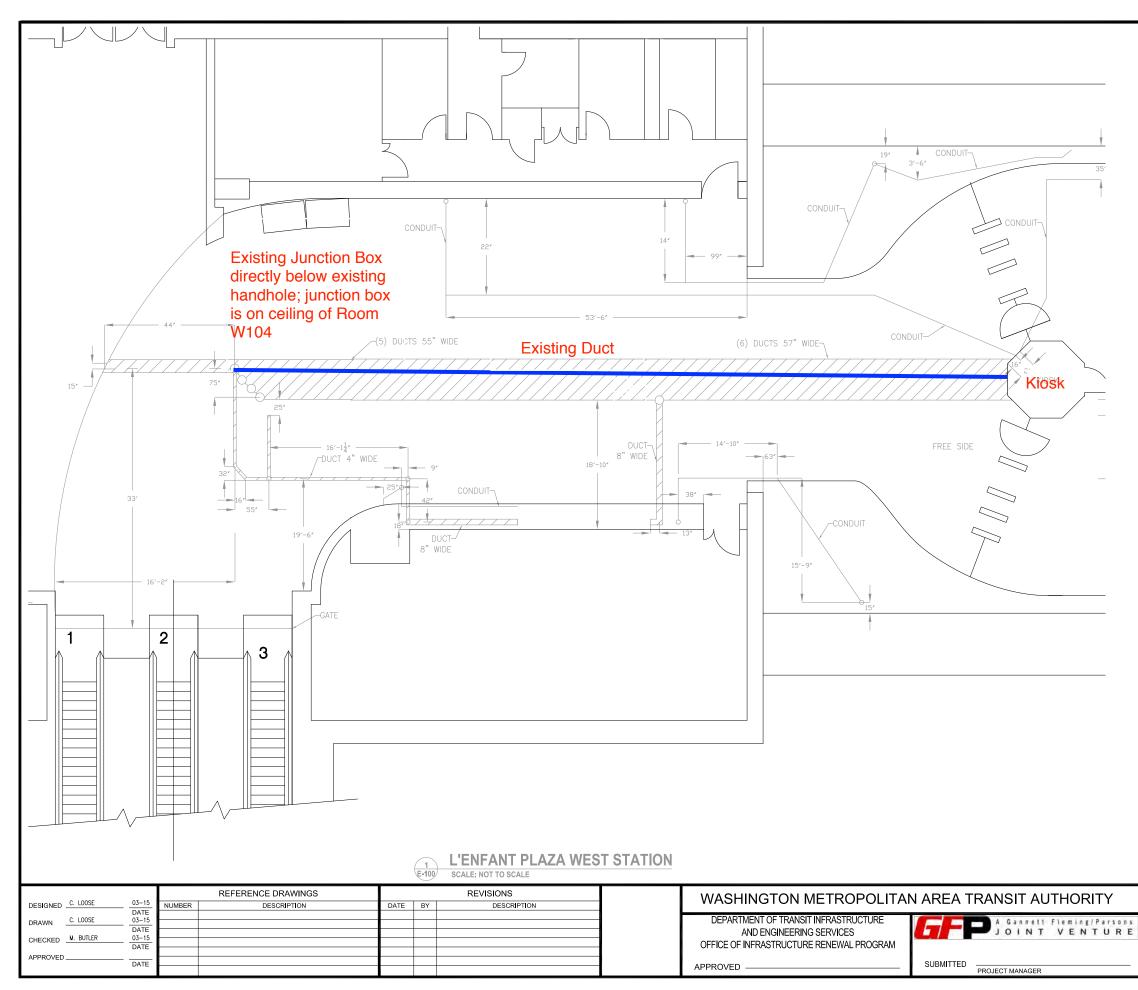
- DIMENSIONS ARE IN FEET AND INCHES.
   DIMENSIONS ARE FOR REFERENCE ONLY.
   EXISTING IN-FLOOR DUCTS/CONDUITS WERE INDENTIFIED USING A PORTABLE GPR SCANNING DEVICE.
   THE SCANNING COVERAGE IS LIMITED TO THE MEZZANINE ELOOR ONLY
- FLOOR ONLY. 5. GPR SCANNING HAS THE FOLLOWING LIMITATIONS: (i) 12
   INCHES VISIBLE SCANNING DEPTH; (ii) VISIBILITY BEYOND CONGESTED OR NEAR SURFACE REINFORCEMENT LAYERS; (iii) DETECTION OF PVC AND OTHER NON-METALLIC OBJECTS (iv) DETERMINATION OF SIZE AND EXTENTS OF SUBSURFACE ANOMALIES SUCH AS SLAB VOIDS OR REBAR SIZES; AND (v) VISIBILITY WHEN VARIABLE MOISTURE CONDITIONS EXIST IN THE SUBSTRATE THE SUBSTRATE.

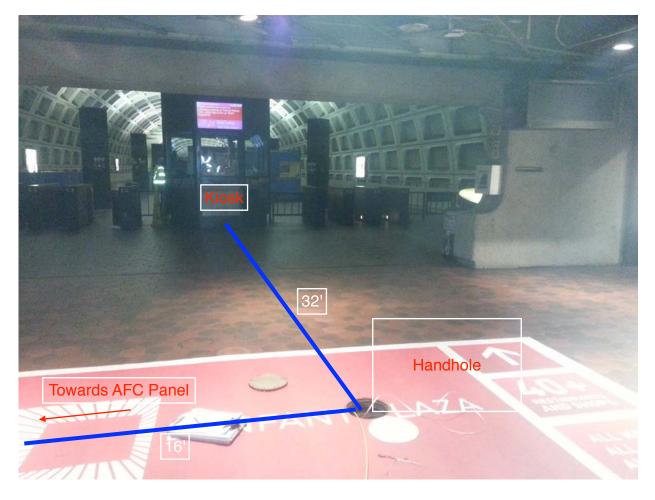
Photo #1 – Power duct run from Kiosk to Handhole on mezzanine floor.
