Mezzanine Inspection Report

Date: 06/10/15	Station Name: D04 Federal Center	Mezzanine #: 058	Completed By: Mike Butler
-----------------------	---	-------------------------	----------------------------------

15-NEPP-01
IN - FLOOR DUCT INSPECTIONS
D04 Federal Center
PROPOSED POWER ROUTE
SCALE
NOT TO SCALE

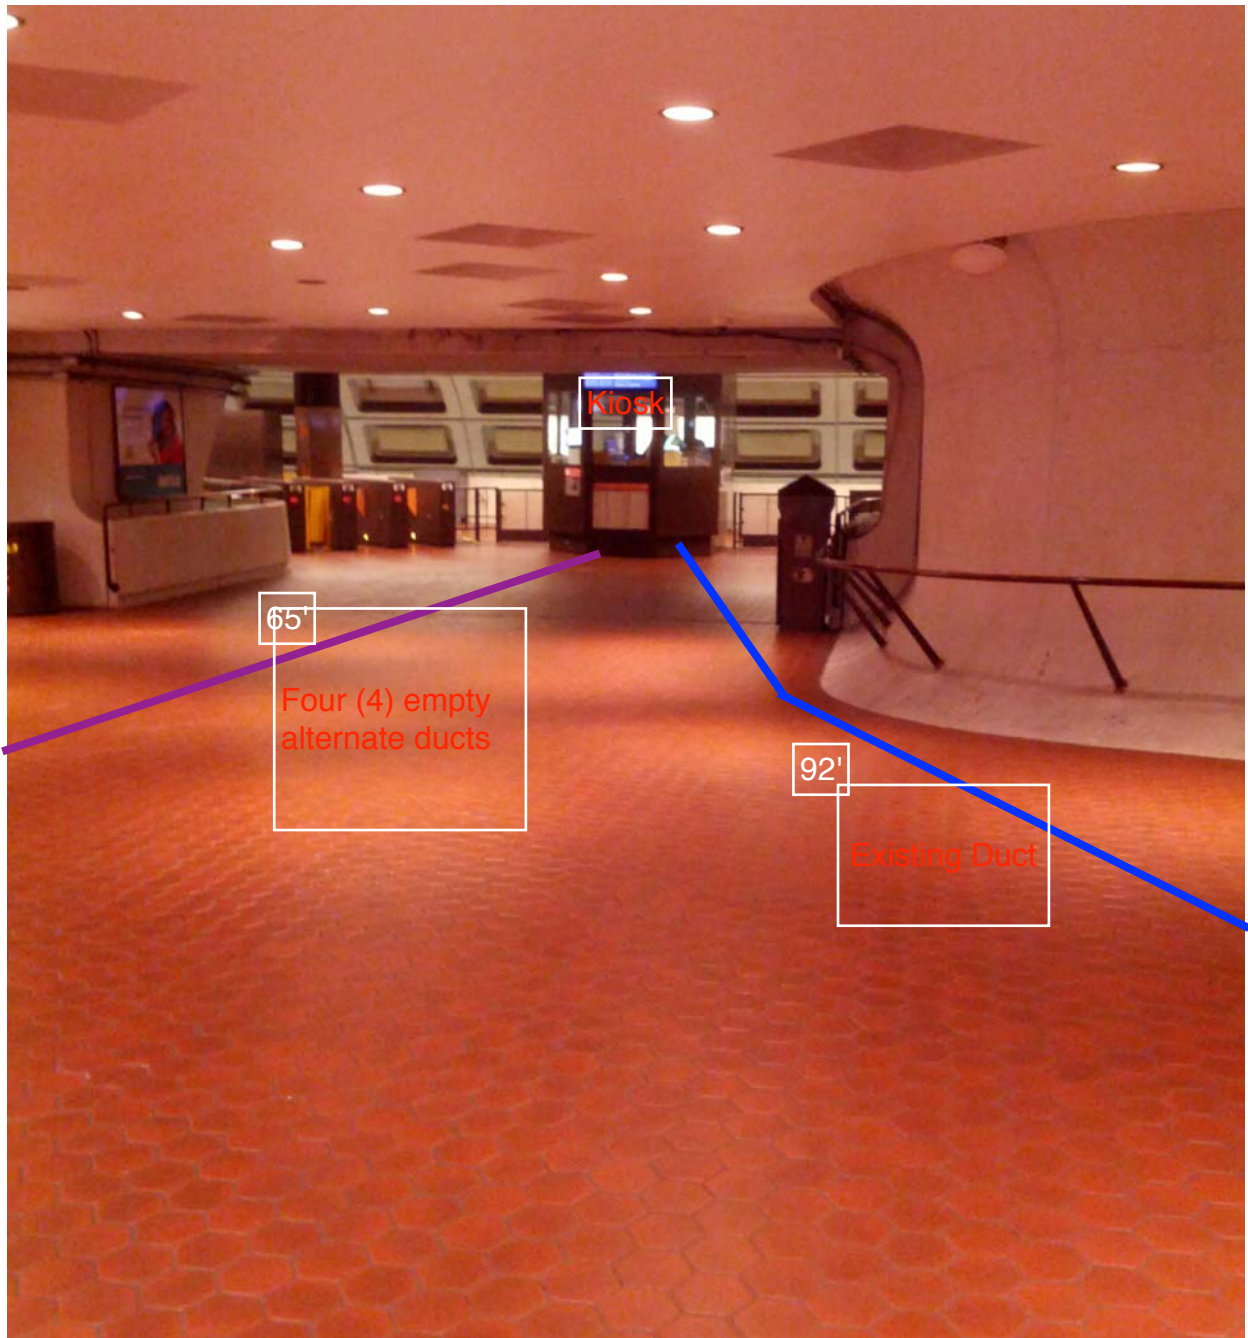
Photo 1 – Existing and alternate ducts on mezzanine floor.

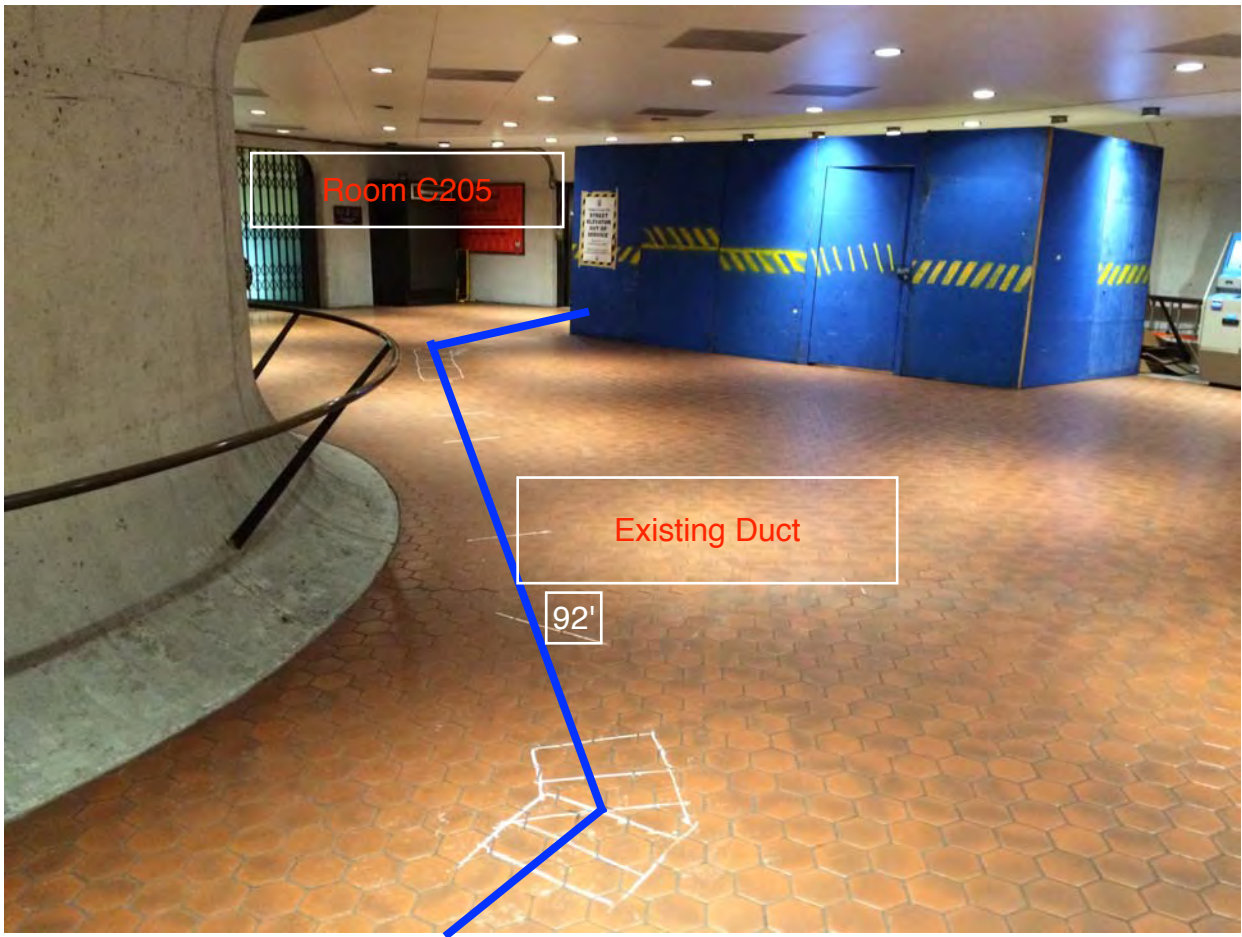
Photo 2 – Existing duct on mezzanine floor.

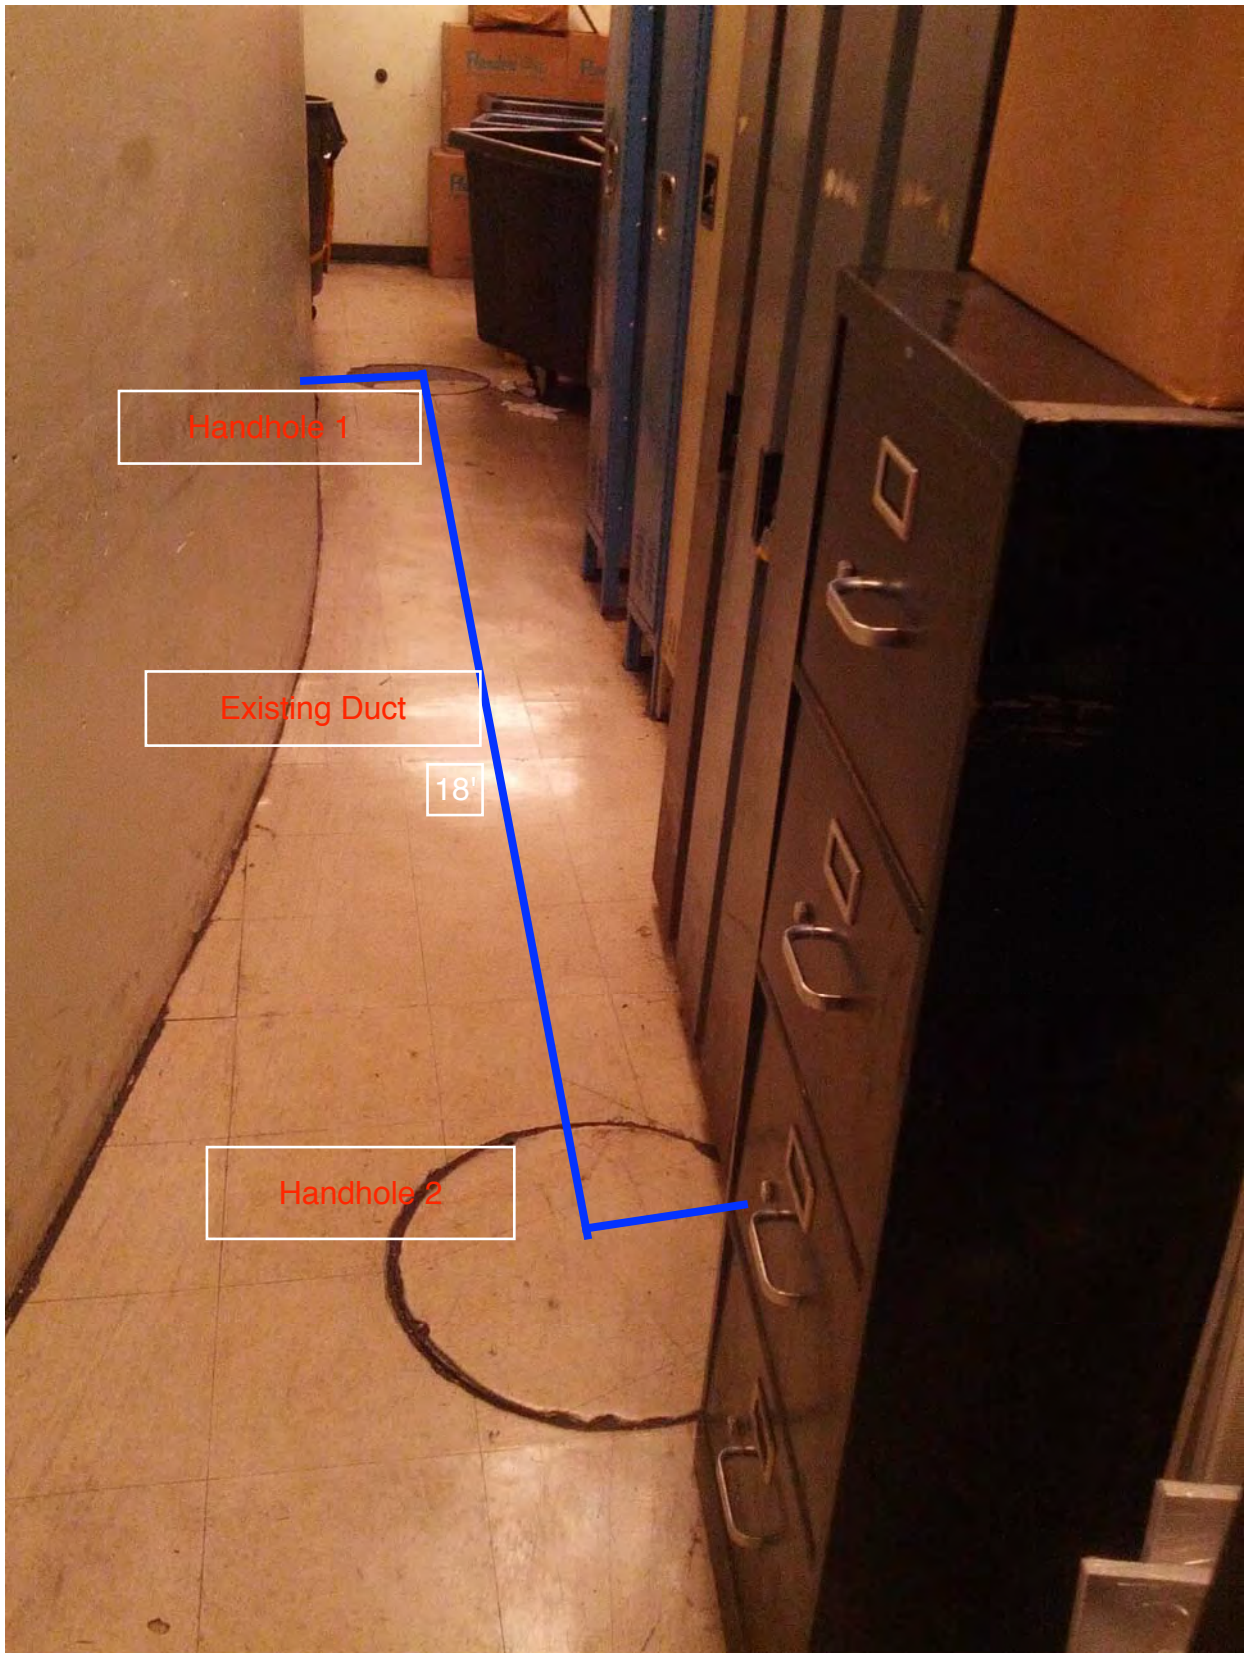
Photo 3 – Existing duct / handholes in Room C205.

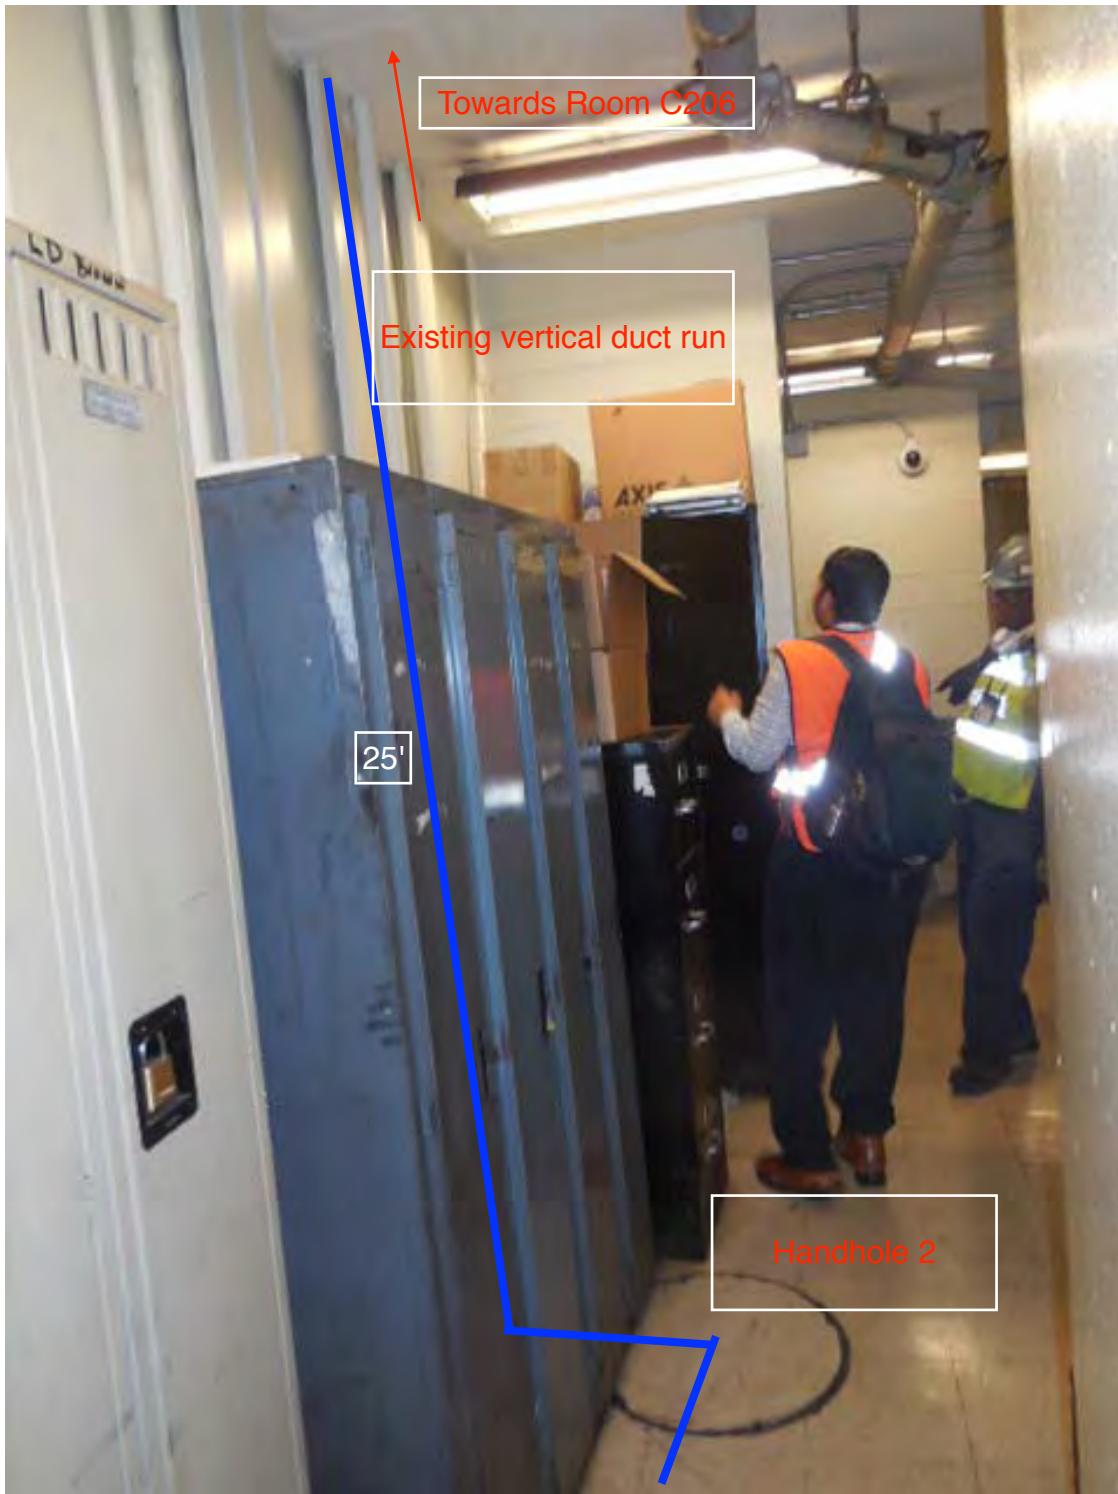
Photo 4 – Existing vertical duct run up to Room C206 where AFC Panel is located.

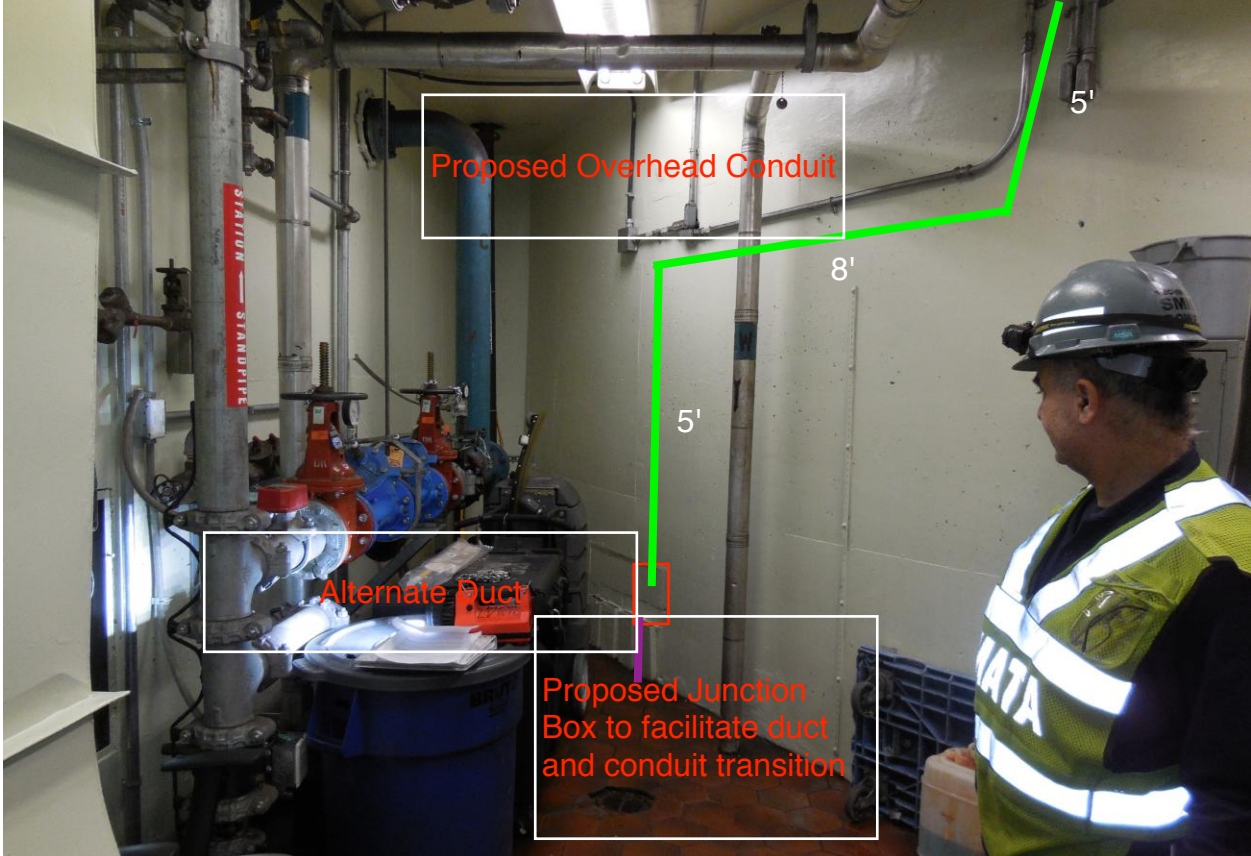
NEPP-02: Video scoping and pull string installation was attempted in 4 empty ducts that run parallel from the Kiosk to Cleaners Room. It was not possible to complete video scoping or pull string installation in the 4 alternate ducts because there are collapses at 5' from either side of the duct runs. It is recommended to repair and replace one of the empty alternate ducts by replacing the damaged duct section(s) with a new walker duct. A junction box is proposed at the duct stub-up location in Cleaners Room. A proposed overhead conduit will run from the proposed junction box to AFC Panel.

Photo 5 – Proposed junction box and overhead conduit from duct stub-up in Cleaners Room.

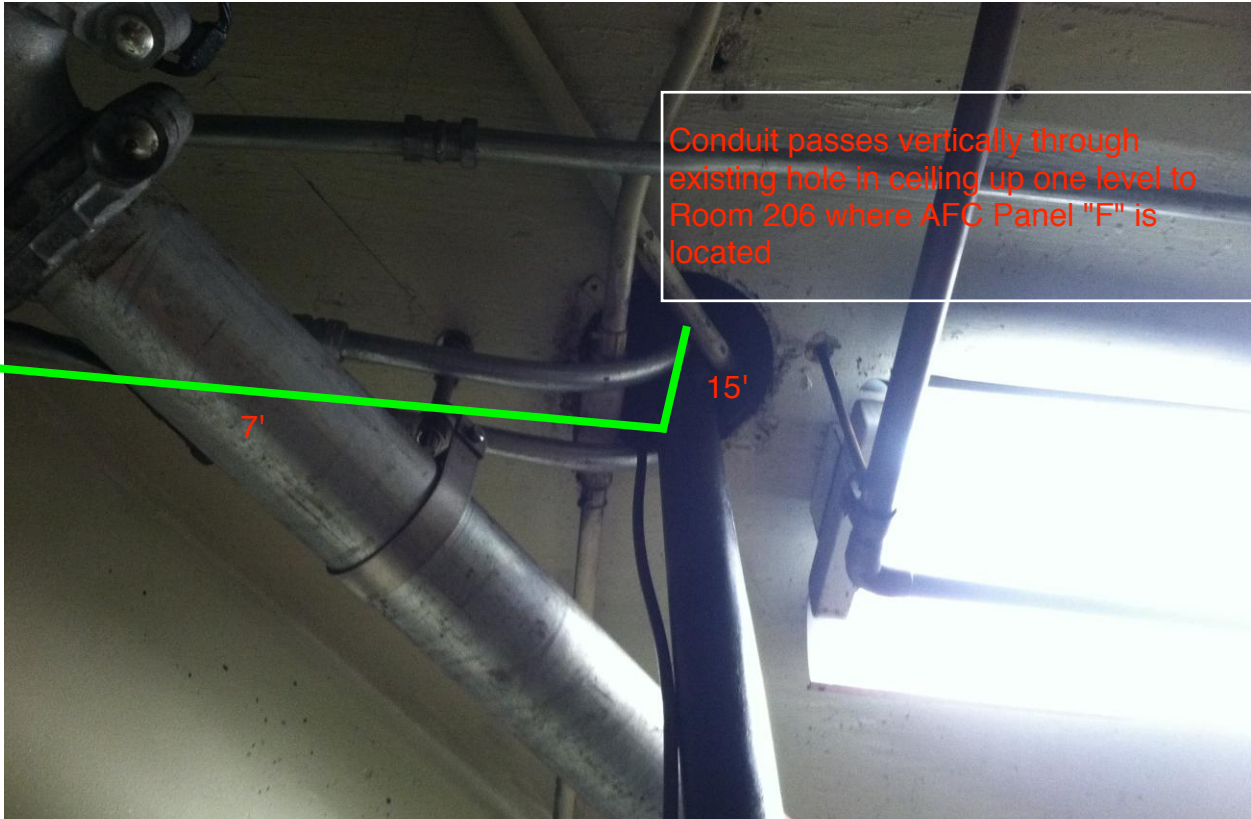
Photo 6 – Proposed overhead conduit in Cleaners Room.

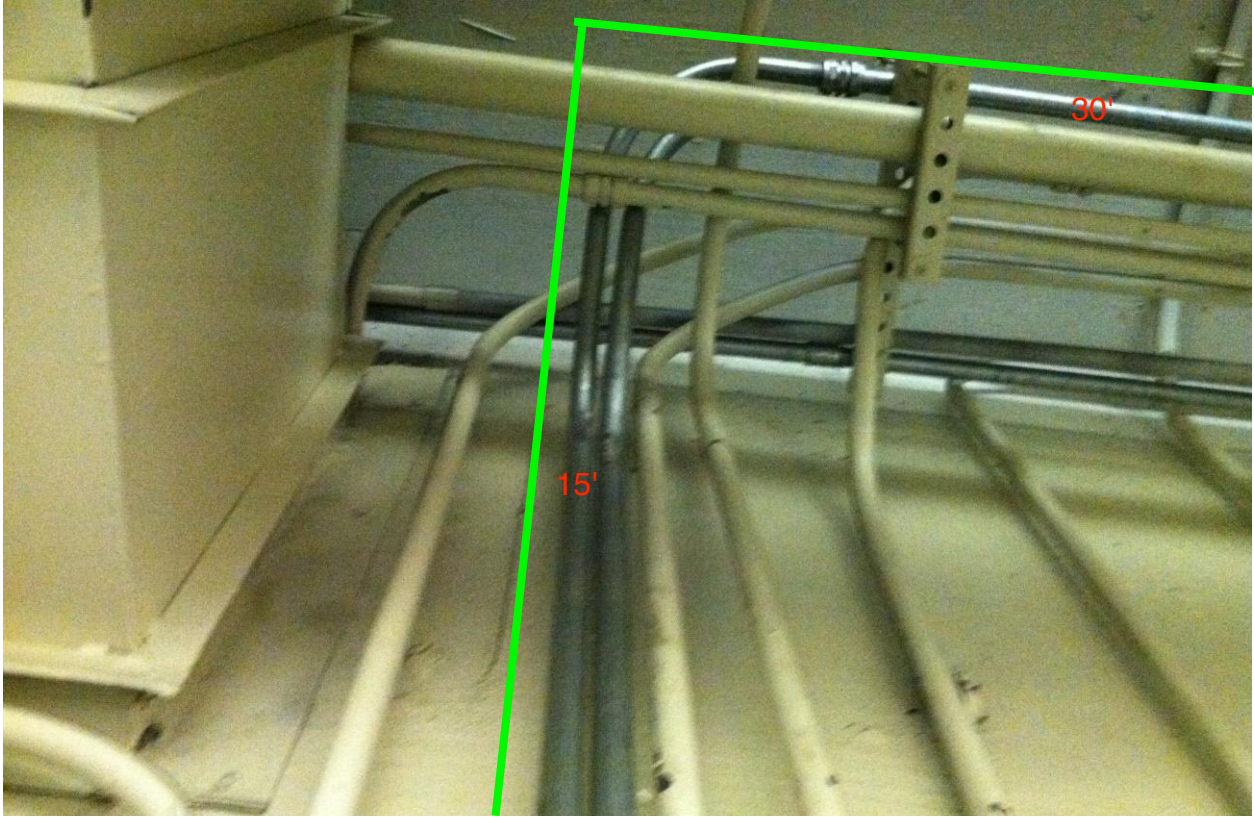
Photo 7 – Proposed overhead conduit in Room 206.

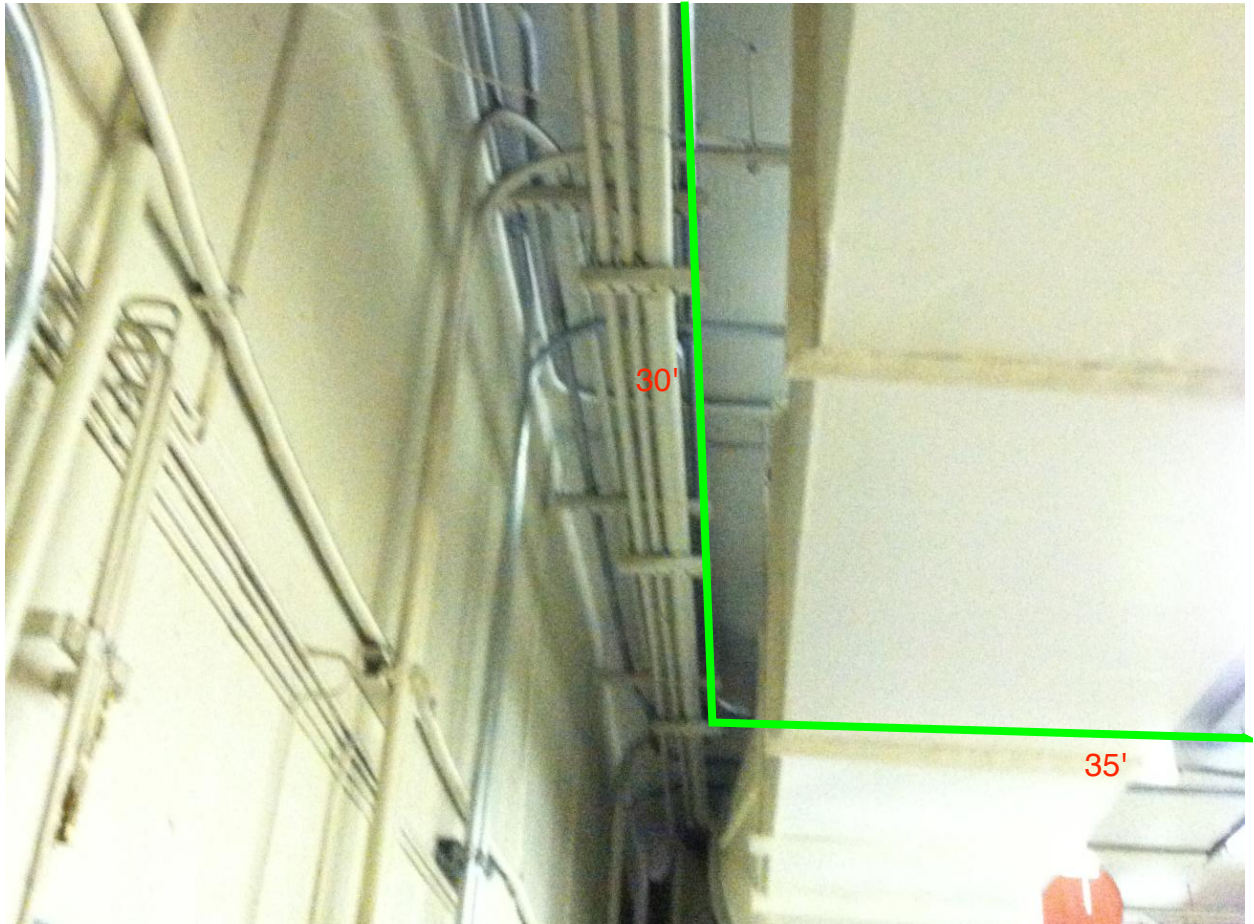
Photo 8 – Proposed overhead conduit in Room 206.

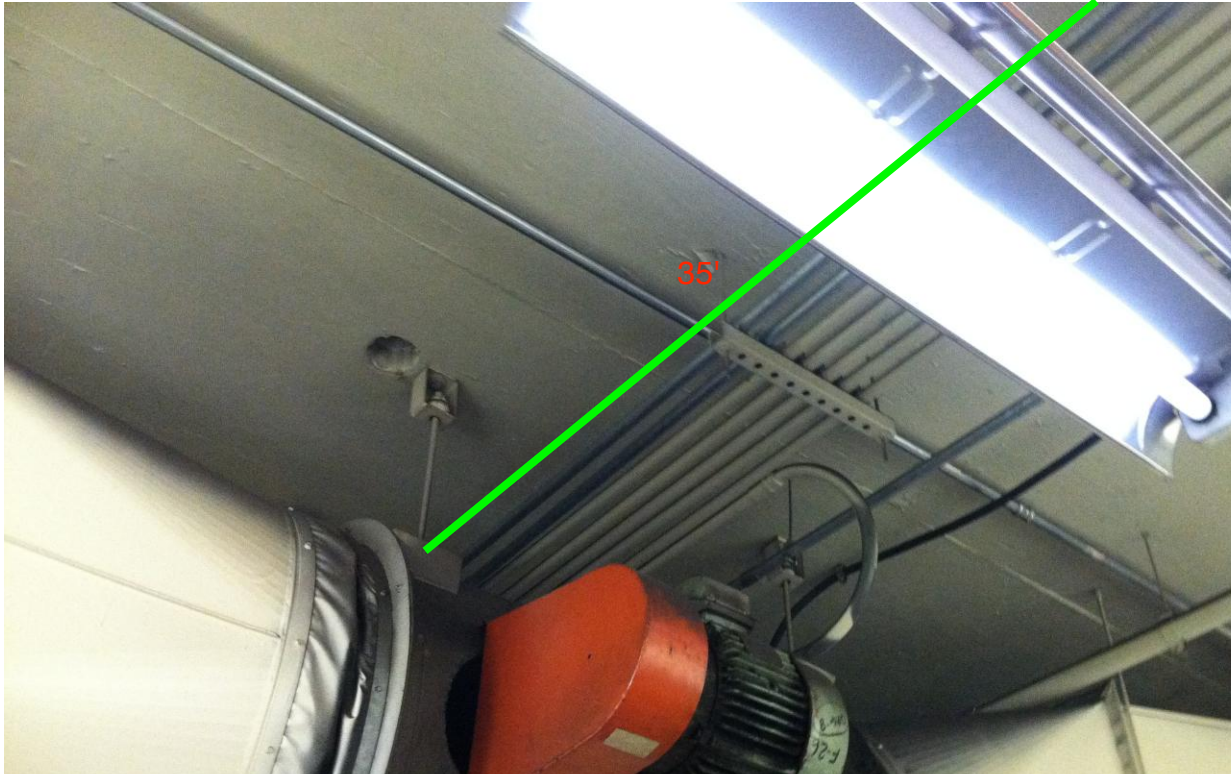
Photo 9 – Proposed overhead conduit in Room 206.

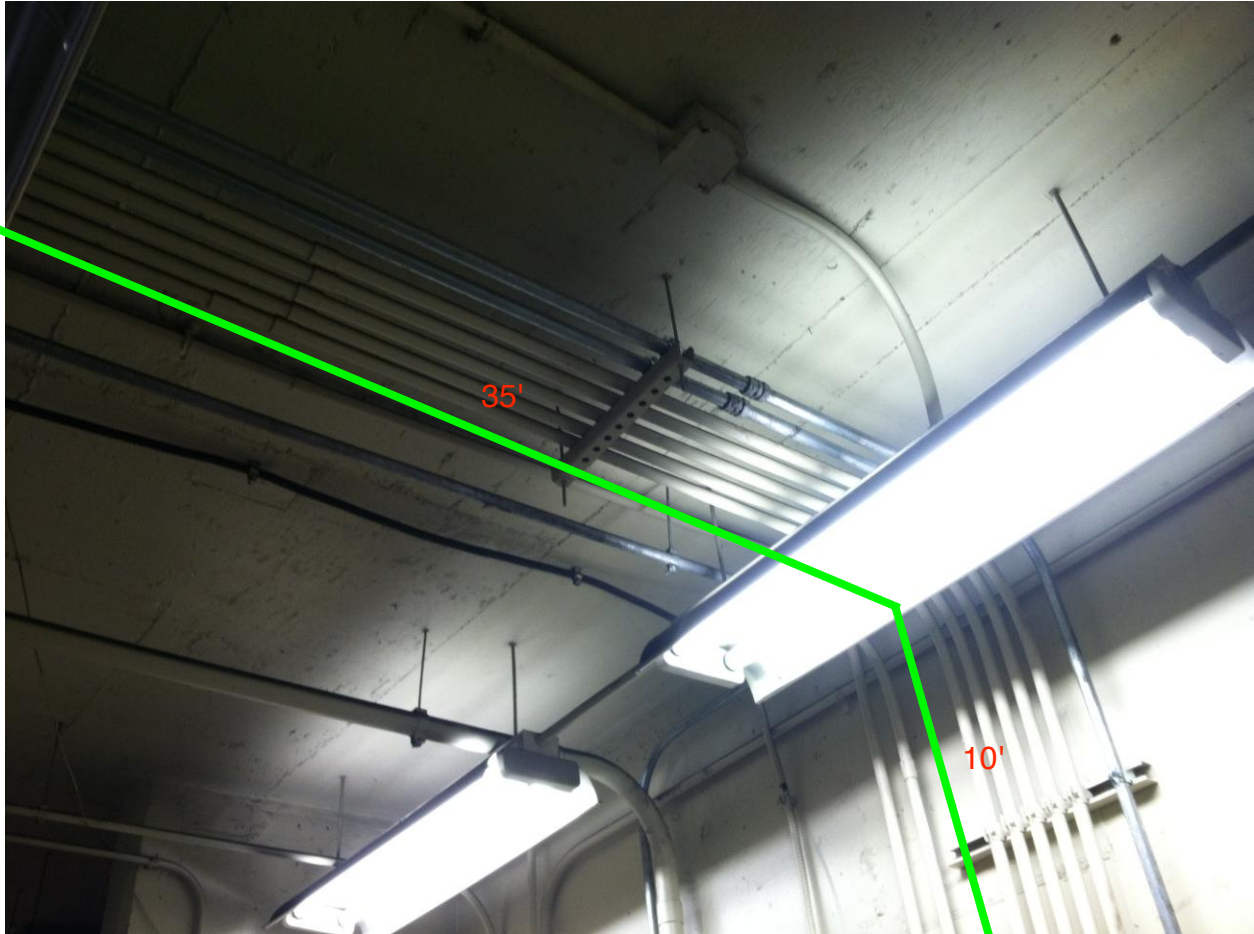
Photo 10 – Proposed overhead conduit in Room 206.

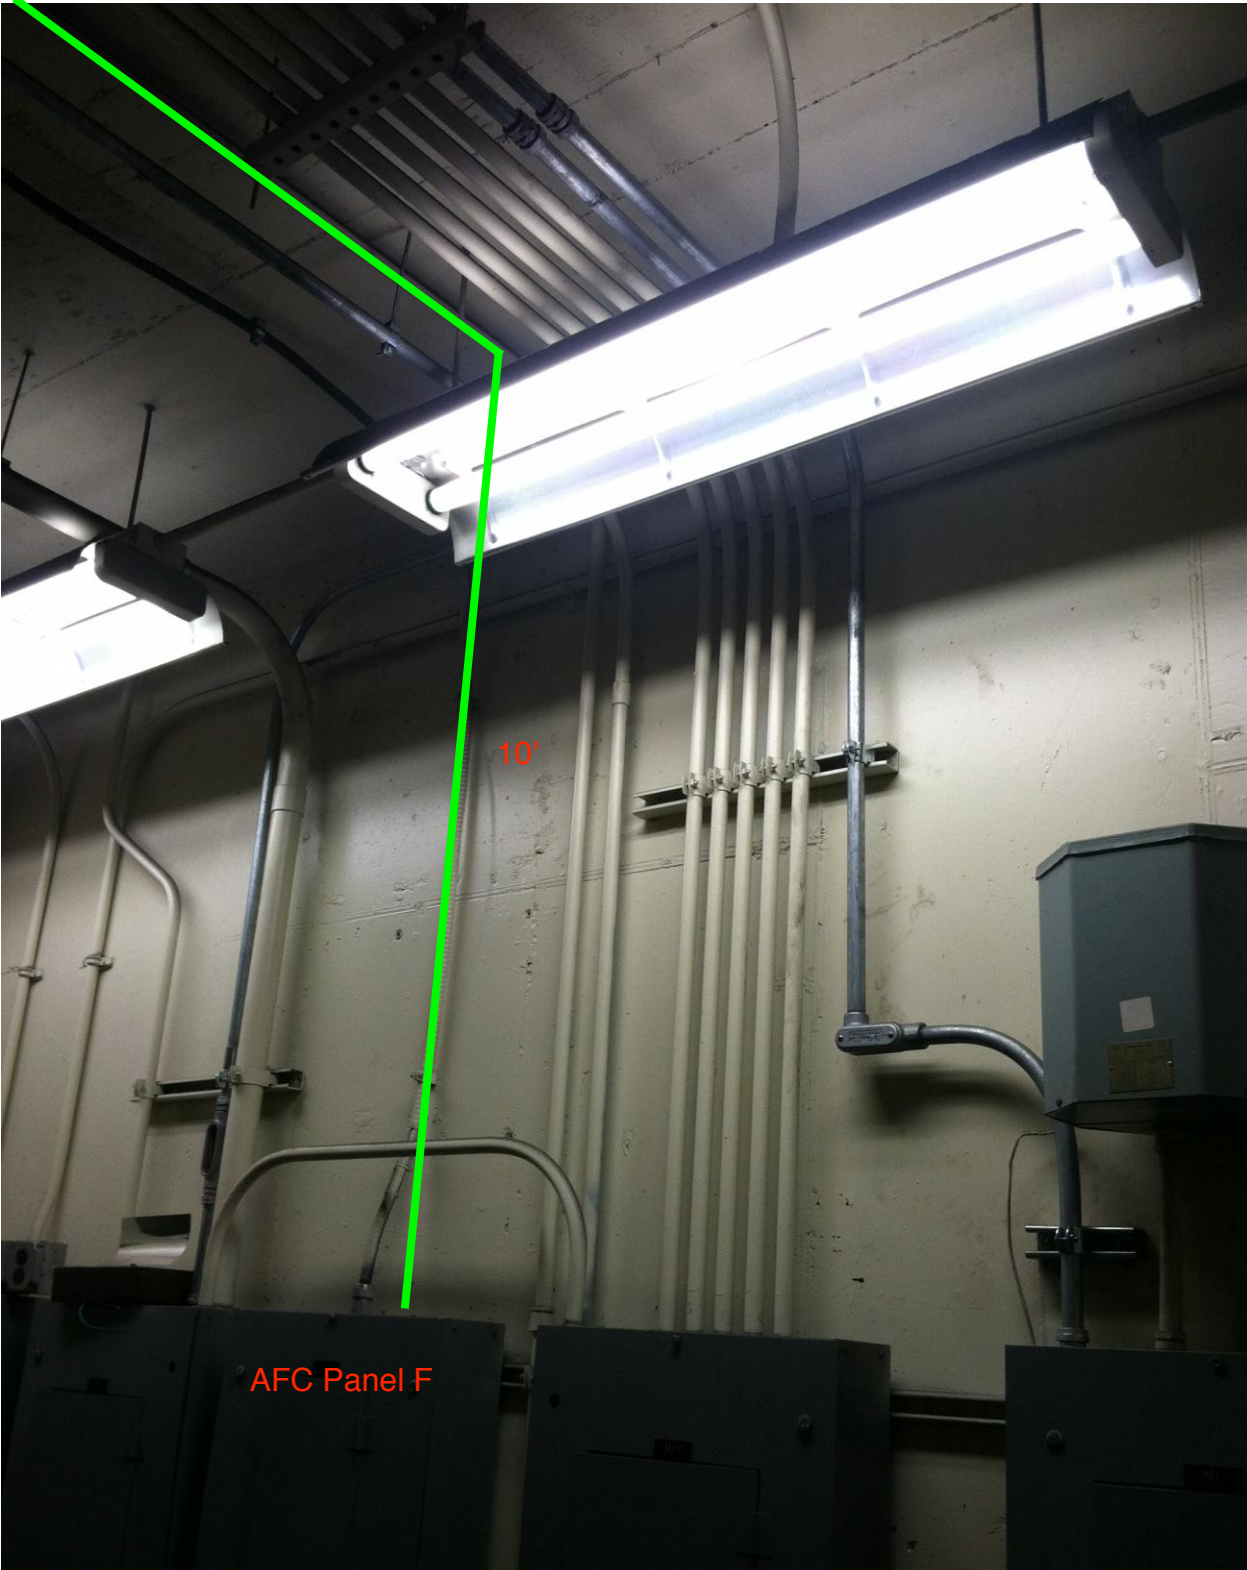
Photo 11 – Proposed overhead conduit in Room 206.
