## Mezzanine Inspection Report (Scoping)

<b>Date:</b> 01/29/2015	<b>Station Name:</b> D05 Capitol South	<b>Mezzanine #:</b> 059	<b>Completed By:</b> Chris Loose
-------------------------	--	-------------------------	----------------------------------

15-NEPP-01  
IN - FLOOR DUCT INSPECTIONS  
D05 Capitol South  
PROPOSED POWER CONDUIT RUN

15-NEPP-01  
IN - FLOOR DUCT INSPECTIONS  
D06 Eastern Market  
PROPOSED POWER CONDUIT RUN

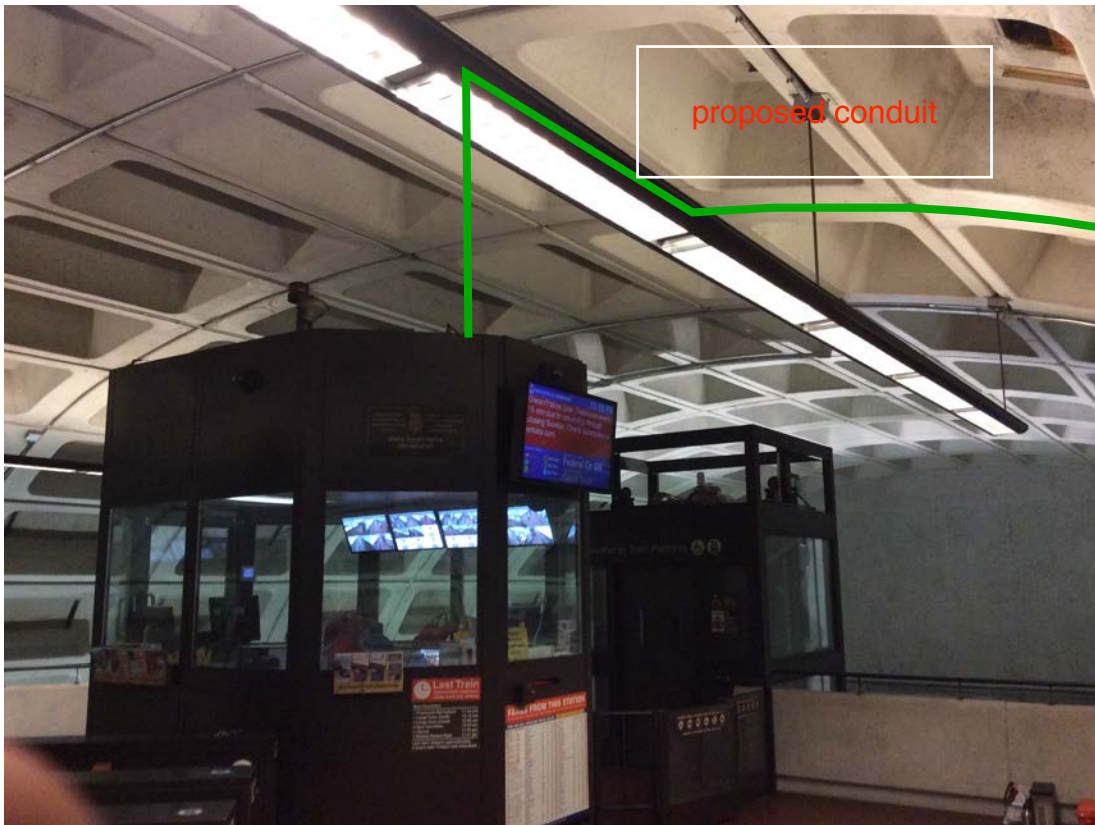
Photo #1 – D05 Capitol South: Proposed overhead conduit along mezzanine ceiling

Scanning was completed at this station. Due to existing in floor conduits and ducts, no clear in-floor path is feasible, and therefore an overhead conduit run is proposed for this station. The conduit will run along the recessed channels in the mezzanine ceiling and wrap around the wall towards room #C207. The conduit will be core drilled through the wall above the door and into the backroom hallway. The conduit will continue along the ceiling of the backrooms until reaching the area in the wall in front of room #C201 where the AFC panel is. The proposed conduit will then be core drilled through the wall and drop down to the top of the AFC panel.

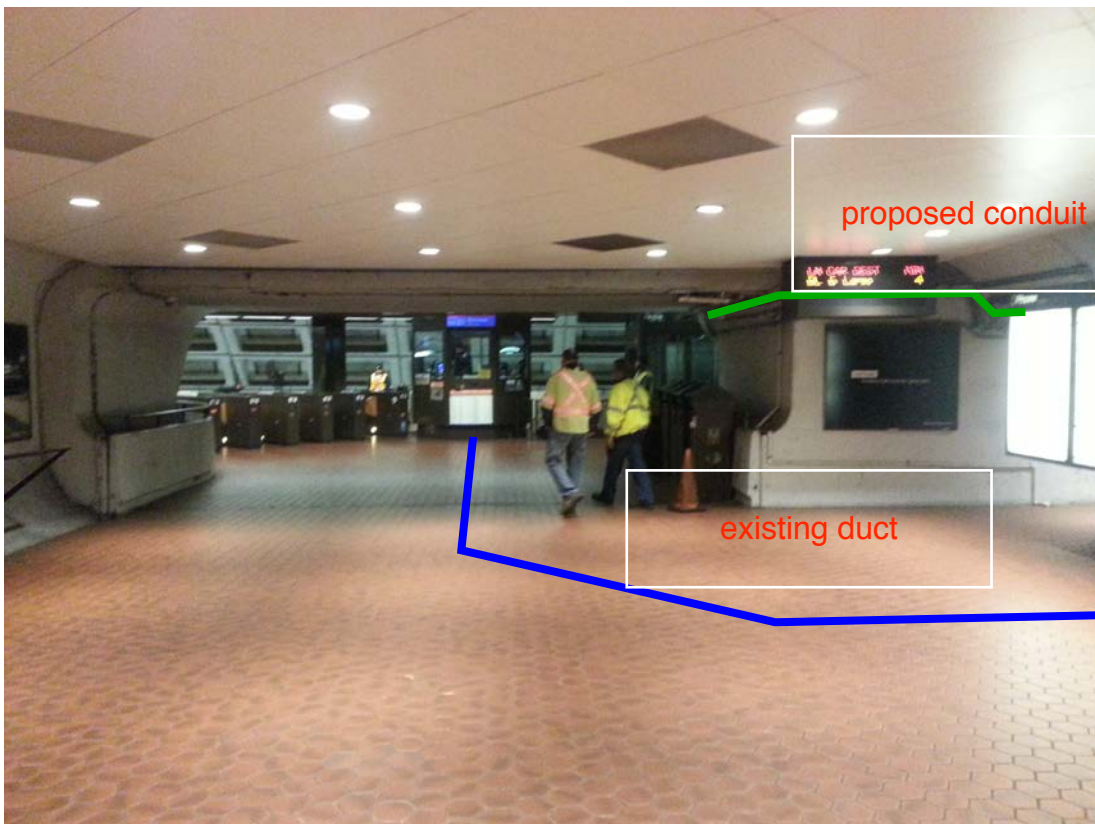
Photo #2 – D05 Capitol South: Proposed overhead conduit and existing in floor duct runs

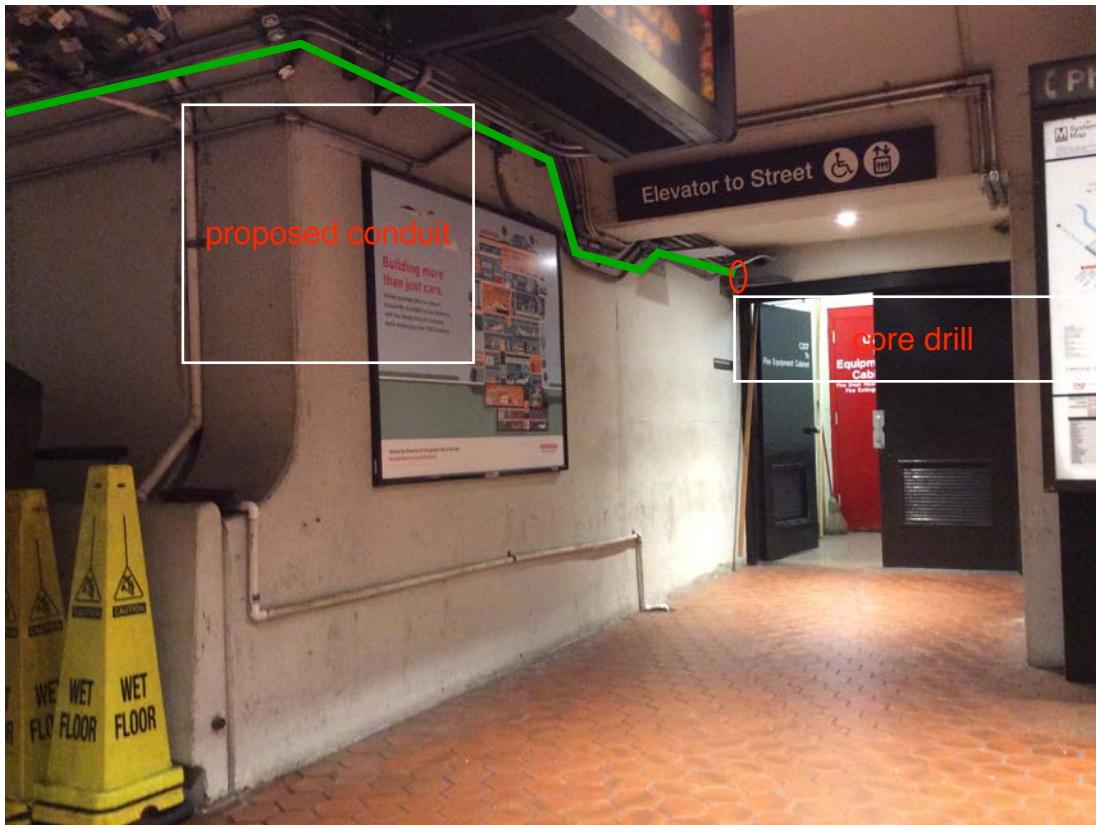
Photo #3 – D05 Capitol South: Proposed overhead conduit into backrooms

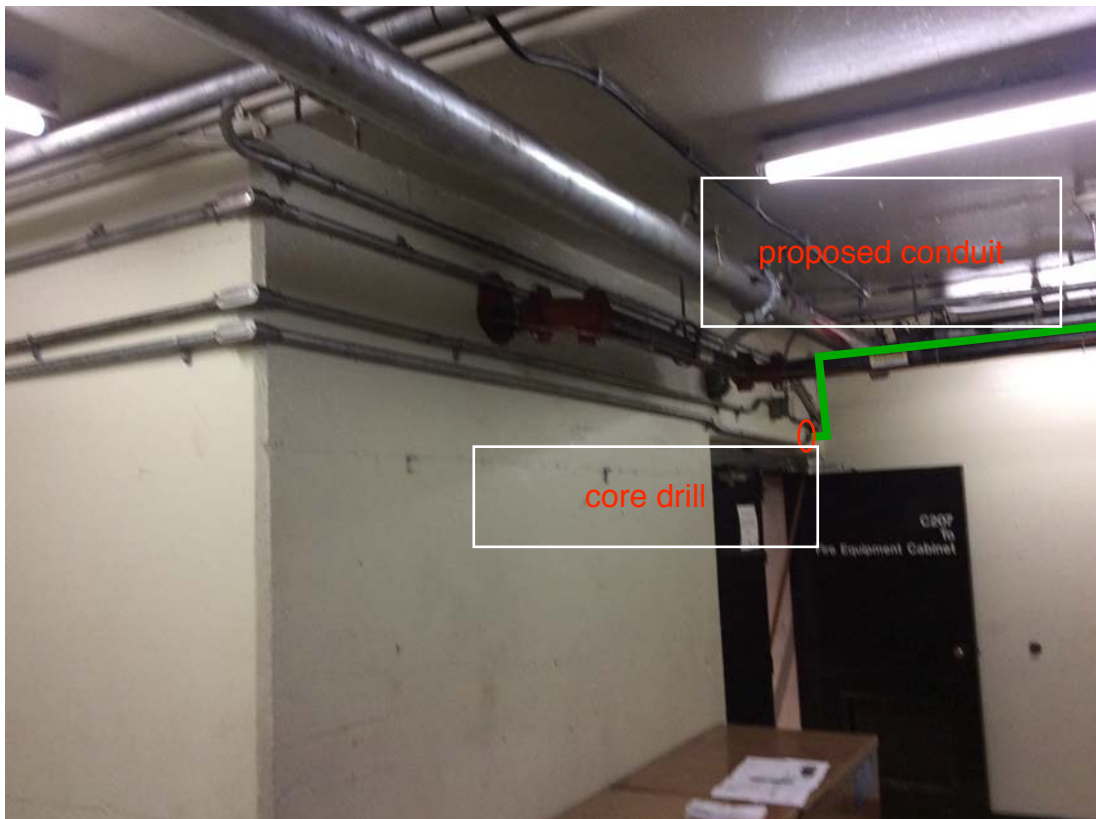
Photo #4 – D05 Capitol South: Proposed overhead conduit inside backrooms

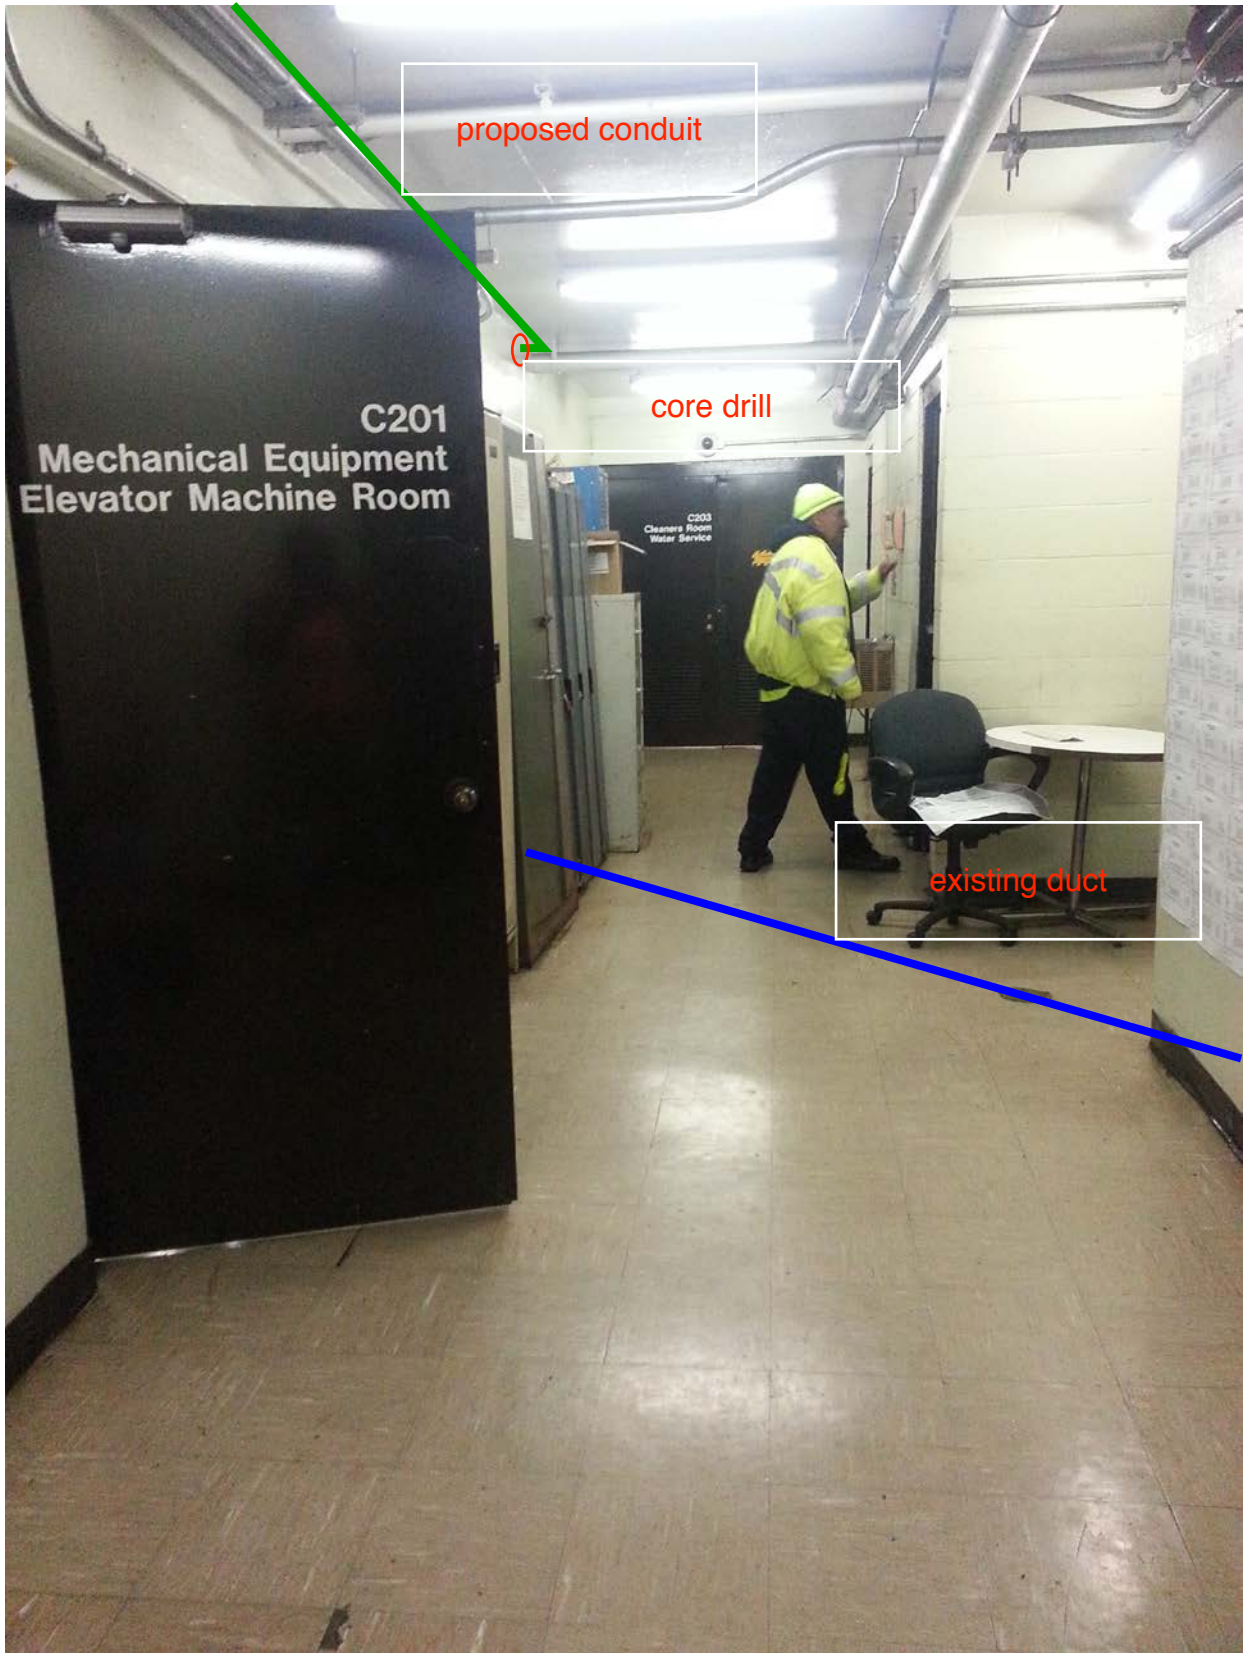
Photo #5 – D05 Capitol South: Proposed overhead conduit and existing in floor duct runs

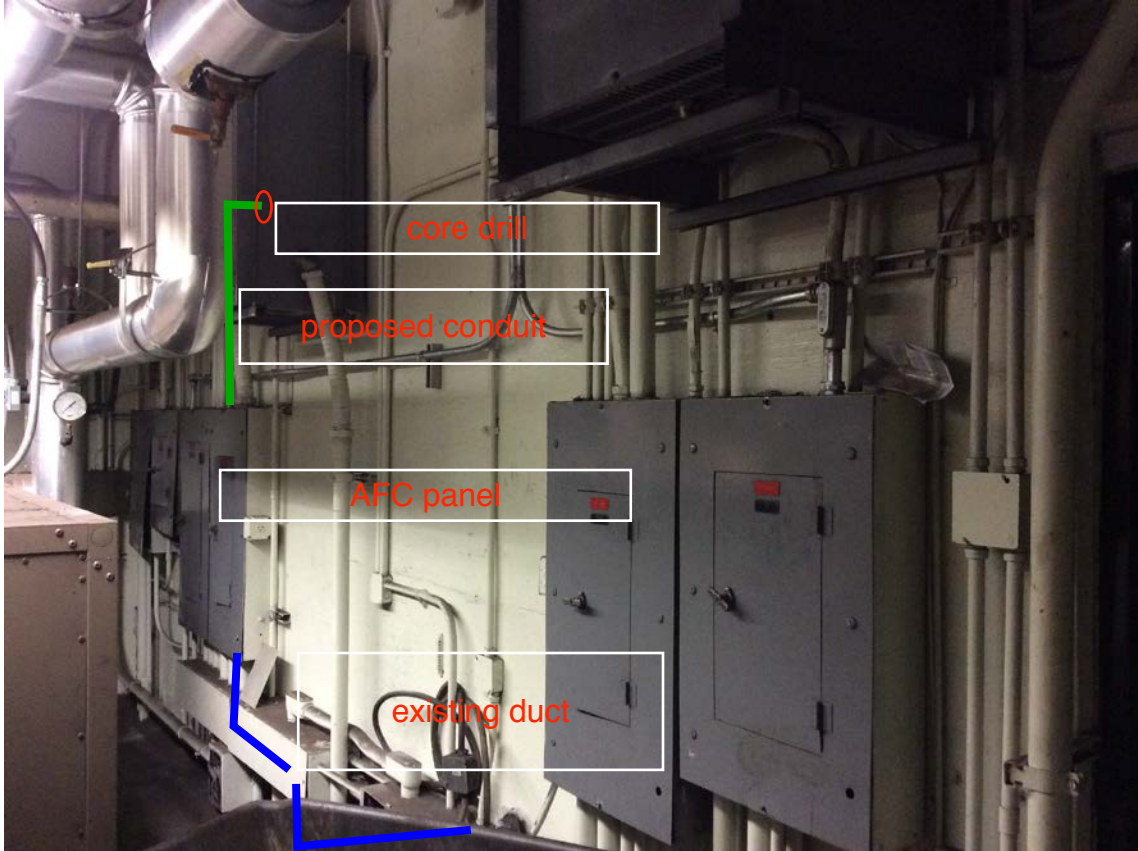
Photo #6 – D05 Capitol South: Proposed overhead conduit into AFC panel and existing in floor duct run into junction box below AFC panel

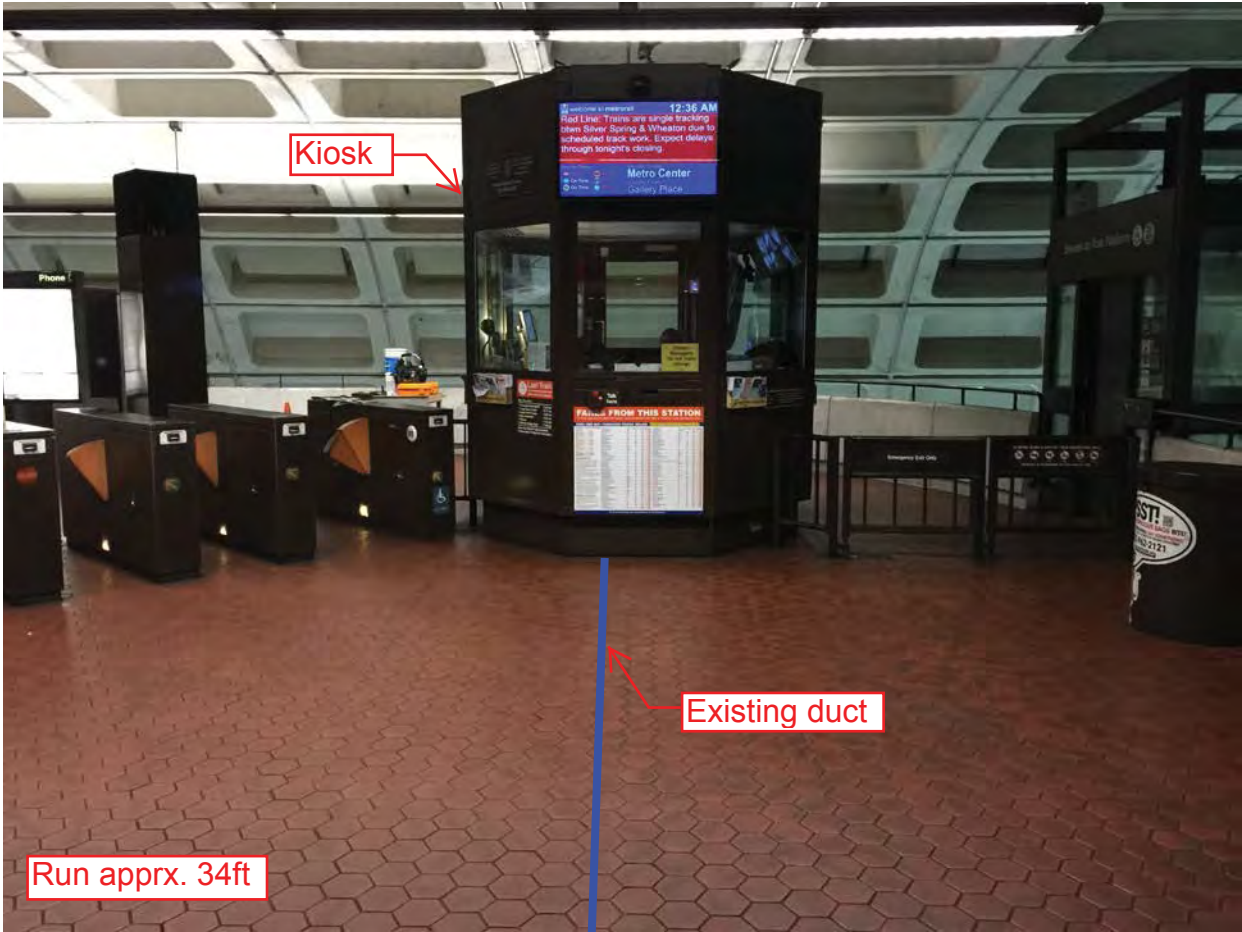
<b>Observations / Issues / Next Steps</b>		
<p>Total run from kiosk to AFC Panel is approximately 95 feet.</p> <p>AFC power run duct was collapsed at expansion joint between kiosk and handhole 1. Duct was in good condition other than expansion joint collapse. Due to duct run between kiosk and hanhole 1 being empty, duct can be repaired and is viable for further usage.</p>		
<b>Sign Off</b>		
	<b>GFP Representative</b>	<b>WMATA PRGM</b>
<b>Name:</b>	Balkis Hassane	
<b>Signature:</b>

Picture 1: D06 Eastern Market – Duct run from kiosk toward handhole 1

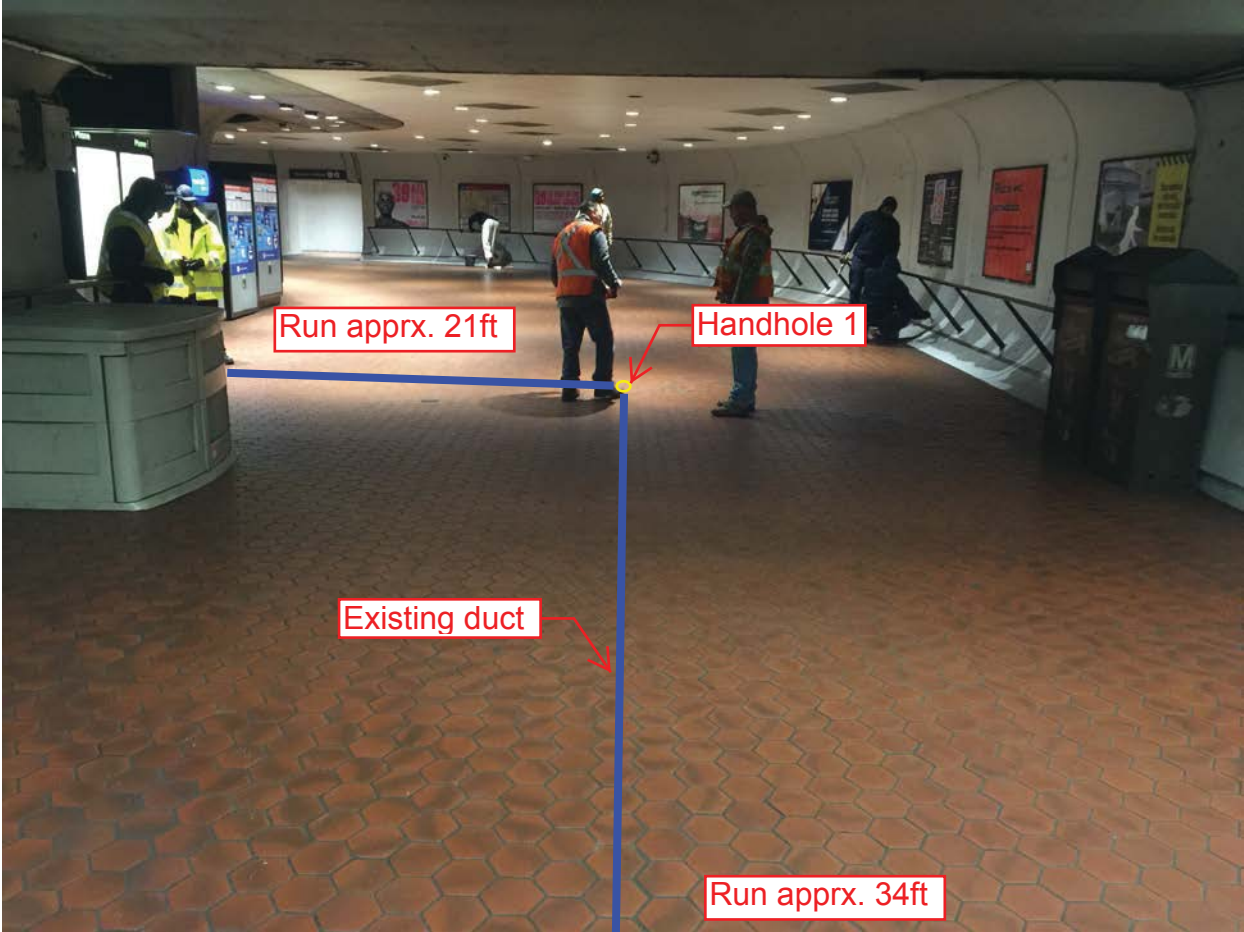
Picture 2: D06 Eastern Market – Duct run from kiosk toward handhole 1

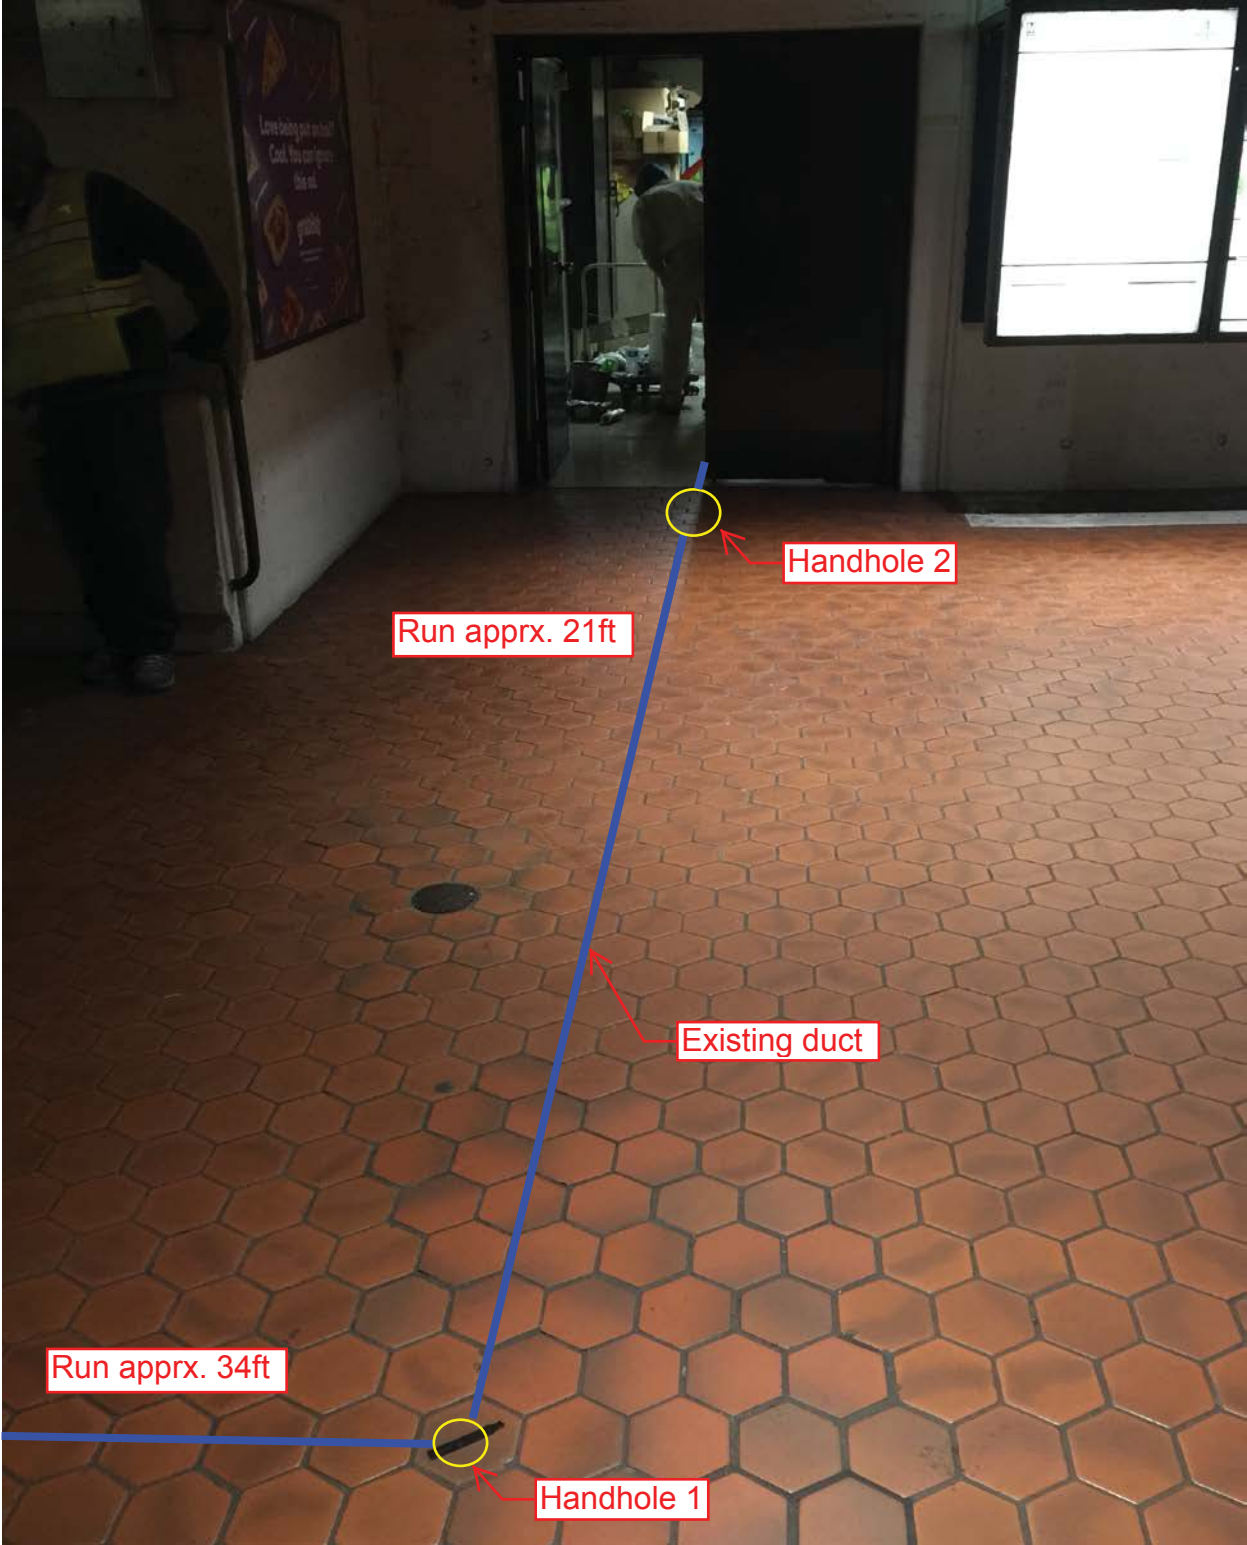
Picture 3: D06 Eastern Market – Duct run from handhole 1 to handhole 2

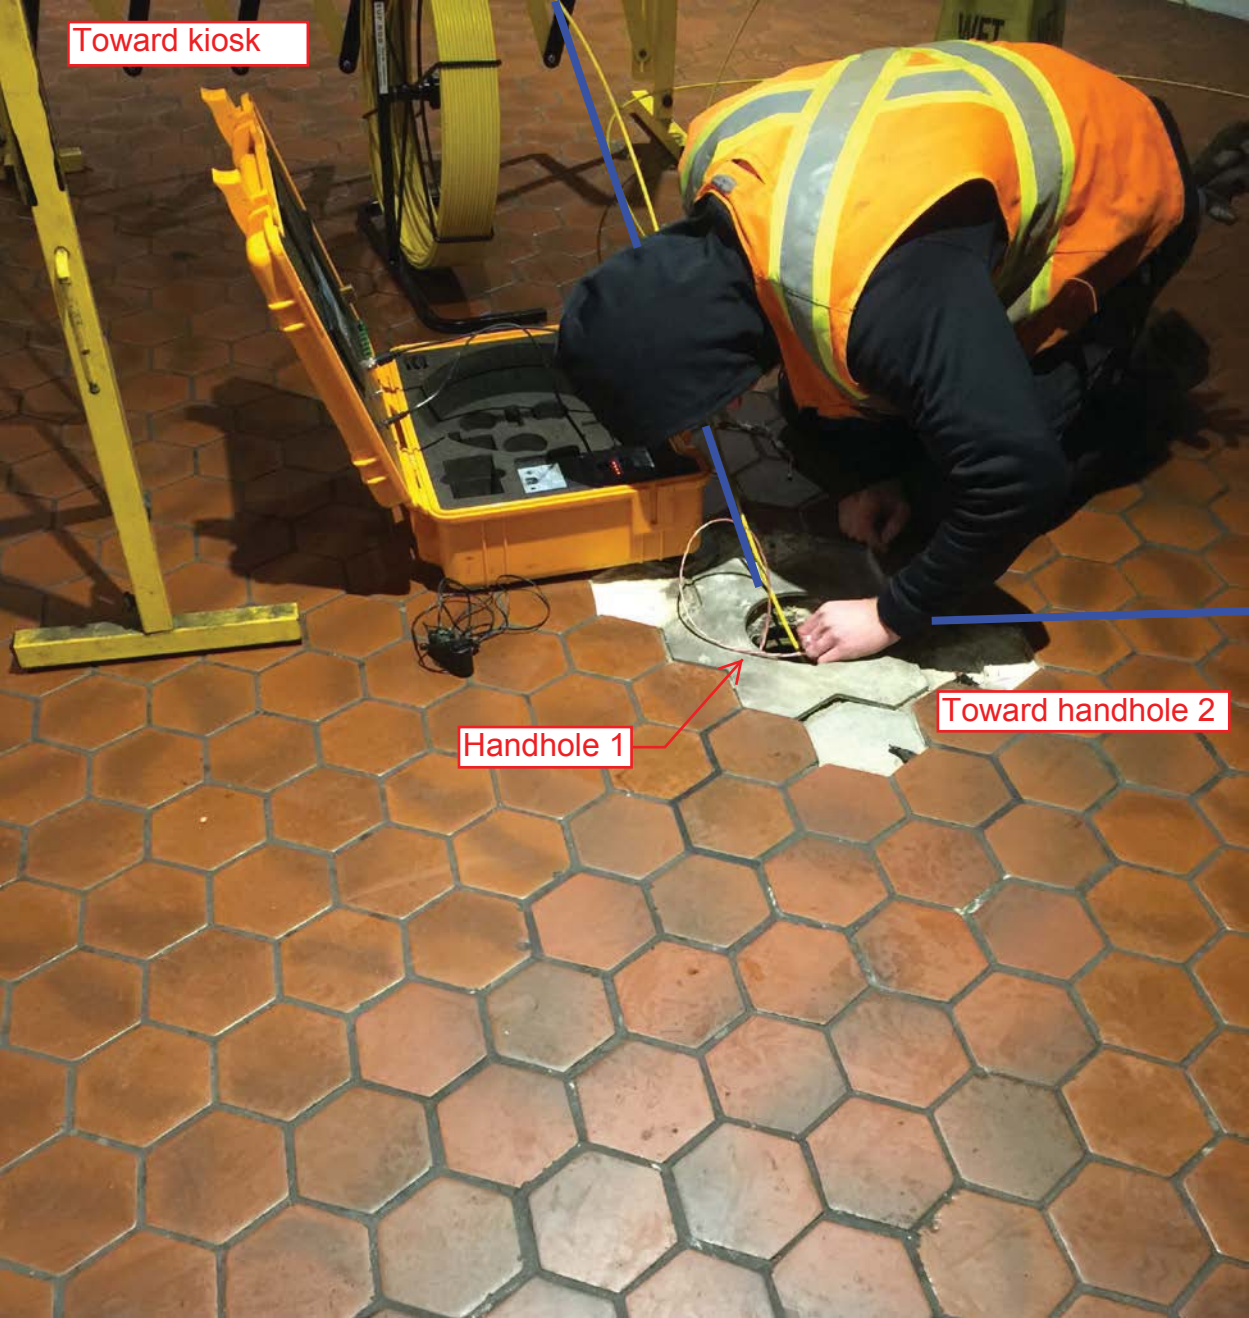
Picture 4: D06 Eastern Market – Handhole 1 location exposed

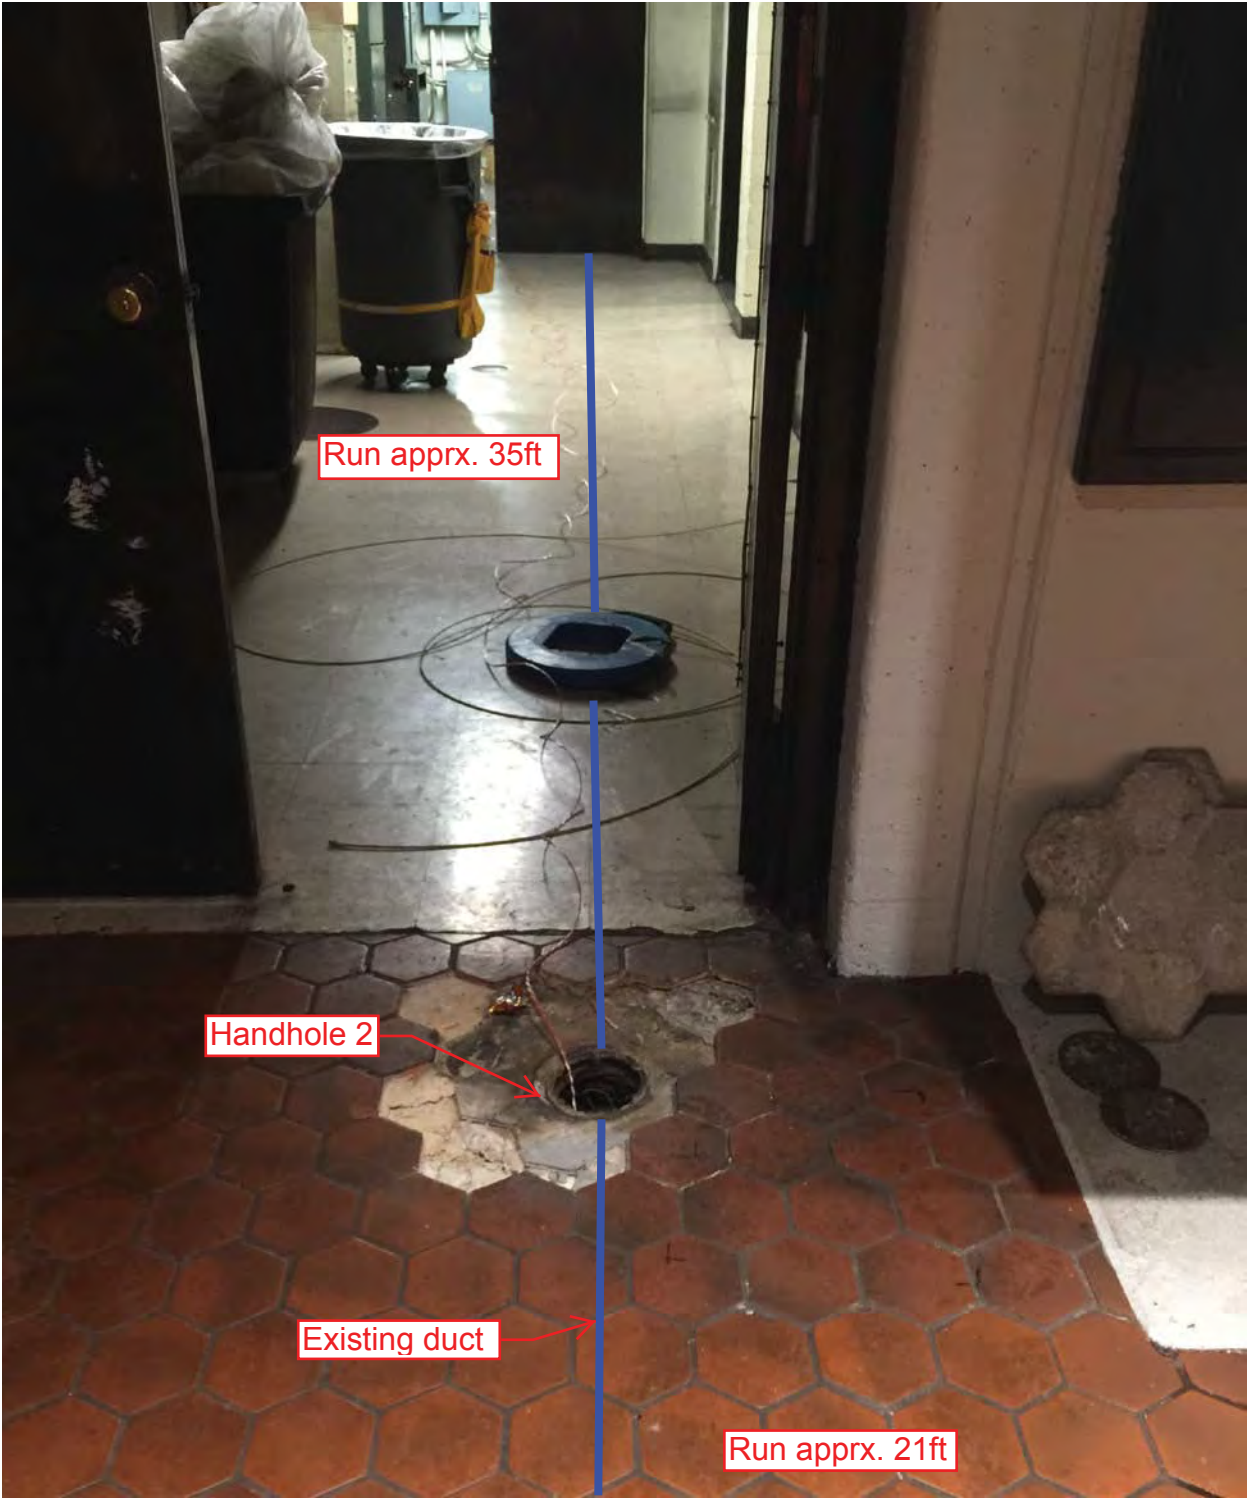
Picture 5: D06 Eastern Market – Handhole 2 location exposed

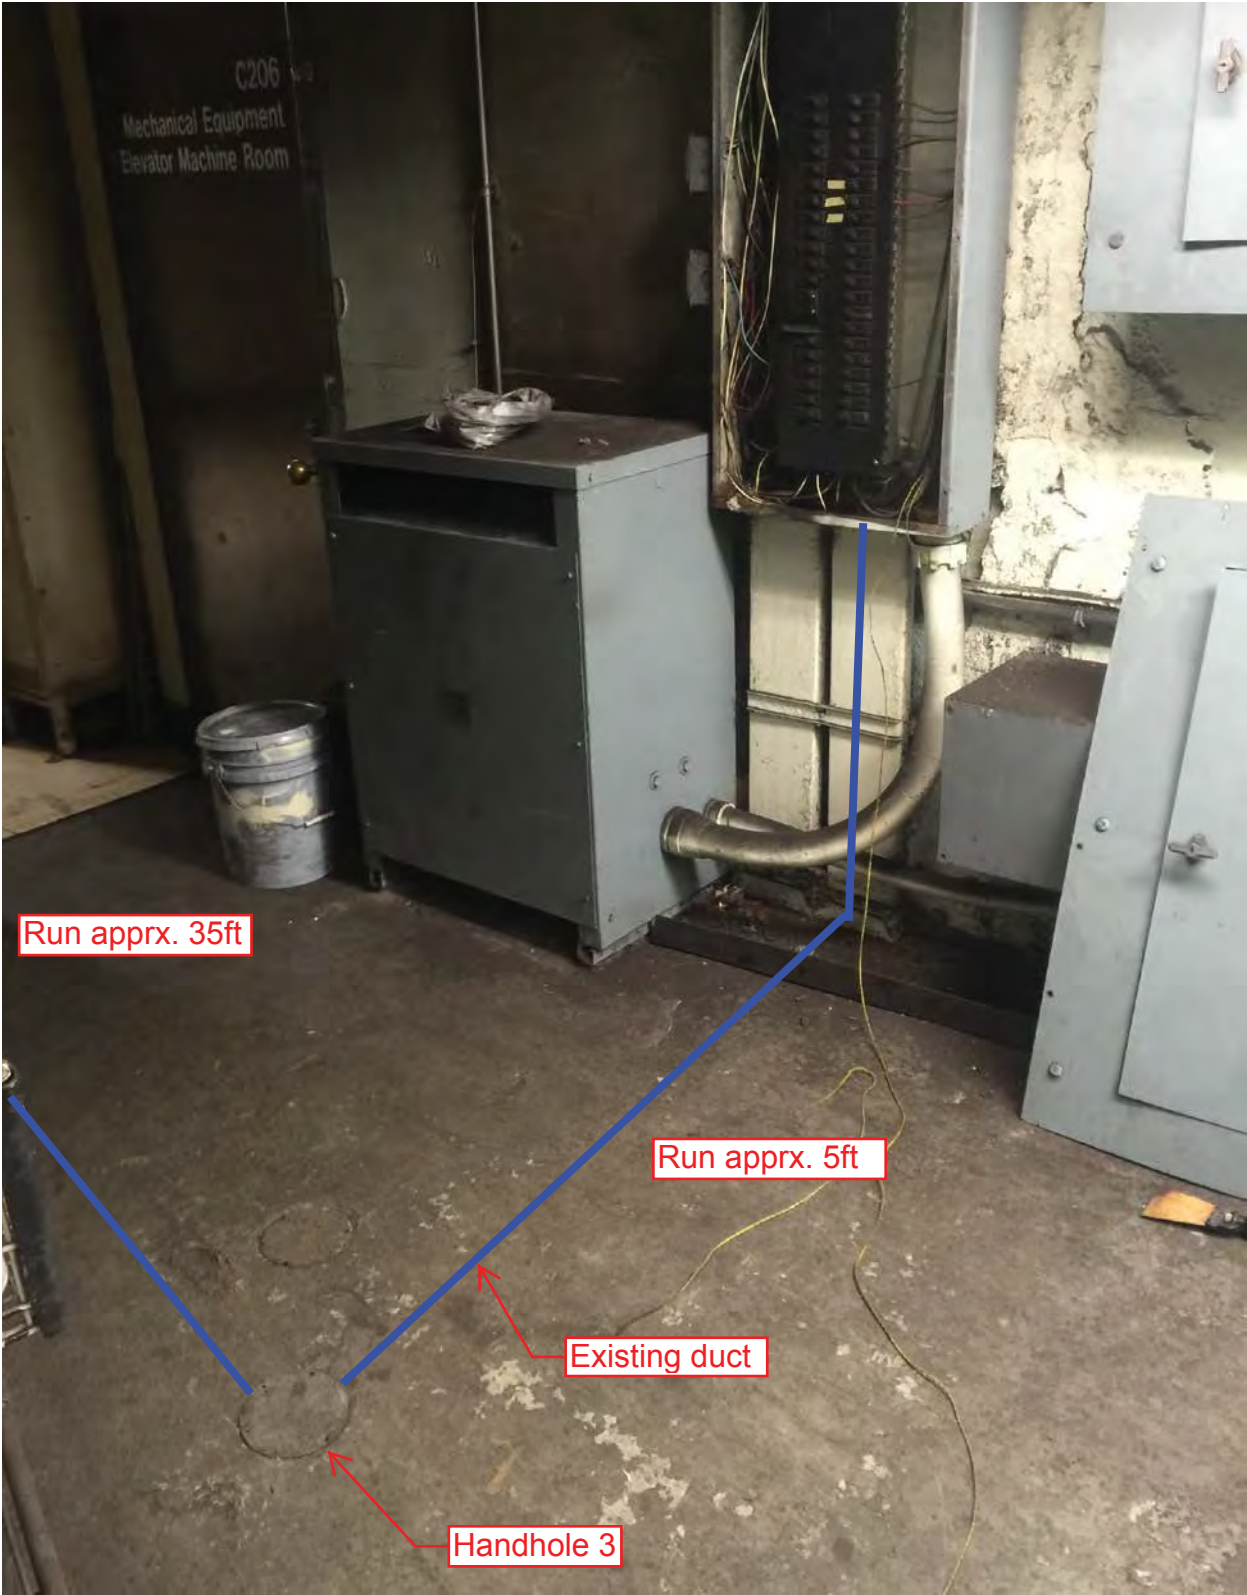
Picture 6: D06 Eastern Market – Duct run from handhole 3 to AFC Panel

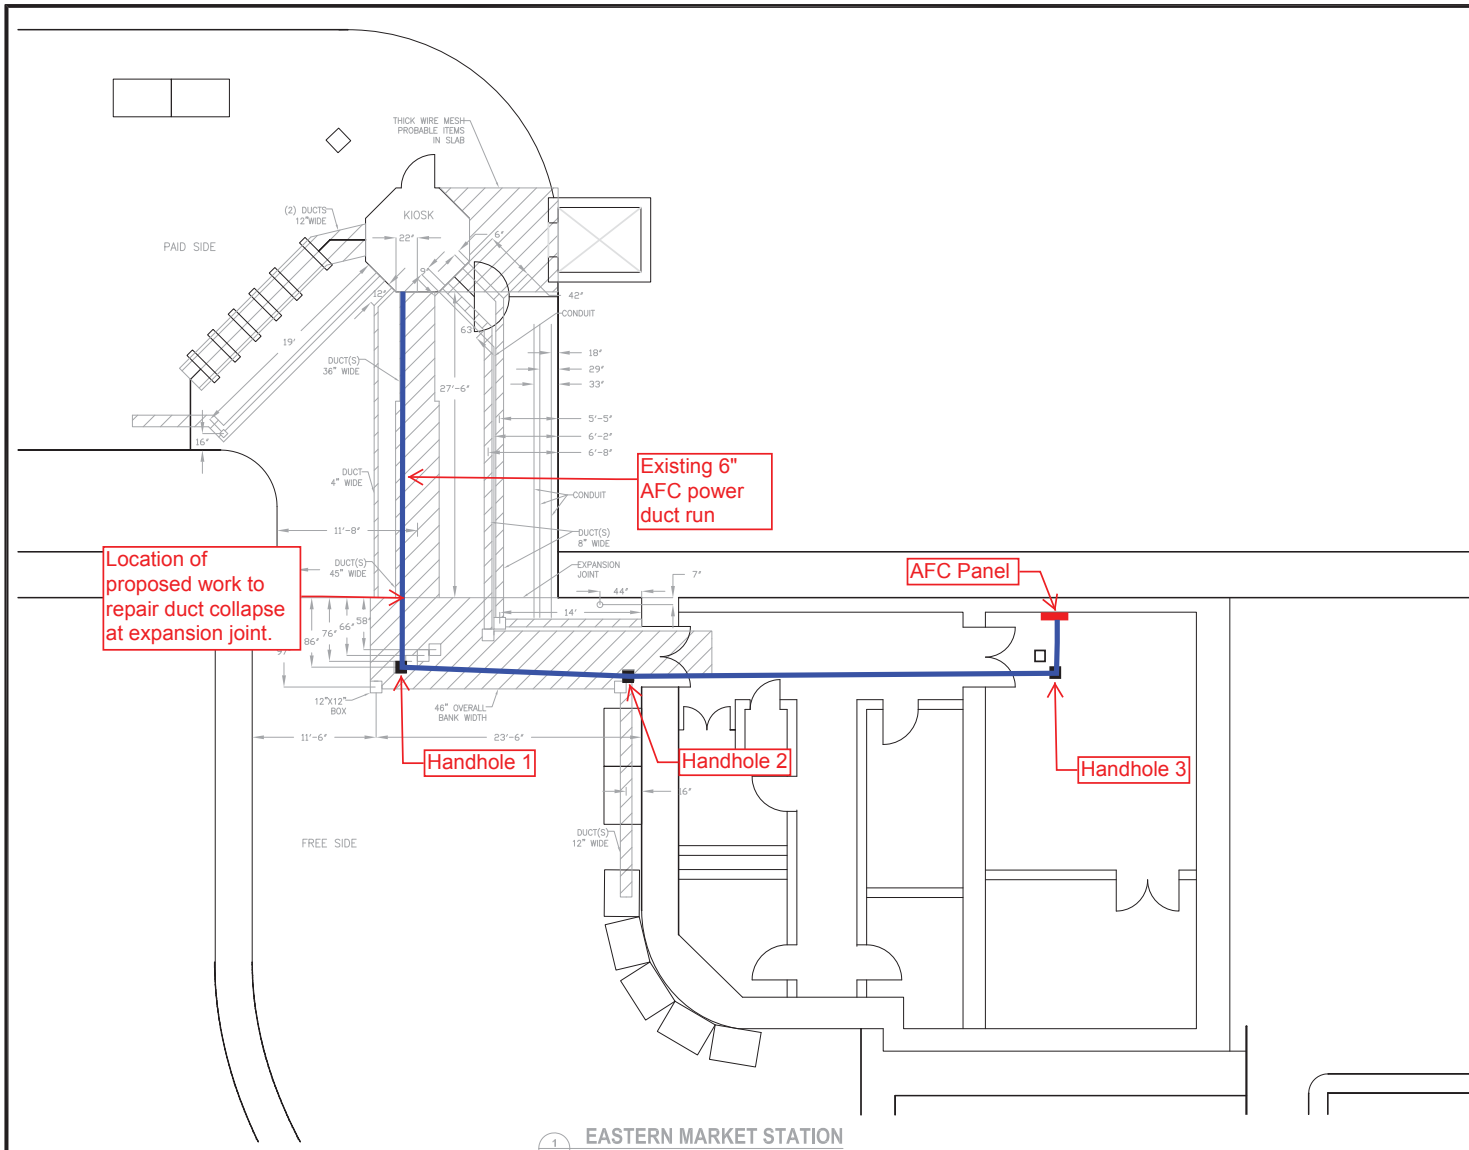
DRAWING NO. **D06-E-100**

Location of proposed work to repair duct collapse at expansion joint.
