## Mezzanine Inspection Report (Scoping)

<b>Date:</b> 01/23/2015	<b>Station Name:</b> Potomac Ave – D07	<b>Mezzanine #:</b> 061	<b>Completed By:</b> Chris Loose
<b>Summary</b>			
<p>Video scoping and pull string installation completed for communication ducts for the faregate arrays. Video scoping completed for power ducts for the faregate arrays as well. Video scoping was partially completed in the power run from the kiosk to junction box 1 due to two 90 degree bends between manhole 1 and junction box 1. Video scoping was not completed from junction box 1 to AFC panel due to run being conduit. Pull string was installed in power run from kiosk to manhole 1, and junction box 1 to AFC panel (via junction box 2). AFC panel is located in mechanical equipment room 301 which is on the 2<sup>nd</sup> floor off of room C201.</p> <p>Scanning was completed at this mezzanine. The proposed run between the kiosk and AFC panel includes a proposed conduit from the kiosk to junction box 1 and then the use of the existing conduit from junction box 1 to the AFC panel via junction box 2. The proposed conduit will run from above the kiosk along the mezzanine and entrance passageway ceiling into juncti

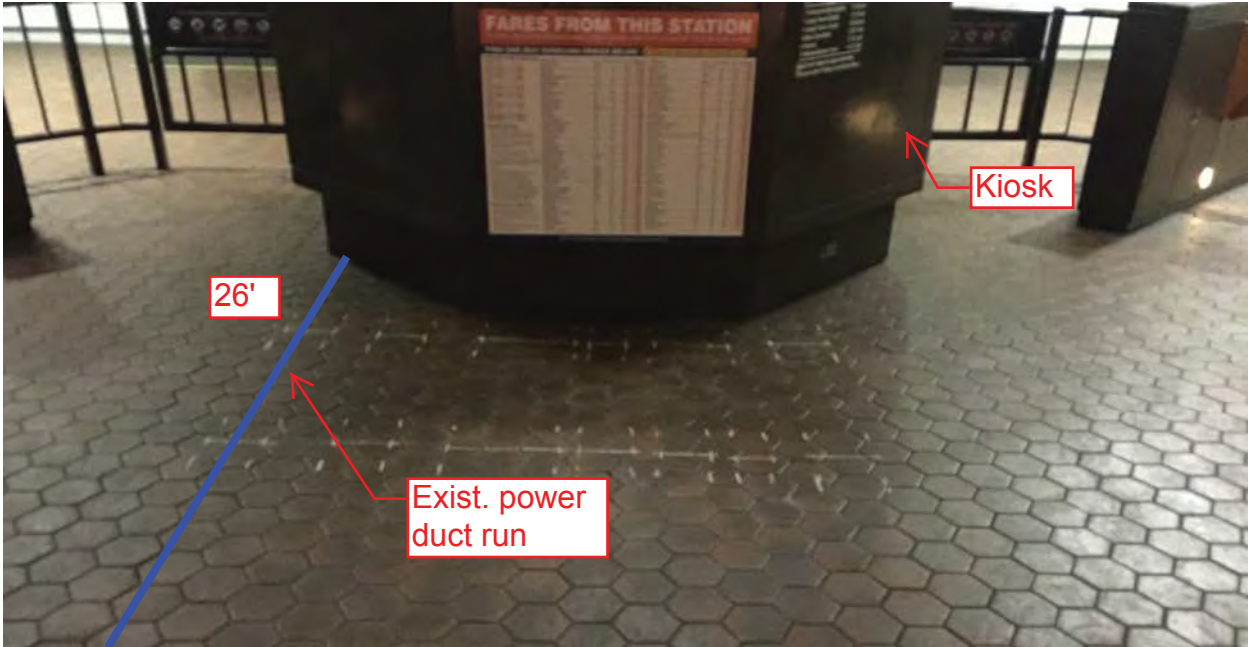
Picture 1: D07 Potomac Ave – Existing duct run from kiosk toward room C201

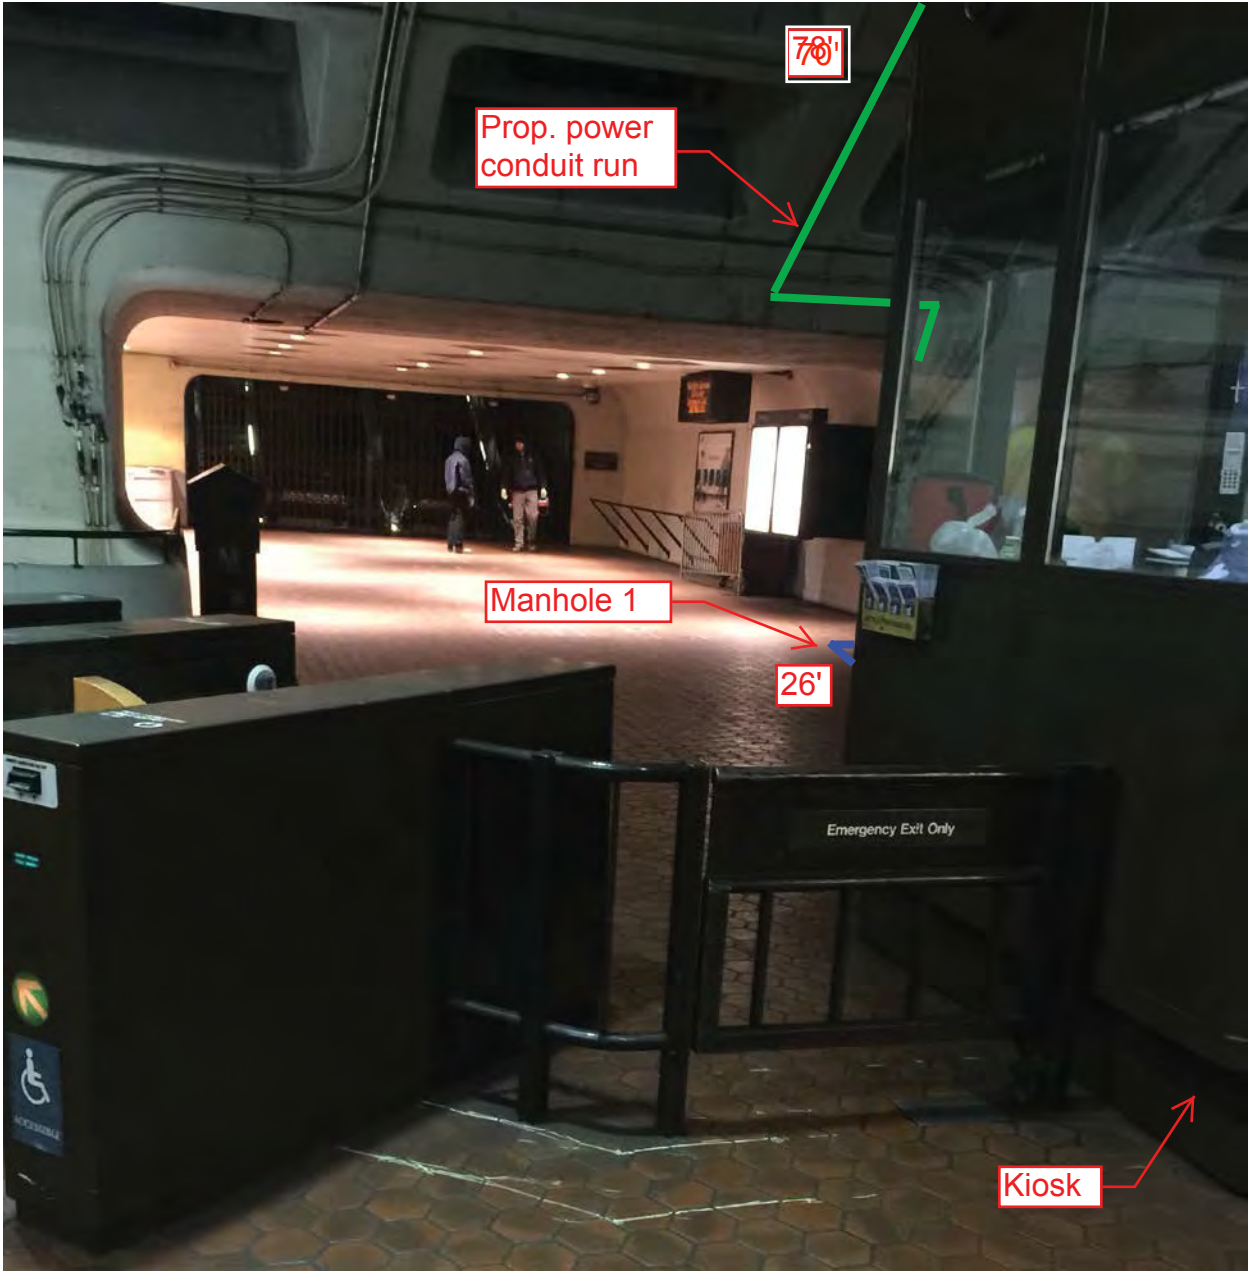
Picture 2: D07 Potomac Ave – Existing & proposed runs from kiosk toward room C201

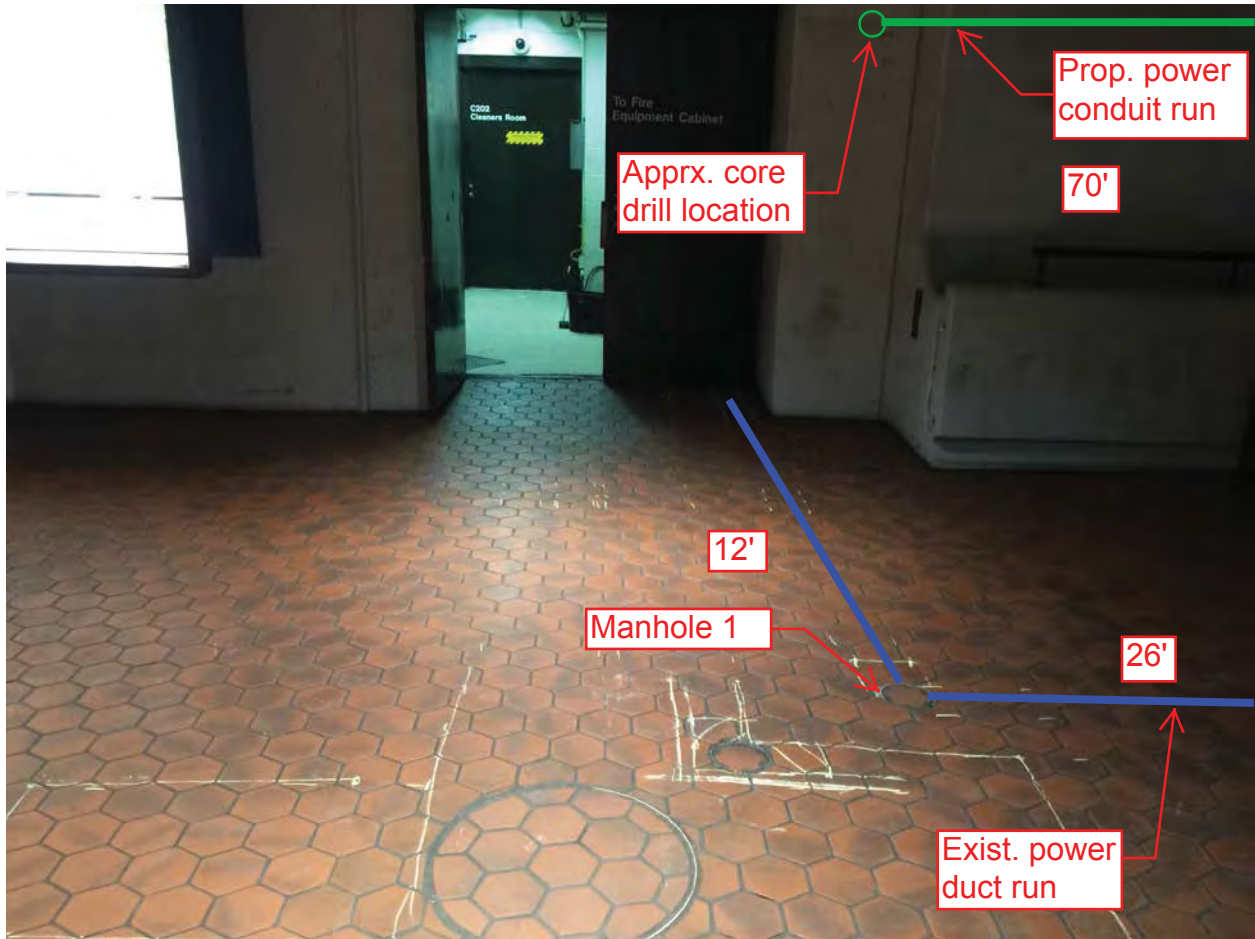
Picture 3: D07 Potomac Ave – Existing duct run from manhole 1 to junction box 1 & proposed conduit to junction box 1

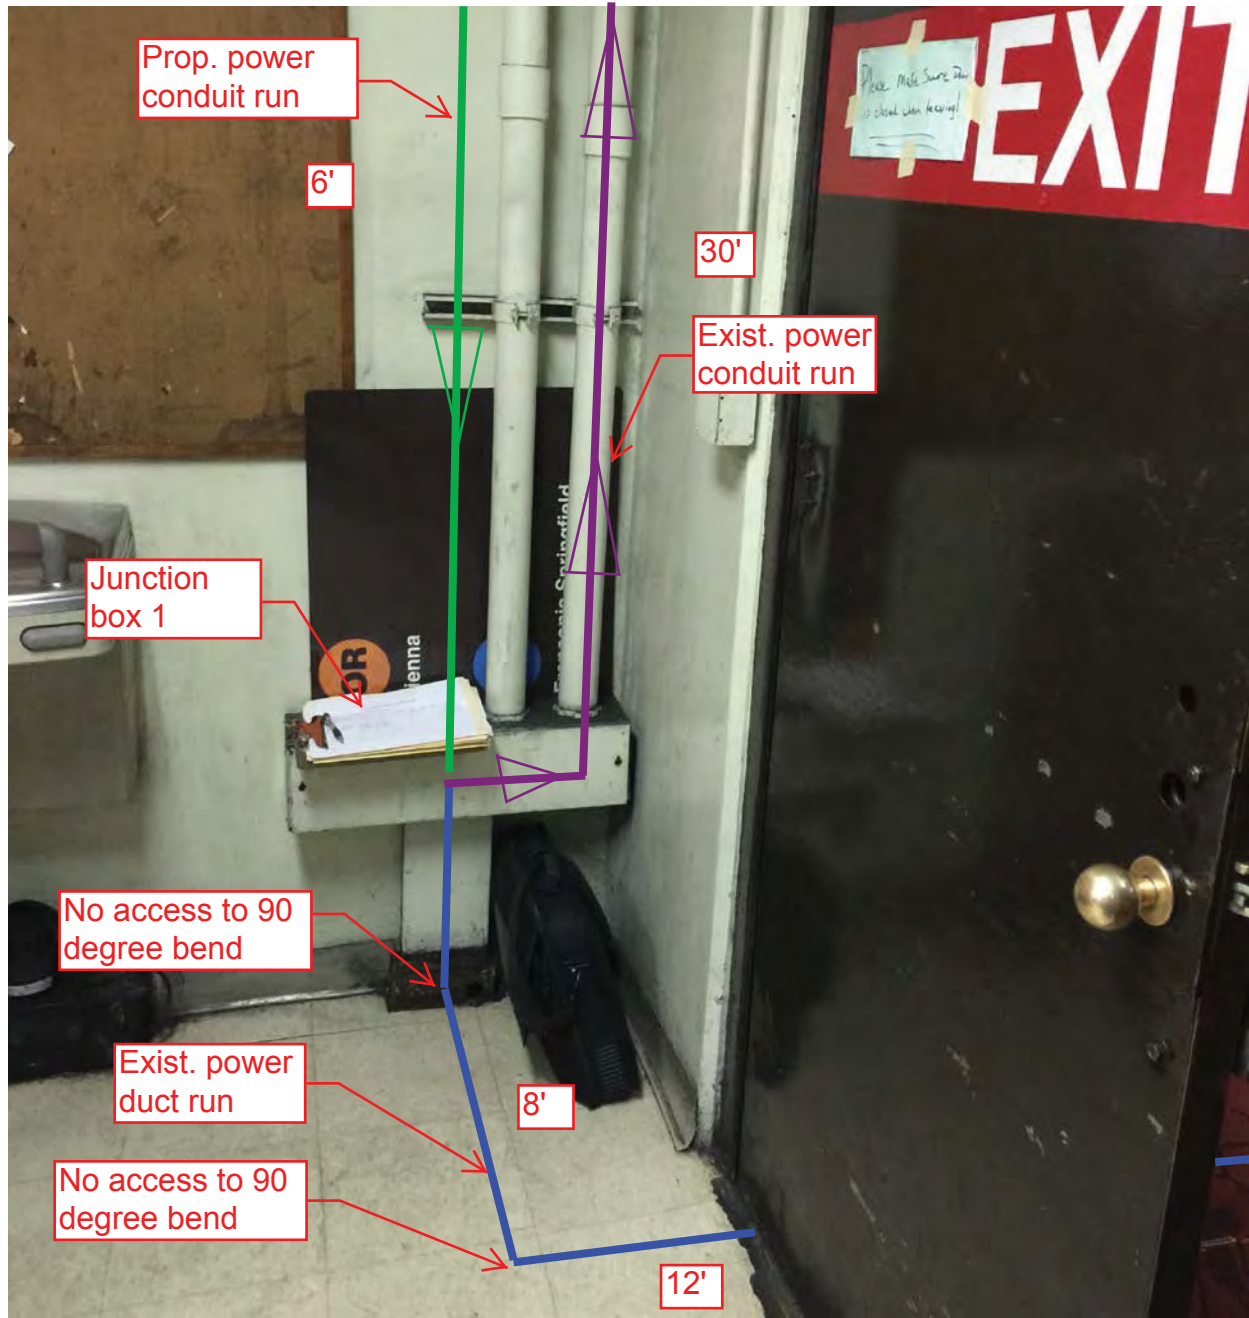
Picture 4: D07 Potomac Ave – Existing duct run into junction box 1 & proposed conduit to junction box 1
