## Mezzanine Inspection Report

Date: 01/14/15	Station Name: D08 Stadium Armory South	Mezzanine #: 062	Completed By: Mike Butler
----------------	--	------------------	---------------------------

Date: 02/05/15	Station Name: D08 Stadium Armory North	Mezzanine #: 063	Completed By: Mike Butler
----------------	--	------------------	---------------------------

Date: 12/05/15	Station Name: D09 Minnesota Avenue	Mezzanine #: 064	Completed By: Mike Butler
<b>Summary</b>			
<p>The upper and lower faregate arrays were scoped and pull strings were installed in communication ducts. The video scoping and pull string installation was successfully completed in the power conduit between the Kiosk and AFC Panel.</p> <p>Scanning is not required at this mezzanine.</p>			
<b>Scoping of Faregate Array(s)</b>			
Task	Yes/No	Notes	
<b>Communications Duct – Upper Faregate Array (4 gates)</b>			
Was video scoping completed for the entire duct run?	Yes	Refer to "WMATA Minnesota Ave 3inch Comm Upper Faregate Video.avi"	
Were pull strings installed at all faregates in the array?	Yes		
Were there any obstructions or blockages? Provide details of type and specific location.	No	Some corrosion evident.	
Is the

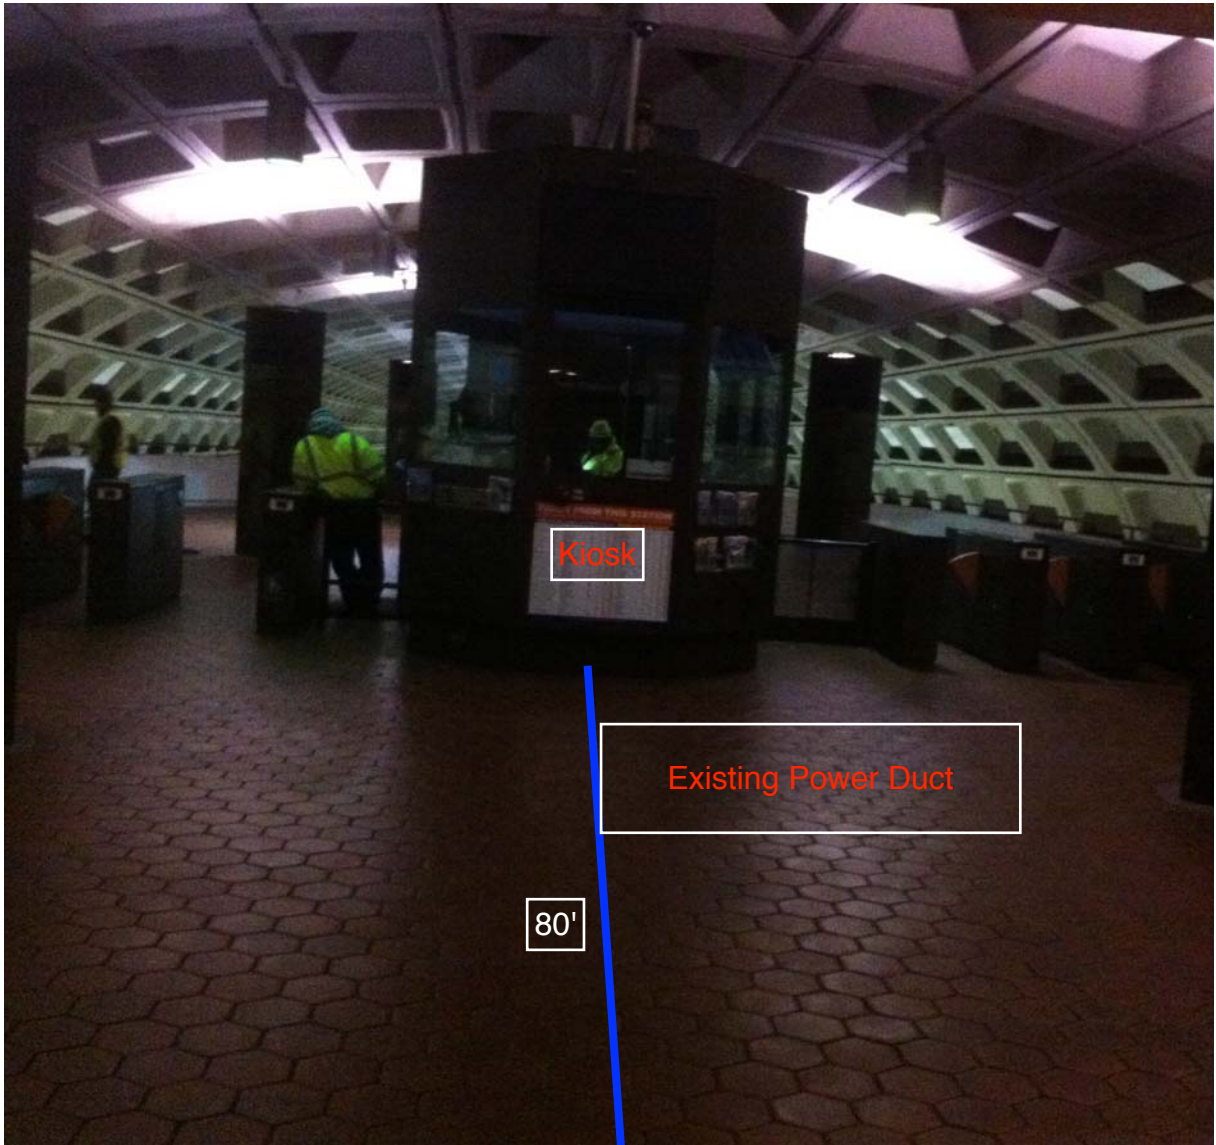
Photo #1 – Faregate arrays and existing power duct run from Kiosk on mezzanine level

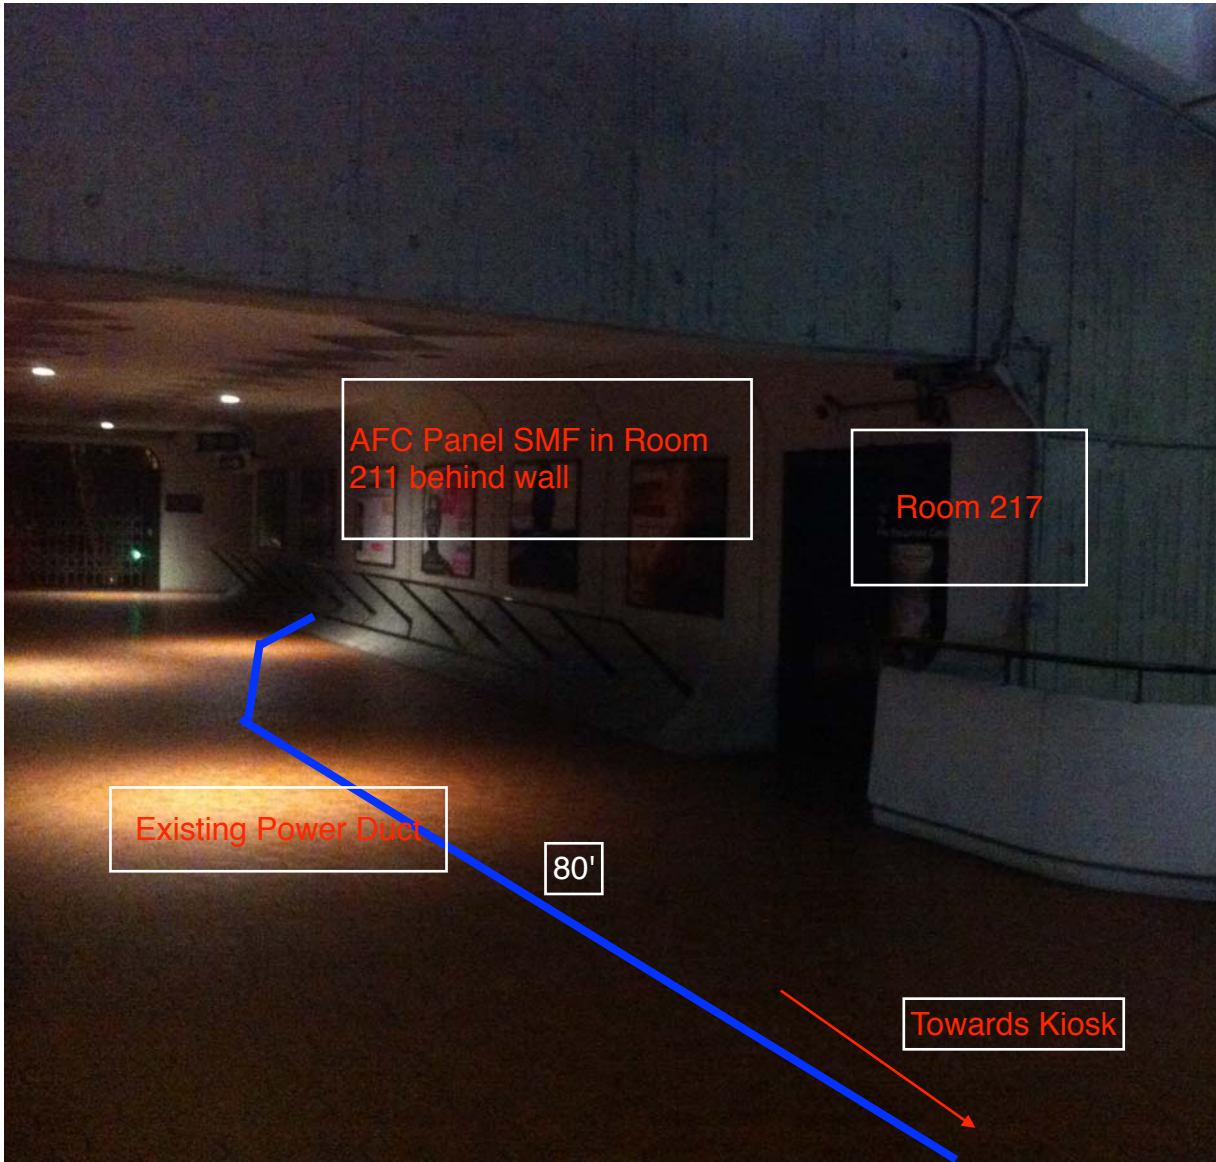
Photo #2 – Existing power duct run from Kiosk towards AFC Panel on mezzanine level

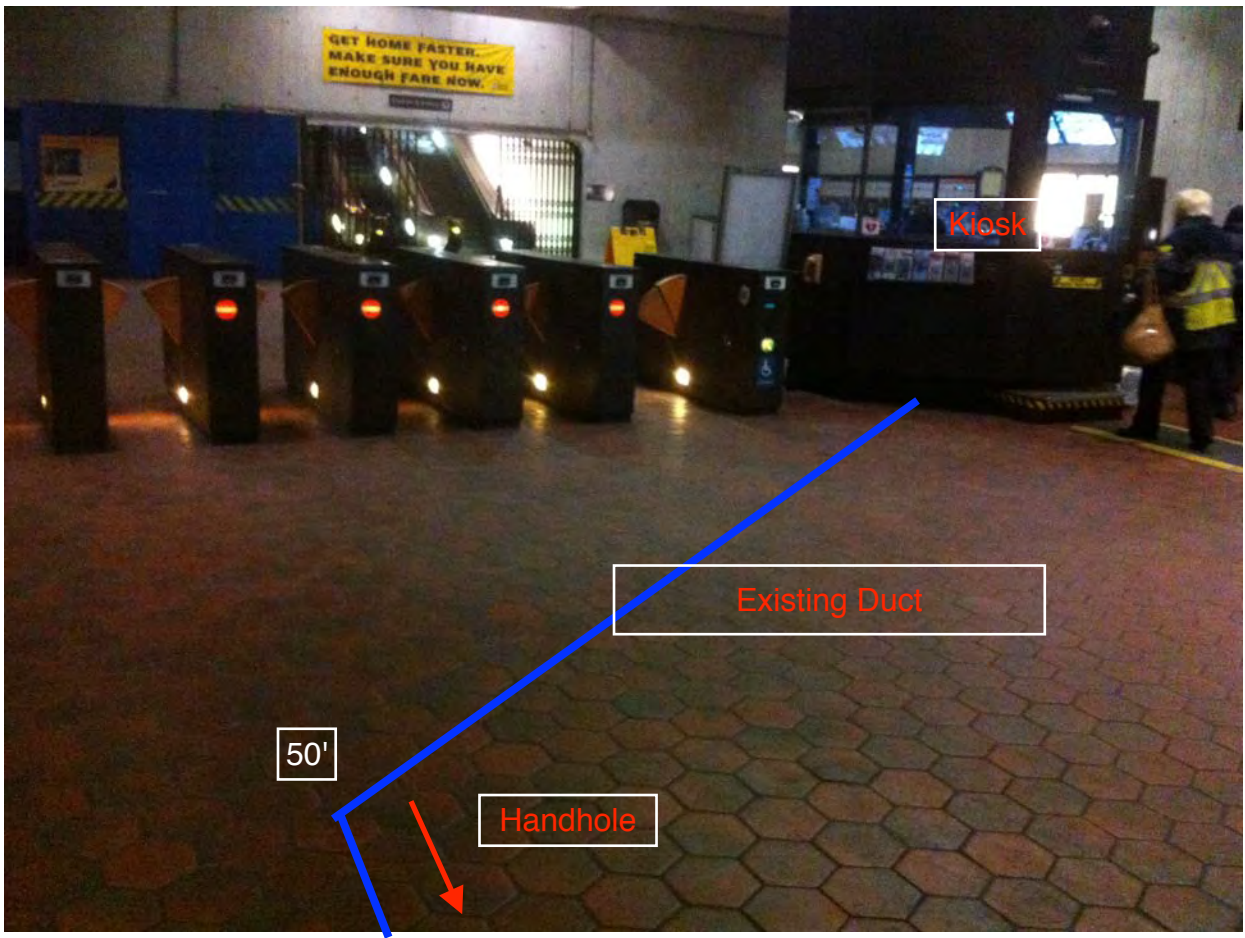
Photo #1 – Existing duct on mezzanine floor.

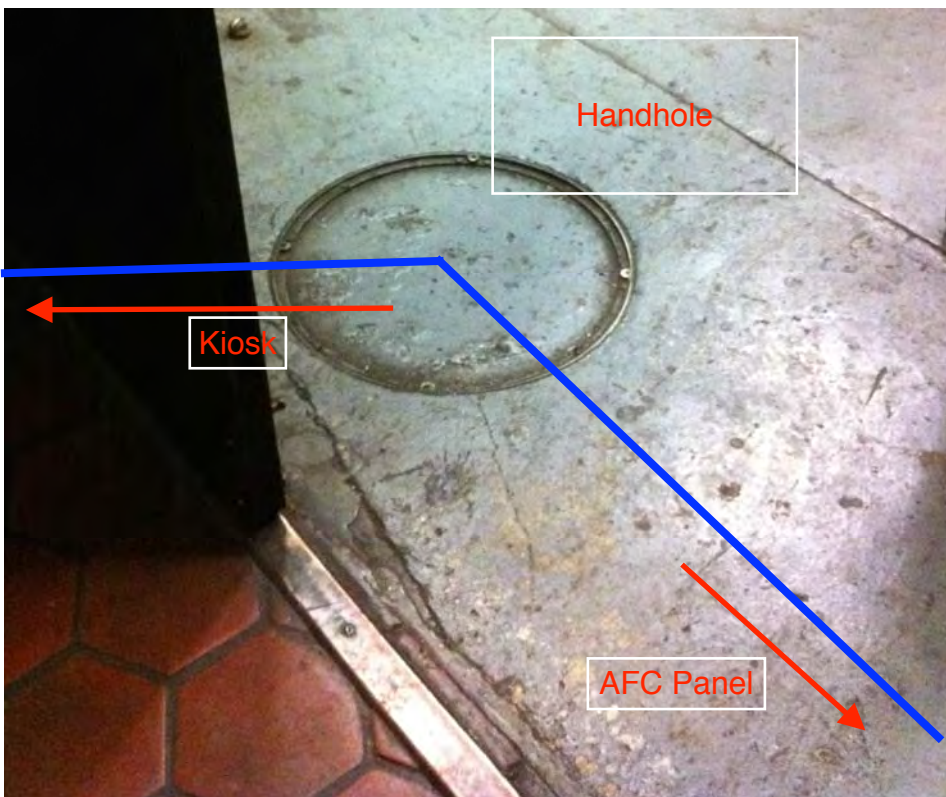
Photo #2 – Handhole in Room 212

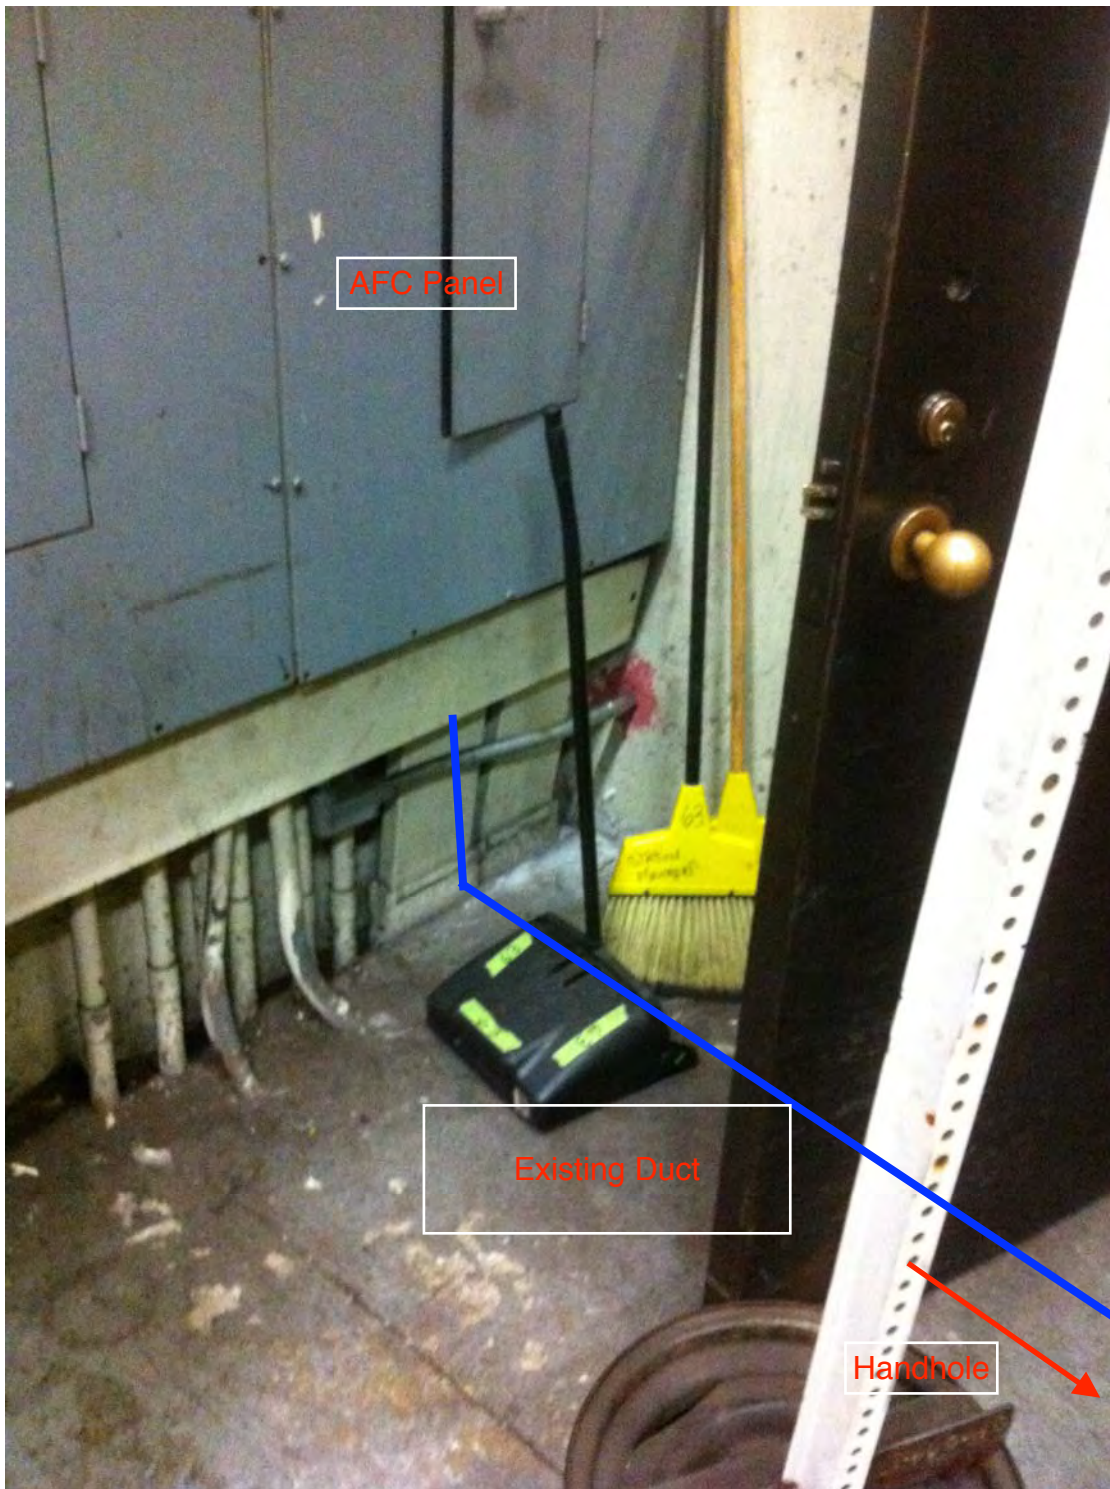
Photo #3 – AFC Panel in Room 212
