Mezzanine Inspection Report (Scoping)				
Date: 12/15/14	Station Name: D10 - Deanwood	Mezzanine #: 065	Completed By: Mike Butler

## Mezzanine Inspection Report Date: 02/19/15 Station Name: D11 Cheverly Mezzanine #: 066 Completed By: Mike Butler Summary

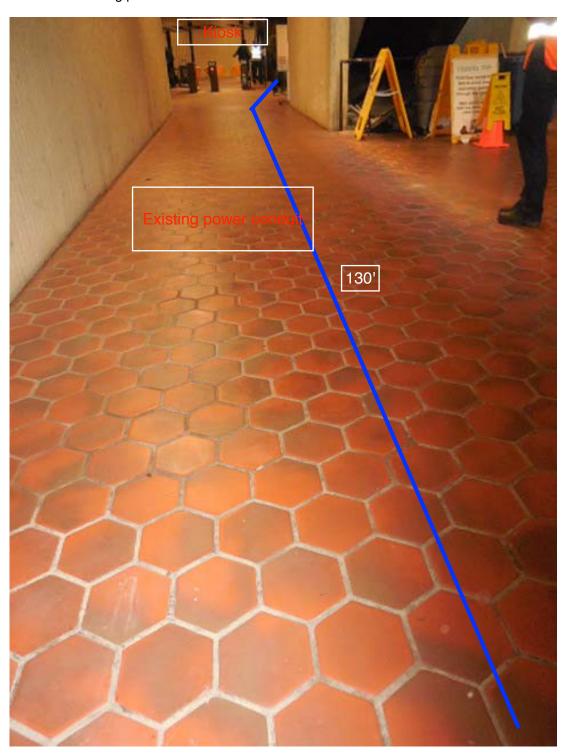
Photo #1 – Existing power conduit on mezzanine floor.

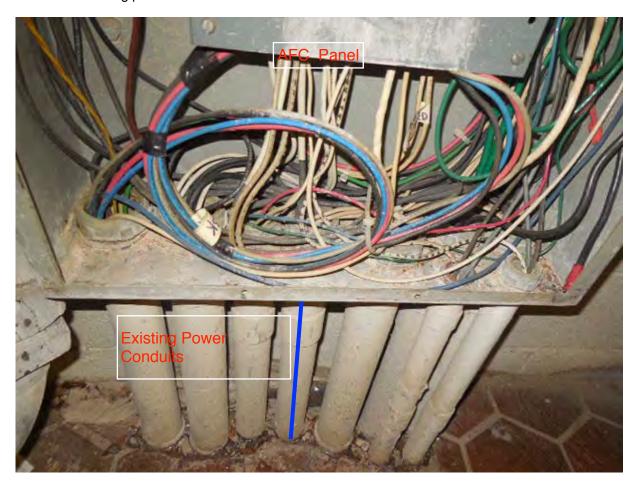
Photo #2 – Existing power conduit feeds to AFC Panel.

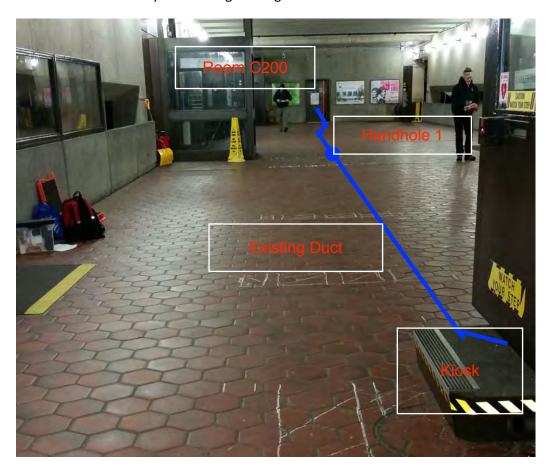
Photo 1 – Mezzanine layout showing existing duct route.

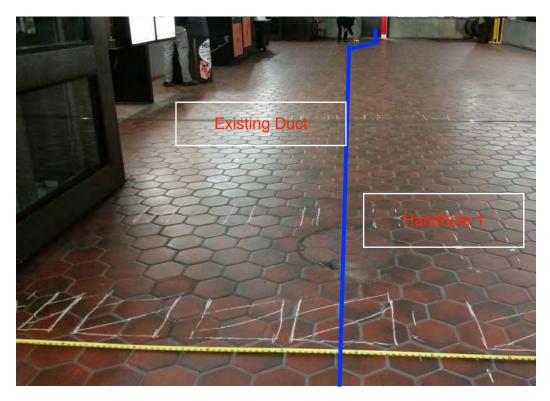
Photo 2 – Close-up of Handhole 1 on mezzanine floor.

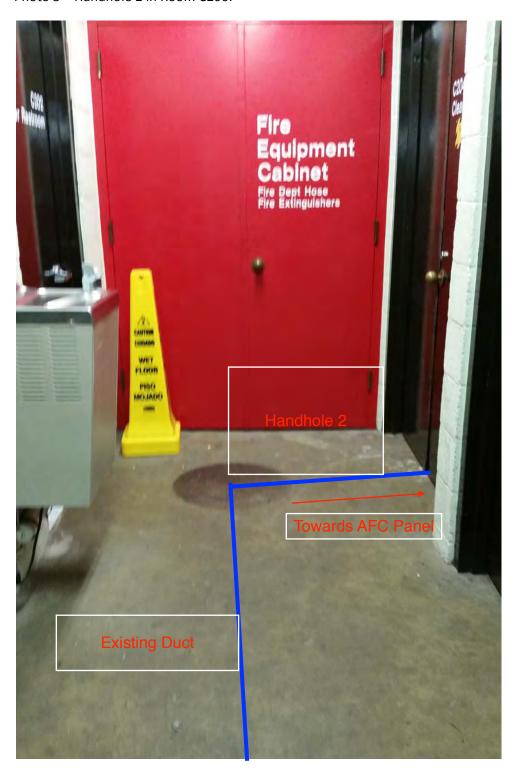
Photo 3 – Handhole 2 in Room C200.

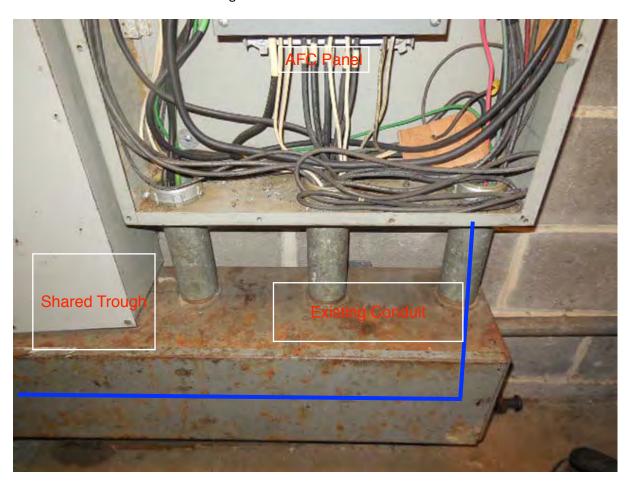
Photo 4 – AFC Panel and shared trough in Room C205.
