Mezzanine Inspection Report (Scoping)

Date: 12/04/14	Station Name: D12 Landover	Mezzanine #: 067	Completed By: Mike Butler
Summary			
<p>Video scoping and pull string installation was completed for communication duct in upper faregate array. Video scoping completed for power duct in upper faregate array. The video scoping and pull string installation was completed in the power duct between Kiosk, Handhole 1, Handhole 2, Handhole 3 and AFC Panel.</p> <p>Scanning is not required at this mezzanine.</p>			
Scoping of Faregate Array(s)			
Task	Yes/No	Notes	
Communications Duct – Upper Faregate Array (7 gates)			
Was video scoping completed for the entire duct run?	Yes	Refer to "WMATA Landover 6 inch Comm. Faregate Video.avi".	
Were pull strings installed at all faregates in the array?	Yes		
Were there any obstructions or blockages? Provide details of type and specific location.	No		
Is the duct at capacity? Provide additional details about the dimensions of ducts and number of wires.	No	6" walker ducts in good condition and not at capacity (< 10wires).

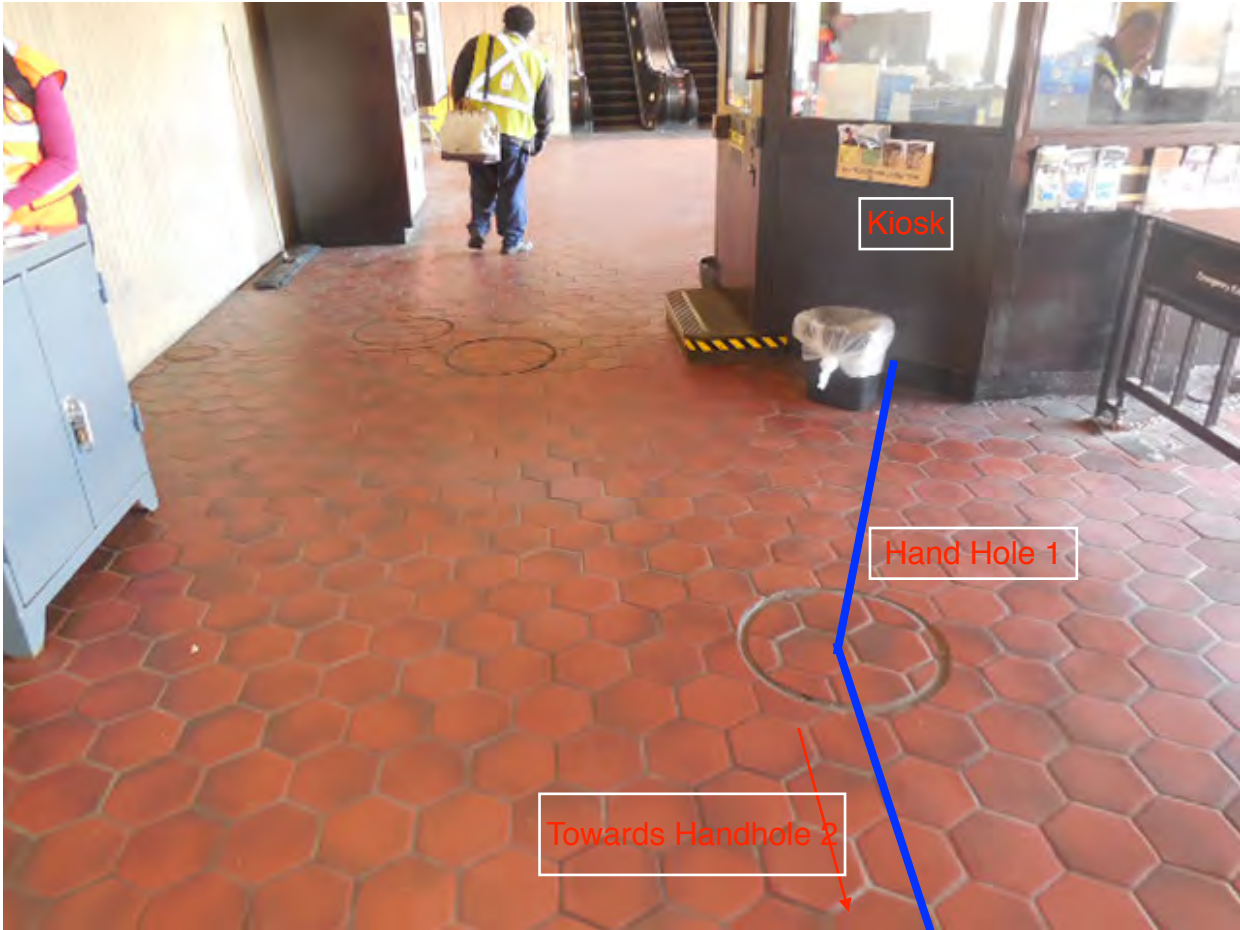
Photo #1 - Hand Hole 1 from Kiosk

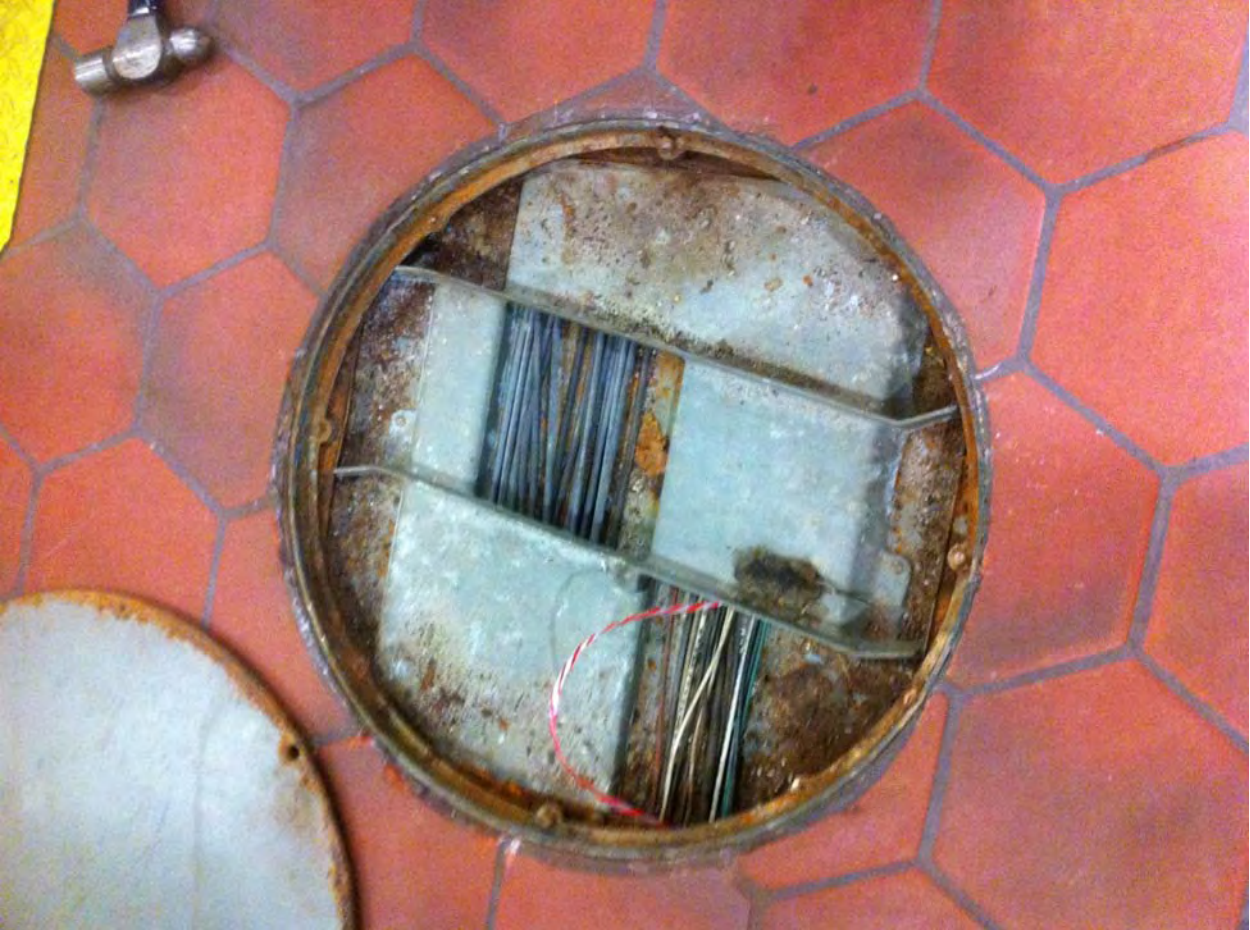
Photo #2 - Hand Hole 1 in good condition and not at capacity

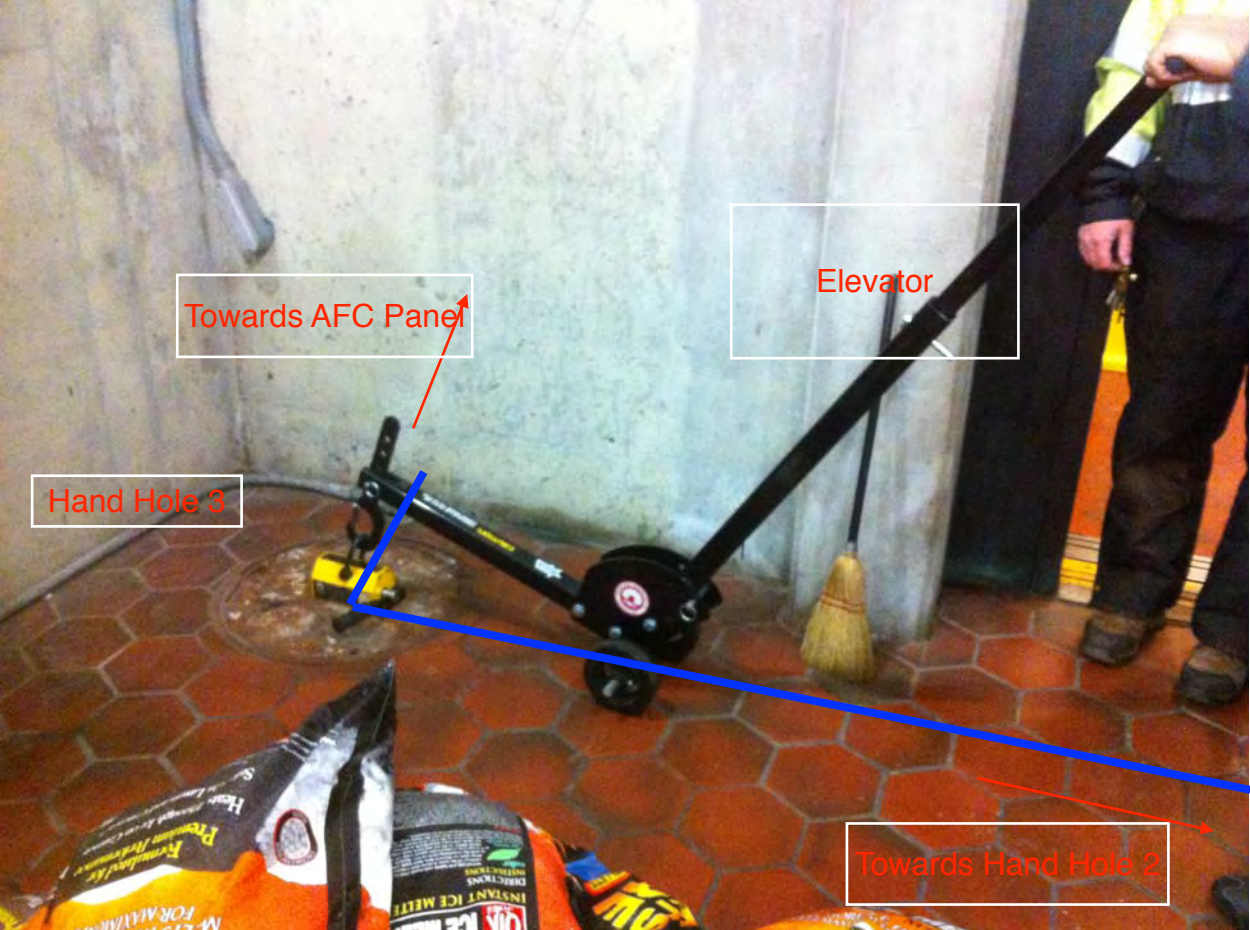
Observations / Issues / Next Steps		
Handhole 3 is hidden beneath Salt Box, but is easily accessible upon removal of salt bags and box.		
Sign Off		
	GFP Representative	WMATA PRGM
Name:	Mike Butler	
Signature:

Photo # 3 – Hand Hole 3 under Salt Box and adjacent to elevator.

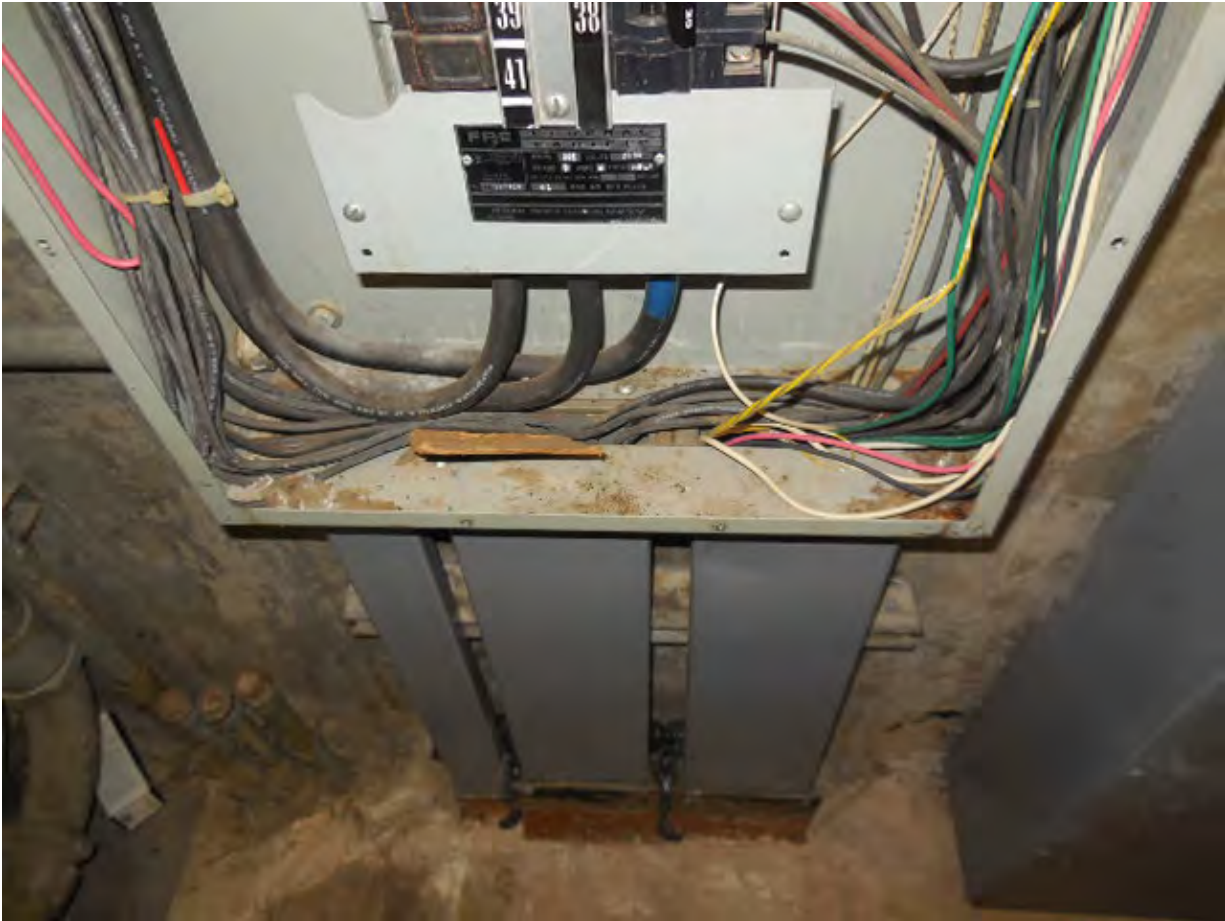
Photo #4 - Walker duct connection to AFC Panel in Room C108
