Mezzanine Inspection Report

Date: 12/04/14	Station Name: D13 New Carrollton	Mezzanine #: 068	Completed By: Mike Butler
-----------------------	---	-------------------------	----------------------------------

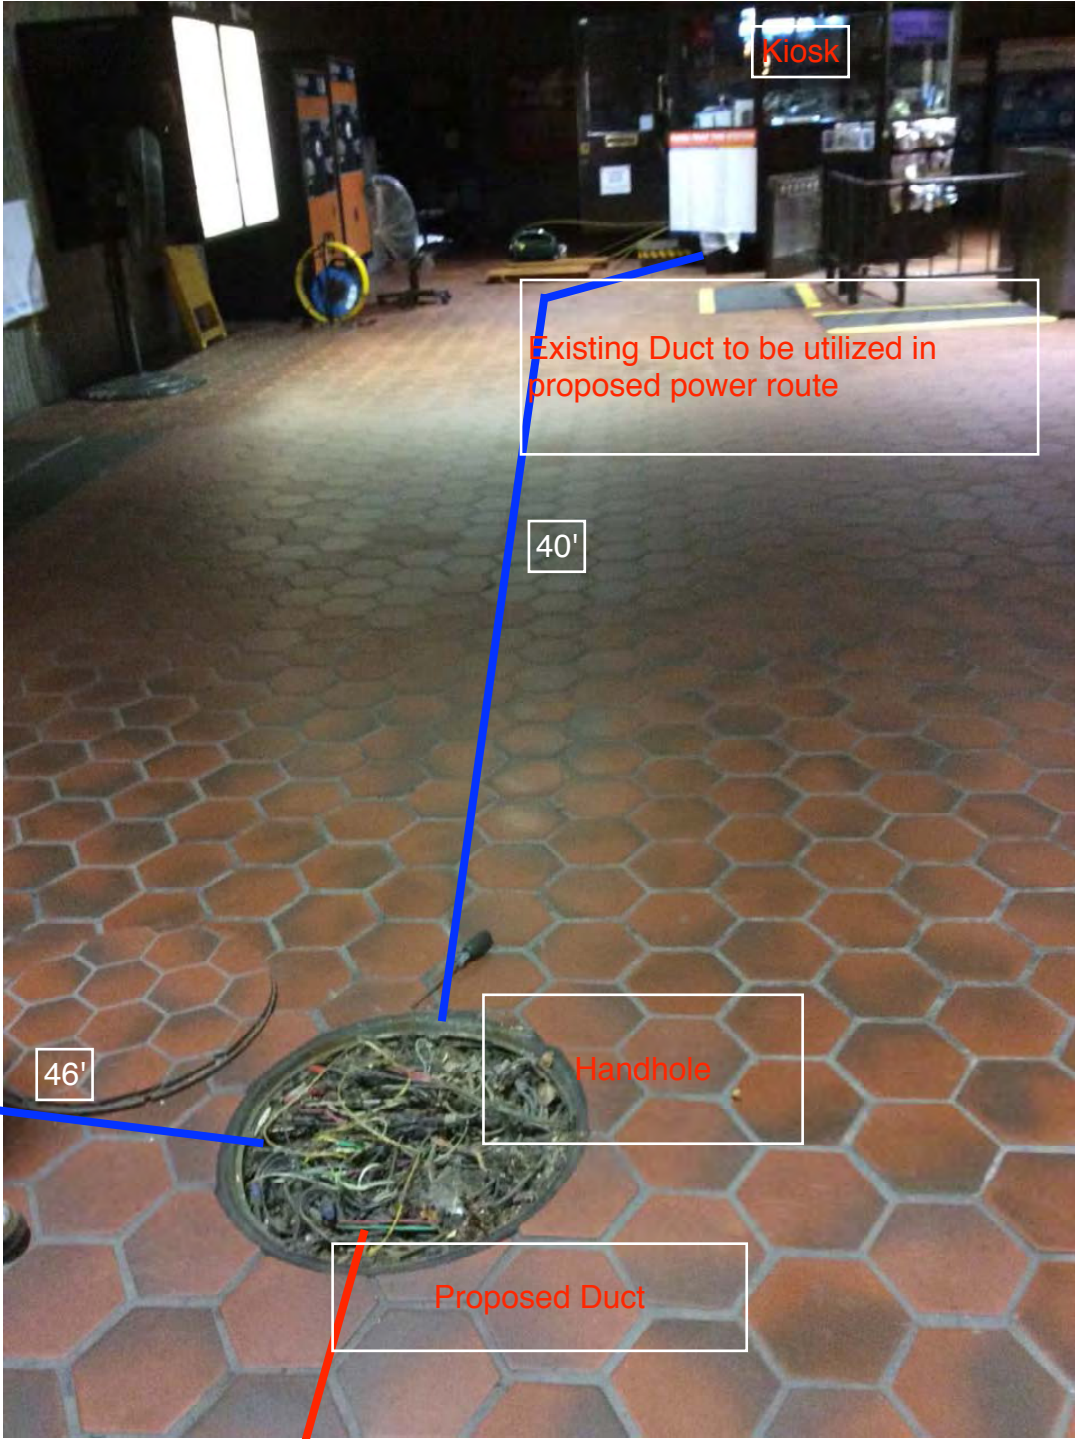
Photo #1: Existing and proposed ducts on mezzanine floor

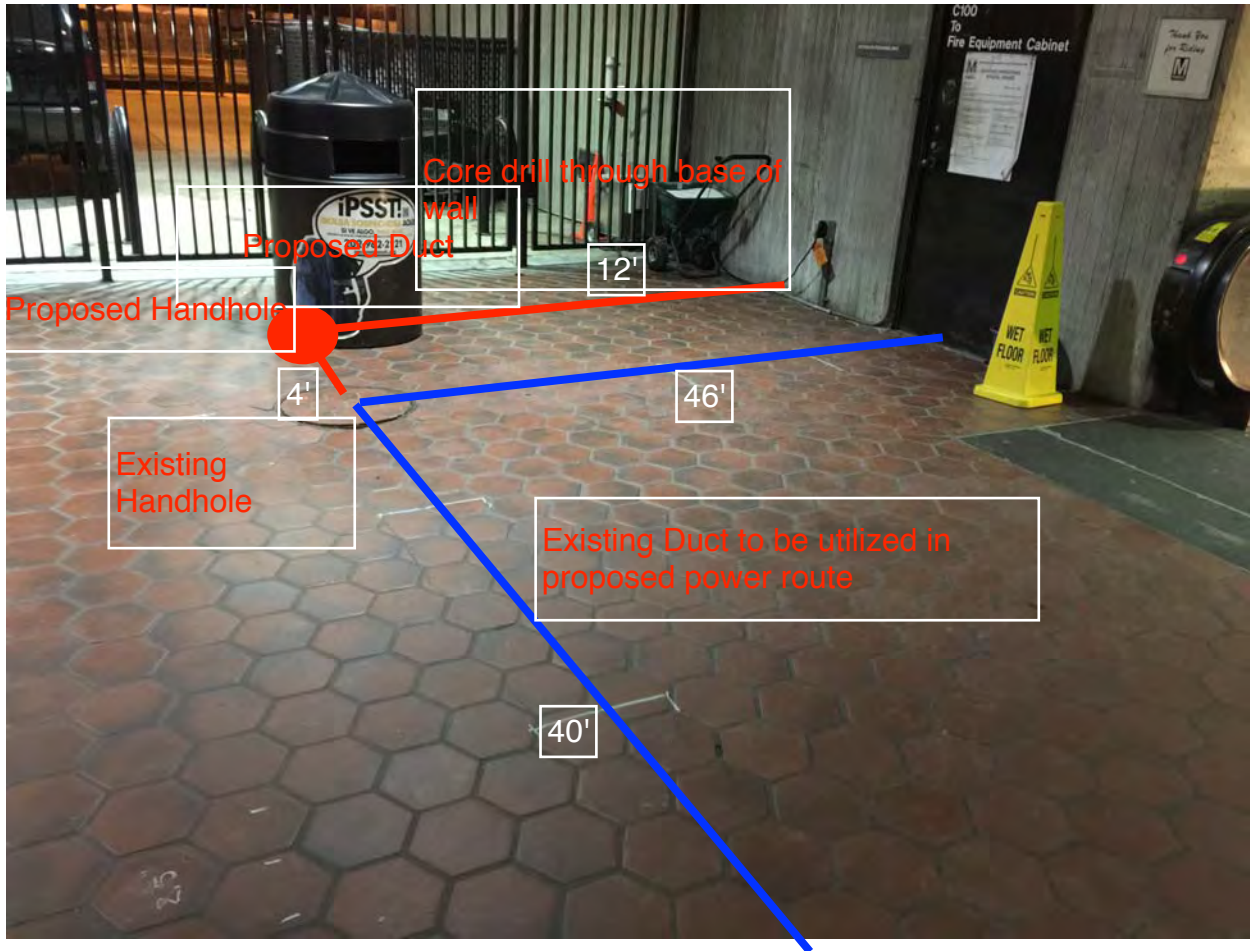
Photo #2: Existing and proposed duct on mezzanine floor

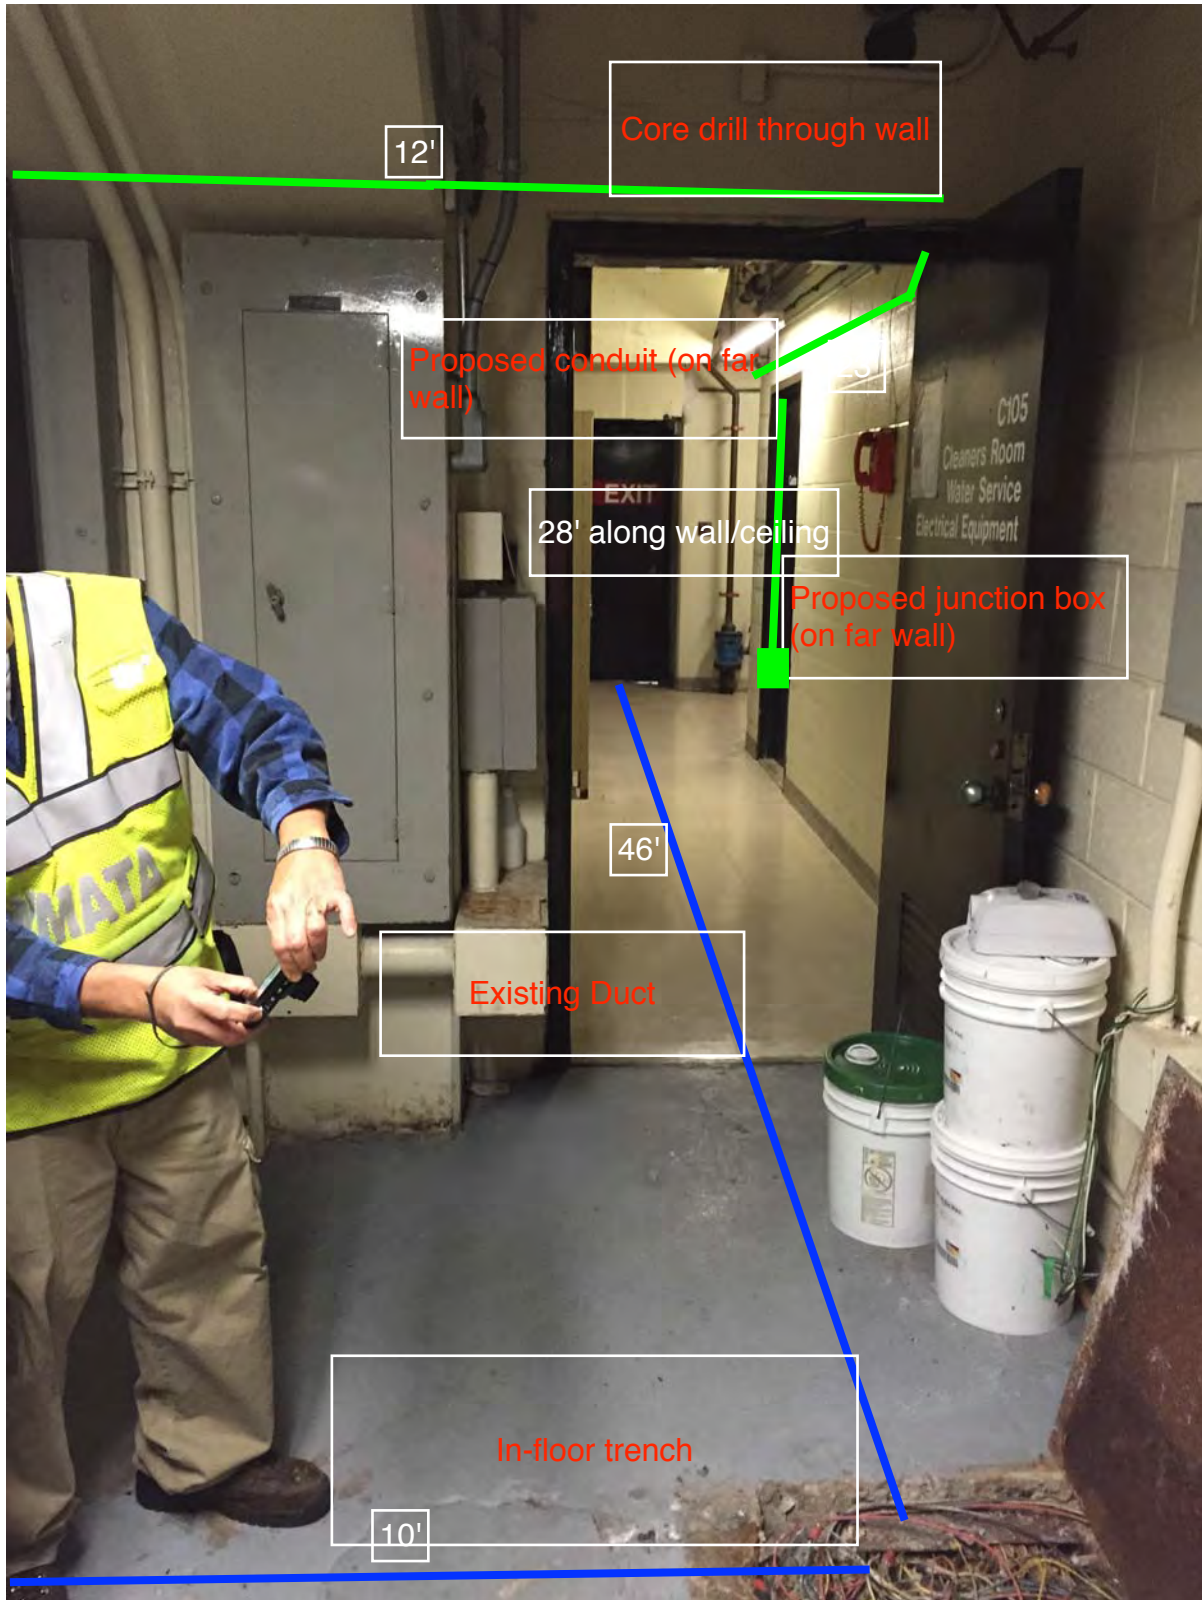
Photo #3: Existing duct and proposed conduit route

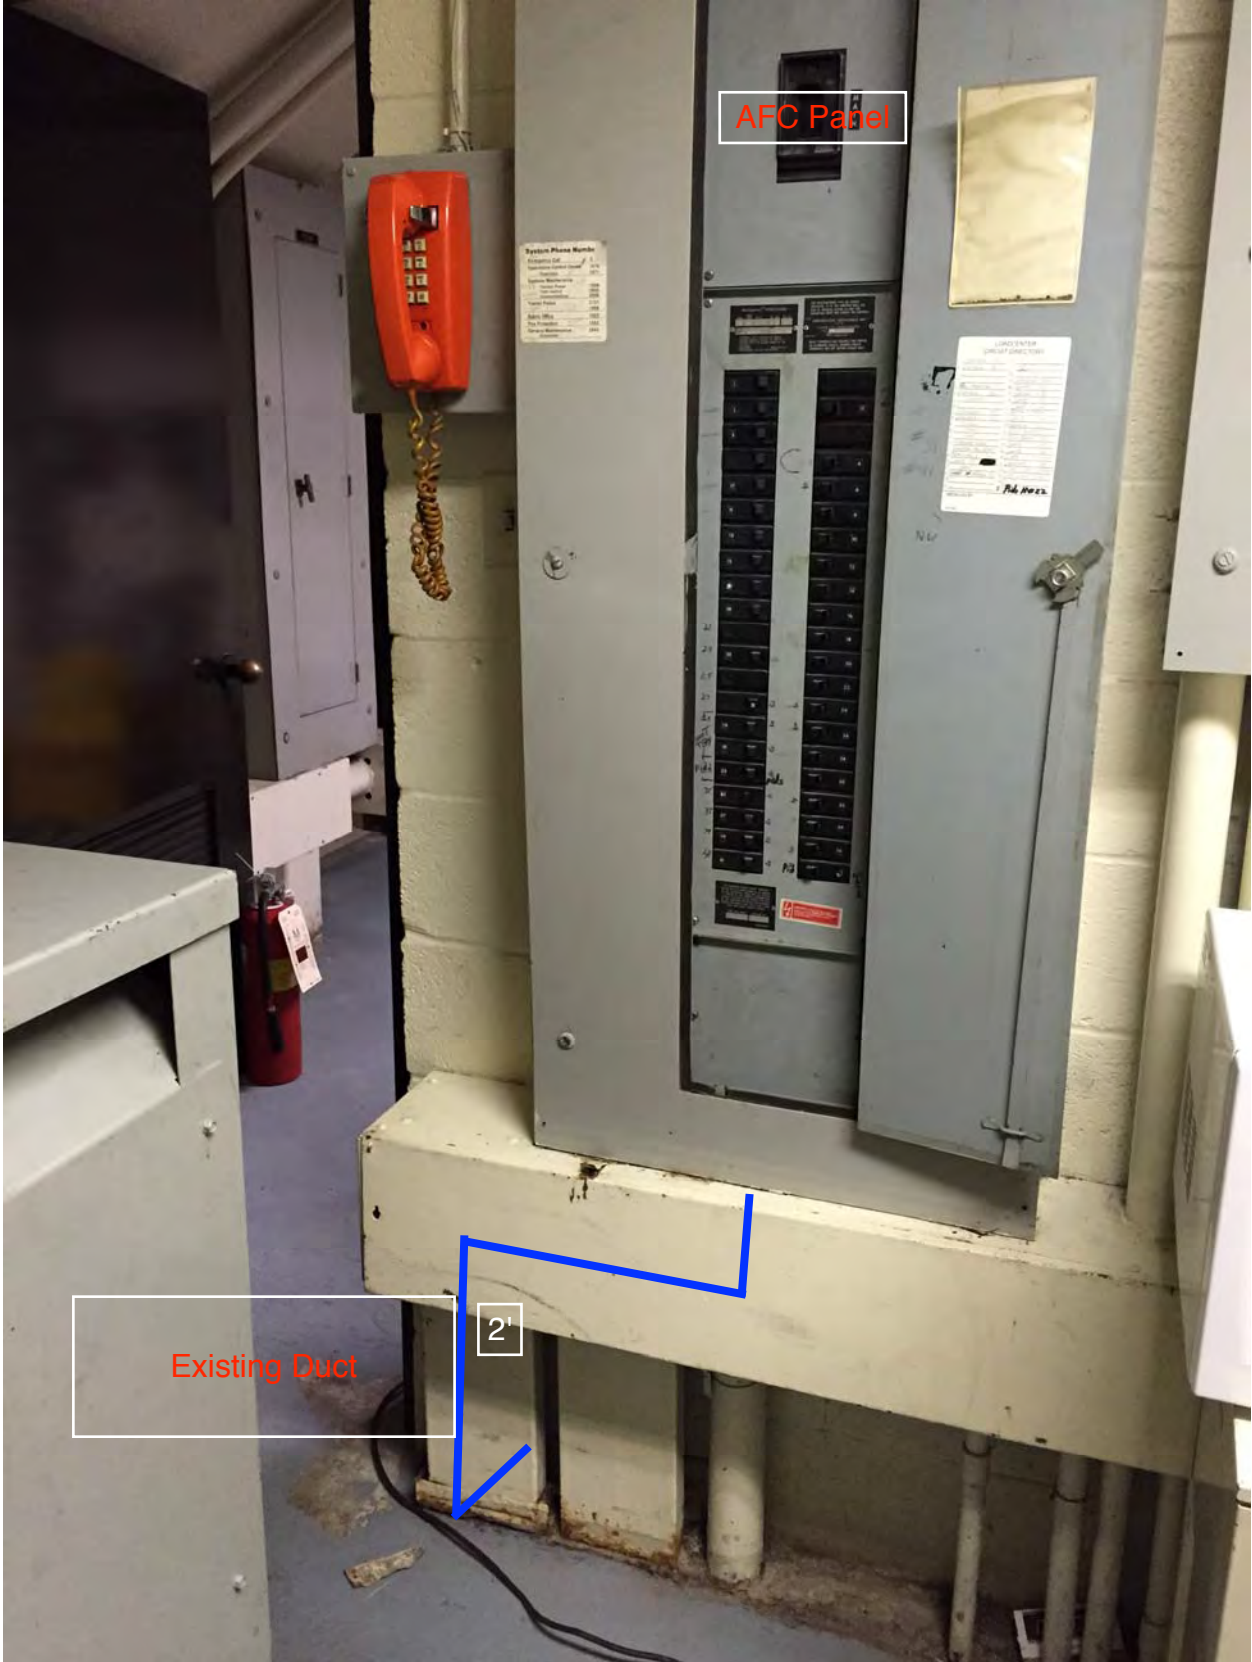
Photo #4: Existing duct route
