Mezzanine Inspection Report (Scoping)

Date: 12/17/2014	Station Name: G01 Benning Road	Mezzanine #: 090	Completed By: Megan Powell
Summary			
<p>Video scoping and pull string installation was completed for the communication ducts in the upper and lower faregate arrays. Video scoping was completed for the power ducts in the upper and lower faregate arrays. However, the power ducts for the upper and lower faregate arrays had seal tight on the wires inside the kiosk and the seal tight went right into the duct which prevented access to view the wires inside the ducts to verify capacity. Pull string was installed in the 1" conduit run from the kiosk on the mezzanine level to the AFC panel on the platform level.</p> <p>Scanning is not required at this mezzanine.</p>			
Scoping of Faregate Array(s)			
Task	Yes/No	Notes	
Communications Duct – Upper Faregate Array (3 Gates)			
Was video scoping completed for the entire duct run?	Yes	Refer to WMATA Benning Rd 6inch Upper Comm to faregates Video.avi file.

Date: 01/22/2015	Station Name: G02 Capitol Heights	Mezzanine #: 091	Completed By: Zach Fitzwater
------------------	-----------------------------------	------------------	------------------

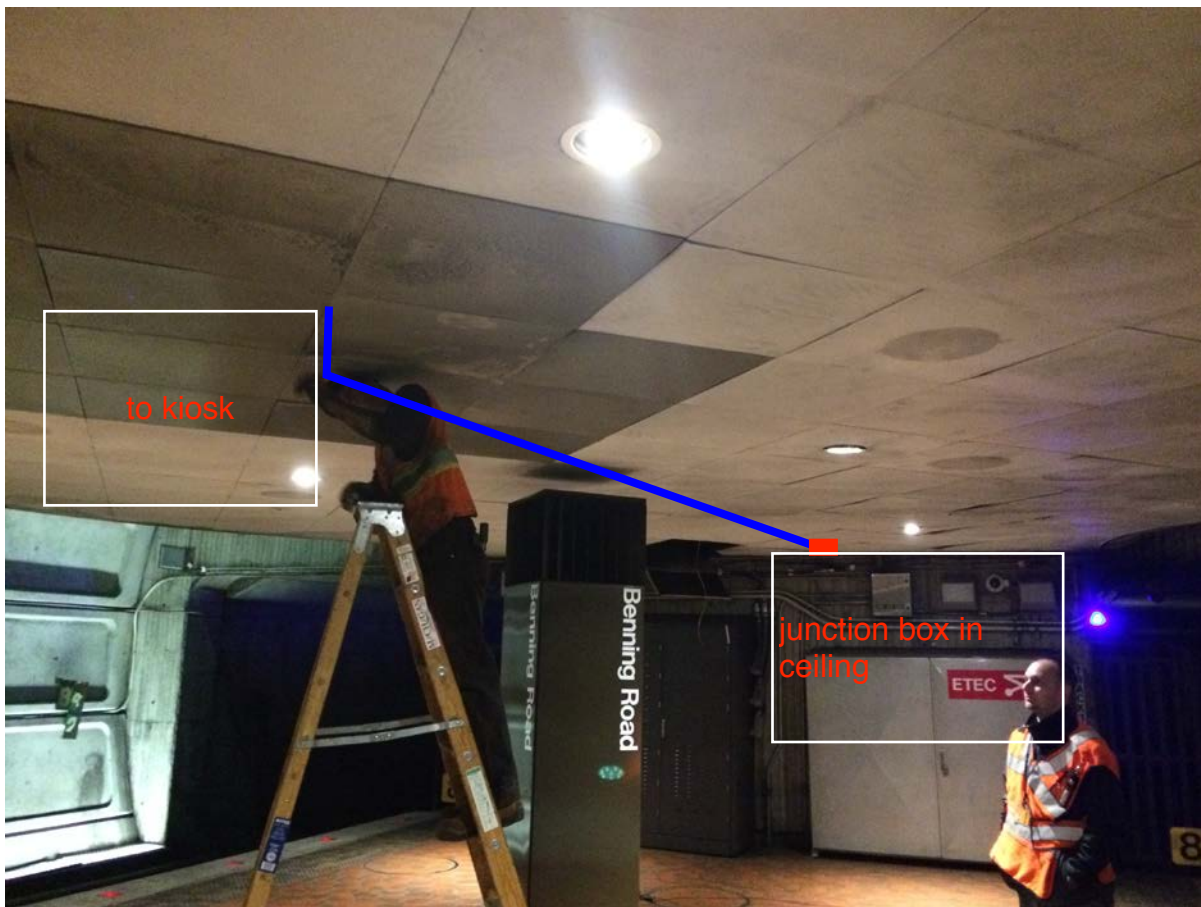
Photo #1 – G01 Benning Road: Ceiling tiles under kiosk where conduit run begins

Is the duct / conduit at capacity? Provide additional details about the dimensions of duct / conduit and number of wires.	No	Empty 1" conduit
Observations / Issues / Next Steps		
<p>Extension of conduit/seal tight will be needed to bring pull string to kiosk from conduit underneath as the conduit is cut/broke off.</p> <p>Total run from kiosk to AFC panel is approximately 73 feet of conduit through multiple 90 degree bends.</p>		
Sign Off		
	GFP Representative	WMATA PRGM
Name:	Zach Fitzwater	
Signature:

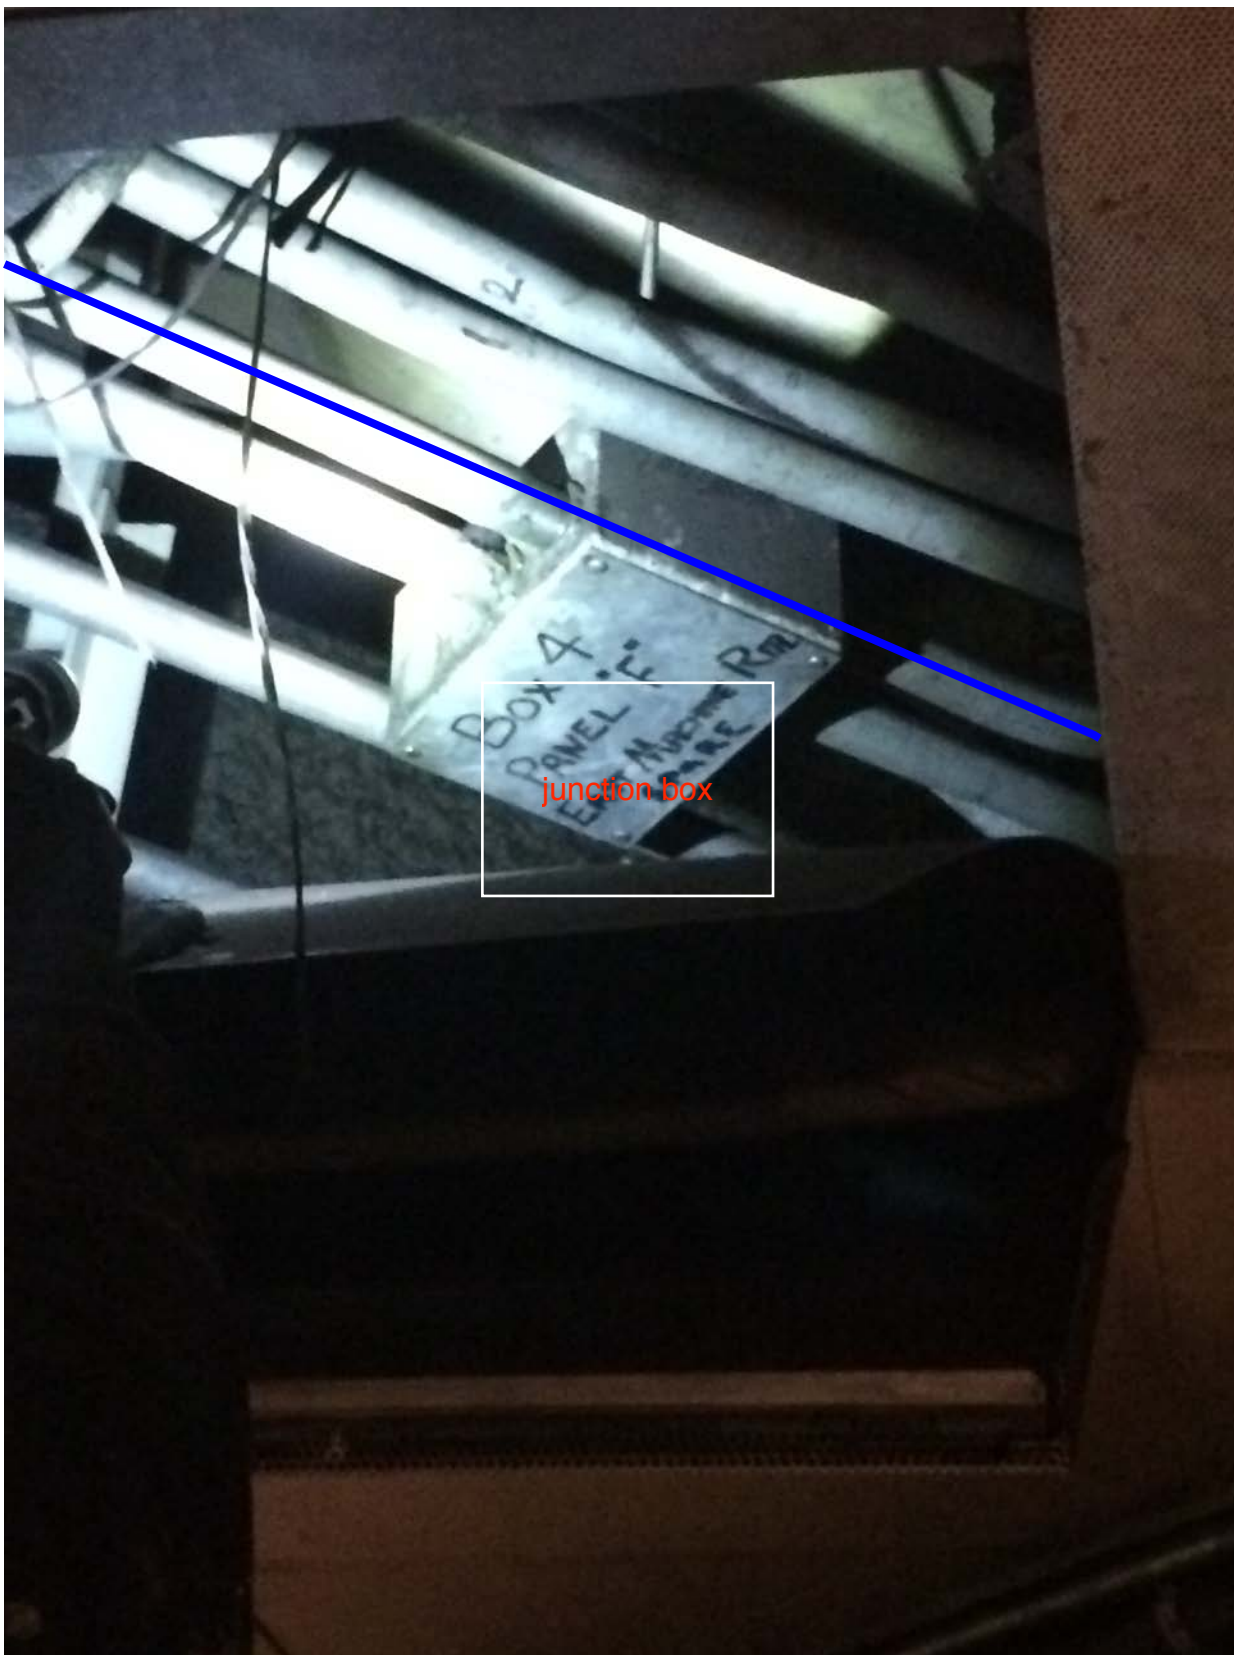
Photo #2 – G01 Benning Road: Junction box in ceiling near wall on platform level

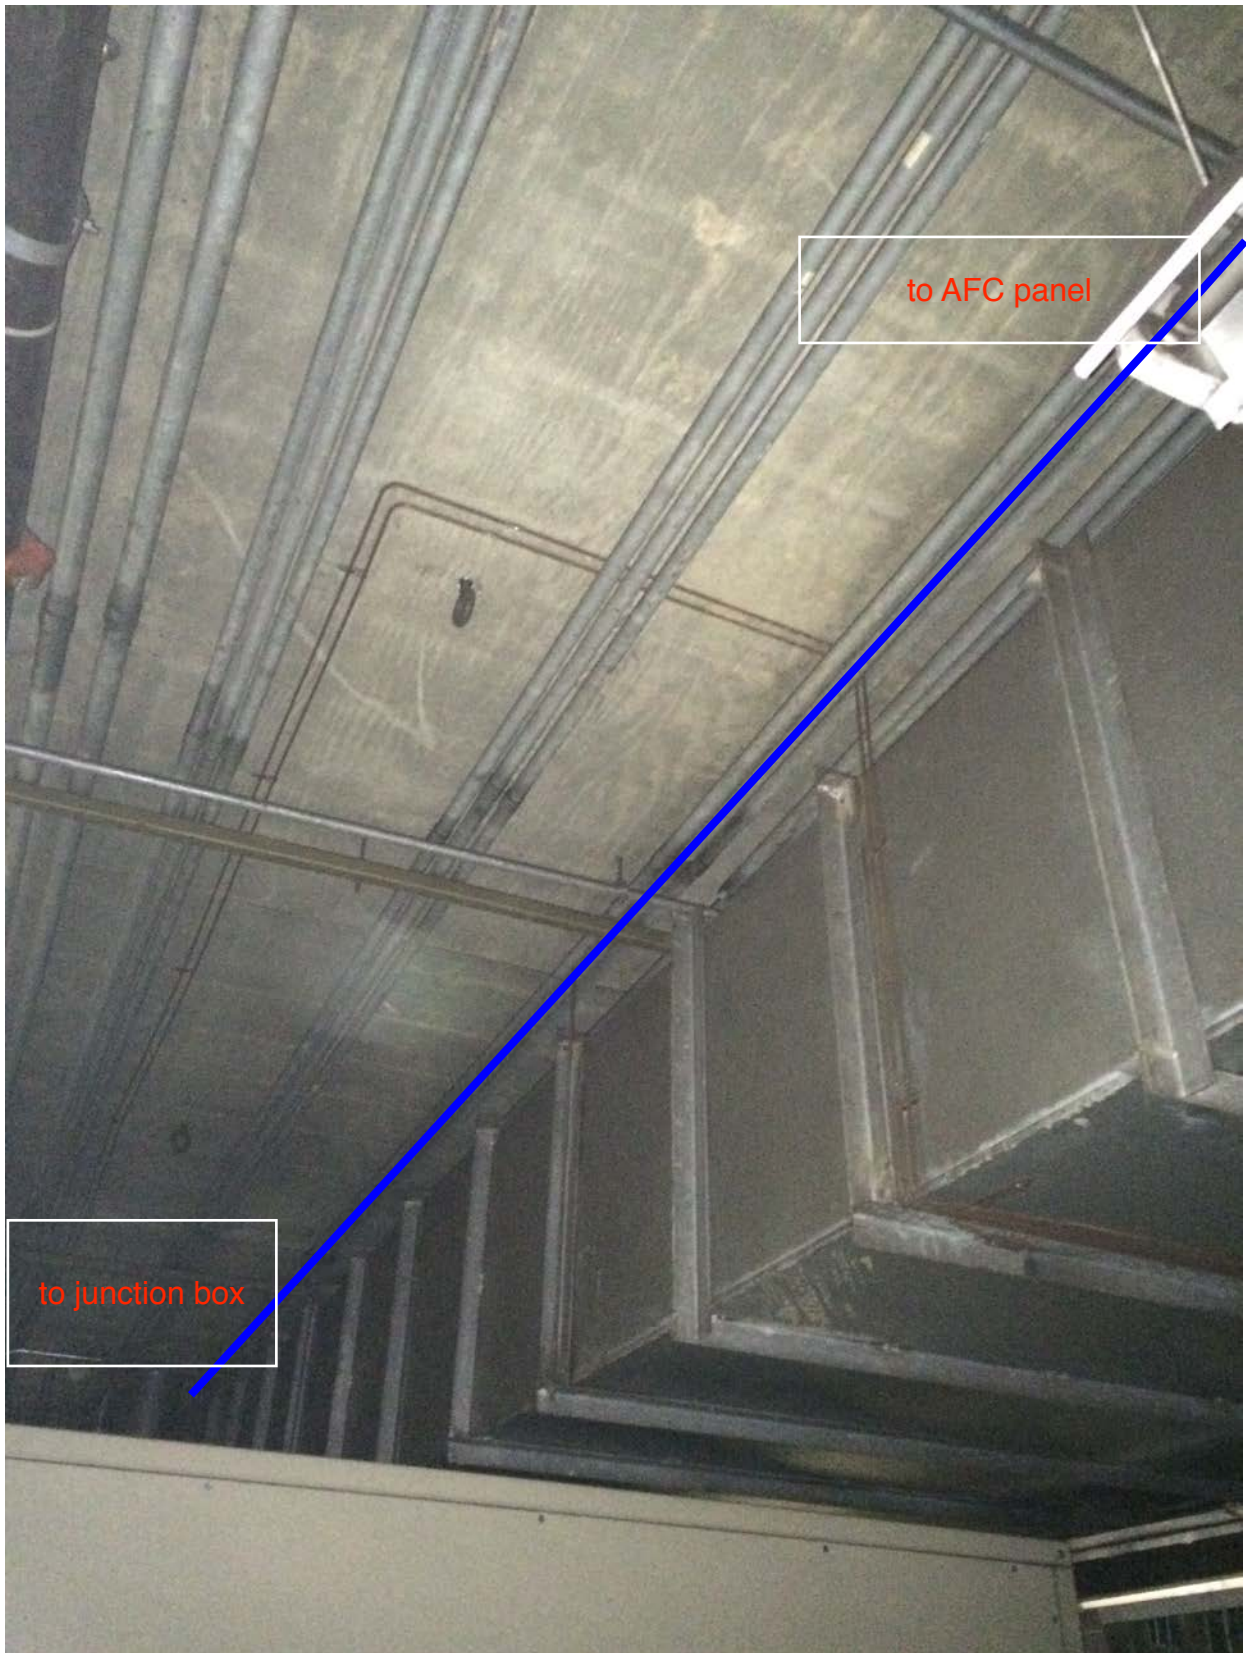
Photo #3 – G01 Benning Road: Conduit run from junction box inside AFC panel room

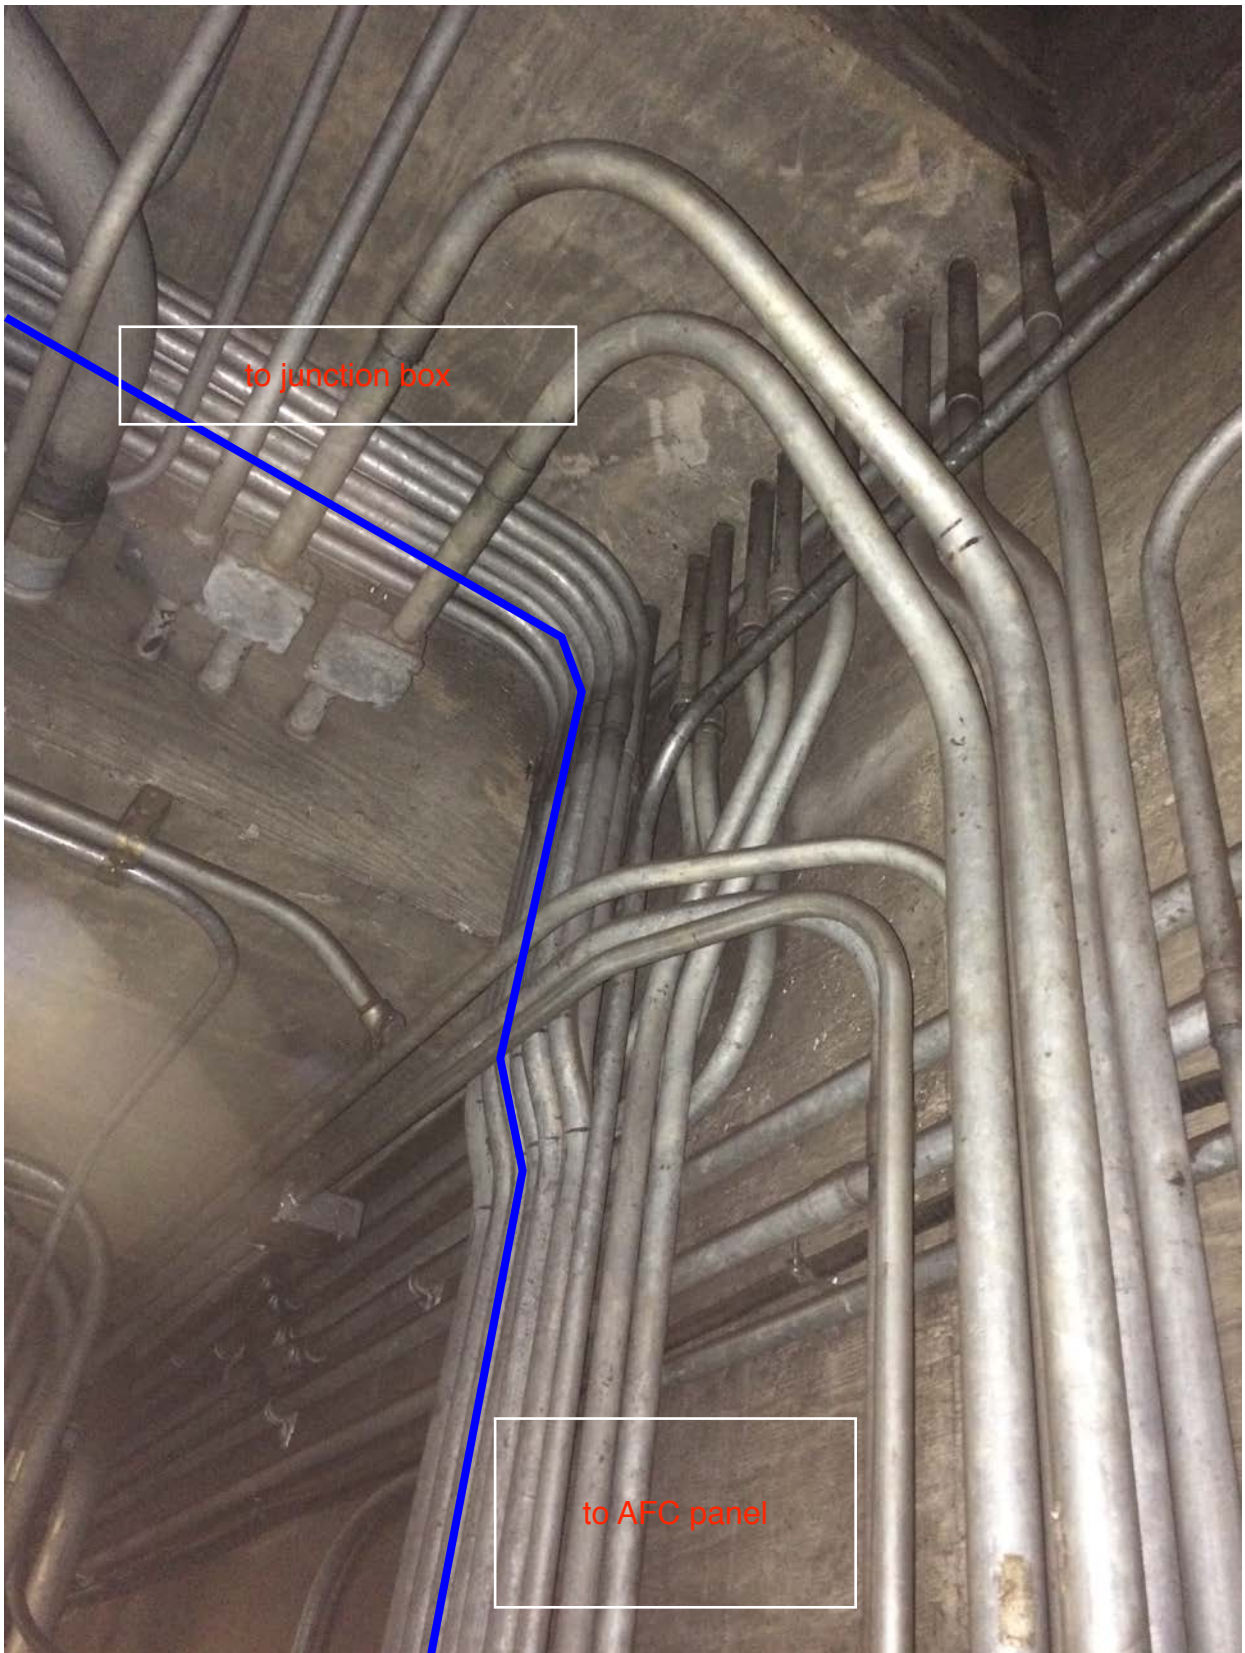
Photo #4 – G01 Benning Road: Conduit 90 degree bend down wall into AFC panel

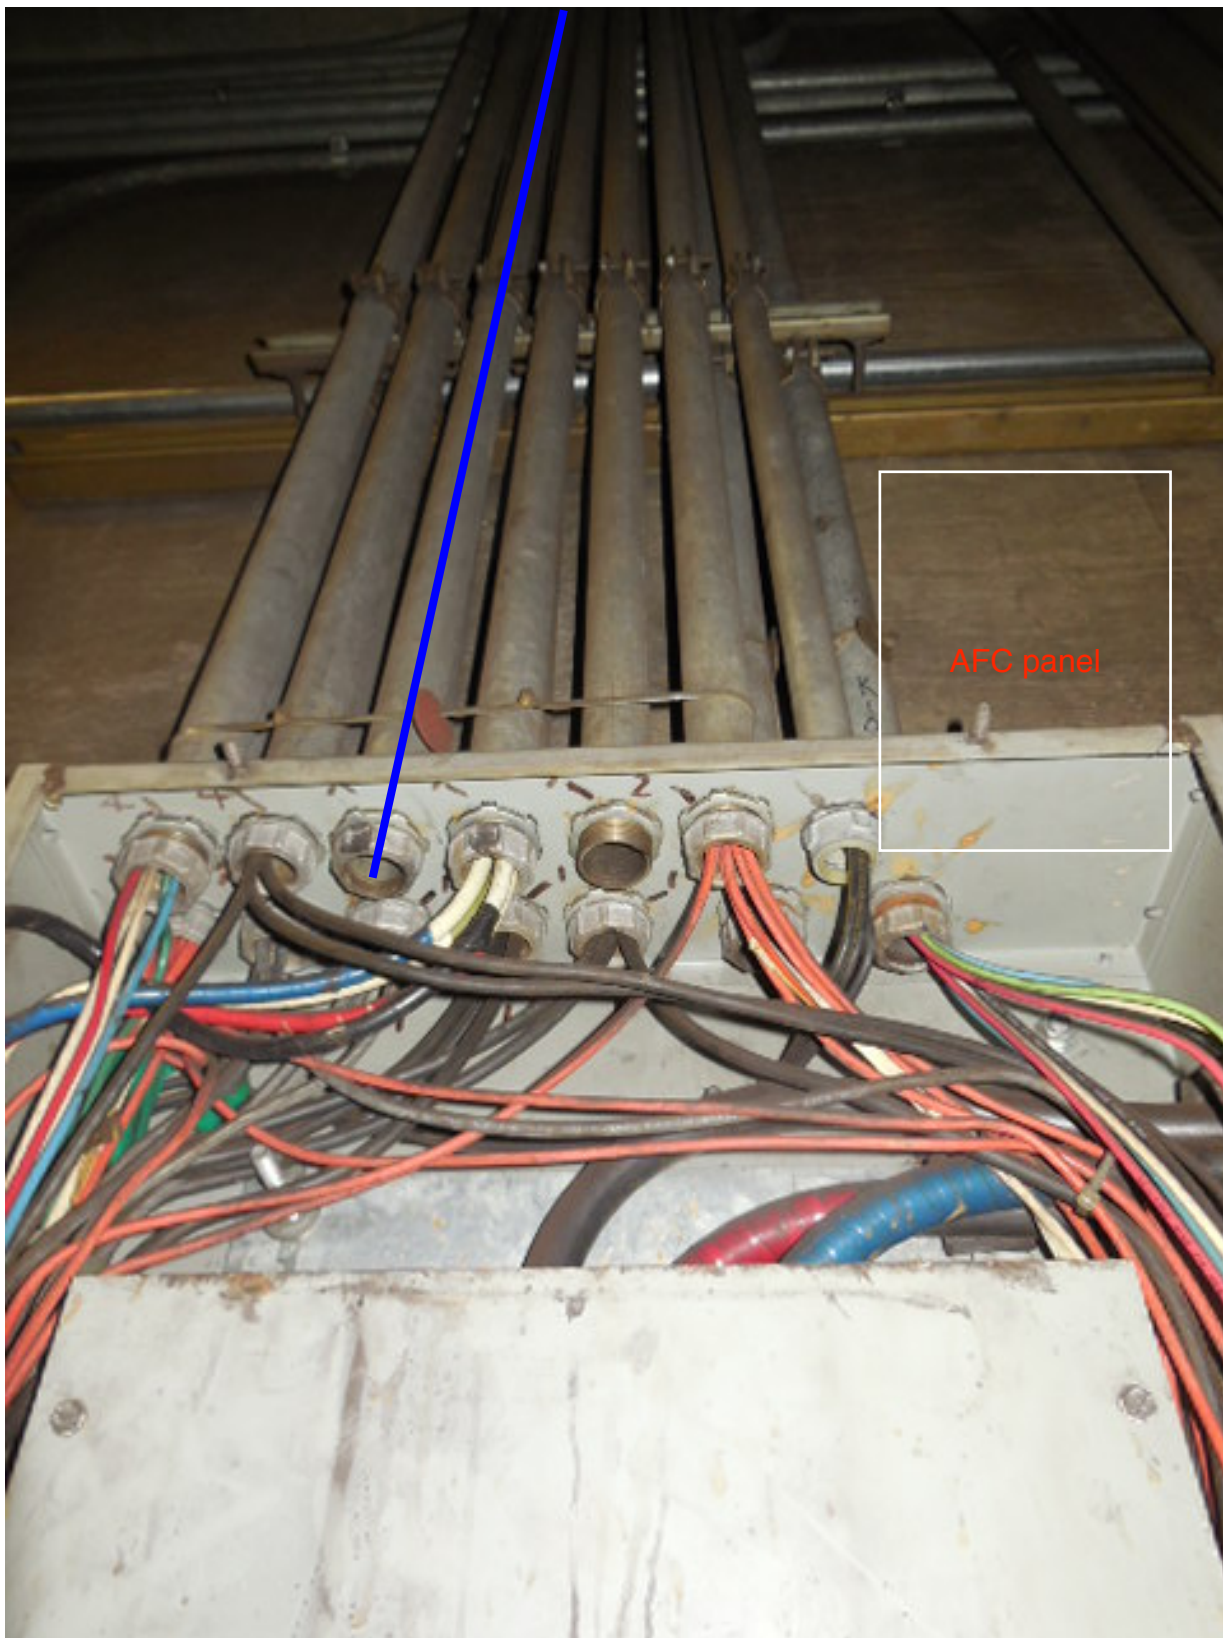
Photo #5 – G01 Benning Road: Conduit into AFC panel

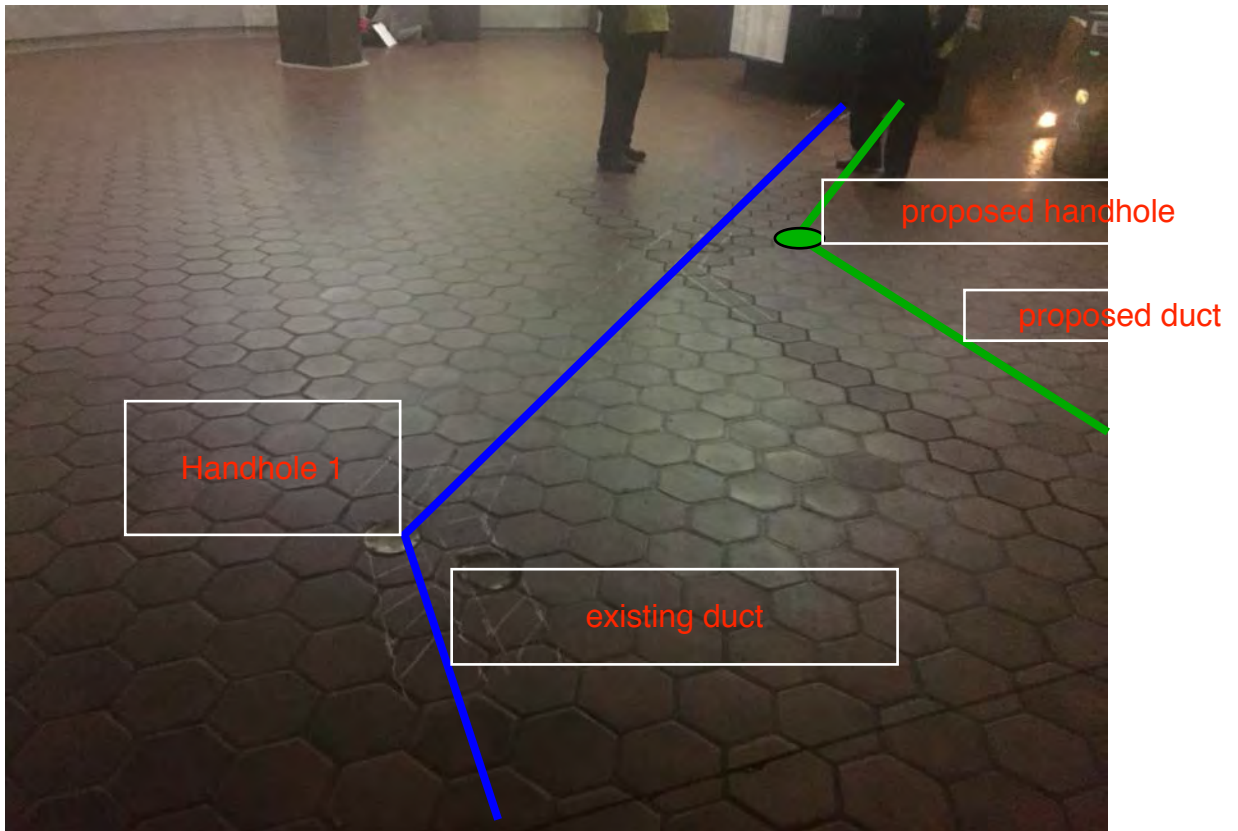
Scoping and pull string installation was not completed at this station in the power or communication ducts for the upper and lower faregates due to collapsed ducts. All ducts were in very poor condition due to heavy water damage and rust. Ducts were collapsed either at the entrance inside the kiosk or just inside the duct entrance. Standing water present inside kiosk at the time of scoping. Scoping and pull string installation was not completed for the power run between the kiosk and AFC panel due to collapsed ducts. Rodding was attempted at all handholes for AFC power run, but could not be completed due to duct collapse. Ducts run into shared electrical trough in AFC panel room. Live wires in the shared trough would require shut down of more panels.

Photo #1 – G02 Capitol Heights: Proposed and existing duct runs from kiosk

Scanning was done at this station. The proposed duct will run out of the kiosk at a 45 degree angle to a new proposed handhole. It will then run straight to a second proposed handhole and turn 90 degrees towards the door to the backrooms. Once inside the backroom area, the duct will stop at a third proposed handhole and transition to conduit. The conduit will come out of the floor and up the wall vertically to the ceiling. At the ceiling the conduit will turn 90 degrees and run towards the AFC room. The conduit will be core drilled through the wall and run along the ceiling of the AFC panel room and turn 90 degrees into the top of the AFC panel.

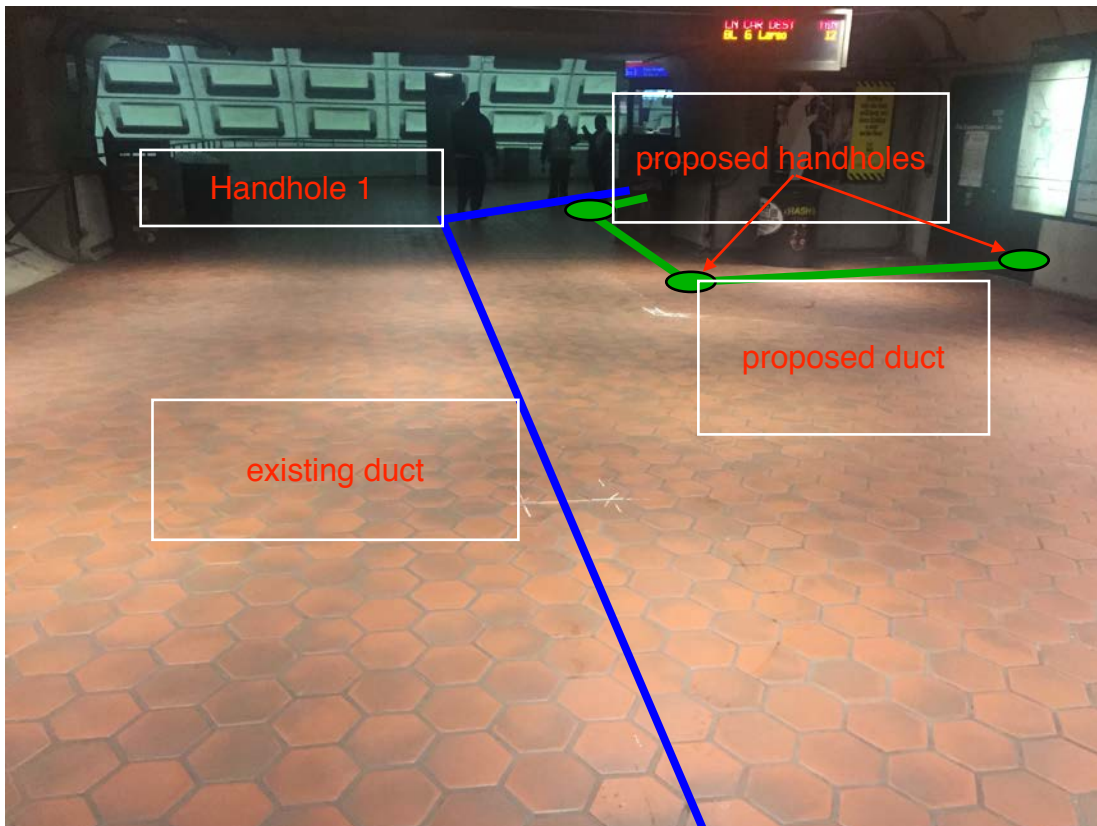
Photo #2 – G02 Capitol Heights: Proposed and existing runs on mezzanine floor

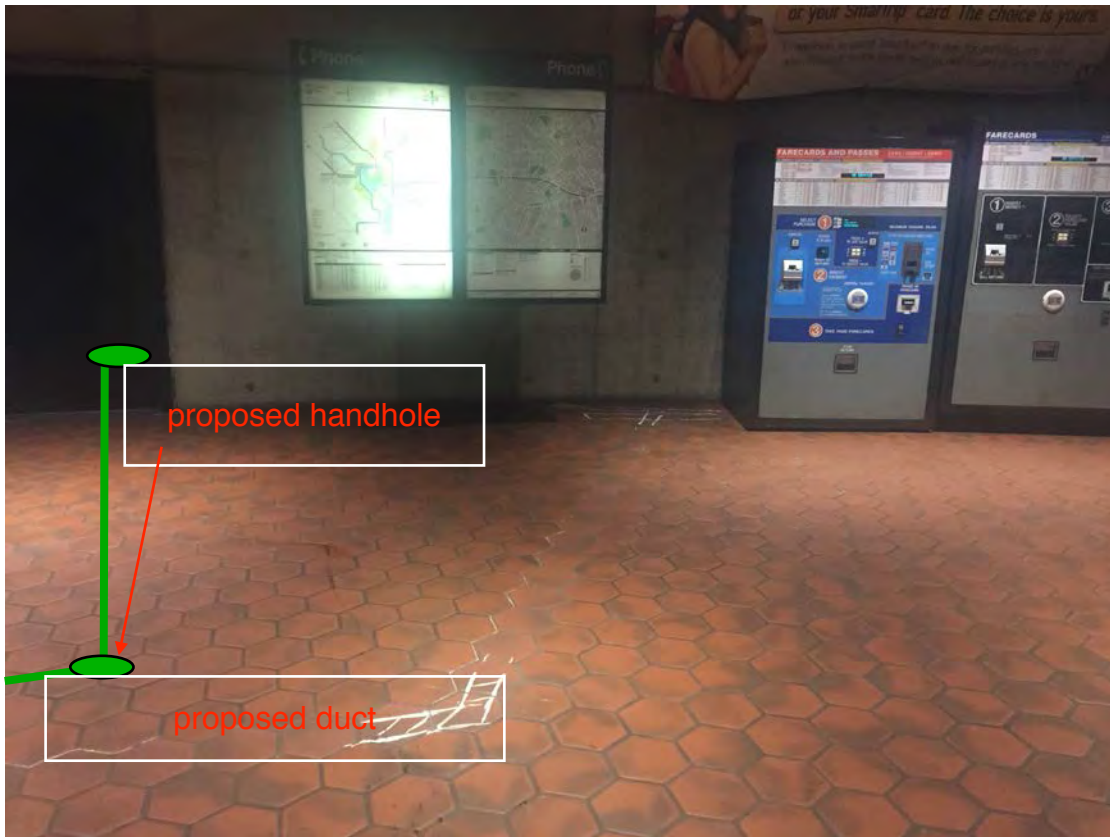
Photo #3 – G02 Capitol Heights: Proposed and existing duct runs into backrooms

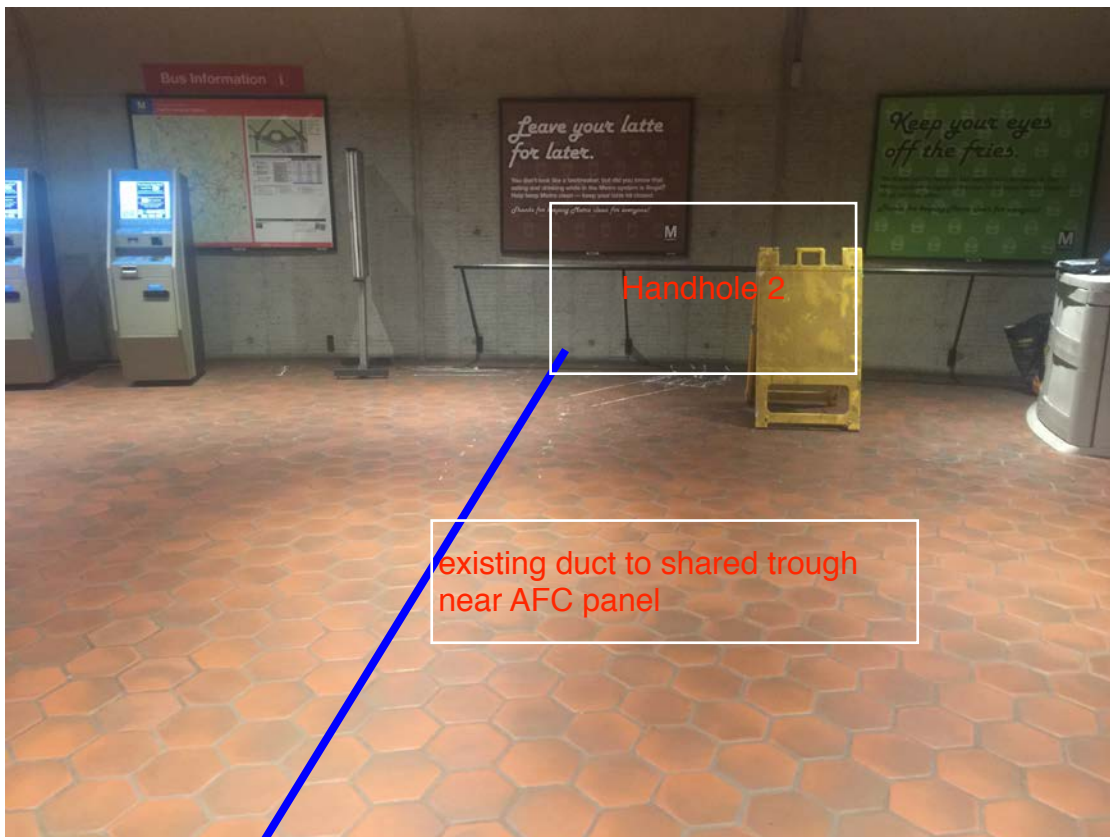
Photo #4 – G02 Capitol Heights: Existing duct run into backroom shared electrical trough

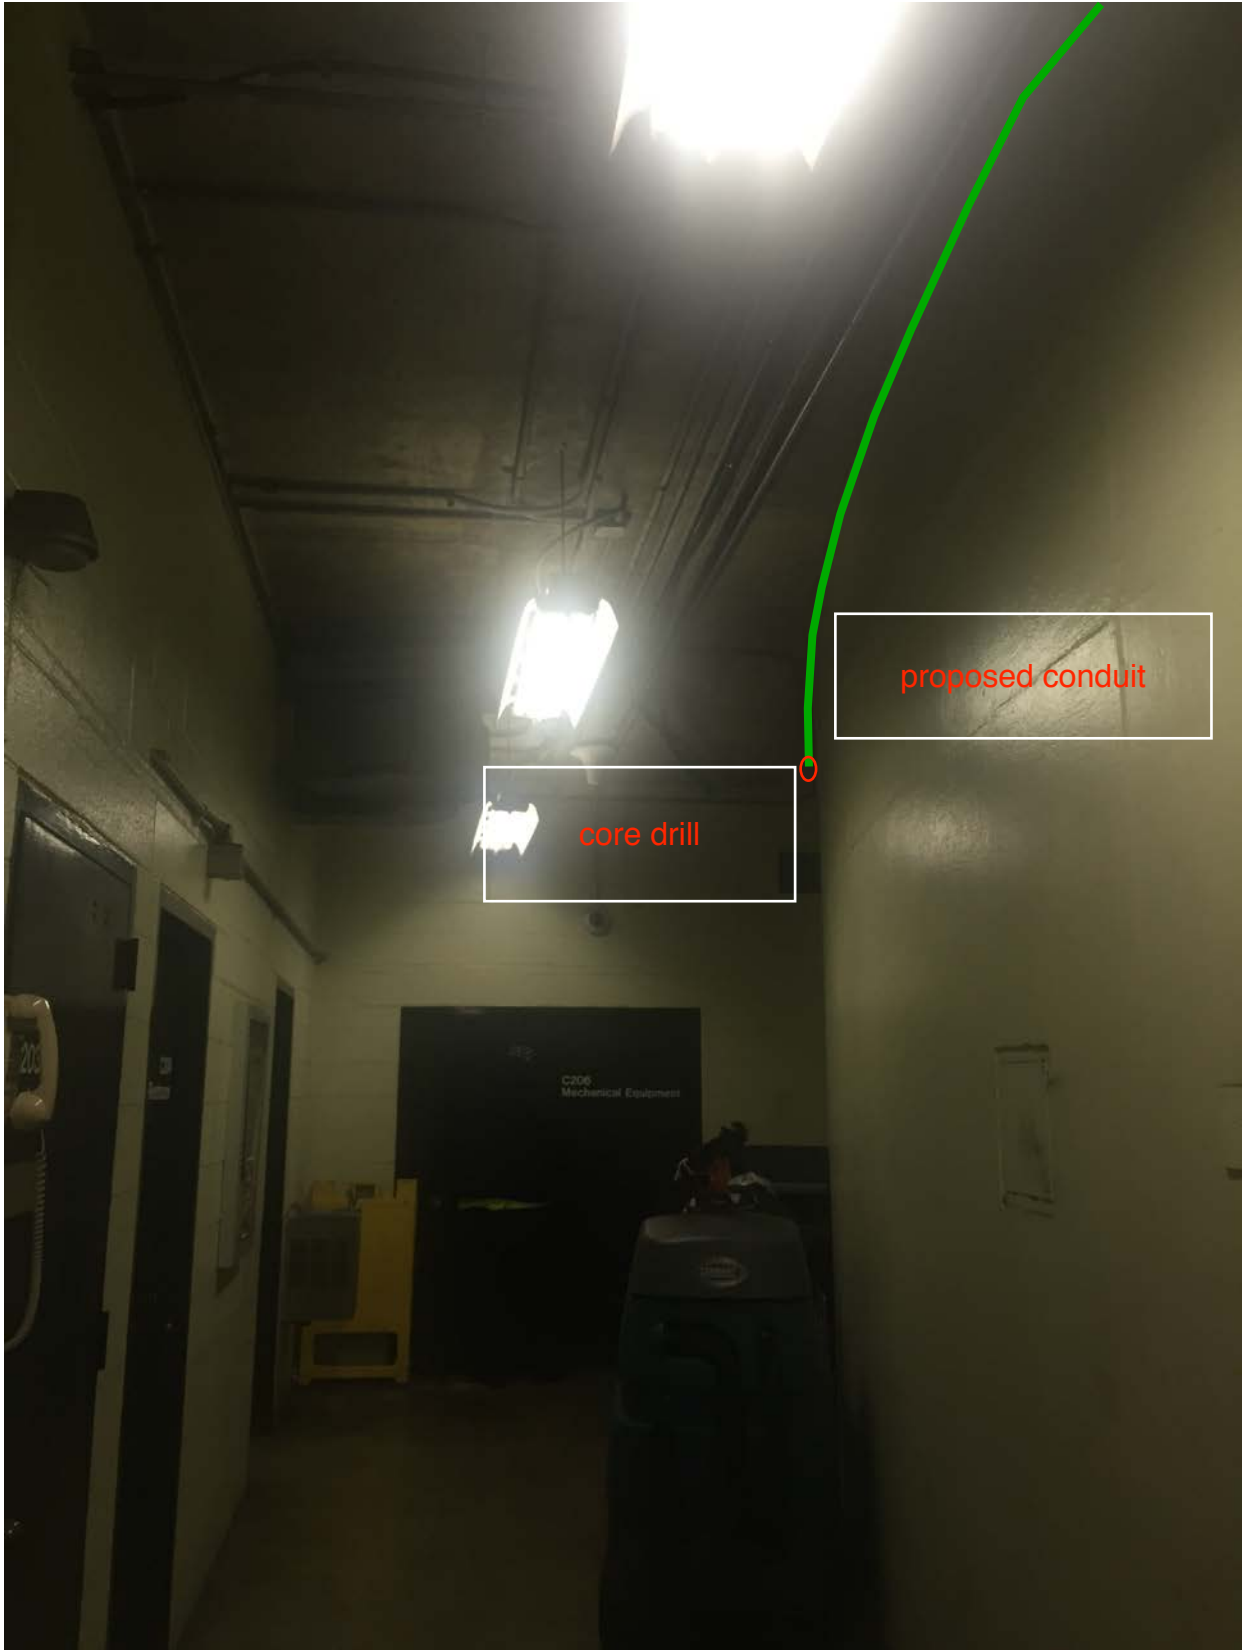
Photo #5 – G02 Capitol Heights: Proposed run transition to conduit along hallway of backrooms towards AFC panel

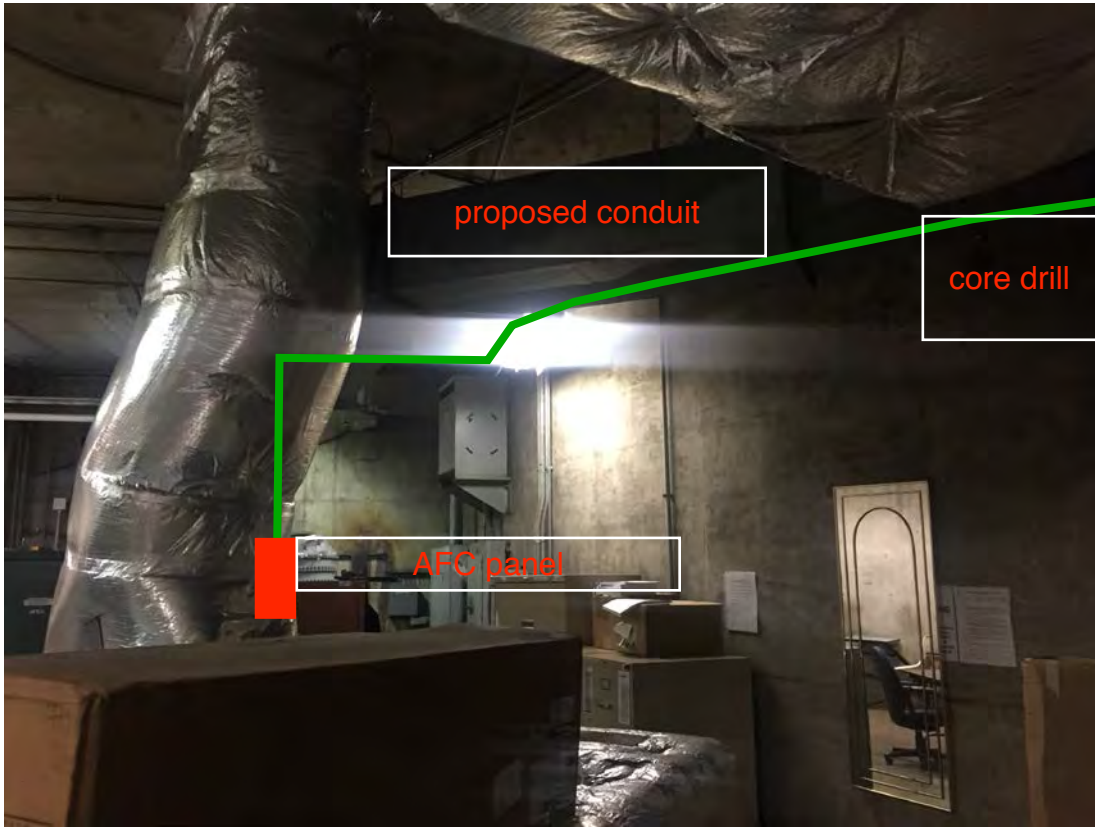
Photo #6 – G02 Capitol Heights: Proposed conduit along ceiling of AFC panel room

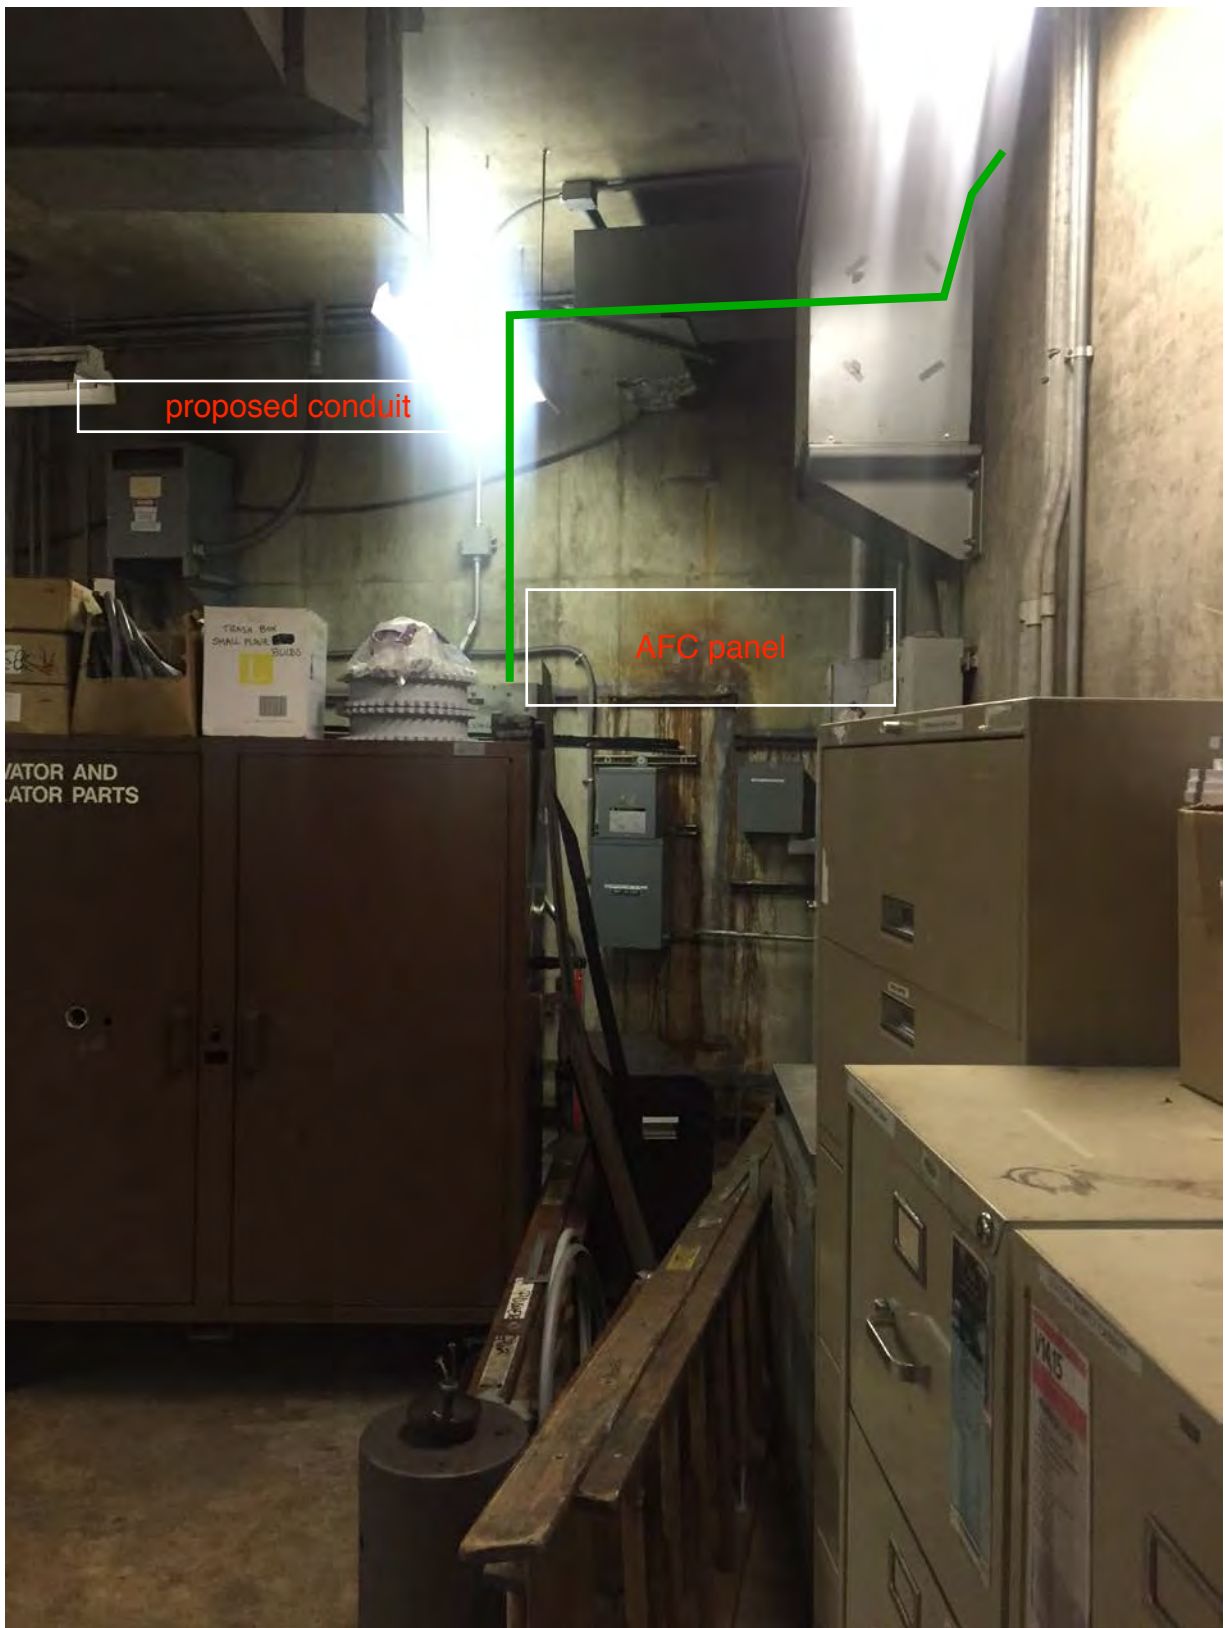
Photo #7 – G02 Capitol Heights: Proposed conduit and existing duct runs to AFC panel
