Mezzanine Inspection Report (Scoping)

Date: 01/23/2015	Station Name: G03 Addison Road	Mezzanine #: 092	Completed By: Zach Fitzwater
Summary			
<p>All communications and power ducts scoped. Upper communications ducts collapsed and pull string was not installed. Pull string was successfully installed in lower communications duct in faregate array. Pull string was installed in the duct between the Kiosk and junction box, and in the conduit from the junction box to the AFC panel.</p> <p>No scanning is required at this mezzanine.</p>			
Scoping of Faregate Array(s)			
Task	Yes/No	Notes	
Communications Duct – Upper Faregate Array (4 Gates)			
Was video scoping completed for the entire duct run?	No	Refer to WMATA Addison Rd 6inch Upper Comm Faregate.avi file.	
Were pull strings installed at all faregates in the array?	No		
Were there any obstructions or blockages? Provide details of type and specific location.	Yes	Both 3" and 6" ducts in poor condition with heavy debris and collapsed ducts

Date: 12/18/14	Station Name: G04 Morgan Boulevard	Mezzanine #: 110	Completed By: Mike Butler
-----------------------	---	-------------------------	----------------------------------

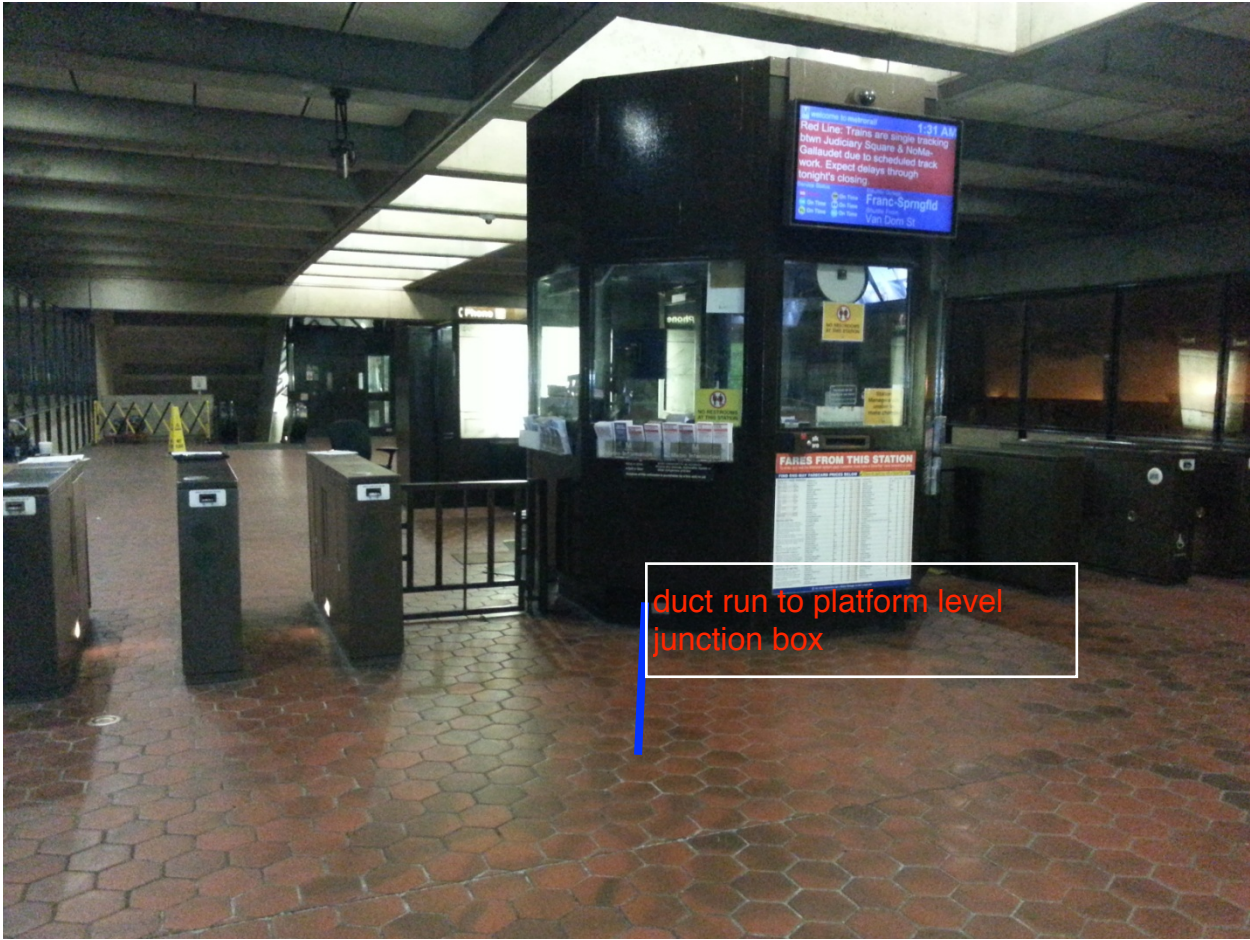
Photo #1 – G03 Addison Road: Kiosk and faregate array

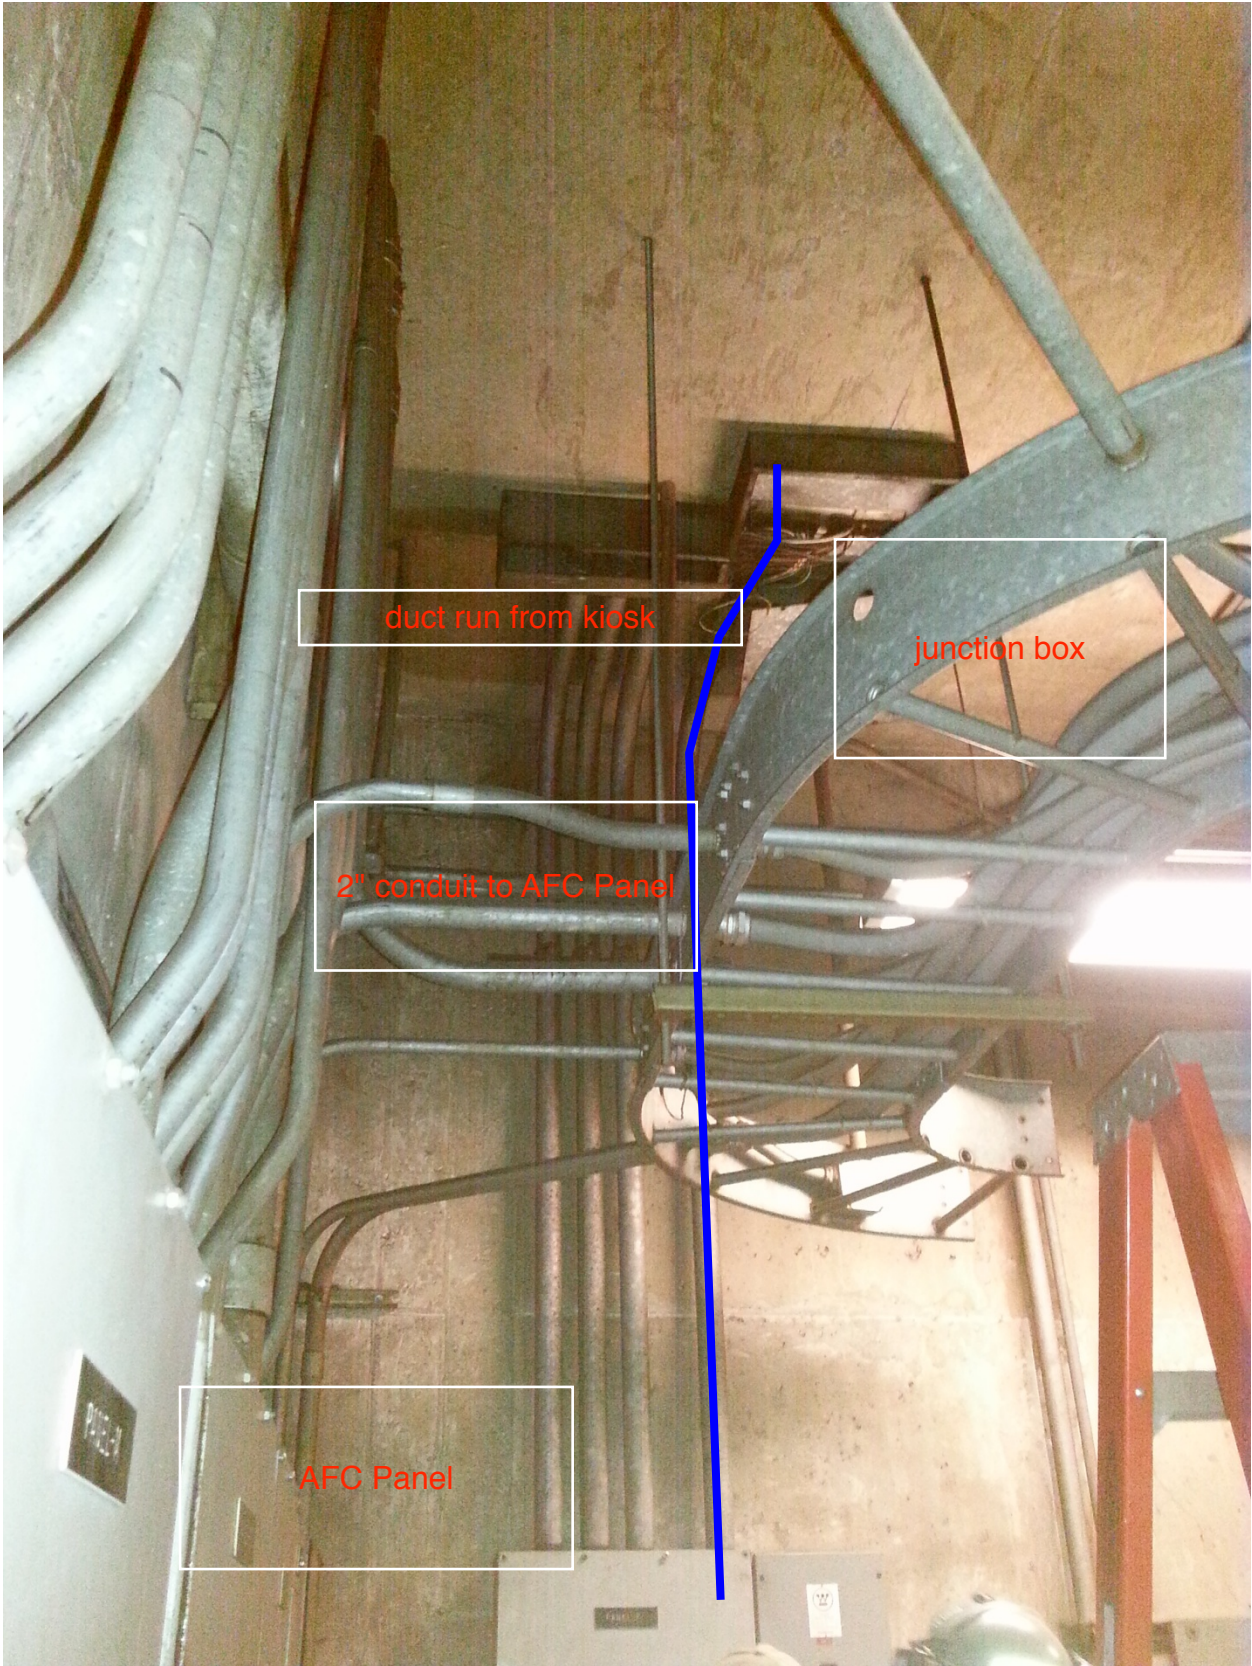
Photo #2 – G03 Addison Road: Junction box to AFC Panel

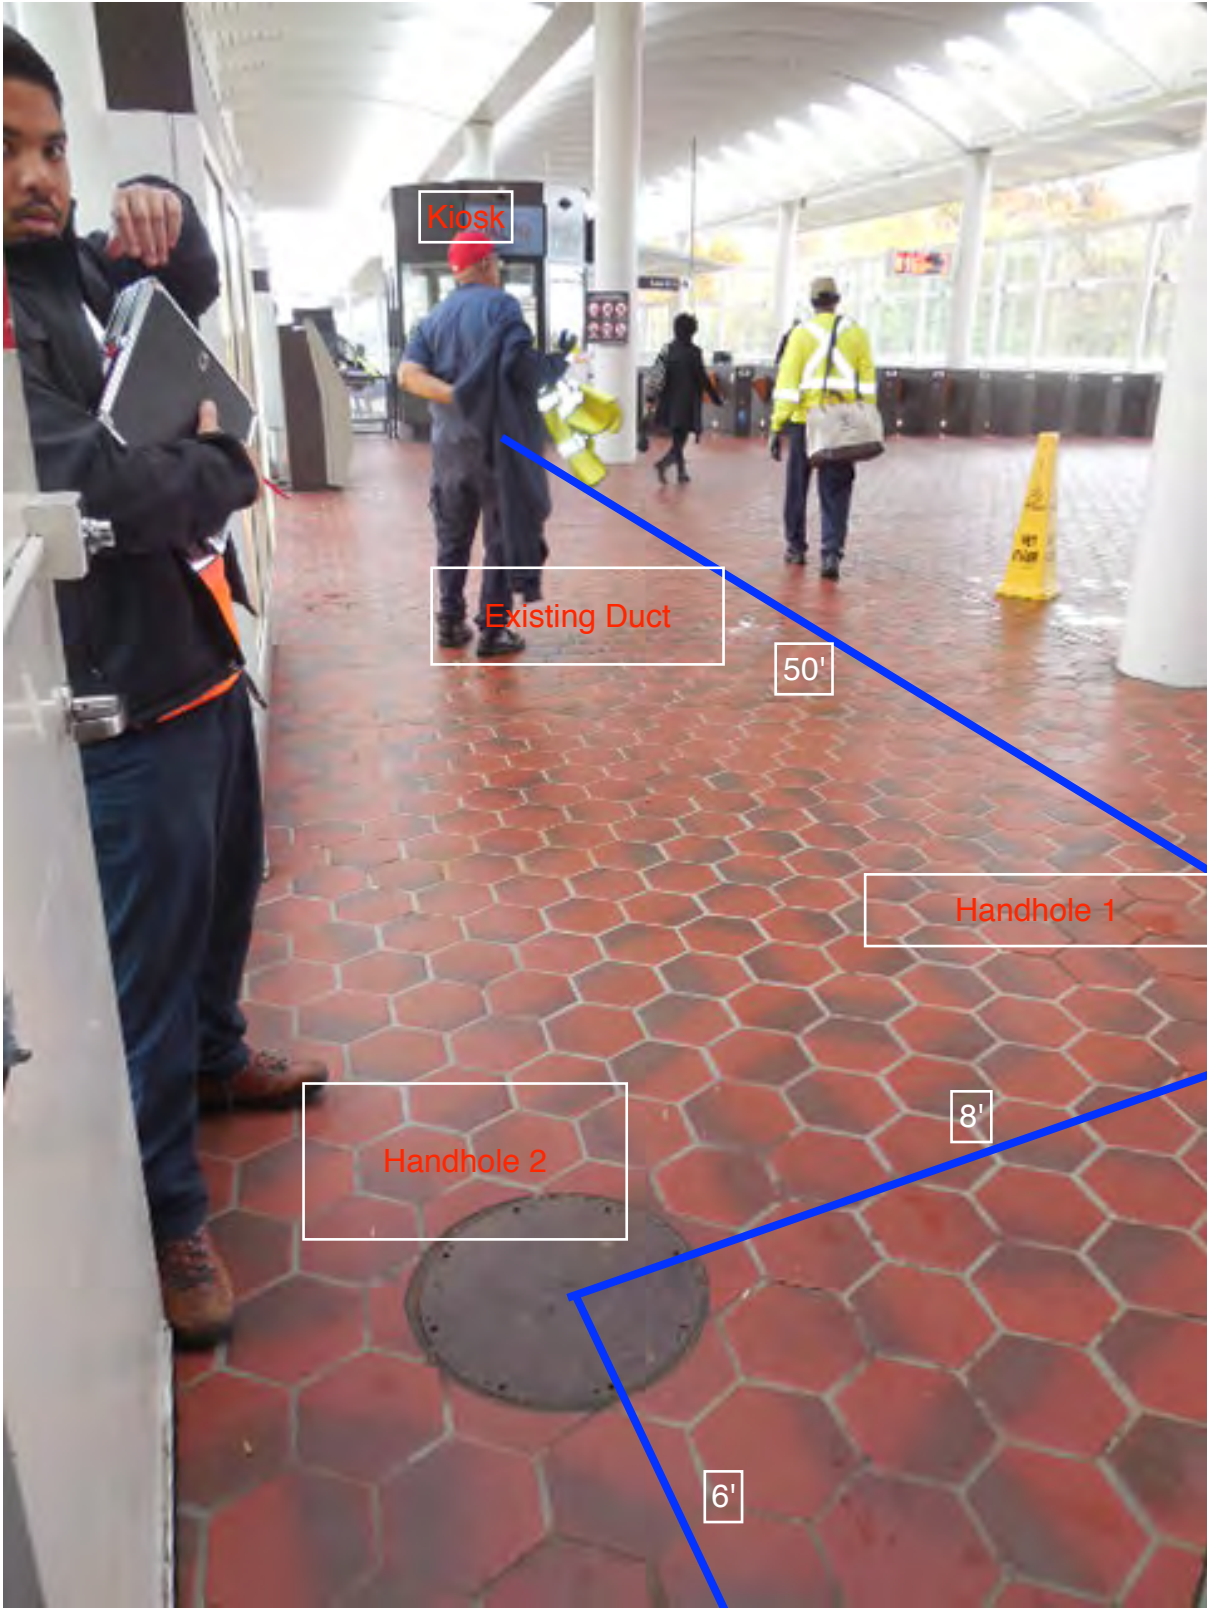
Photo#1 – Existing duct layout on mezzanine floor

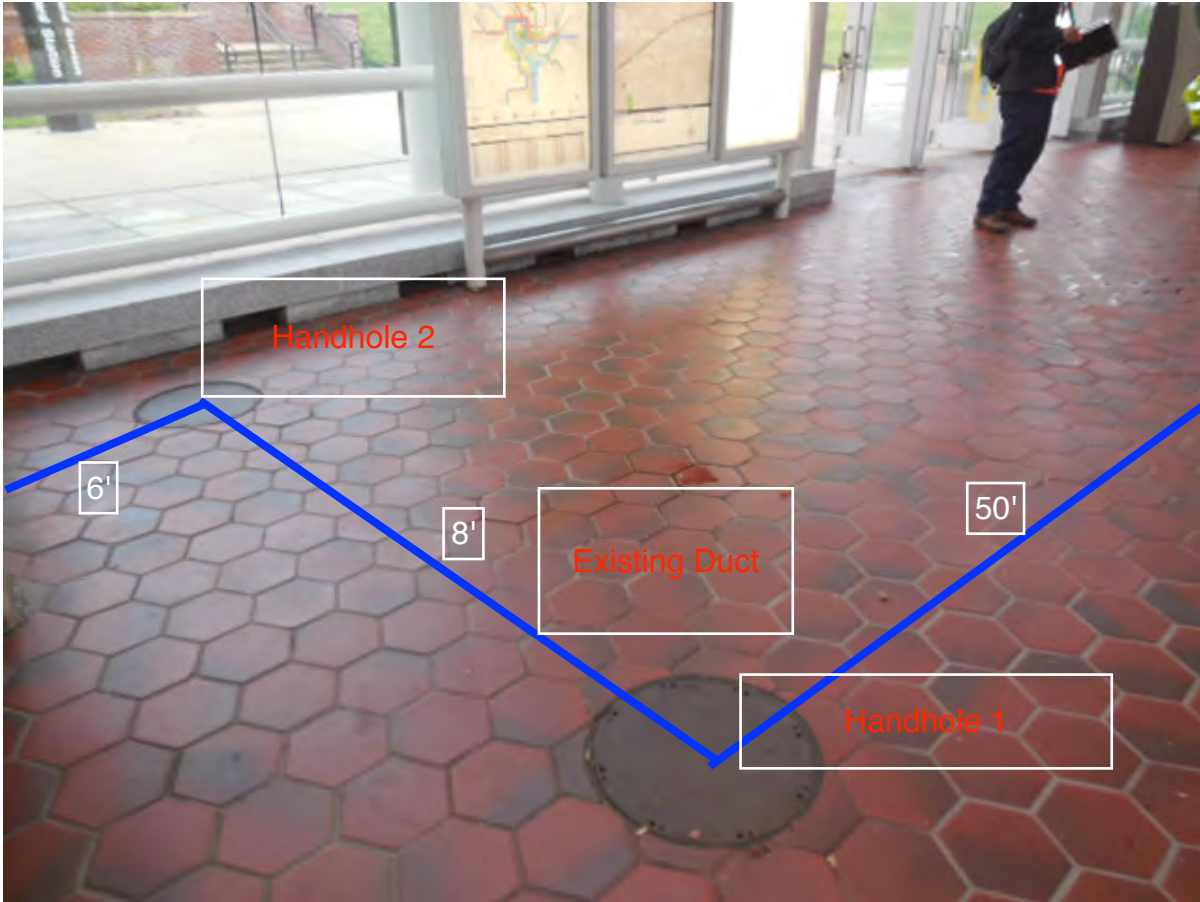
Photo#2 – Existing duct layout on mezzanine floor

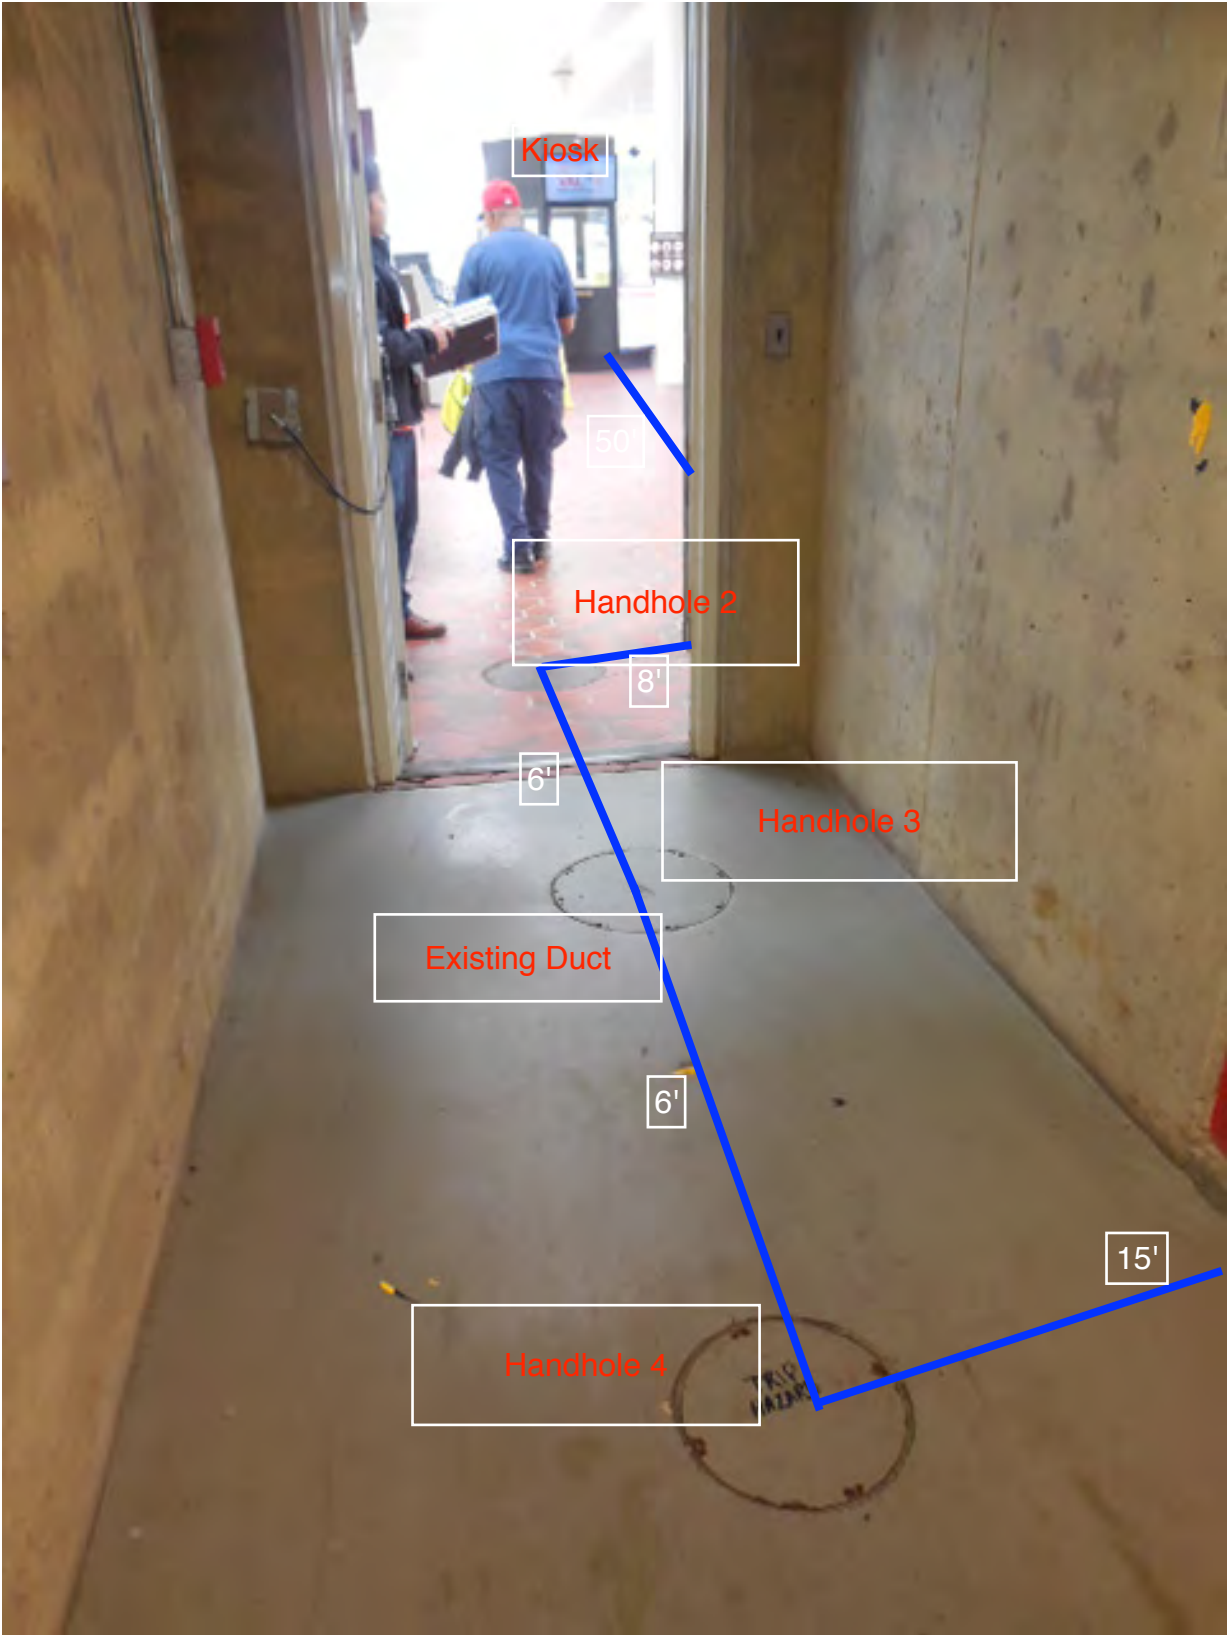
Photo#3 – Existing duct layout in back room corridor

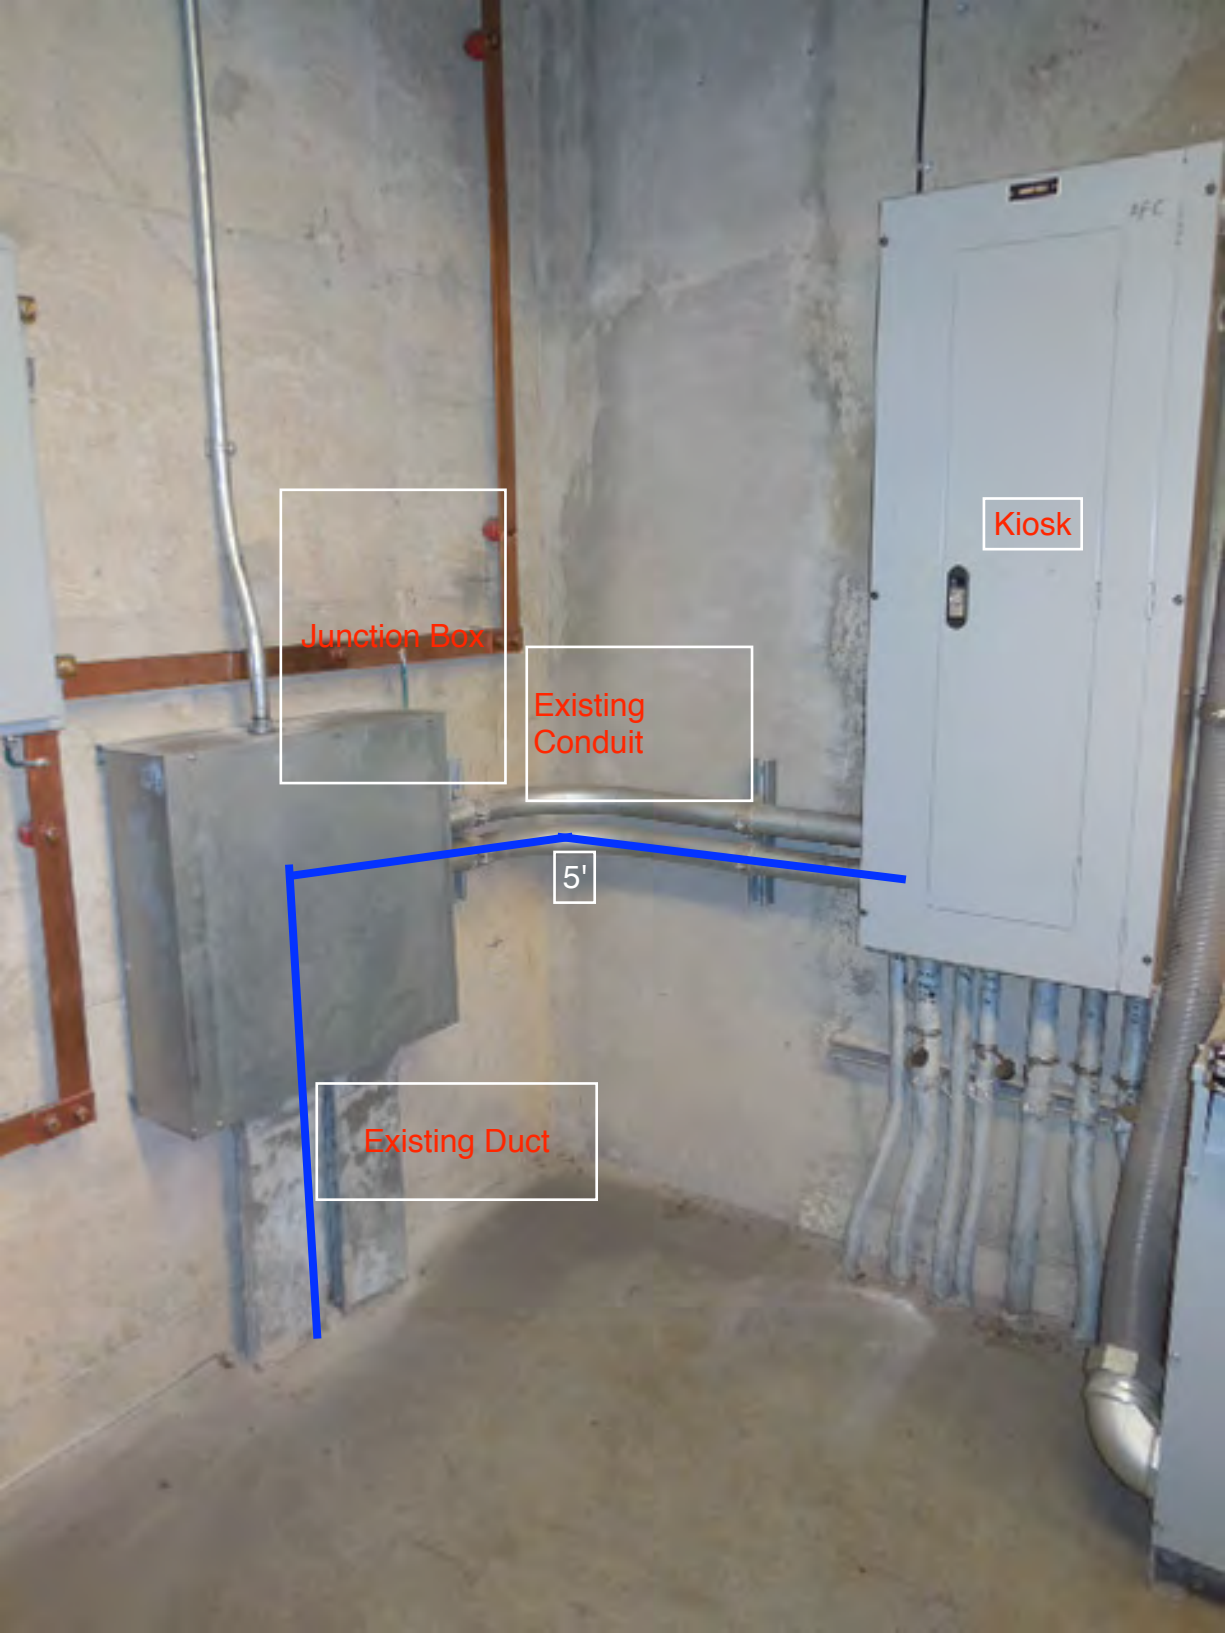
Photo#4 – Existing duct and conduit layout in Room 205
