Mezzanine Inspection Report (Scoping)

Date: 12/19/2014	Station Name: G05 Largo Town Center	Mezzanine #: 111	Completed By: Mike Butler
-------------------------	--	-------------------------	----------------------------------

Date: 11/26/2014	Station Name: J02 Van Dorn Street	Mezzanine #: 094	Completed By: Balkis Hassane
-------------------------	--	-------------------------	-------------------------------------

Date: 01/15/2015	Station Name: J03 Franconia-Springfield	Mezzanine #: 095	Completed By: Tino Sahoo
-------------------------	--	-------------------------	---------------------------------

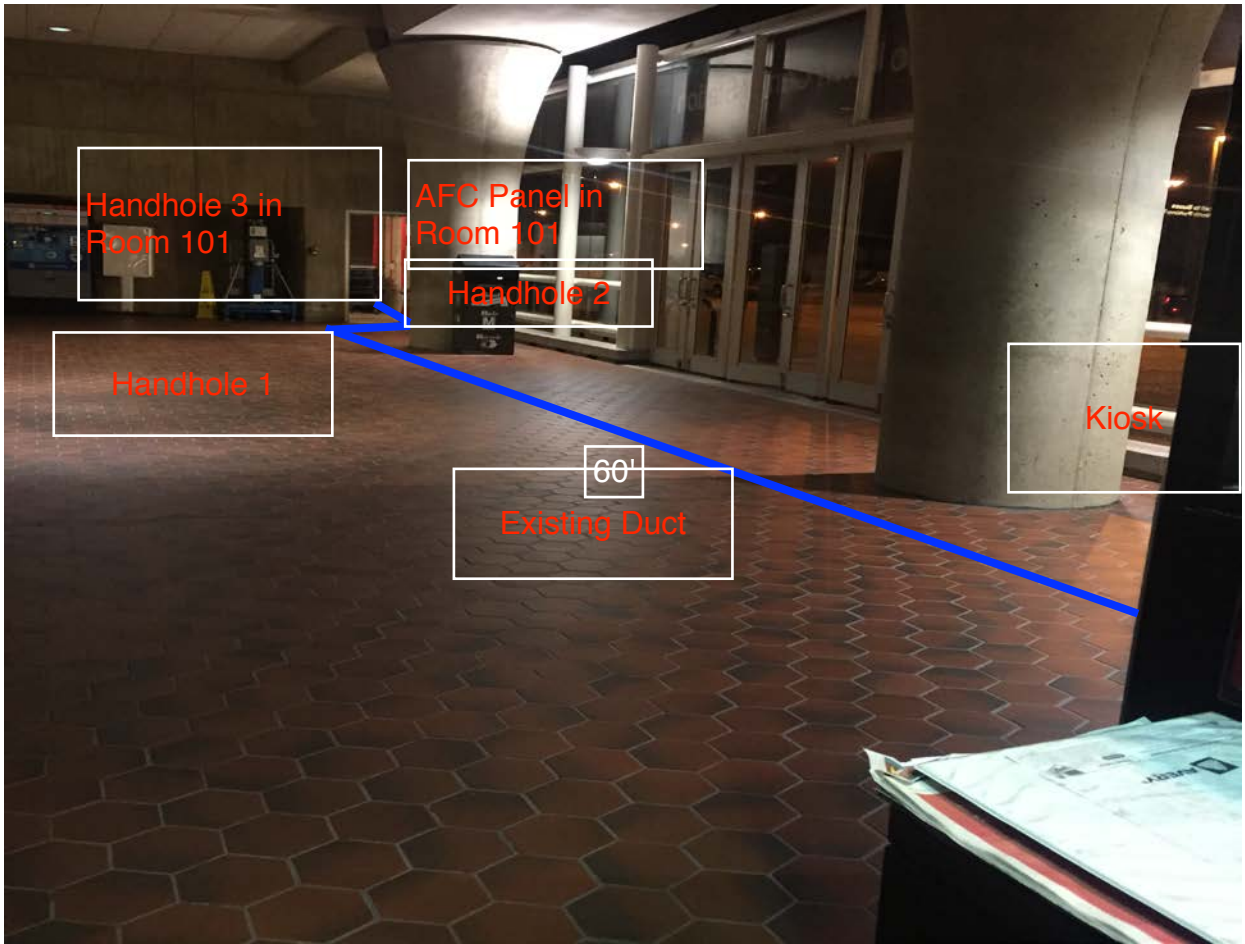
Observations / Issues / Next Steps		
Total power duct run from Kiosk to AFC Panel is 79'. Refer to attached photos for details of existing duct run.		
Existing AFC Installation Plan not available for this mezzanine.		
Sign Off		
	GFP Representative	WMATA PRGM
Name:	Mike Butler	
Signature:

Photo #1: Existing Duct Run from Kiosk to AFC Panel

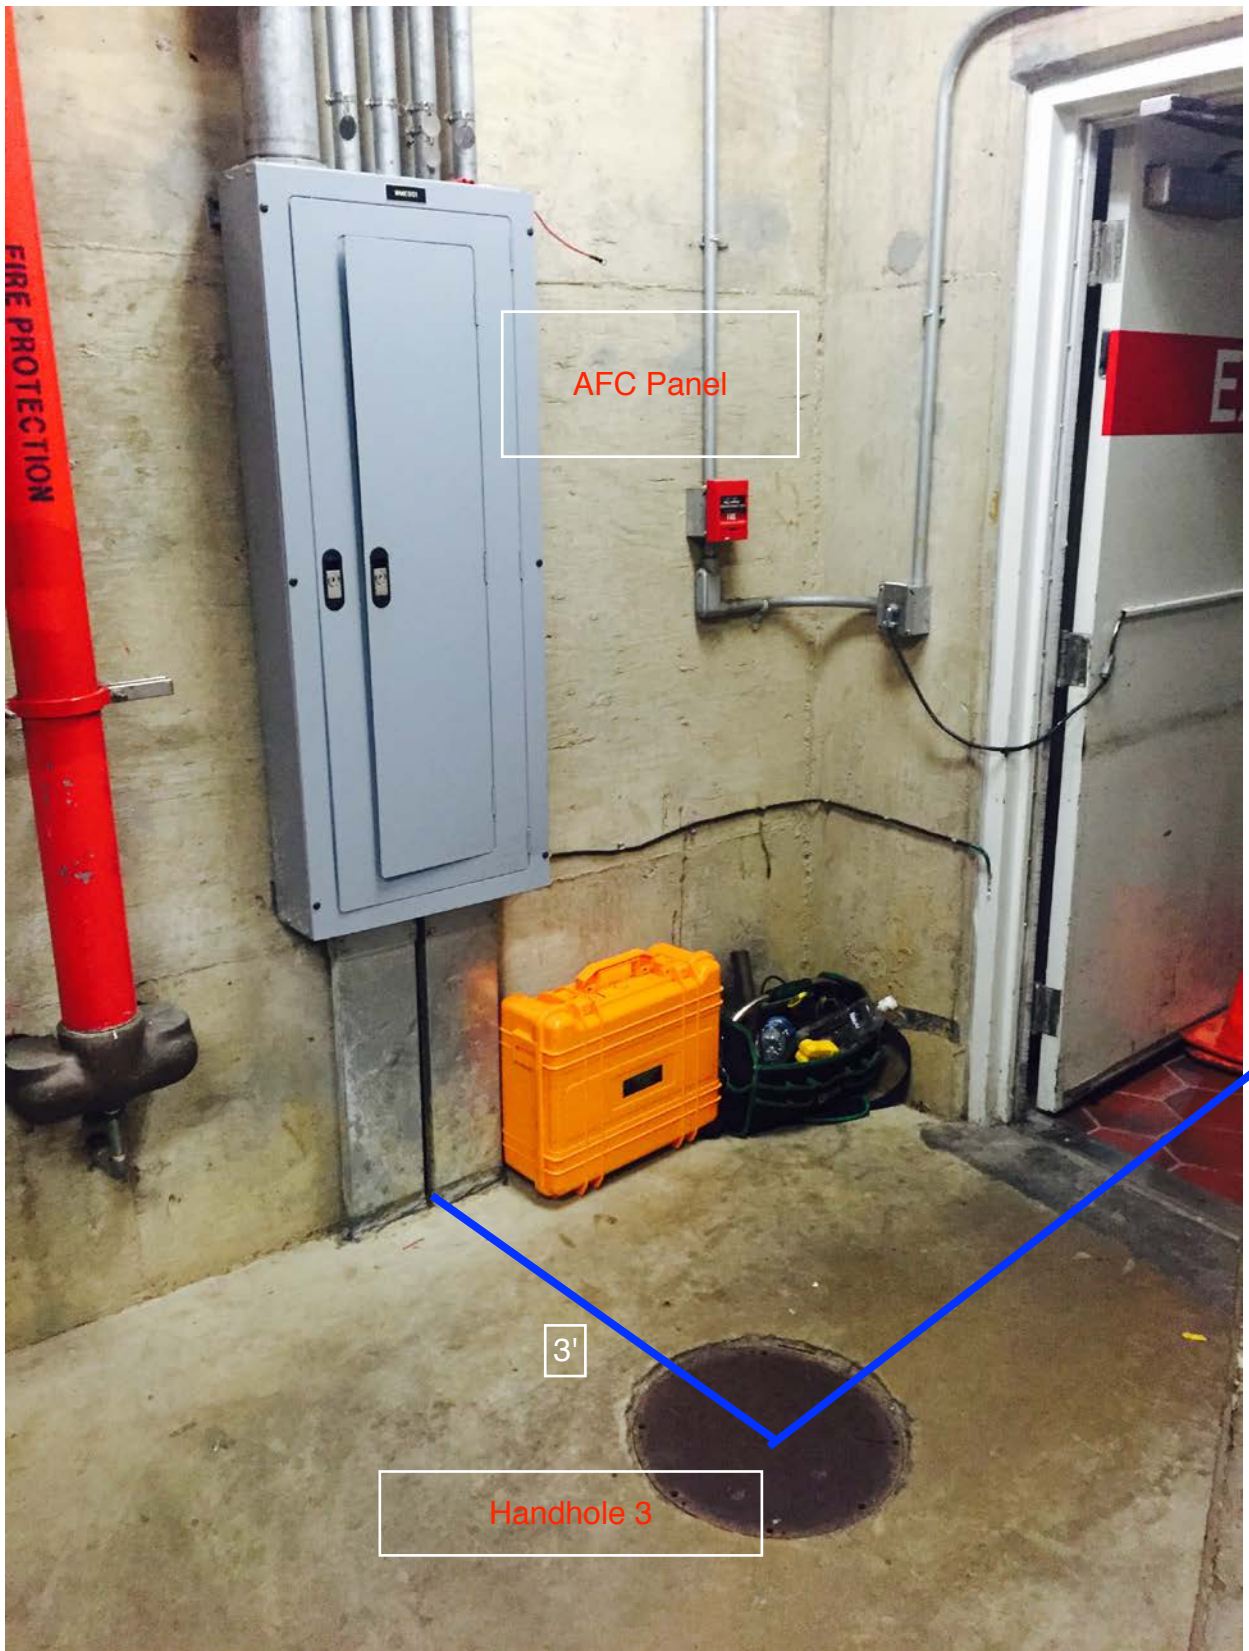
Photo #2: Existing duct run from Handhole 3 to AFC panel (Room 101)

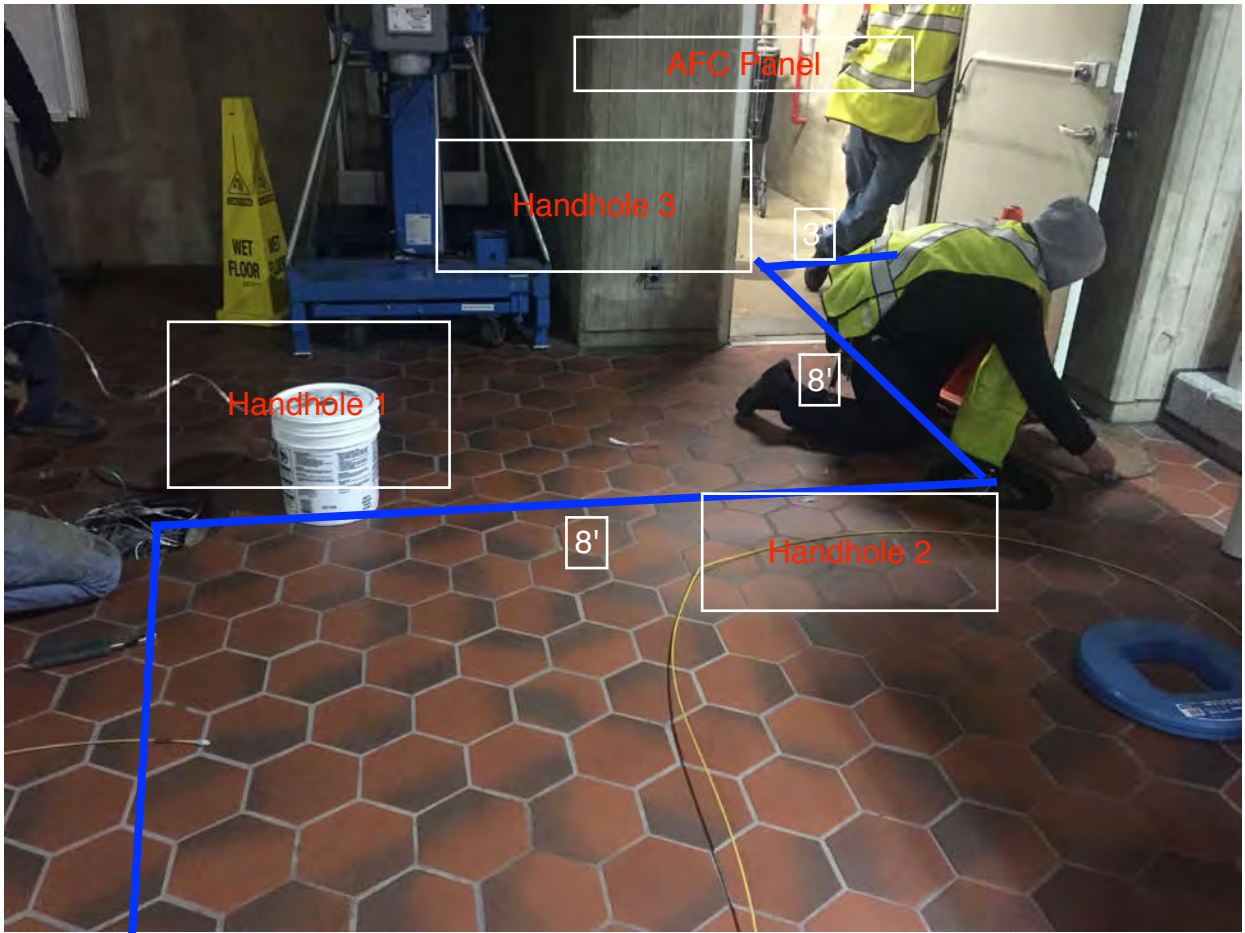
Photo #3: Existing duct run (3 handholes)

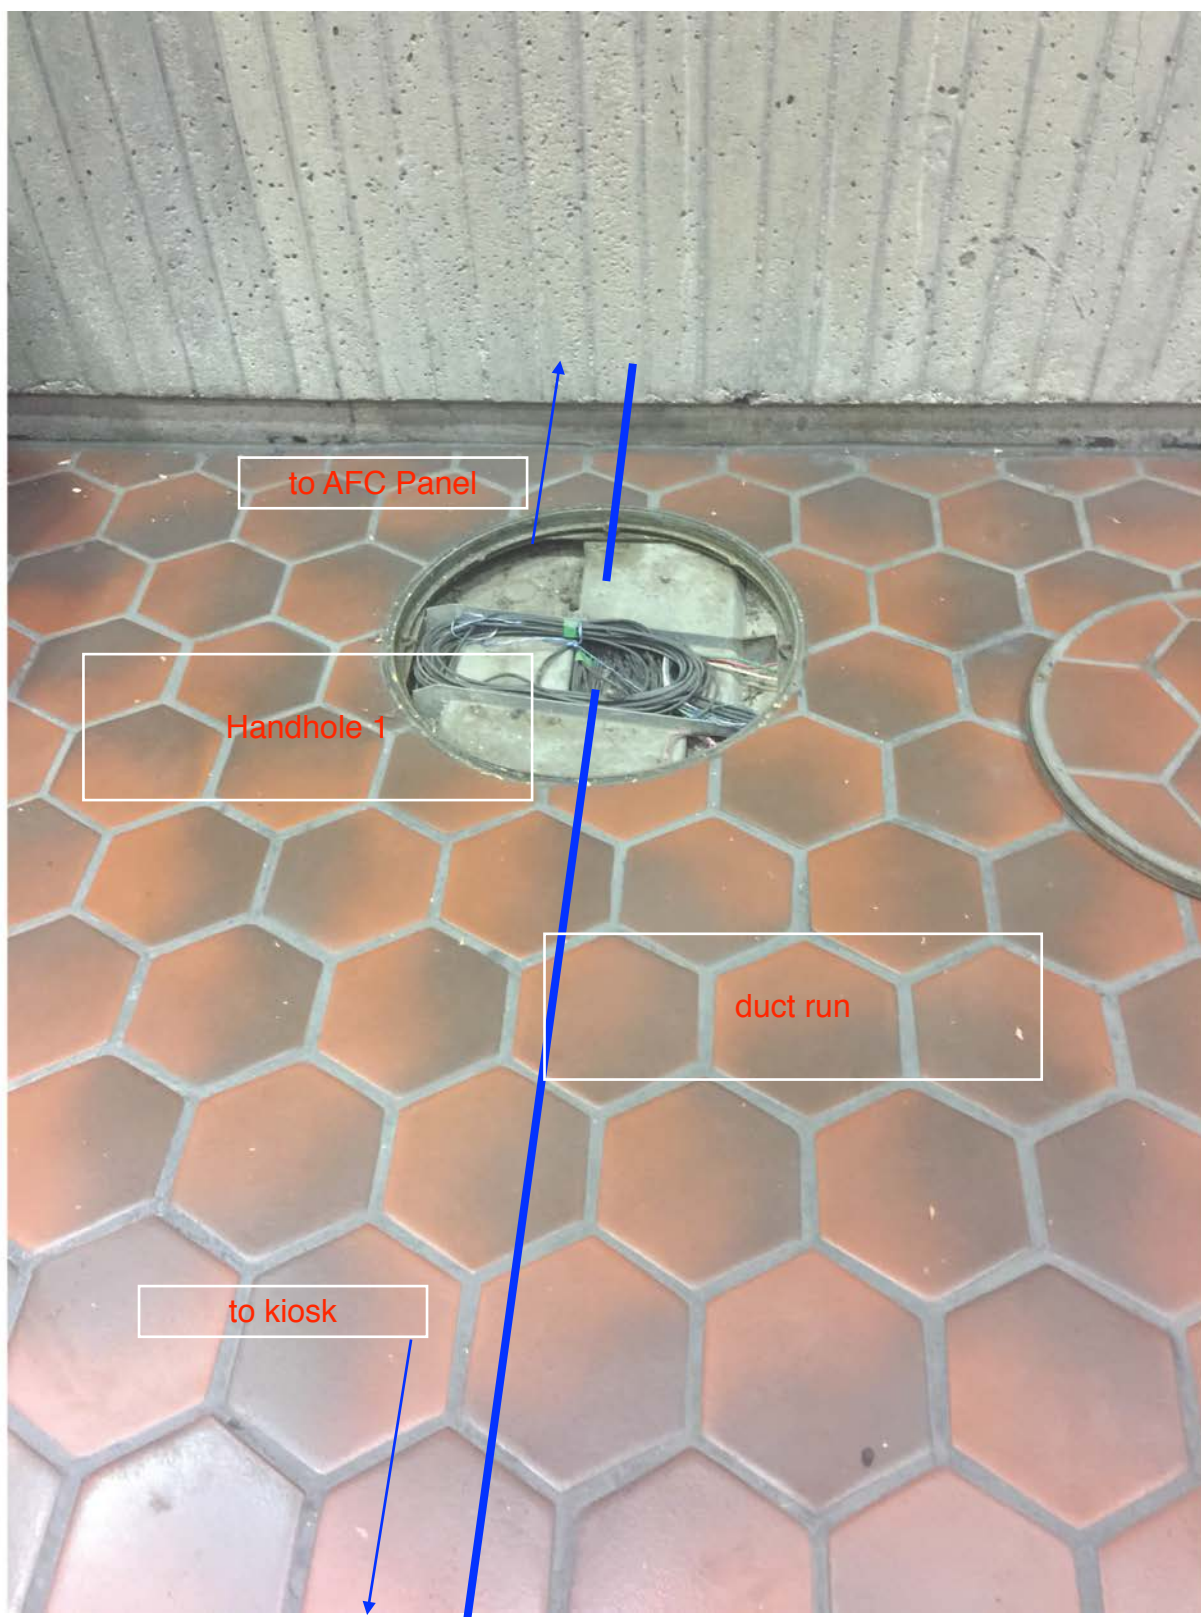
Photo #1 – J02 Van Dorn Street: Handhole 1 on mezzanine floor

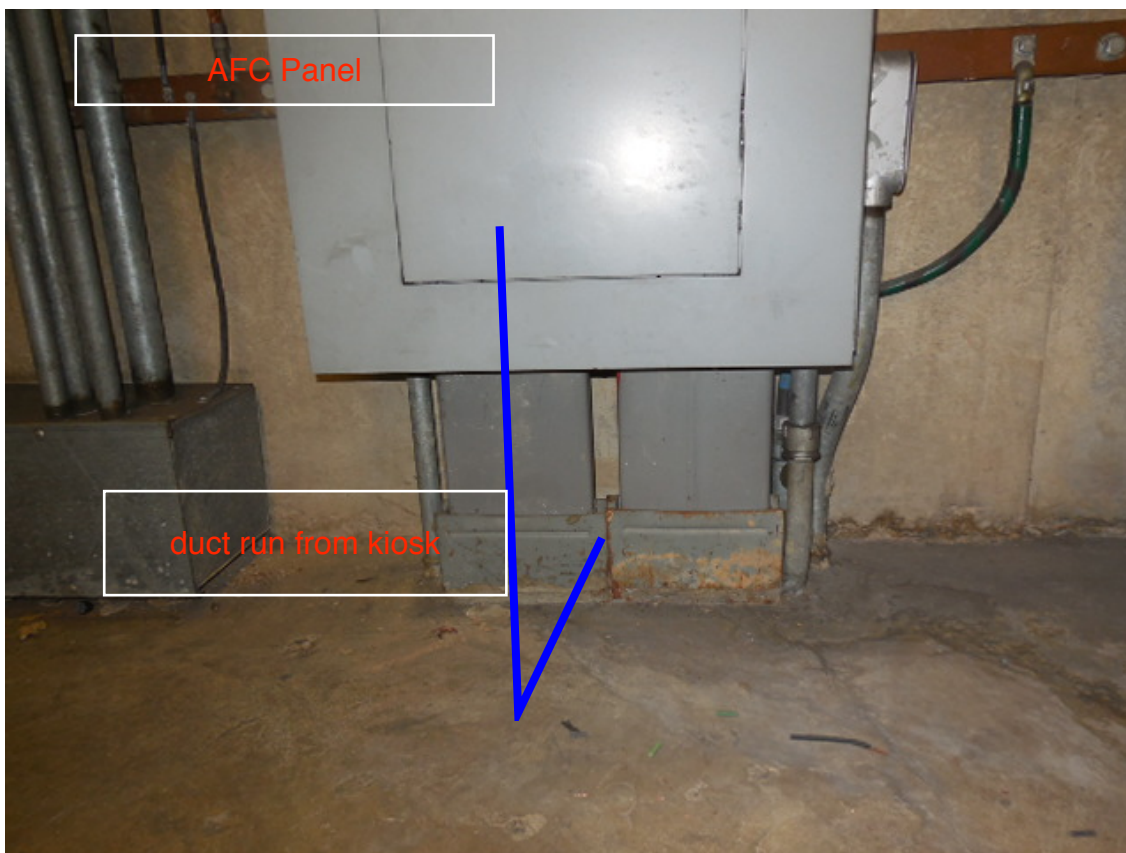
AFC panel is on the other side of the wall next to handhole 1. Walker duct has a 90 degree bend up to AFC panel.		
Sign Off		
	GFP Representative	WMATA PRGM
Name:	Balkis Hassane	
Signature:

Photo #2 – J02 Van Dorn Street: AFC Panel

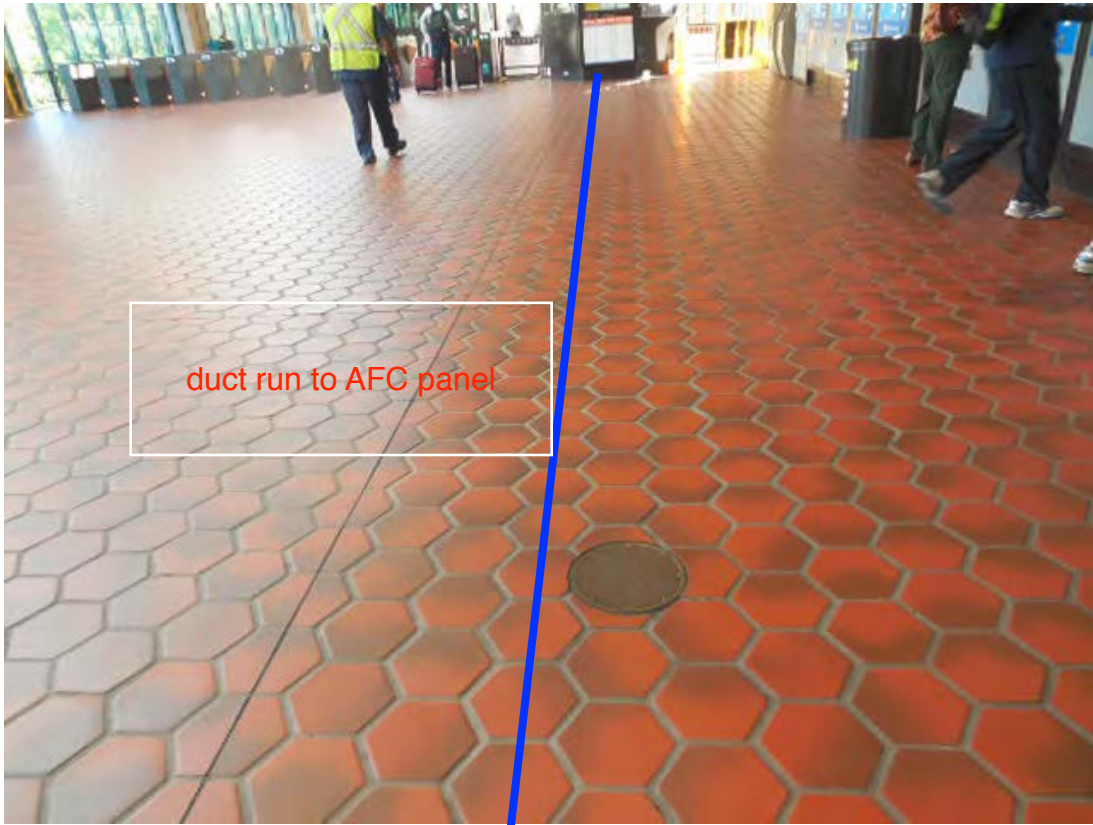
Photo #1 – J03 Franconia-Springfield: Mezzanine floor duct run towards AFC panel

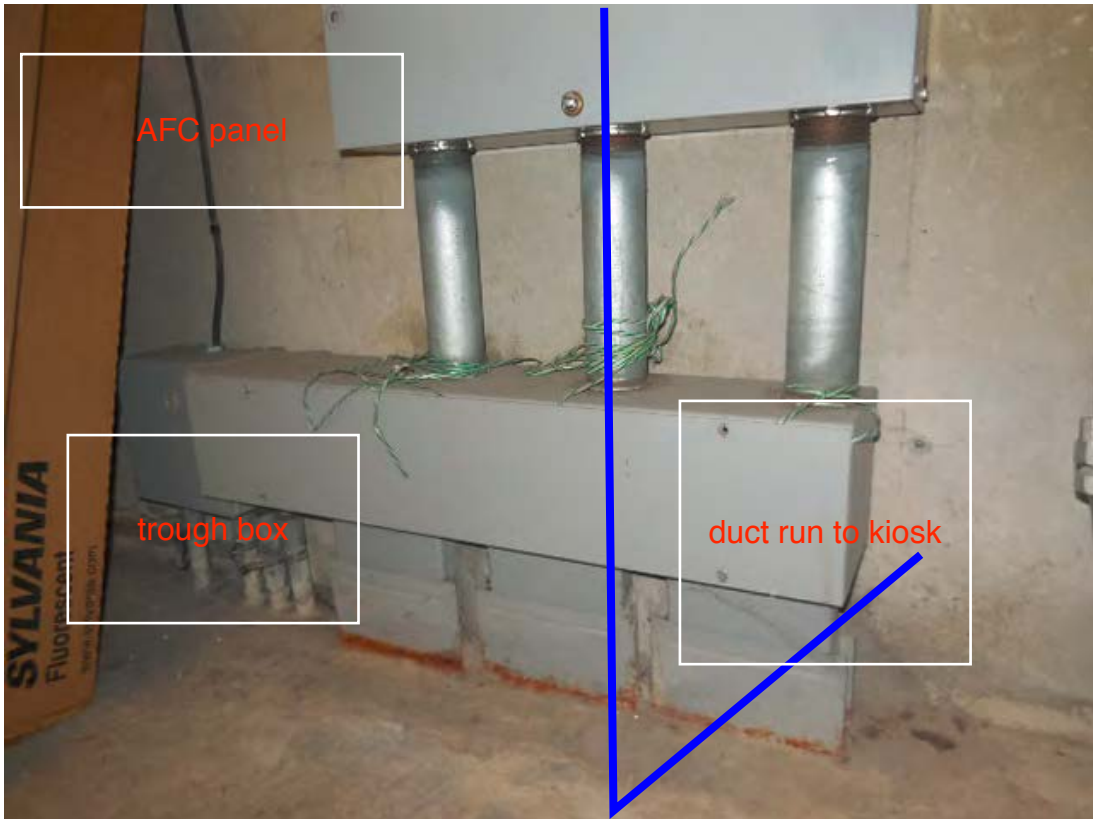
Photo #2 – J03 Franconia-Springfield: AFC panel
