Mezzanine Inspection Report (Scoping)

Date: 03/12/2015	Station Name: Court House – K01	Mezzanine #: 096	Completed By: Balkis Hassane
------------------	---------------------------------	------------------	------------------------------

Mezzanine Inspection Report

Date: 06/08/2015	Station Name: K02 - Clarendon	Mezzanine #: 097	Completed By: Mike Butler
-------------------------	--------------------------------------	-------------------------	----------------------------------

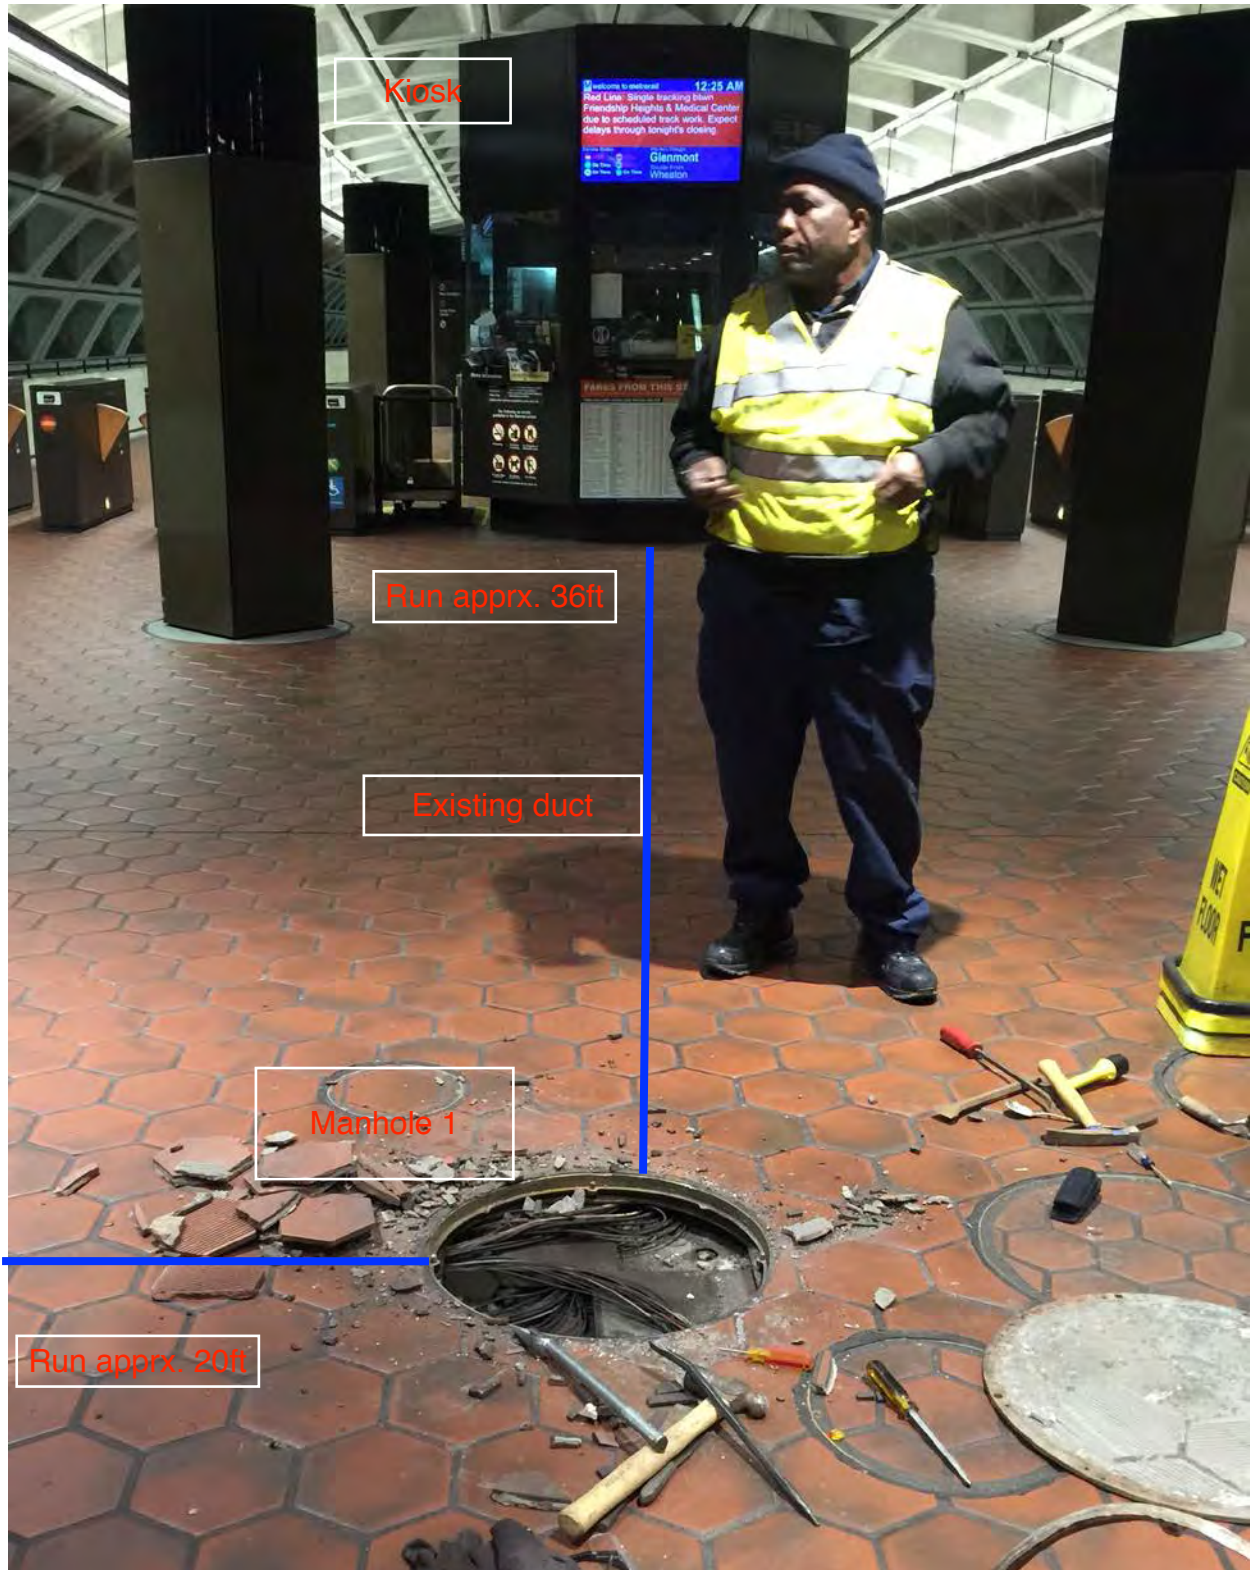
Picture 1: K01 Court House – Duct run from kiosk to manhole 1

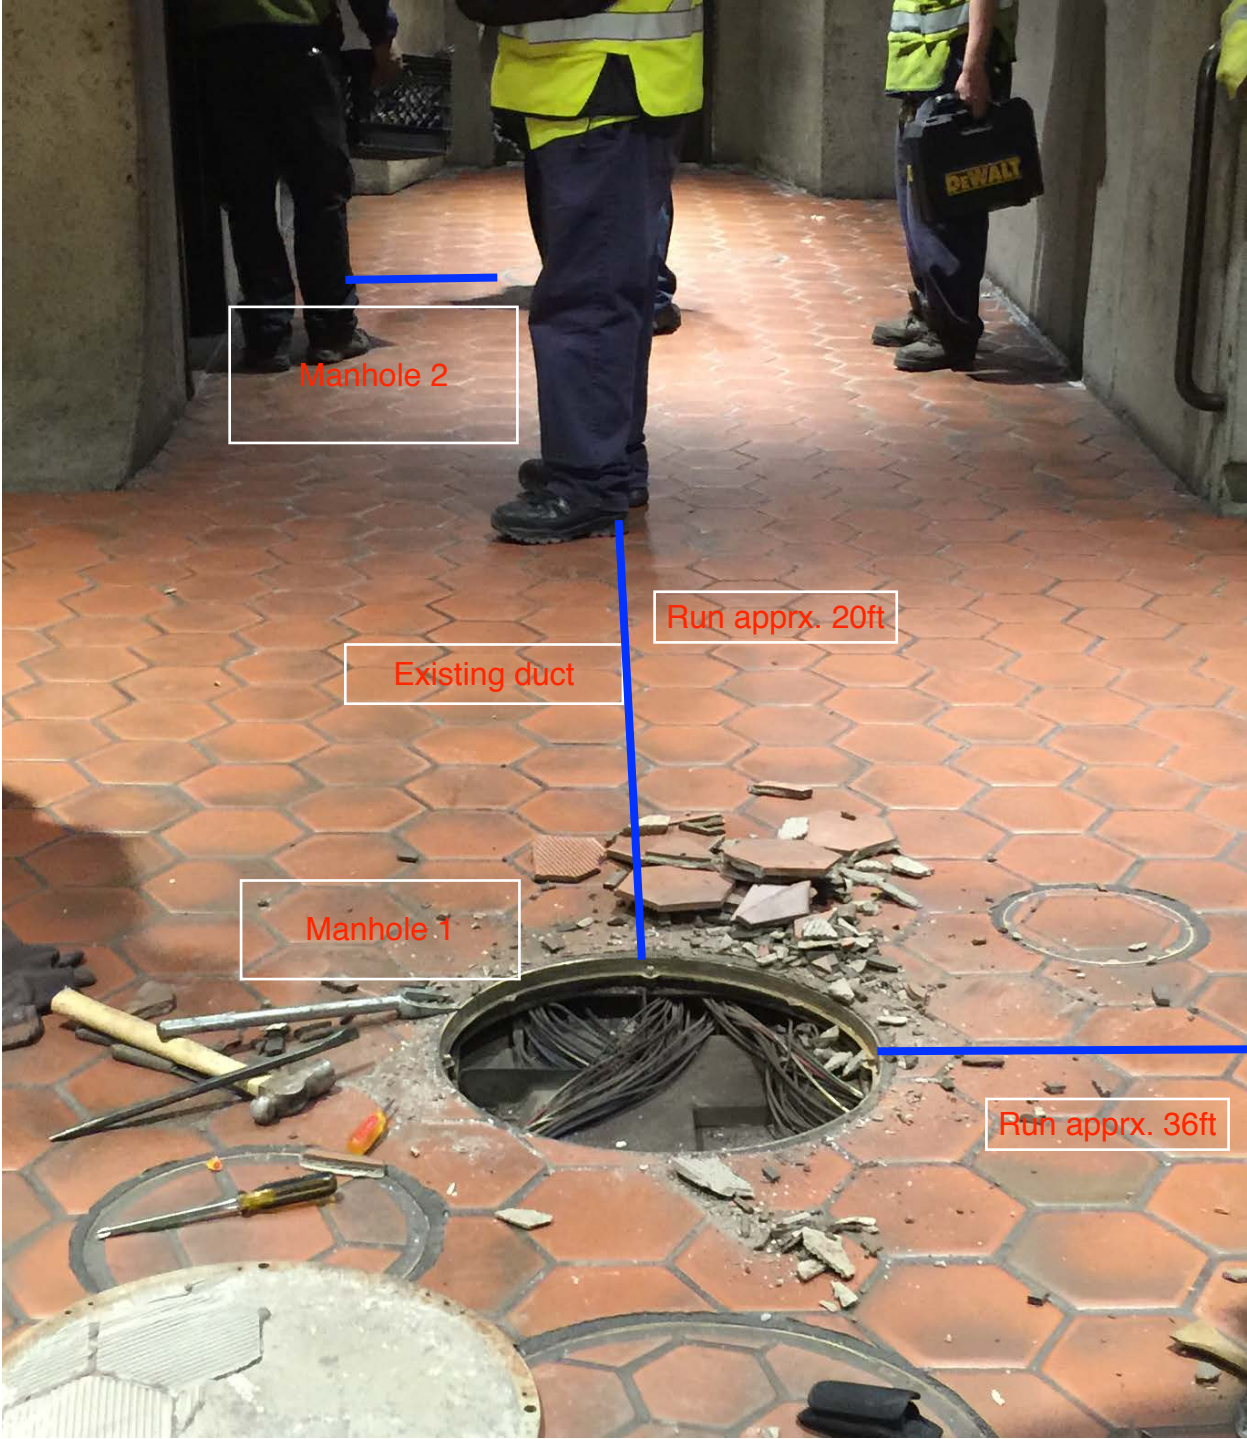
Picture 2: K01 Court House – Duct run from manhole 1 to manhole 2

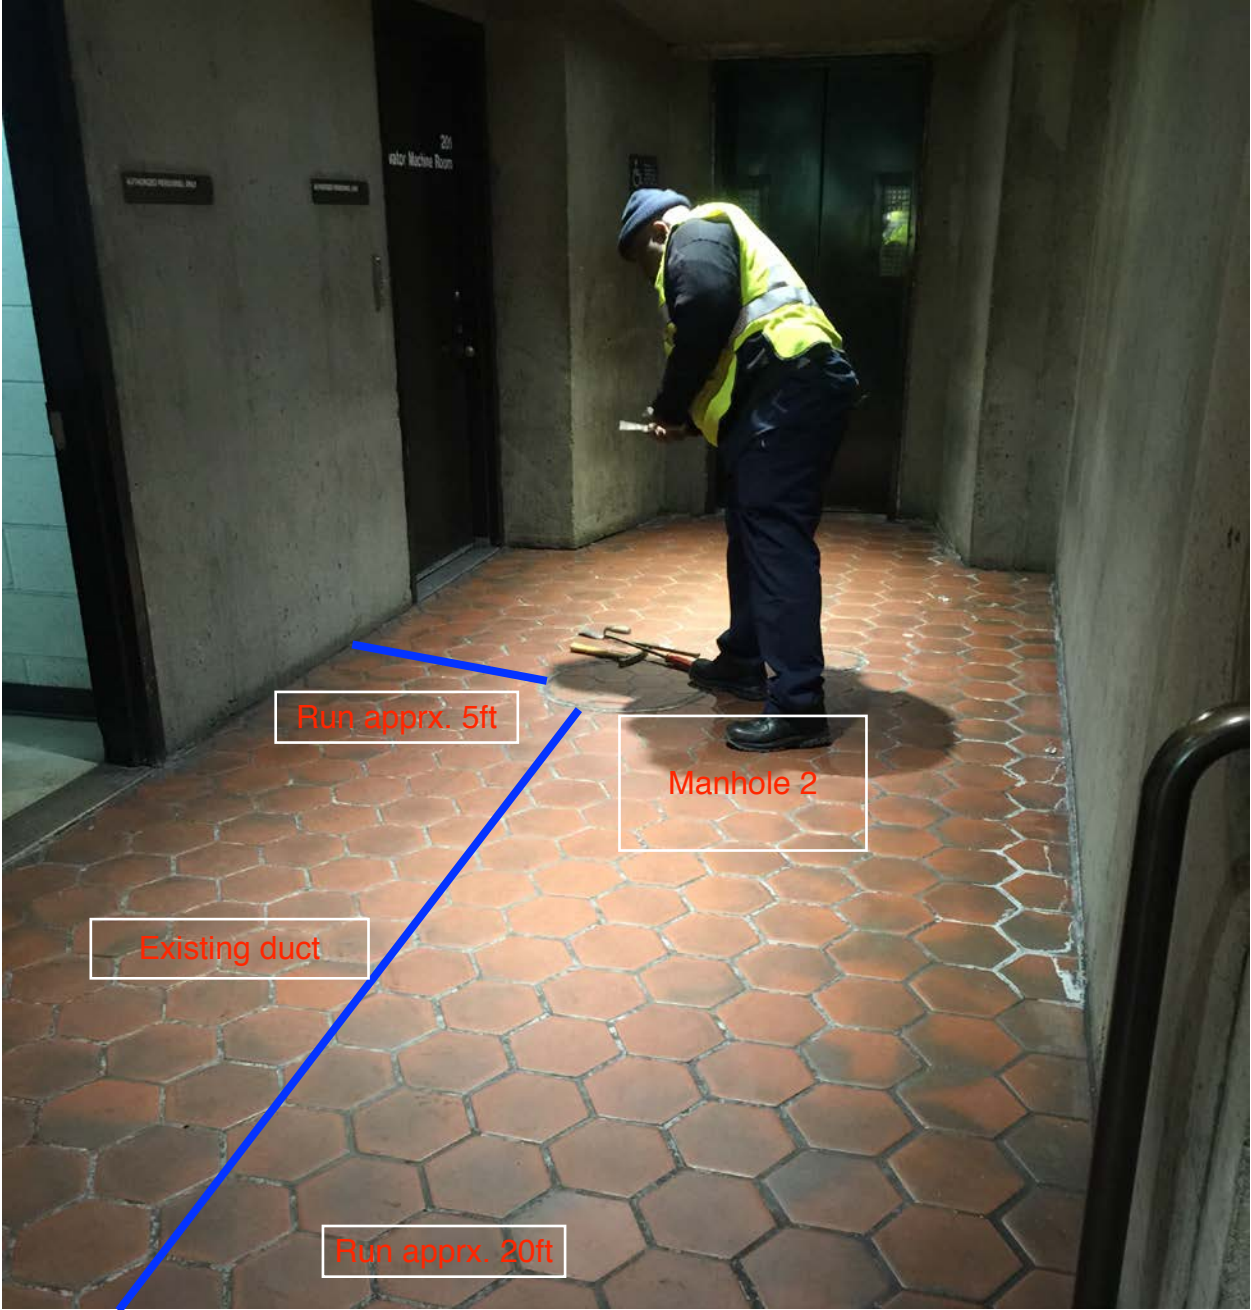
Picture 3: K01 Court House – Duct run from manhole 2 to AFC Panel

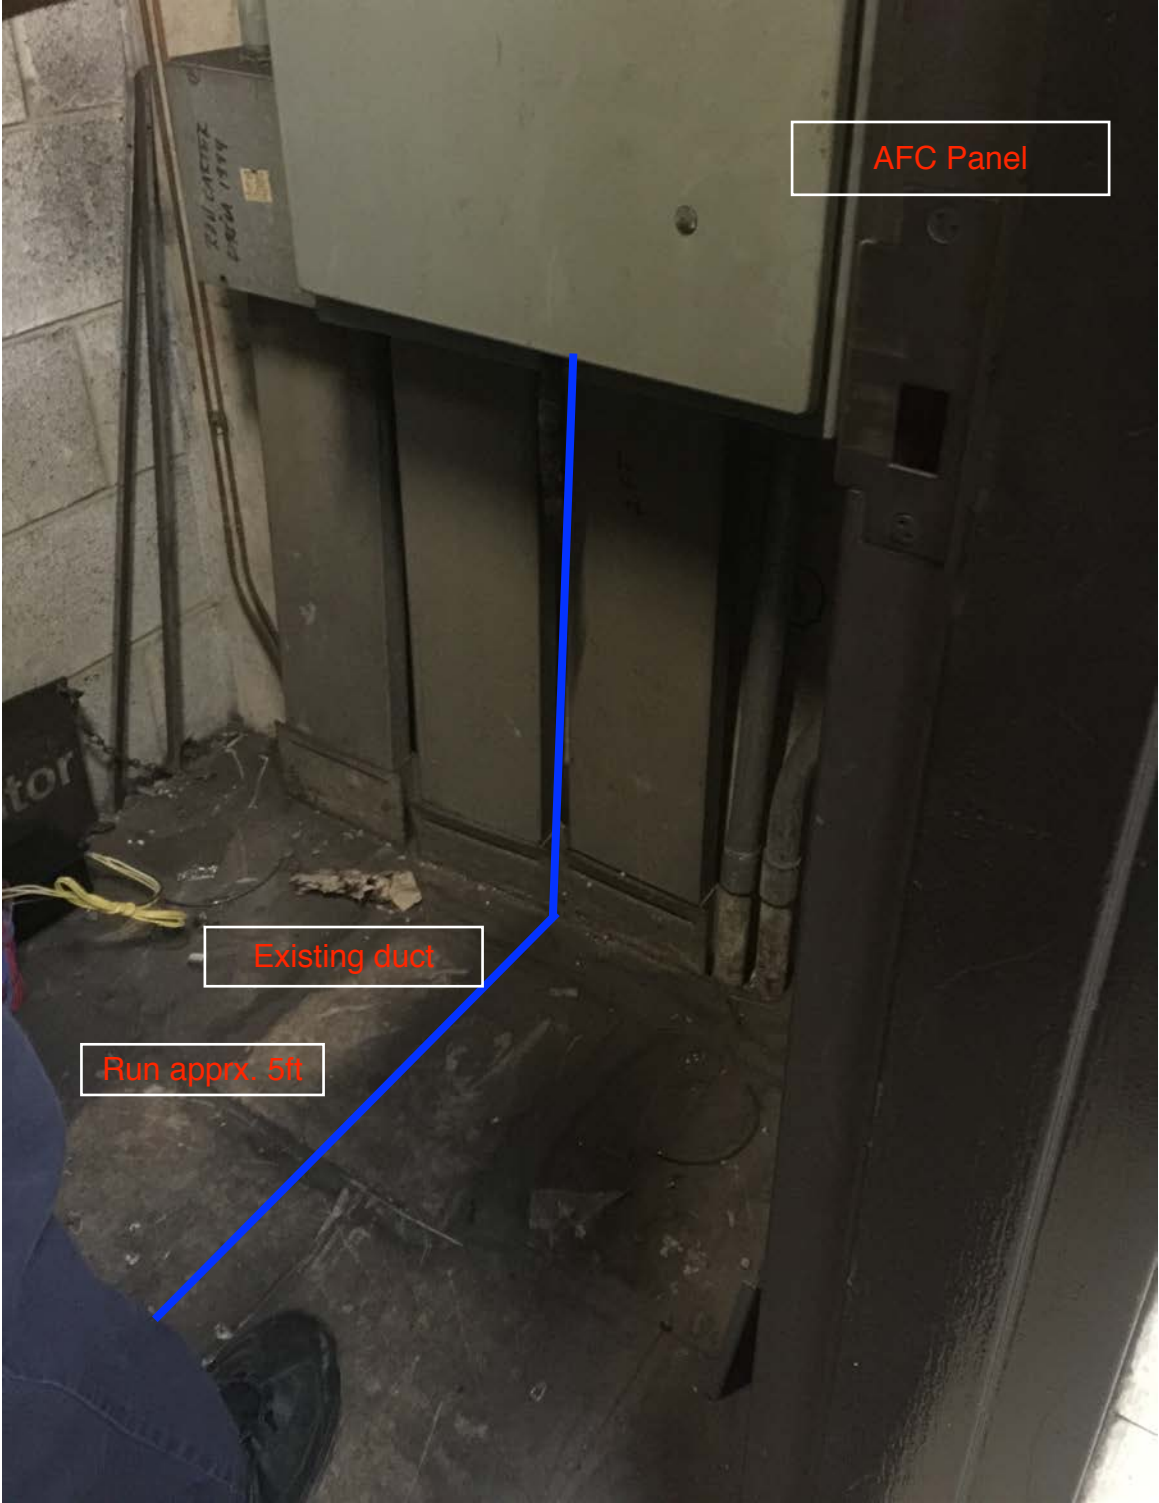
Picture 4: K01 Court House – Duct run into AFC Panel

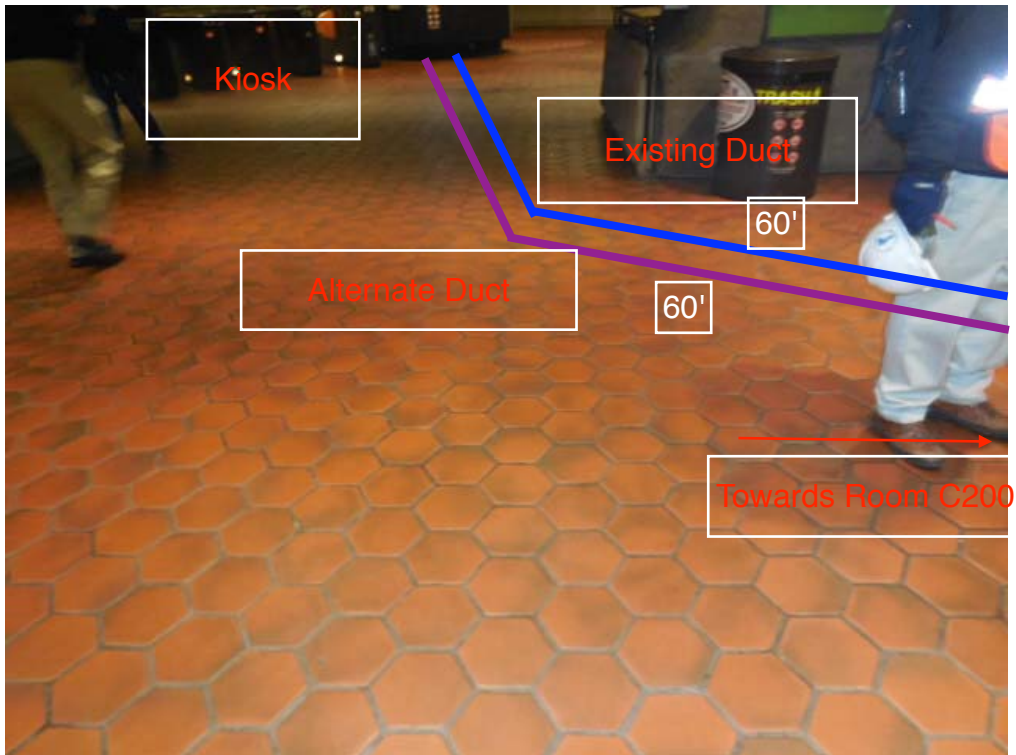
NEPP-01: Scoping of Existing Power Duct - Kiosk to AFC Panel (02/02/15)		
Task	Yes/No	Notes
Kiosk to Handhole in Room C200 (Distance : 60')		
Was video scoping completed for the entire duct / conduit run?	No	Refer to "WMATA Clarendon 6 inch Power HH1 to Kiosk (2).avi".
Was pull string installed?	No	
Were there any obstructions or blockages? Provide details of type and specific location.	Yes	Collapsed at the 45 degree bend, 35' away from kiosk.
Is the duct / conduit at capacity? Provide additional details about the dimensions of duct / conduit and number of wires.	N/A	6" walker duct.
Handhole to AFC Panel in Room C203 (Distance: 65')		
Was video scoping completed for the entire duct / conduit run?	No	Refer to "WMATA Clarendon 6 inch Power HH1 to AFC Panel (2).avi".
Was pull string installed?	No	
Were there any obstructions or blockages? Provide details of type and specific location.	Yes	Duct collapsed at 35' from Handhole.

Photo 1 – Existing and alternate duct runs on mezzanine floor.

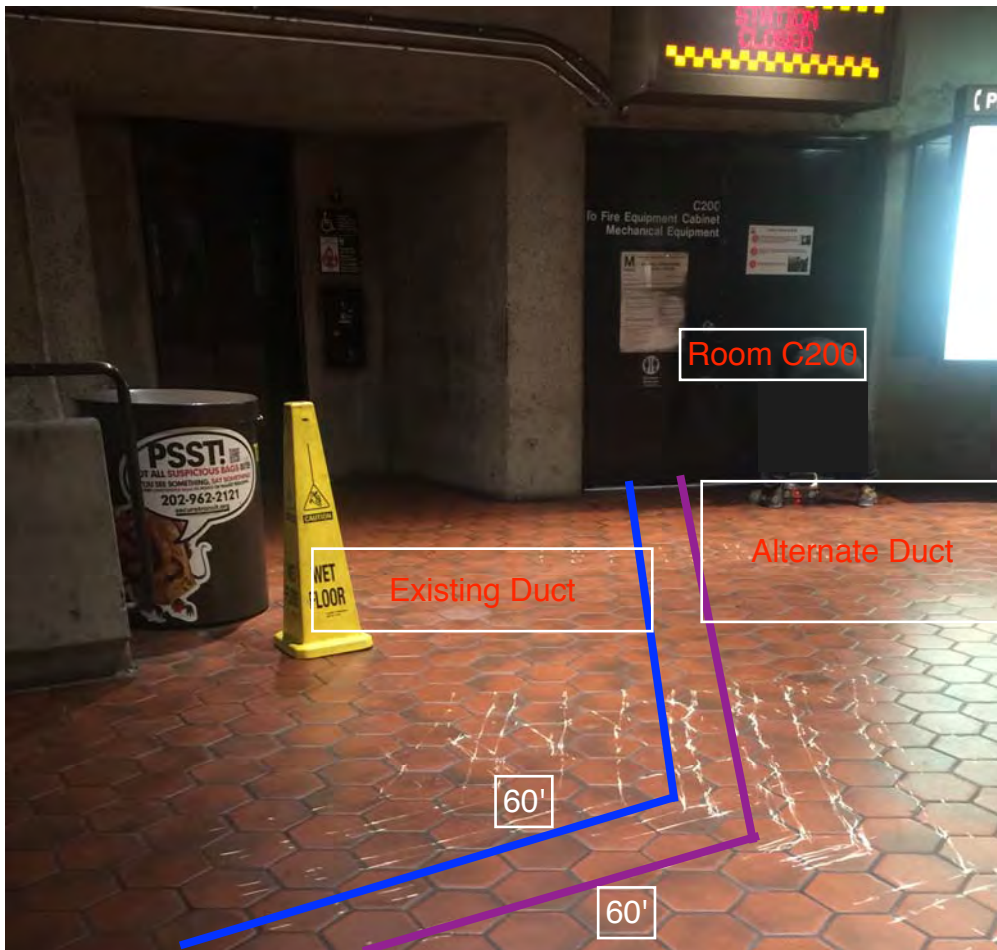
Photo 2 – Existing and alternate duct runs on mezzanine floor.

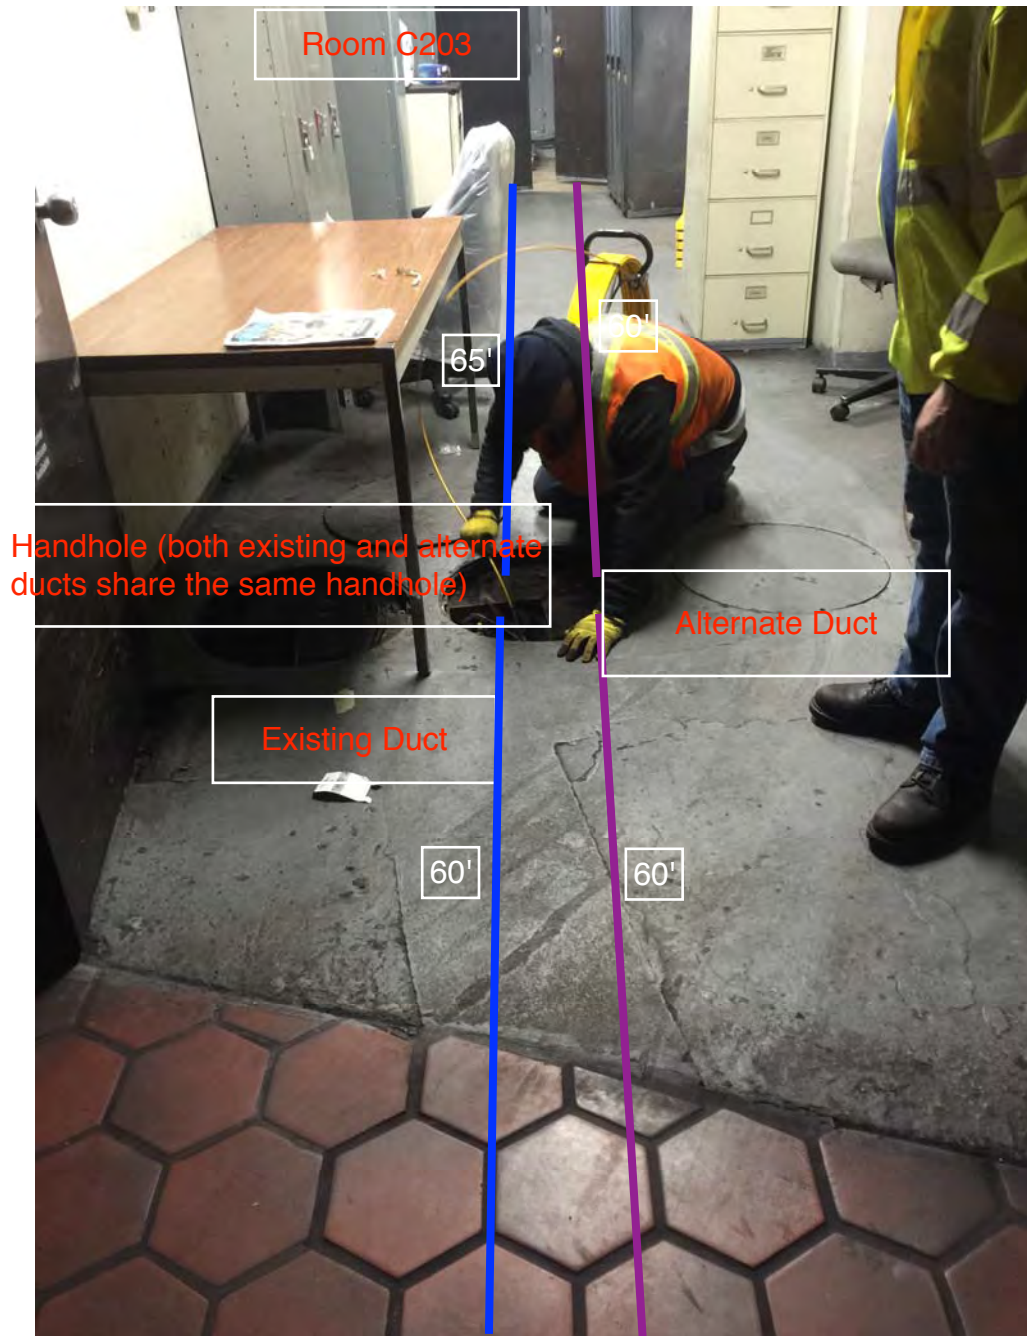
Photo 3 – Existing duct and handhole on in Room C200.

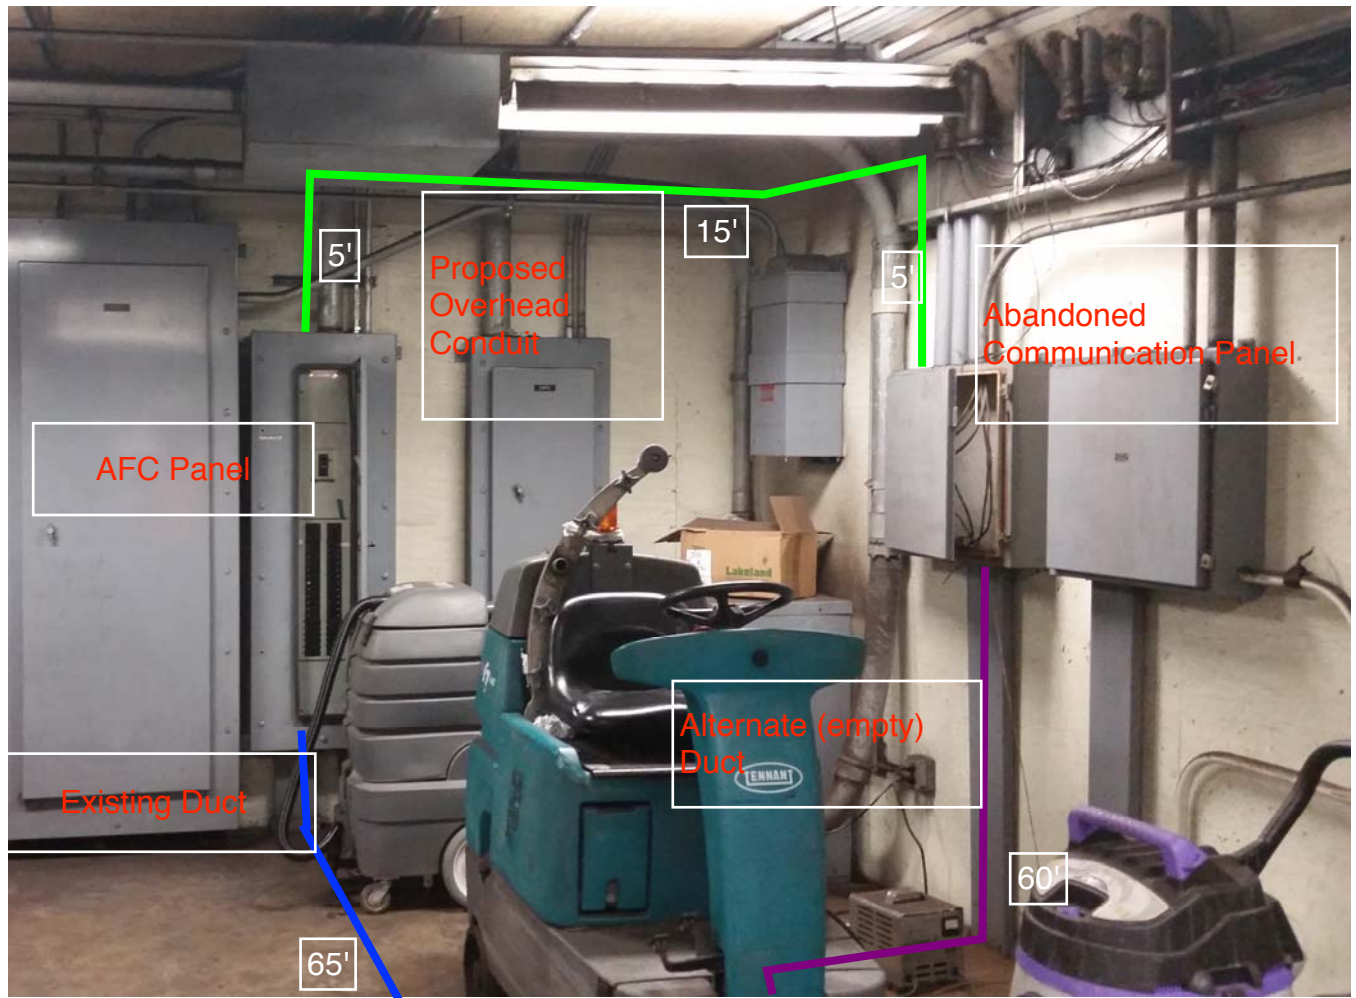
Photo 4 – Existing and alternate duct runs, and proposed overhead conduit from Abandoned Communication Panel to AFC Panel (Room C203)

Observations / Issues / Next Steps		
<ul style="list-style-type: none"> - The distance of proposed power route from Kiosk to AFC Panel is 145', including 120' of empty alternate duct between Kiosk and Abandoned Comm. Panel (Room C203) and 25' of proposed overhead conduit from Abandoned Comm. Panel to AFC Panel in Room C203. - The three panel 'punch outs' in Abandoned Comm. Panel to be sealed off to ensure separation of power and comm. wires. - Refer to attached photos and drawings for further information. 		
Sign Off		
	GFP Representative	WMATA PRGM
Name:	Mike Butler	
Signature:

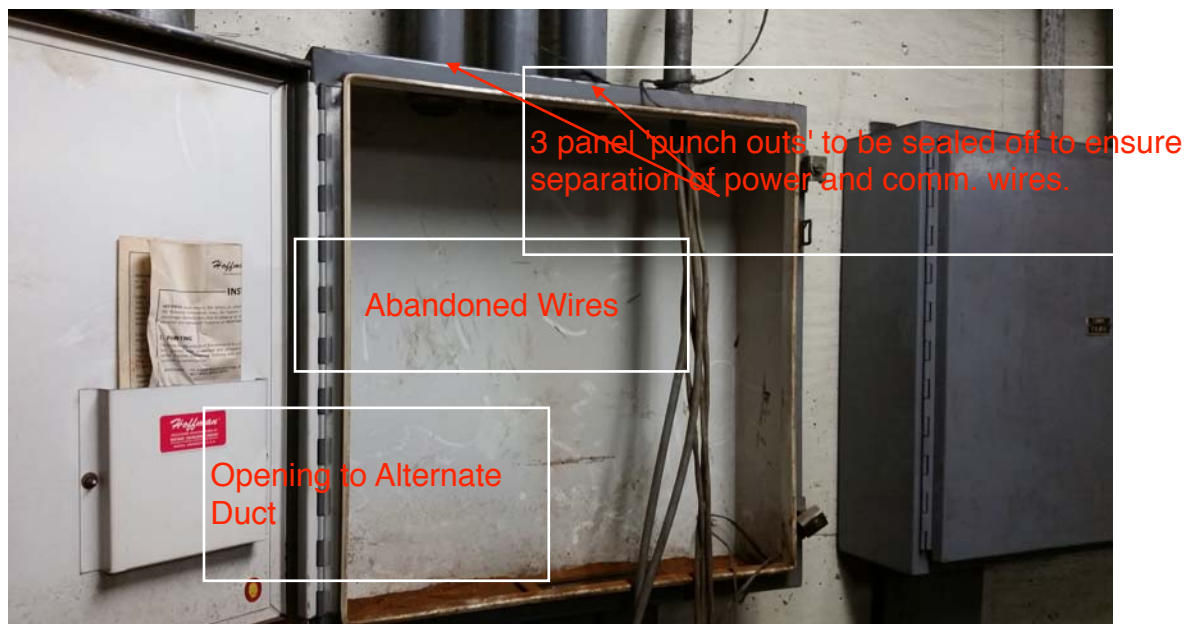
Photo 5 – Close-up of Abandoned Communication Panel (Room C203)

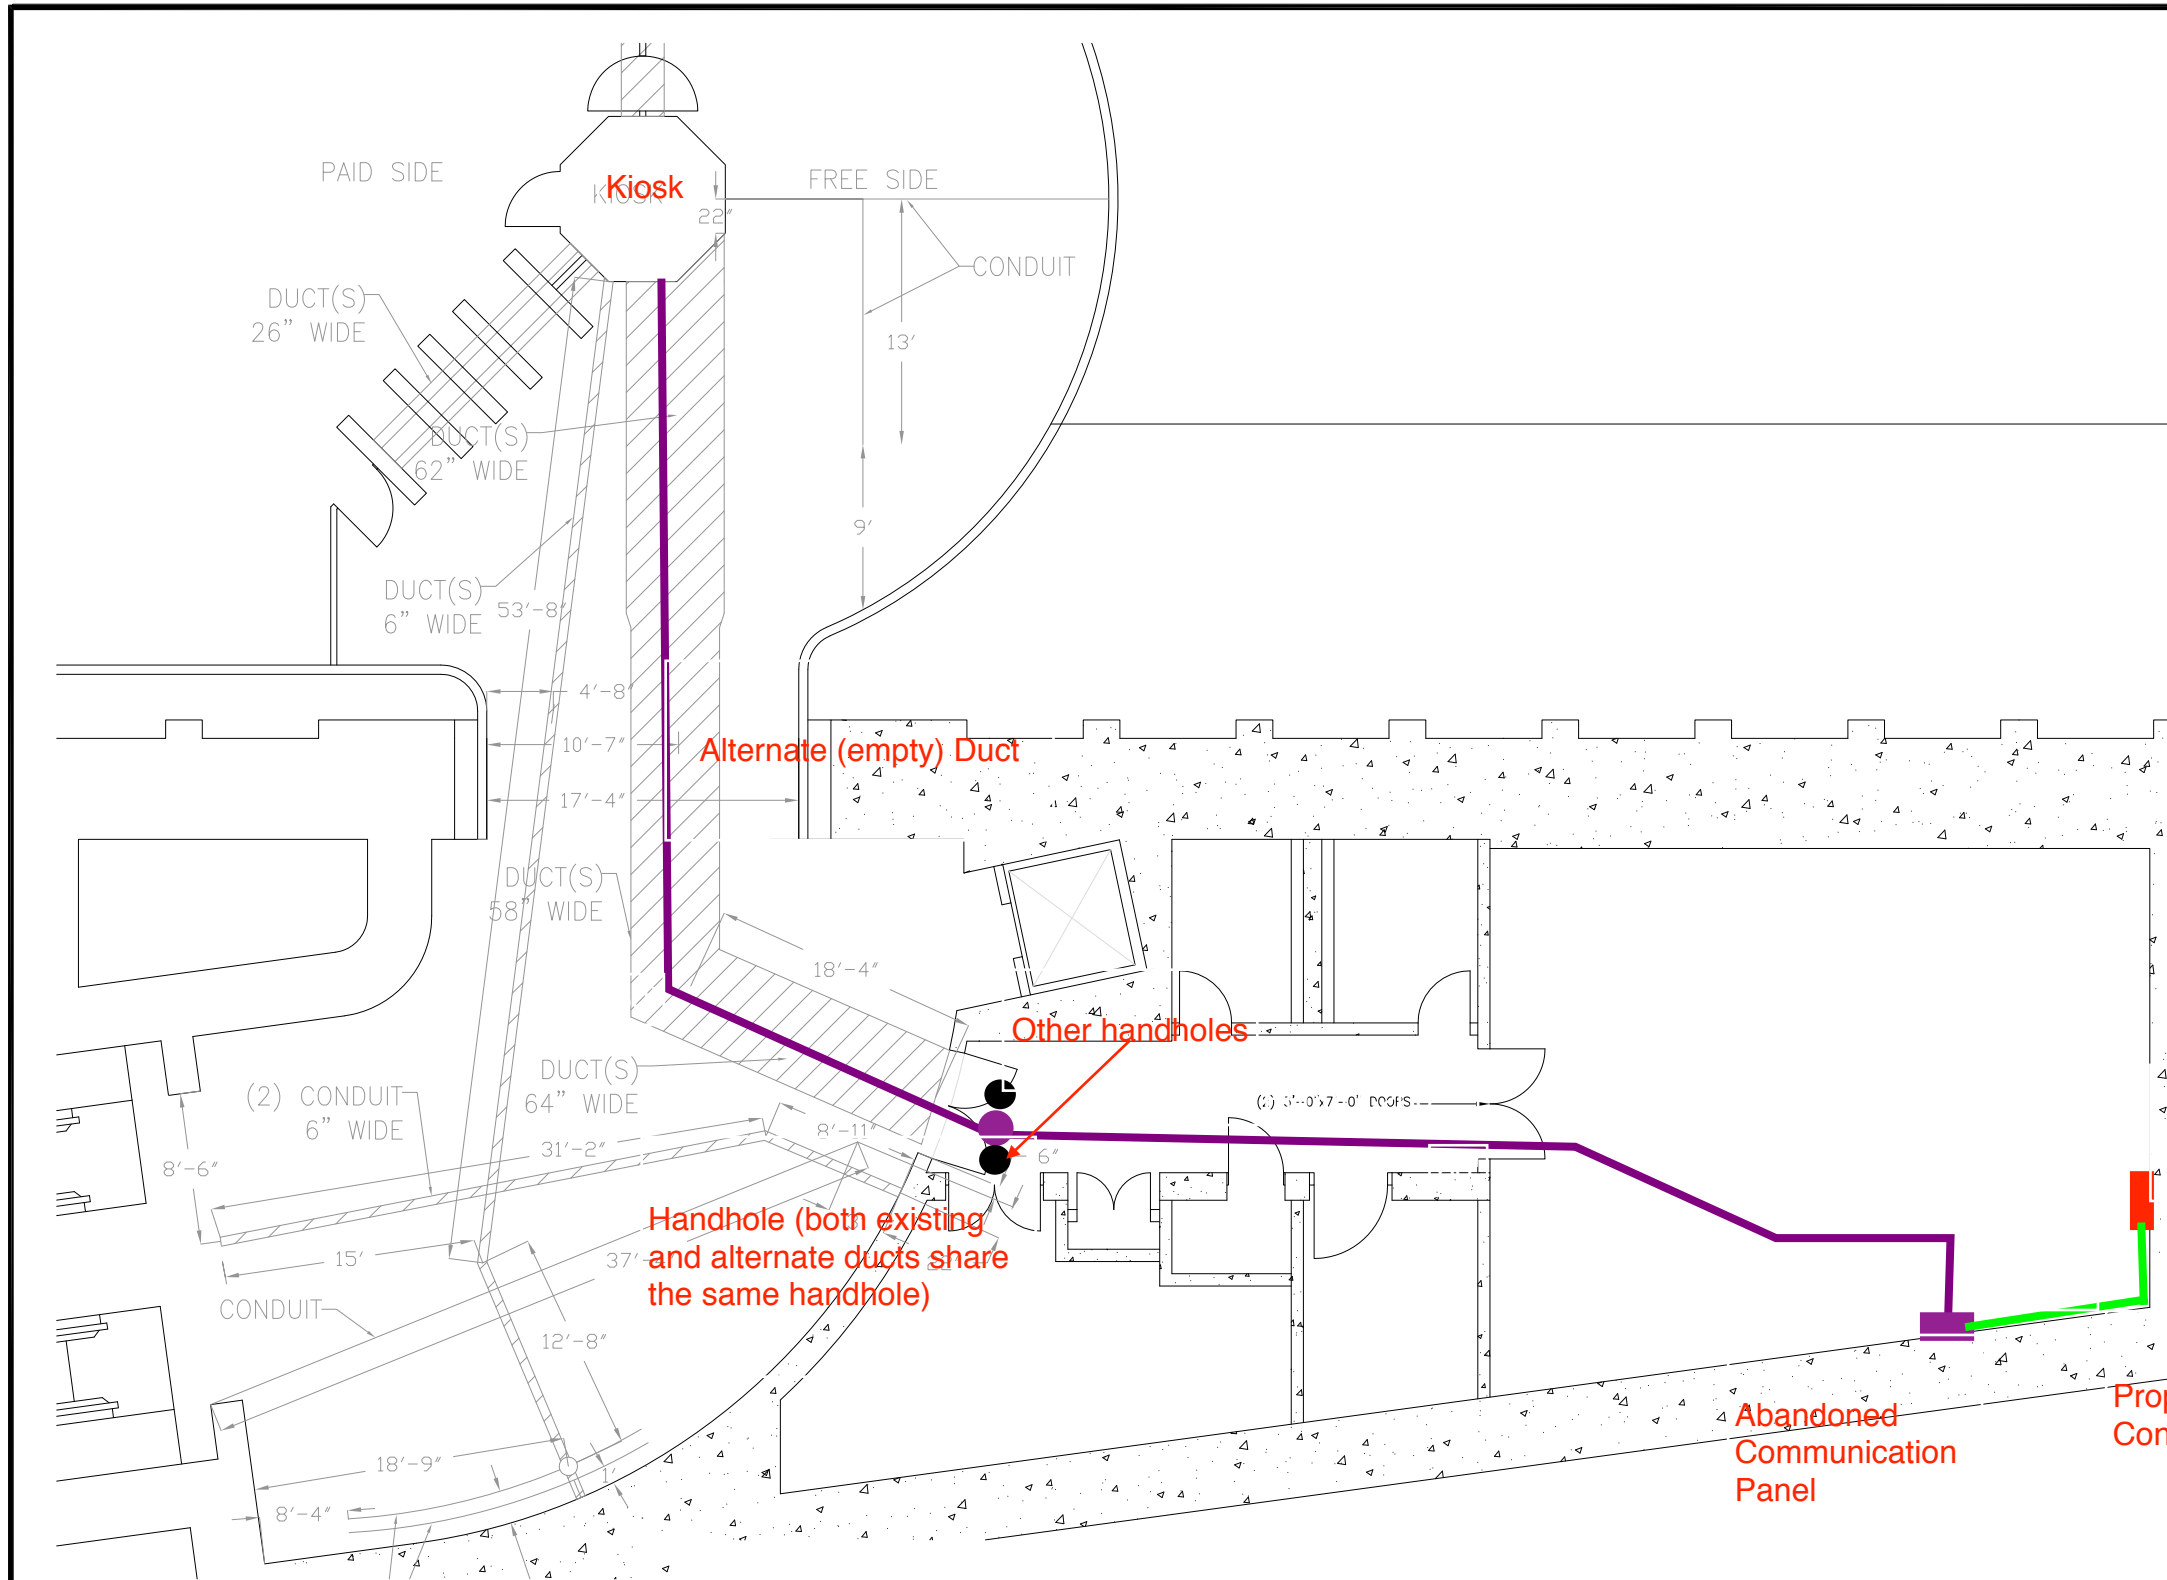
15-NEPP-01
IN - FLOOR DUCT INSPECTIONS
K02 Clarendon
PROPOSED POWER ROUTE
DRAWING NO.
K02-E-100

Scanning was conducted to identify a new power route from the Kiosk to AFC Panel. The scanning results showed that there is space for a proposed duct run; however alternate parallel ducts between the Kiosk and AFC Panel were also identified during scanning.
