Mezzanine Inspection Report (Scoping)

Date: 01/30/2015	Station Name: K03 Virginia Square	Mezzanine #: 098	Completed By: Mike Butler
------------------	-----------------------------------	------------------	---------------------------

Date: 01/30/2015	Station Name: K05 East Falls Church	Mezzanine #: 100	Completed By: Chris Loose
-------------------------	--	-------------------------	----------------------------------

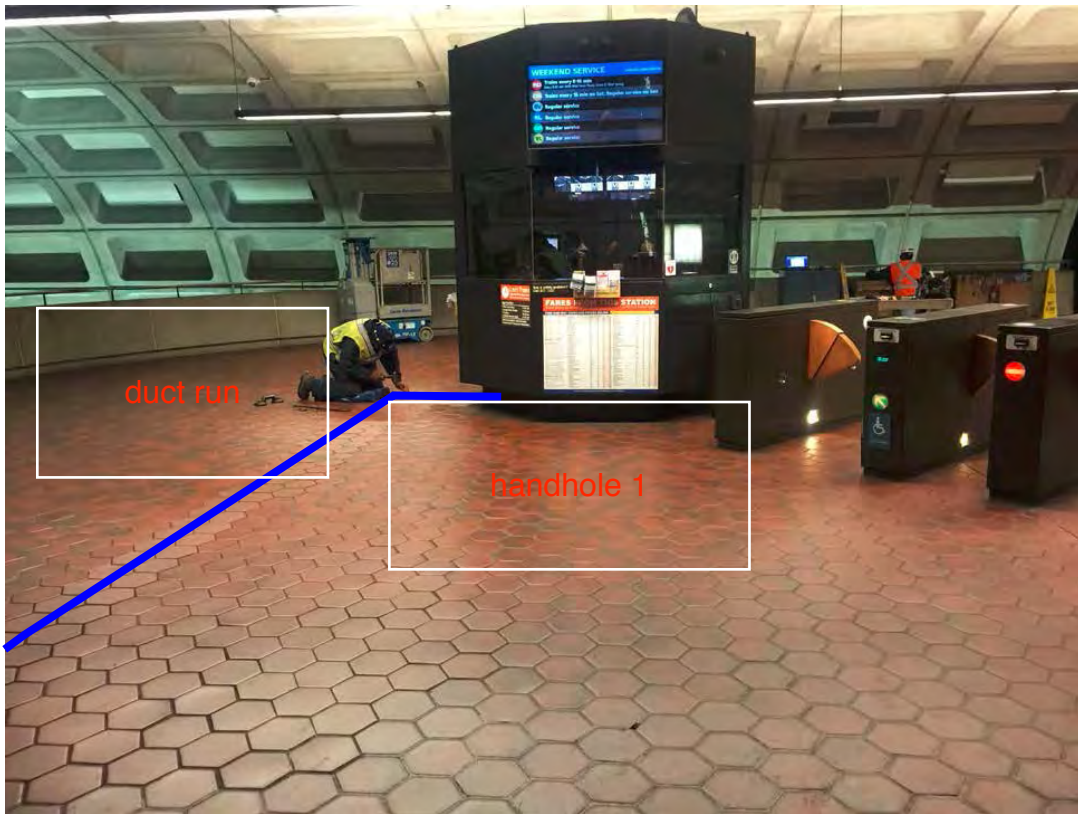
Scoping of Power Duct - Kiosk to AFC Panel		
Task	Yes/No	Notes
Kiosk to Handhole 1 (5' run)		
Was video scoping completed for the entire duct / conduit run?	Yes	Refer to "WMATA Virginia Square 6inch Power Kiosk to HH1 (2).avi"
Was pull string installed?	Yes	
Were there any obstructions or blockages? Provide details of type and specific location.	No	
Is the duct / conduit at capacity? Provide additional details about the dimensions of duct / conduit and number of wires.	No	Two ducts were identified, one holding CAT 6 and the 6" duct holds the power wires with less than 10 wires
Handhole 1 to Handhole 2 (70' run)		
Was video scoping completed for the entire duct / conduit run?	Yes	Refer to "WMATA Virginia Square 6inch Power HH1 to HH2 (1).avi"
Was pull string installed?	Yes	
Were there any obstructions or blockages? Provide details of type and specific location.	No	
Is the duct / conduit at capacity? Provide additional details about the dimensions of duct / conduit and number of wires.	No	6" duct less than 10 wires

Photo #1 – K03 Virginia Square: Duct run from kiosk to handhole 1

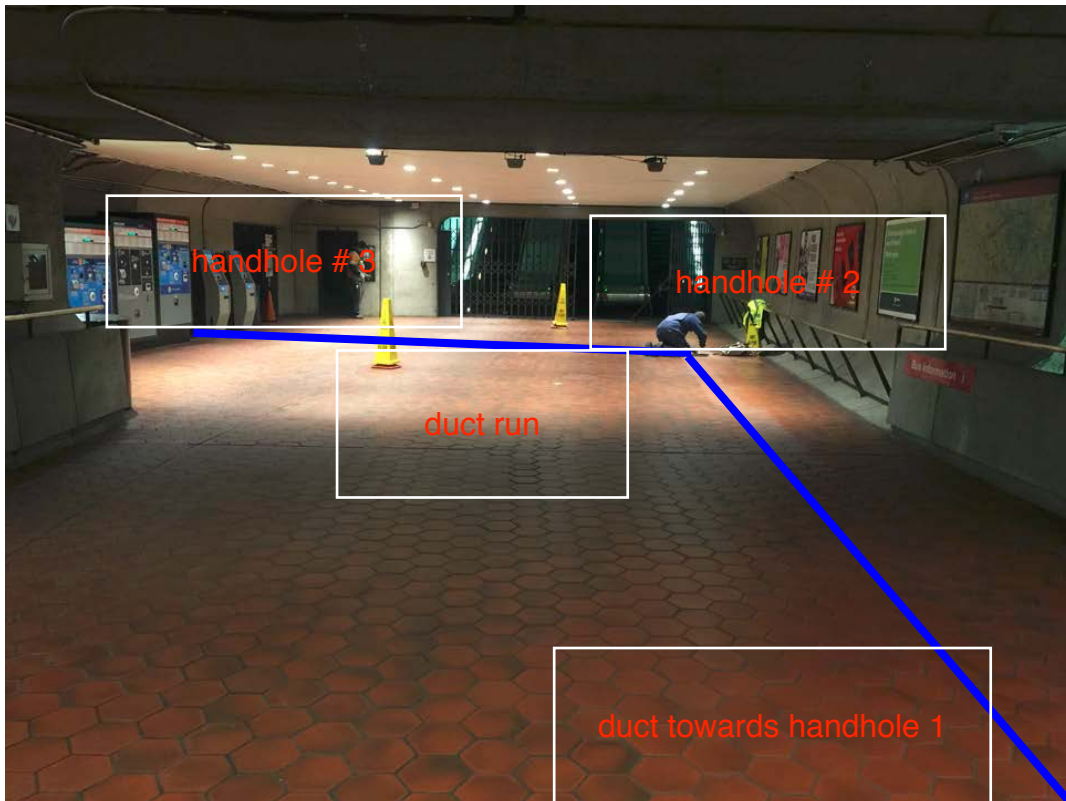
Handhole 2 to Handhole 3 (35' run)		
Was video scoping completed for the entire duct / conduit run?	Yes	Refer to "WMATA Virginia Square 6inch Power HH2 to HH3 (1).avi"
Was pull string installed?	Yes	
Were there any obstructions or blockages? Provide details of type and specific location.	No	Some congestion due to spray foam inside the duct, but the duct is in good condition
Is the duct / conduit at capacity? Provide additional details about the dimensions of duct / conduit and number of wires.	No	6" duct less than 10 wires
Handhole 3 to AFC Panel (5' run)		
Was video scoping completed for the entire duct / conduit run?	No	90 degree bend precluded scoping.
Was pull string installed?	Yes	
Were there any obstructions or blockages? Provide details of type and specific location.	No	
Is the duct / conduit at capacity? Provide additional details about the dimensions of duct / conduit and number of wires.	No	6" duct less than 10 wires

Photo #2 – K03 Virginia Square: Duct run from kiosk to handhole 2 and handhole 3

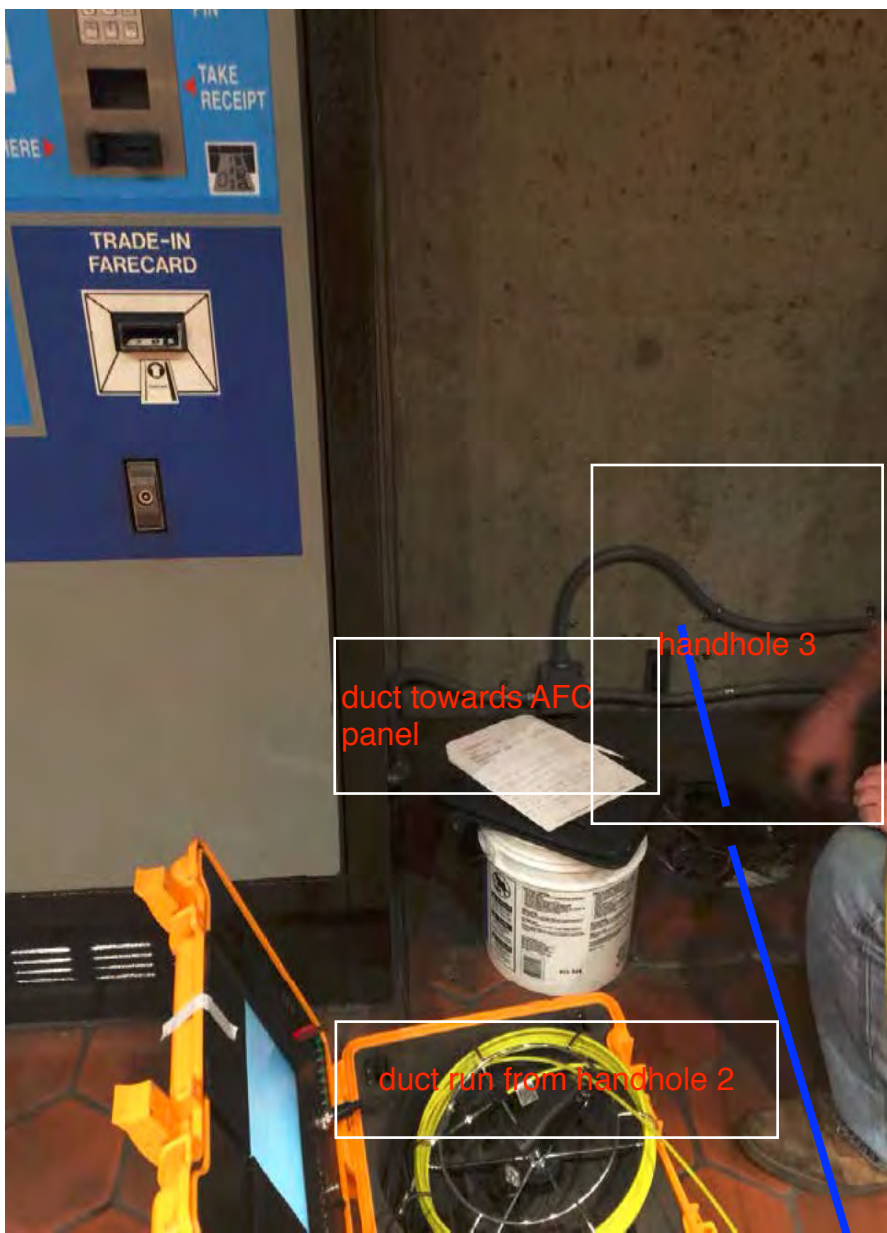
Photo #3 – K03 Virginia Square: Handhole 3 to AFC panel

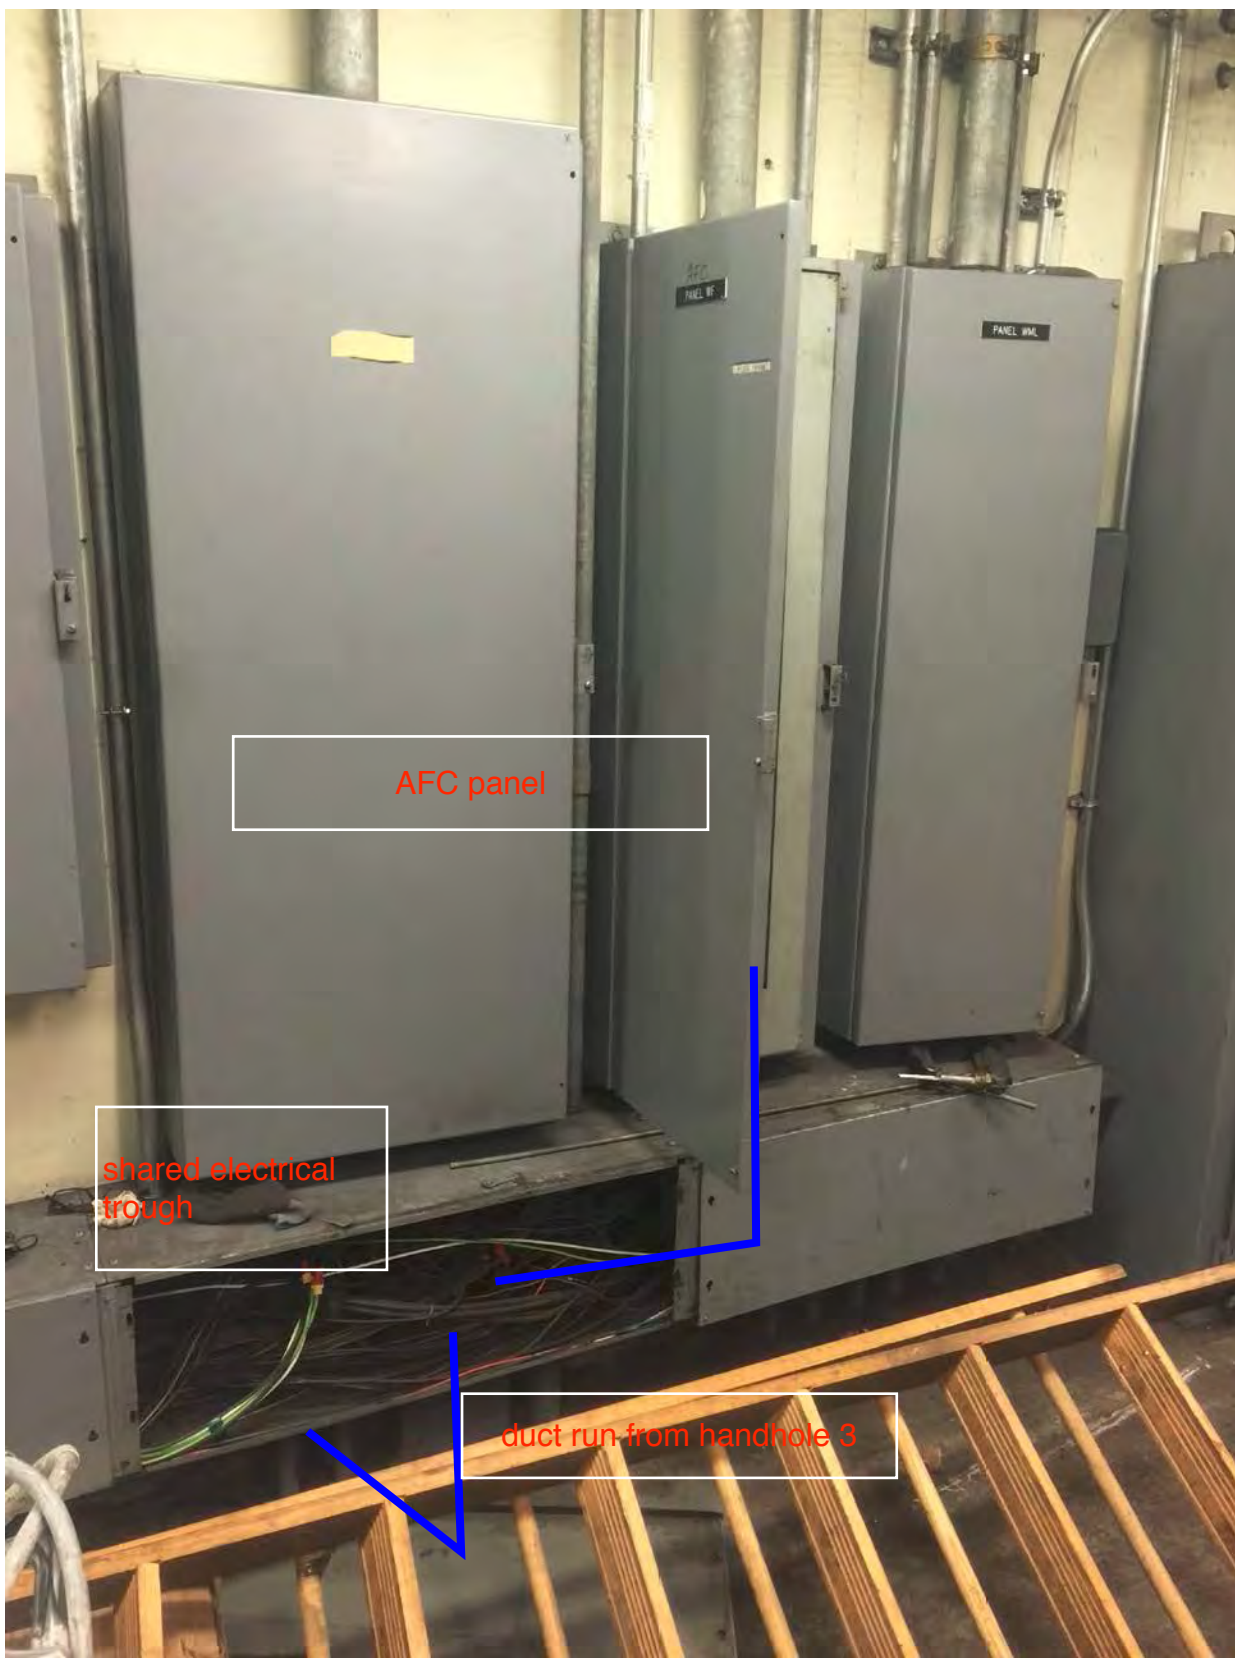
Observations / Issues / Next Steps		
Total power duct run from the kiosk to AFC panel is approximately 115'.		
Sign Off		
	GFP Representative	WMATA PRGM
Name:	Mike Butler	
Signature:

Photo #4 – K03 Virginia Square: Duct into AFC panel from handhole 3

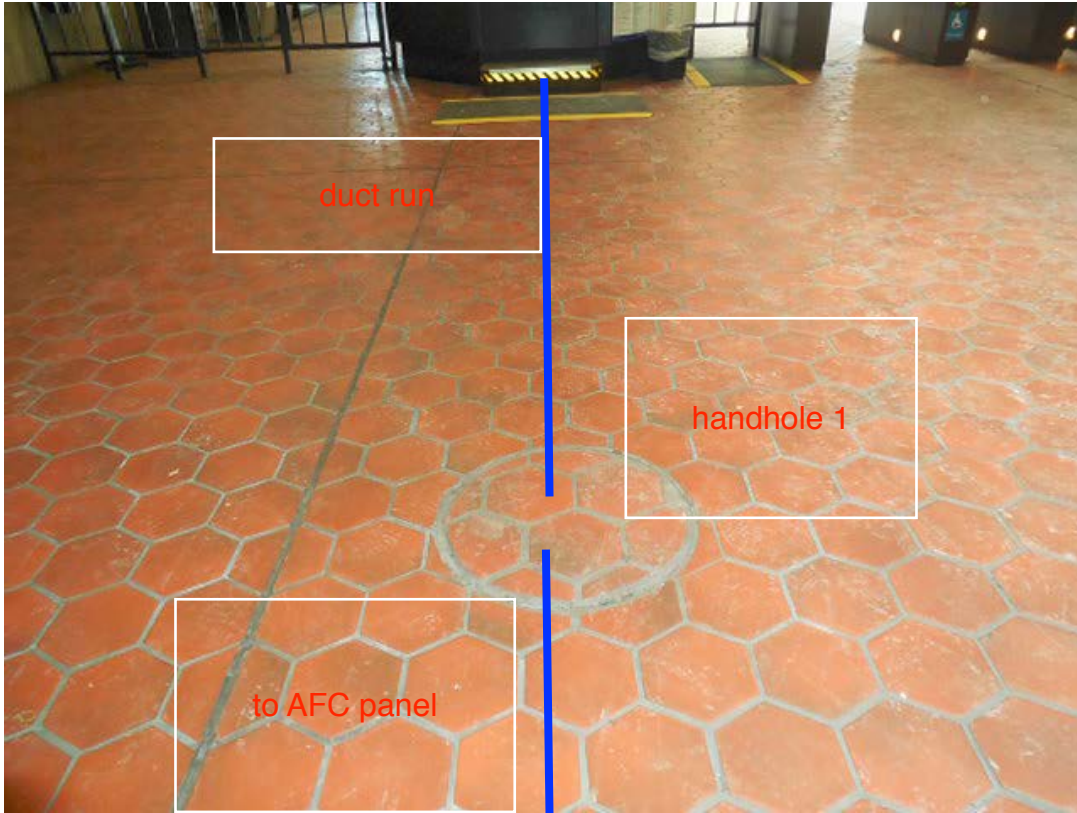
Scoping of Power Duct - Kiosk to AFC Panel		
Task	Yes/No	Notes
Kiosk to Handhole 1 (20' run)		
Was video scoping completed for the entire duct / conduit run?	Yes	Refer to WMATA East Falls Church 6inch Power Kiosk to HH1, HH1 to AFC.avi file.
Was pull string installed?	Yes	
Were there any obstructions or blockages? Provide details of type and specific location.	No	
Is the duct / conduit at capacity? Provide additional details about the dimensions of duct / conduit and number of wires.	No	6" duct less than 15 wires
Handhole 1 to AFC Panel (100' run)		
Was video scoping completed for the entire duct / conduit run?	Yes	Refer to WMATA East Falls Church 6inch Power Kiosk to HH1, HH1 to AFC.avi file.
Was pull string installed?	Yes	
Were there any obstructions or blockages? Provide details of type and specific location.	No	
Is the duct / conduit at capacity? Provide additional details about the dimensions of duct / conduit and number of wires.	No	6" duct less than 15 wires

Photo #1 – K05 East Falls Church: Duct run from kiosk to handhole 1 and from handhole 1 towards AFC panel

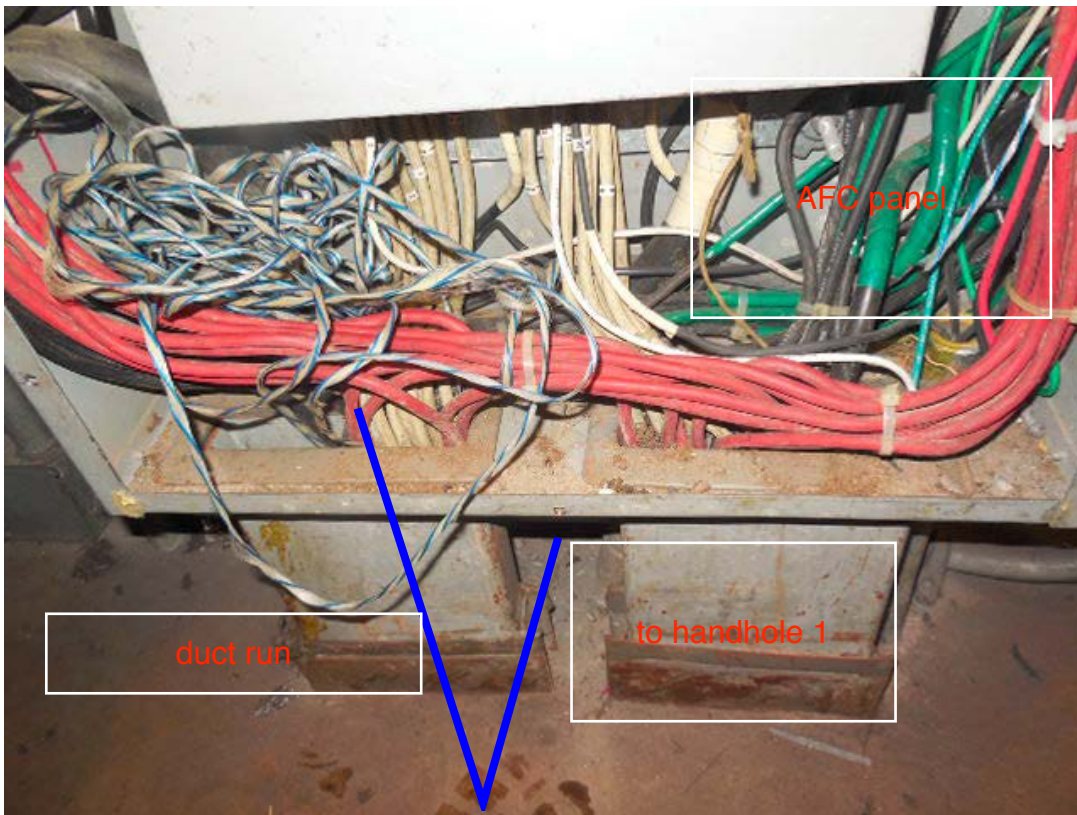
Observations / Issues / Next Steps		
Total power duct run from kiosk to AFC panel is approximately 120'.		
Sign Off		
	GFP Representative	WMATA PRGM
Name:	Zach Fitzwater	
Signature:

Photo #2 – K05 East Falls Church: Duct run into AFC panel from kiosk.
