| | Mezzanine Ins | pection Rep | ort |
| <b>Date:</b> 01/14/15 | Station Name: K06 - West Falls Church | Mezzanine #: 101 | Completed By: Mike Butler |

## Mezzanine Inspection Report (Scoping)

Date: 02/25/2015 Station Name: K07 Dunn Loring Mezzanine #: 102 Completed By: Zach Fitzwater

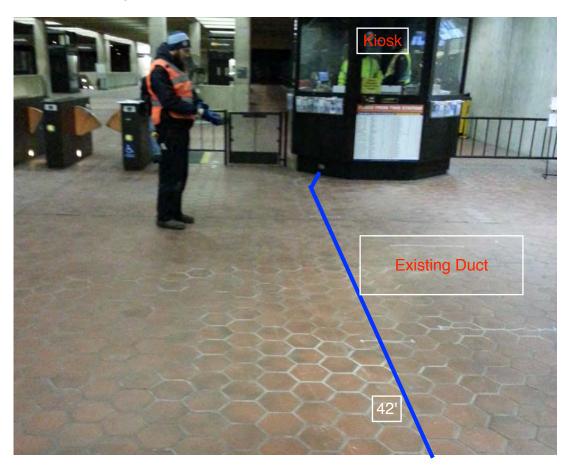
Photo 1 – Existing duct on mezzanine floor

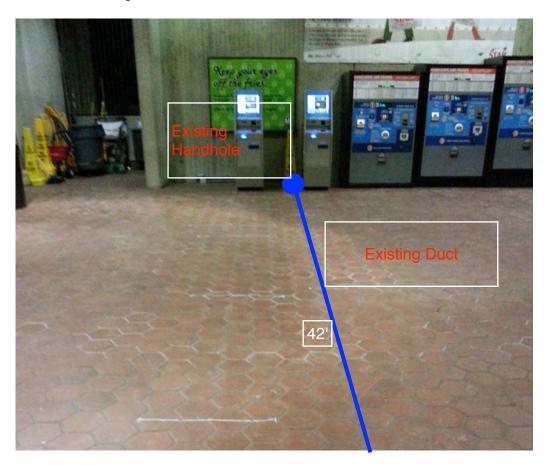
Photo 2 – Existing duct on mezzanine floor

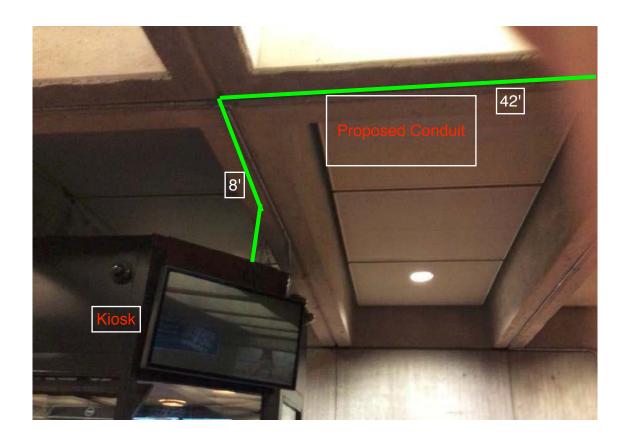
Photo 3 – Proposed overhead conduit

Scanning was conducted to establish a proposed power route between the Kiosk and AFC Panel. The scanning results showed that the mezzanine floor is congested with ducts and there is no clear path for a proposed in-floor duct from the Kiosk to the AFC Panel. An overhead conduit is proposed from the Kiosk to AFC Panel, which will run up vertically from the Kiosk and run across the mezzanine ceiling until it reaches the outer wall between the mezzanine and Room 210. The wall will be core drilled to allow the conduit to pass through. The conduit will run across the ceiling plenum of Room 210 and pass through the next wall between Room 210 and Room 212 (by core drilling). Once inside Room 212, the conduit will snake around the internal wall until it reaches the AFC Panel.

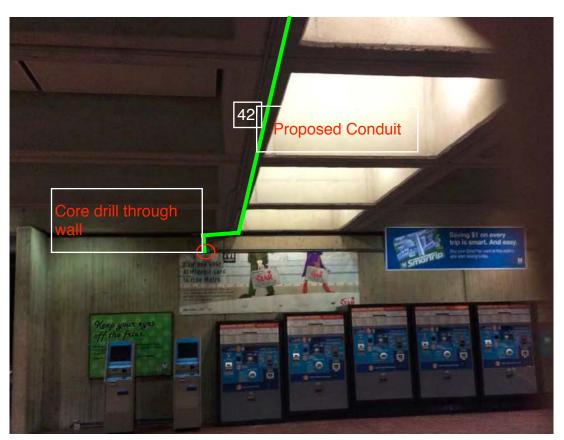
Photo 4 – Proposed overhead conduit

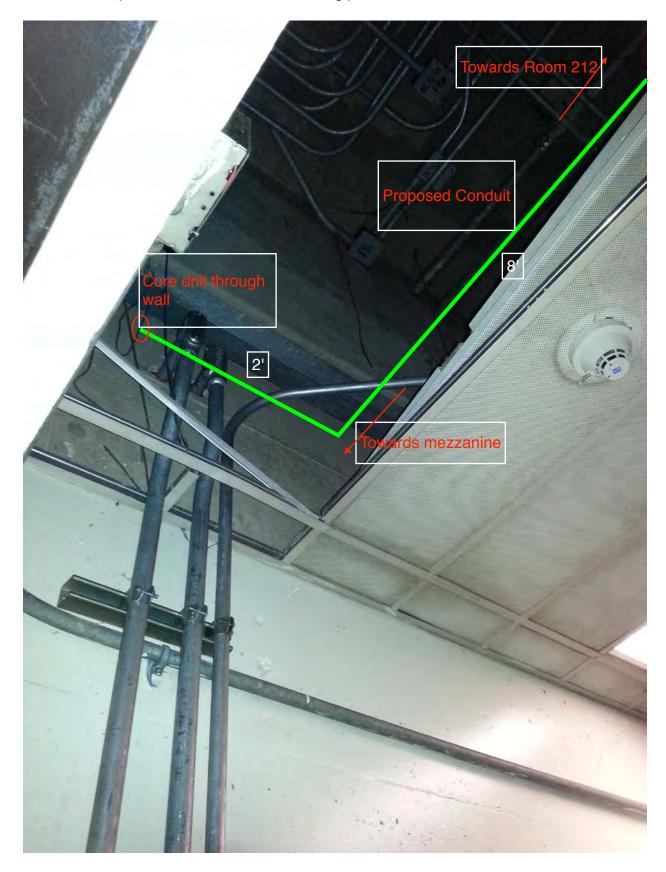
Photo 5 – Proposed conduit in Room 210 ceiling plenum

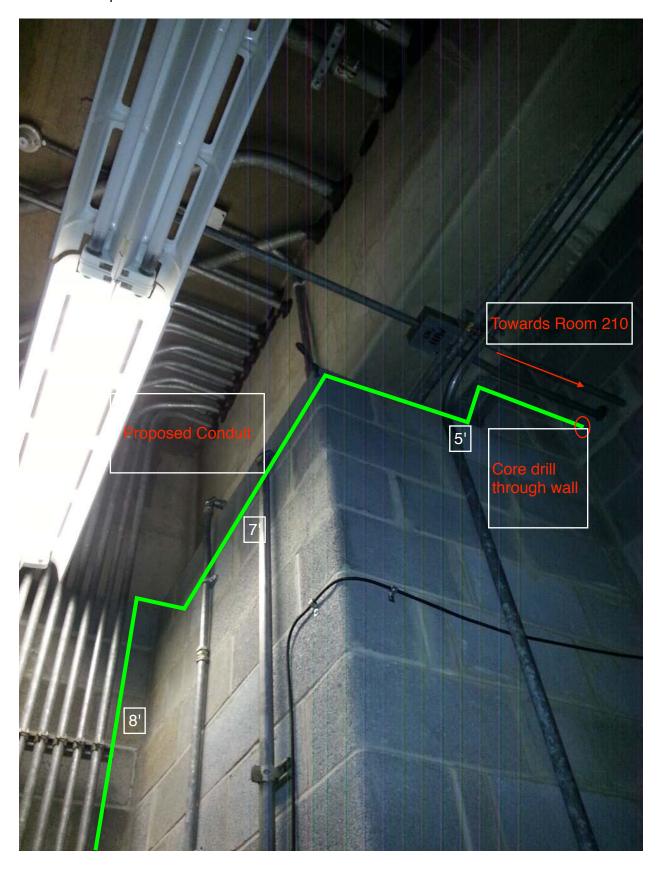
Photo 6 – Proposed conduit in Room 212.

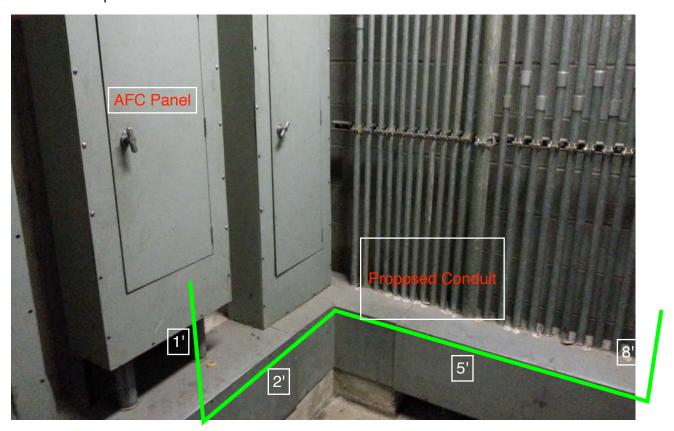
Photo 7 – Proposed conduit in Room 212.

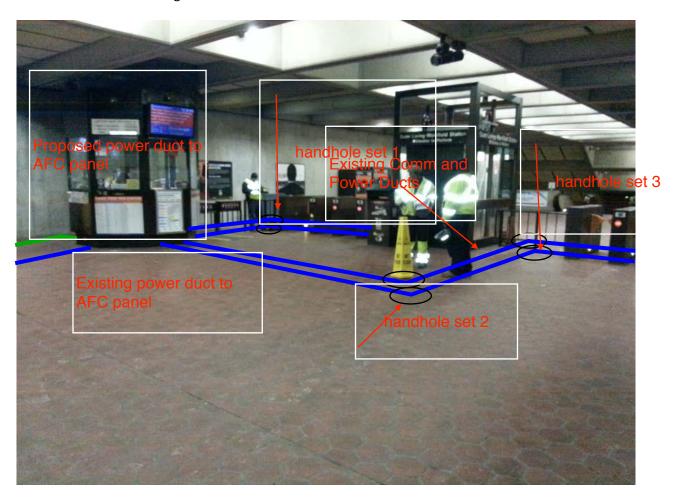
Photo #1 – K07 Dunn Loring: Ducts on Mezzanine floor

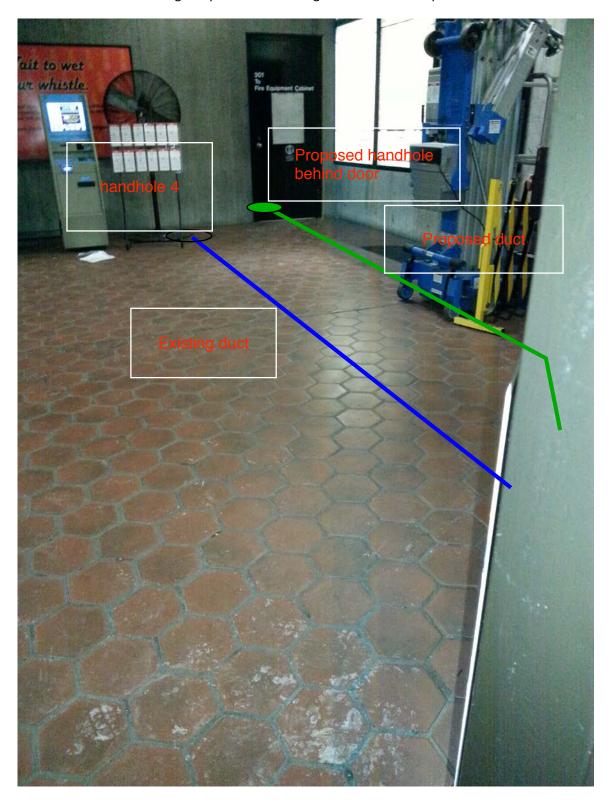
Photo #2 – K07 Dunn Loring: Proposed and Existing runs towards AFC panel

Scanning was completed at this station. A proposed duct run will run parallel to the existing ducts on the outside edge near the far wall towards the back rooms. The duct will run from the kiosk to just inside the door to Room #301 to a proposed handhole. The proposed power run will transition to conduit at the proposed handhole and enter the AFC panel near the bottom on the side of the panel.

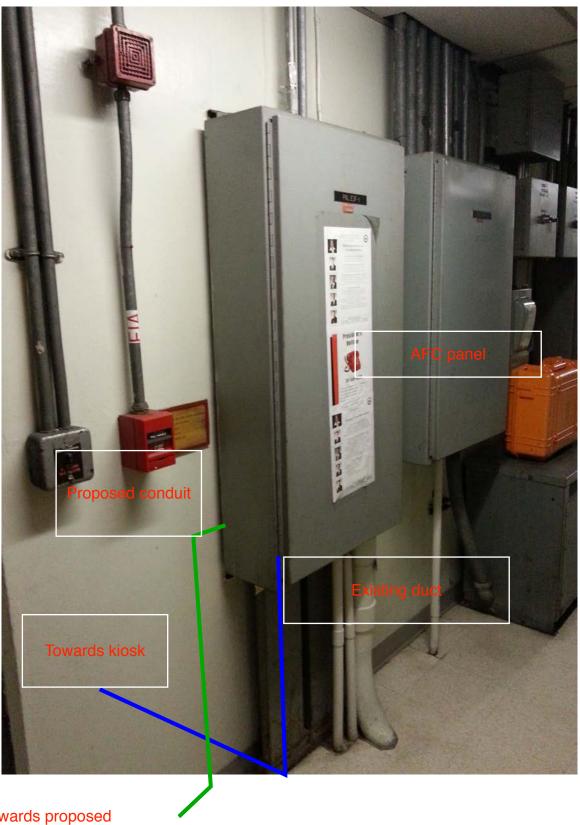
Photo #3 – K07 Dunn Loring: Proposed and Existing runs at AFC panel
