Mezzanine Inspection Report					
<b>Date:</b> 03/16/15	Station Name: K08 - Vienna	Mezzanine #: 103	Completed By: Mike Butler		
Summary

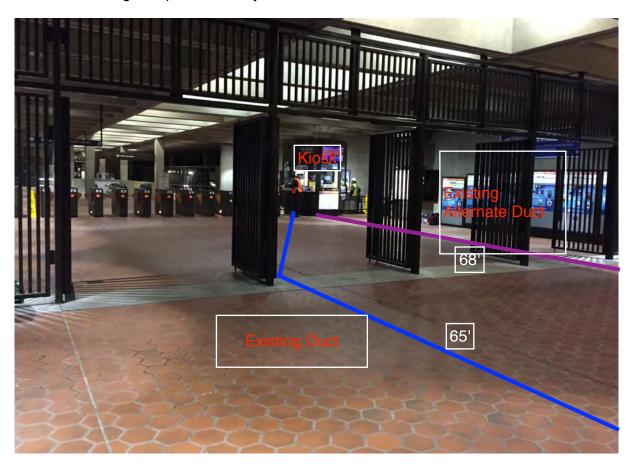
Photo 1 – Existing / Proposed duct layout on mezzanine floor

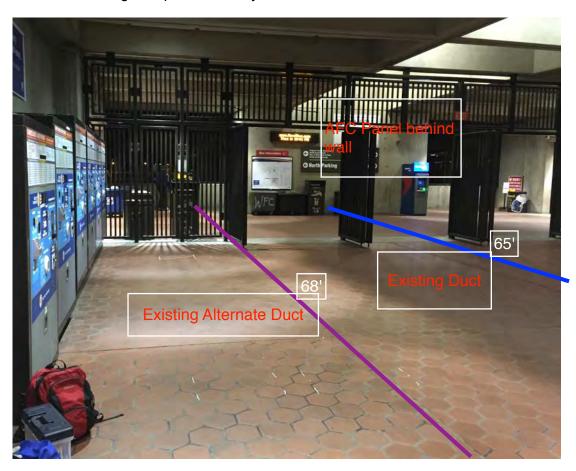
Photo 2 – Existing / Proposed duct layout on mezzanine floor

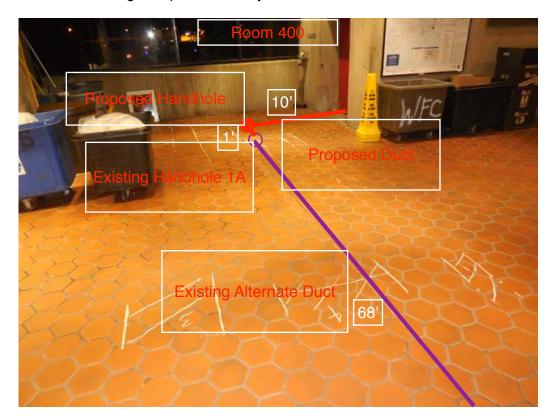
Photo 3 – Existing / Proposed duct layout on mezzanine floor

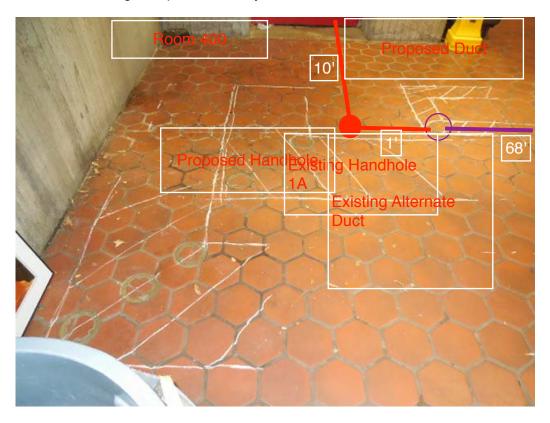
Photo 4 – Existing / Proposed duct layout on mezzanine floor

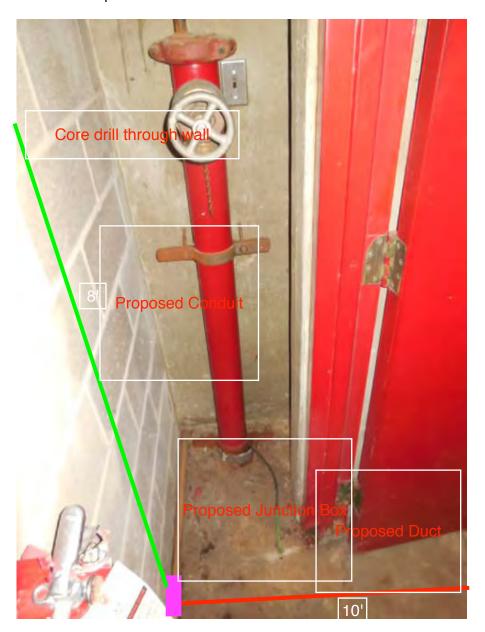
Photo 5 – Proposed Duct / Conduit transition in Room 400

After scanning of the mezzanine floor, an alternate duct was found between the Kiosk and "Handhole 1A", which is located on the mezzanine floor close to Room 400. Video scoping and pull string installation was successfully completed in the alternate duct between the Kiosk and Handhole 1A. Since there is no duct that goes from Handhole 1A to AFC Panel, it is proposed to install a new in-floor duct from Handhole 1A to Room 400. A new handhole is proposed where the duct turns 90-degrees. Once inside Room 400, the duct will transition to an overhead conduit via a proposed junction box at the base of the wall. The proposed conduit will rise up and core drill through the wall into Room 406 and then feed into the AFC Panel.
