ELECTRICAL AND DATA CABLE INSTALLATION

Washington Metropolitan Area Transit Authority

Contract Number FQ17021

Mezzanine Inspection Reports Part 1b Green and Yellow Lines

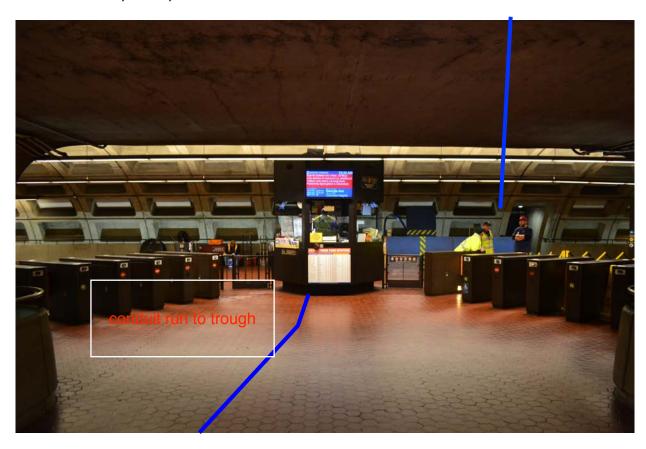
Photo #1 – C09 Crystal City: Power run from kiosk

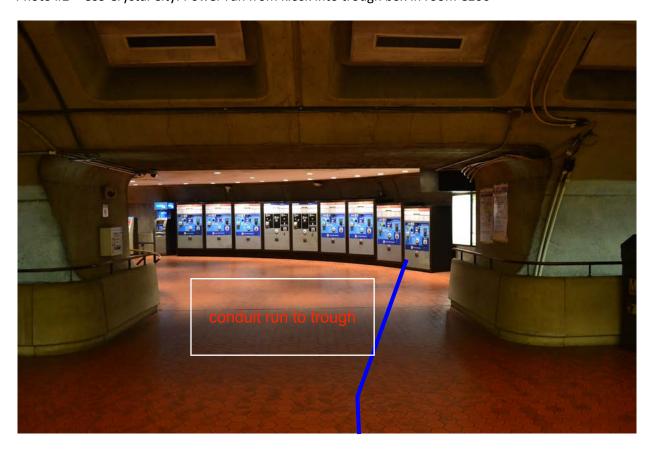
Photo #2 – C09 Crystal City: Power run from kiosk into trough box in room C206

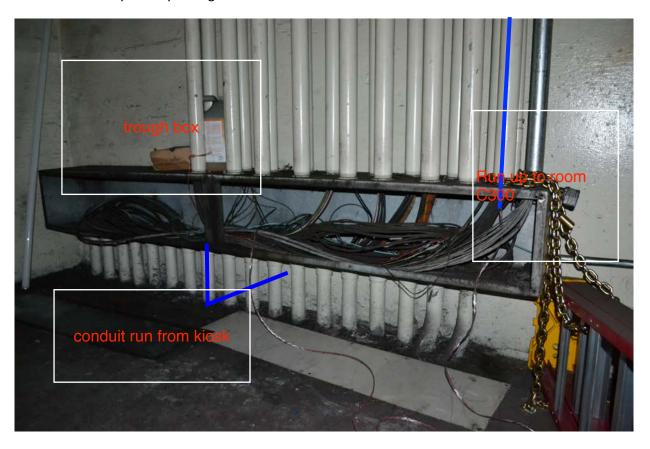
Photo #3 – C09 Crystal City: Trough box in room C206

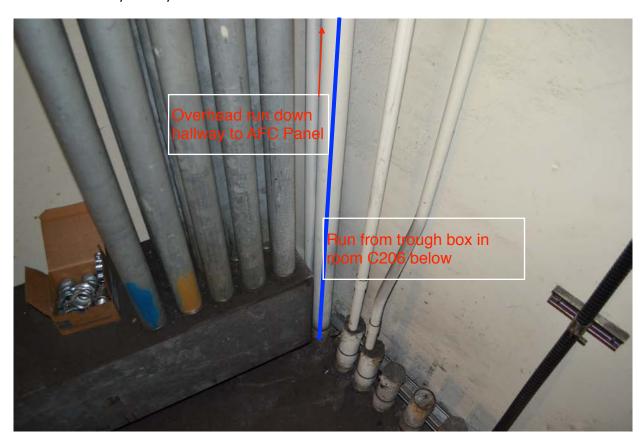
Photo #4 – C09 Crystal City: Conduit in room C300

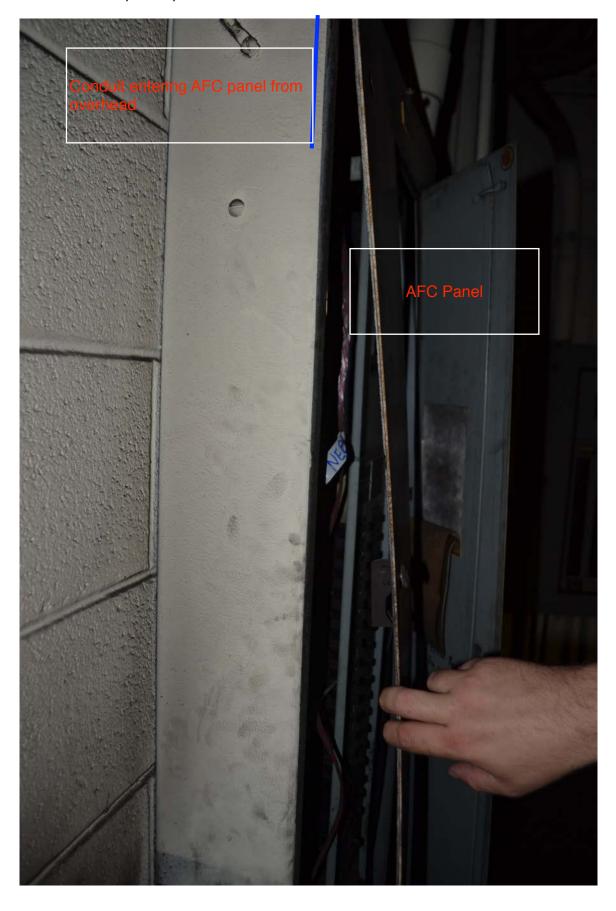
Photo #5 – C09 Crystal City: Run to AFC Panel

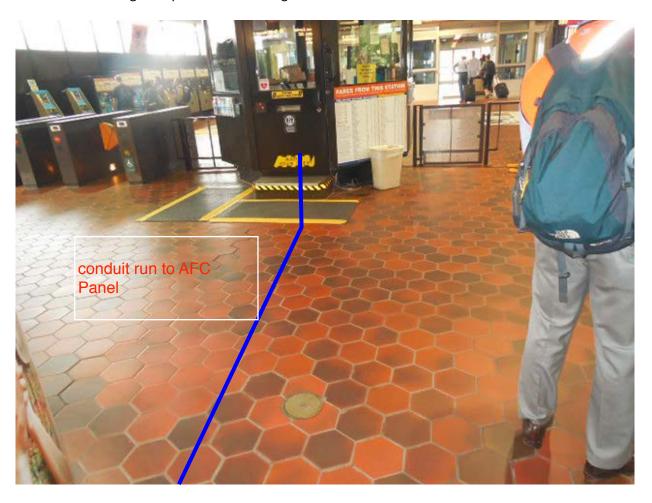
Photo #1 – C10 Reagan Airport South: Existing conduit run from Kiosk towards AFC Panel
