Mezzanin	e Inspe	ction Report (Scoping)			
Date: 11/14/2014	2014 Station Name: C10 Reagan Air		Mezzanine #: 093	Completed By: Chris Loose			
			Summary				
Scoping and pull str	ing installation was completed in a	accordance v	with the scope of work.				
	g completed for communication an not at capacity)	nd power due	cts in Upper and Lower fa	regate arrays; pull string installed in communicatior			
	g and pull string installation complete	eted from Kid	osk to handhole and from	handhole to AFC Panel (ducts			
not at capacil

Mezzanine Inspection Report (Scoping)								
	Date: 12/10/2014 Station Name: C12 – Braddock Road Mezzanine #: 047 Completed By: Chris Lo								
	Summary								
	Video scoping and pull string installation successfully completed in communications ducts in the upper and lower faregate arrays. Video scoping was not completed in the power ducts for the upper and lower faregate arrays. Video scoping was not completed in the power duct run from the kiosk to the AFC panel due to collapsed ducts. The duct was collapsed just inside the kiosk towards handhole 1 and duct was collapsed just inside handhole 1 towards the AFC panel. Scanning was completed at this mezzanine.

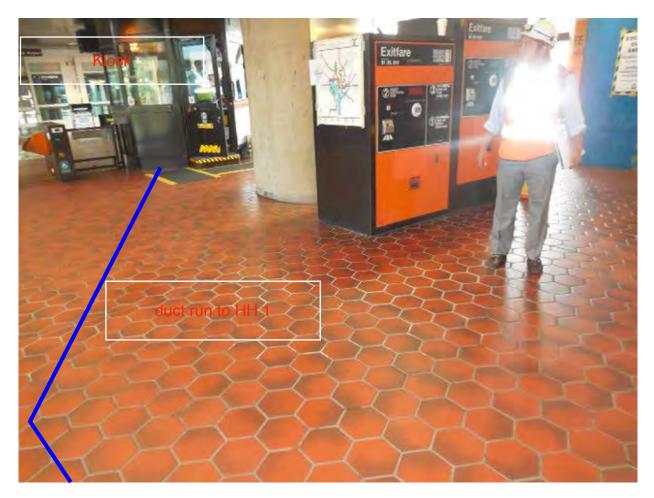
Photo #1 – C10 Reagan Airport North: Mezzanine Kiosk

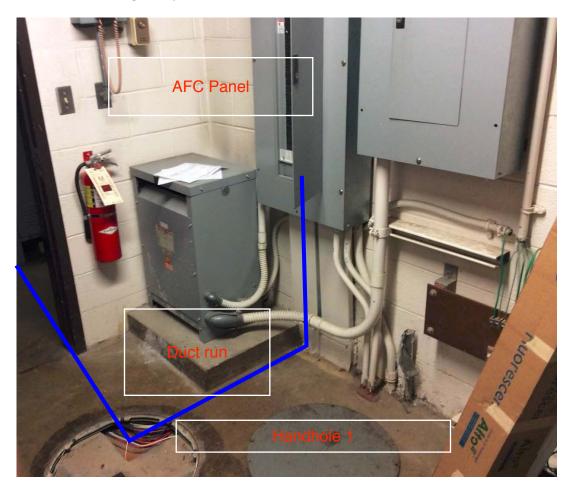
Photo #2 – C10 Reagan Airport North: Handhole 1 to AFC Panel

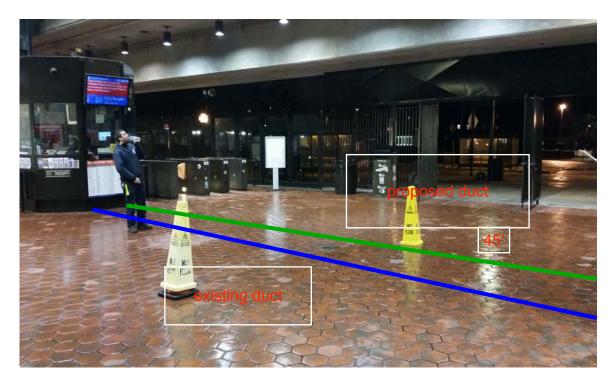
Photo #1 – C12 Braddock Road: Duct runs from kiosk towards backroom corridor.

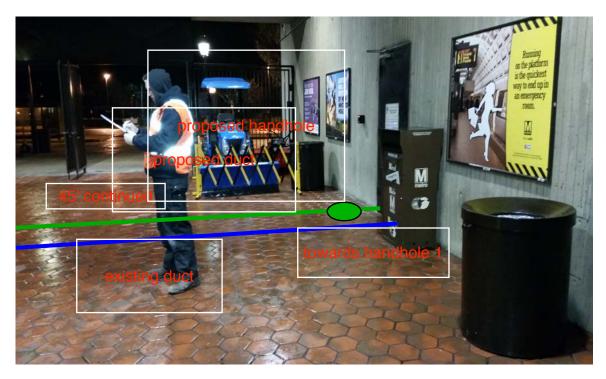
Photo #2 – C12 Braddock Road: Existing duct run towards backroom corridor and proposed duct to proposed handhole.

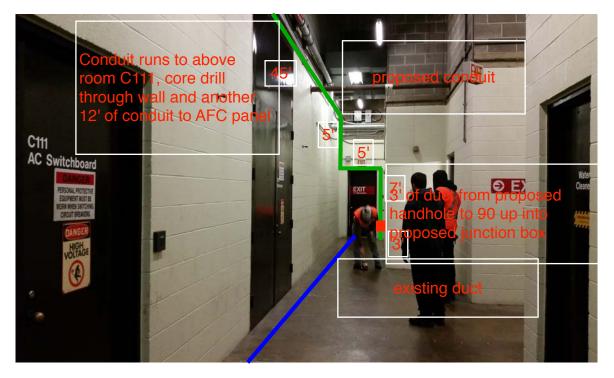
Photo #3 – C12 Braddock Road: Existing duct run from kiosk towards existing handhole 1 and proposed conduit from proposed handhole on mezzanine floor towards AFC panel.

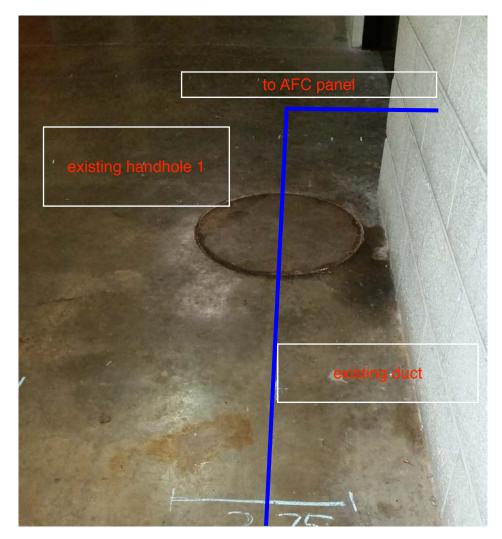
Scoping of Power Duct - Kiosk to AFC Panel							
Task	Notes						
Kiosk to Handhole 1 (95' run)							
Was video scoping completed for the entire duct / conduit run?	No	Refer to WMATA Braddock Road 6inch Left Power Feed Video.avi and WMATA Braddock Road 6inch Right Power Feed Video.avi files.					
Was pull string installed?	No						
Were there any obstructions or blockages? Provide details of type and specific location.	Yes	Duct was collapsed just inside kiosk and heavily rusted in parts that could be seen					
Is the duct / conduit at capacity? Provide additional details about the dimensions of duct / conduit and number of wires.	No	6" duct less than 15 wires					
Handhole 1 to AFC Panel (15' run)							
Was video scoping completed for the entire duct / conduit run?	No						
Was pull string installed?	No						
Were there any obstructions or blockages? Provide details of type and specific location.	Yes	Duct was collapsed less than 2' inside handhole and heavily rusted around the duct entrance at handhole 1

Photo #4 – C12 Braddock Road: Existing duct from kiosk to existing handhole 1.

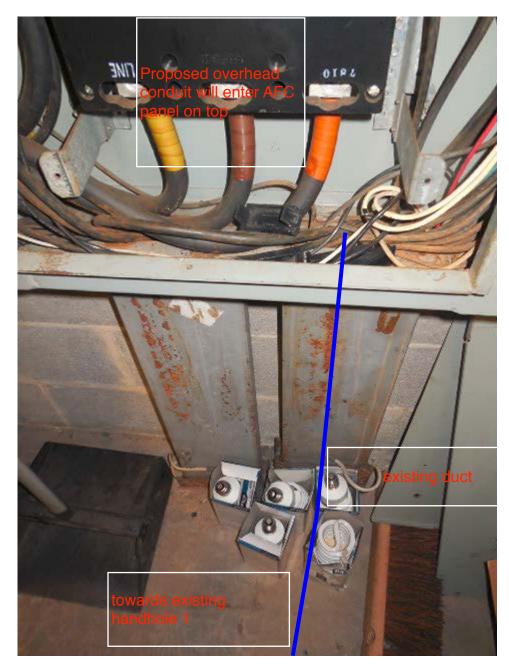
Photo #5 – C12 Braddock Road: Existing duct to AFC panel in Room #C111.
