Mezzanine Inspection Report REVISION 1 Date: 12/12/2014 Station Name: C13 King Street South Mezzanine #: 048 Completed By: Chris Loose

Summary

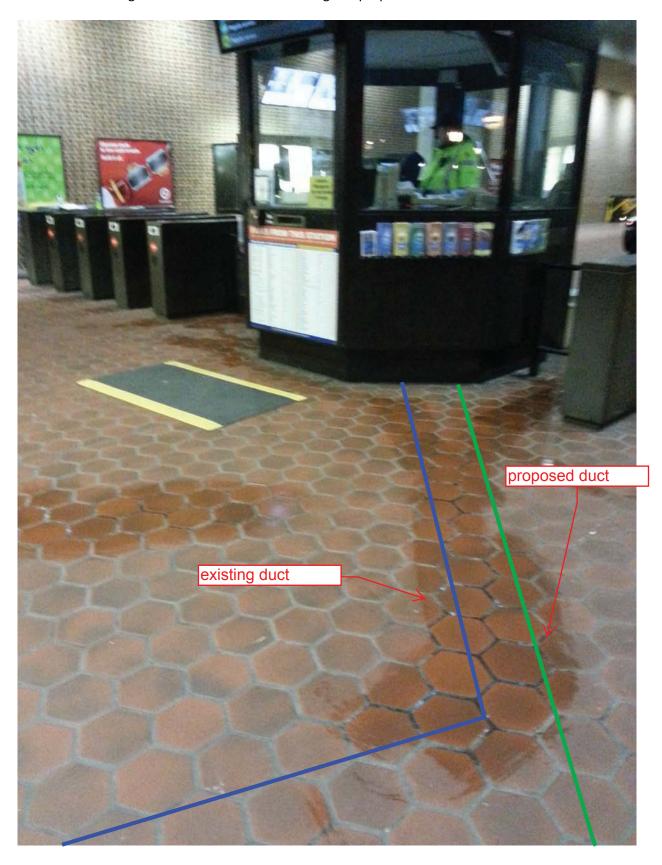
Photo #1 – C13 King Street South: Kiosk with existing and proposed duct runs

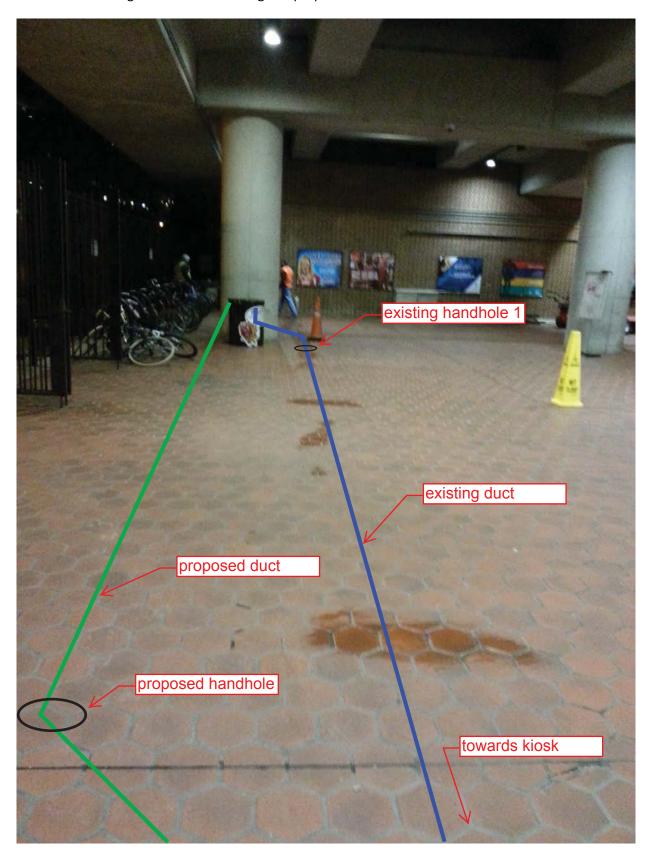
Photo #2 – C13 King Street South: Existing and proposed duct runs towards backrooms

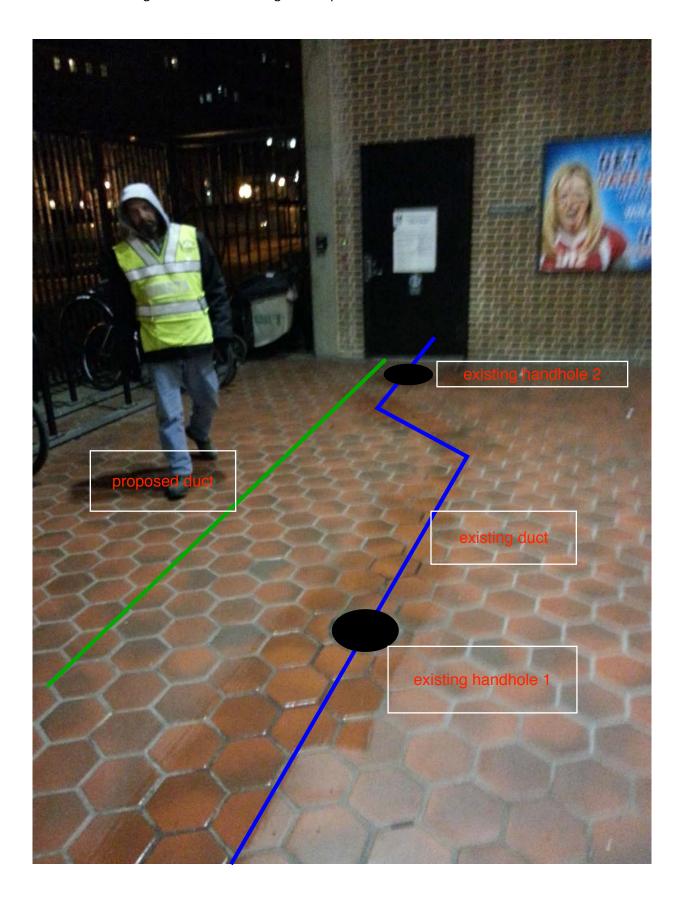
Photo #3 – C13 King Street South: Existing and Proposed Duct runs at door to backroom

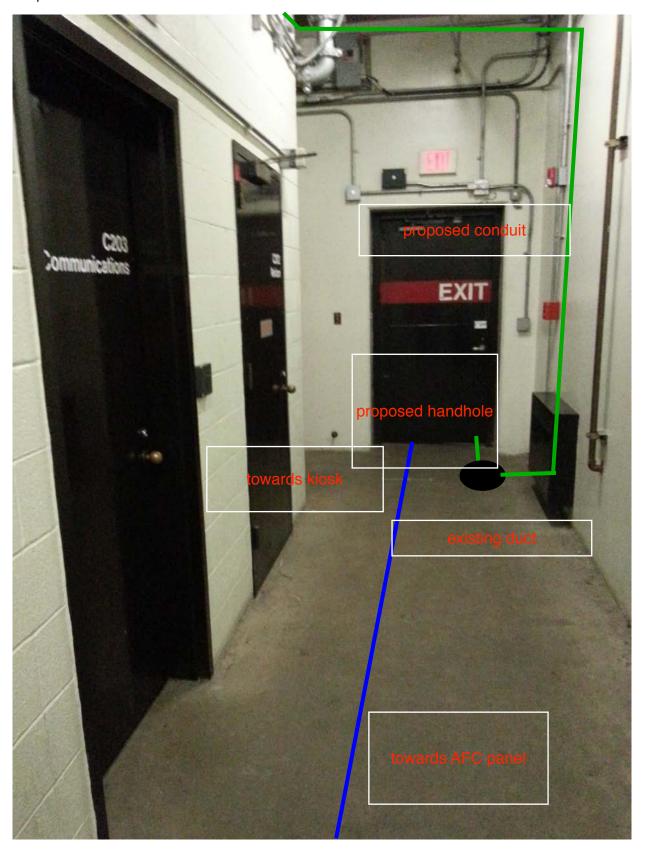
Photo #4 – C13 King Street South: Existing duct and proposed duct /conduit transition in back rooms towards AFC panel

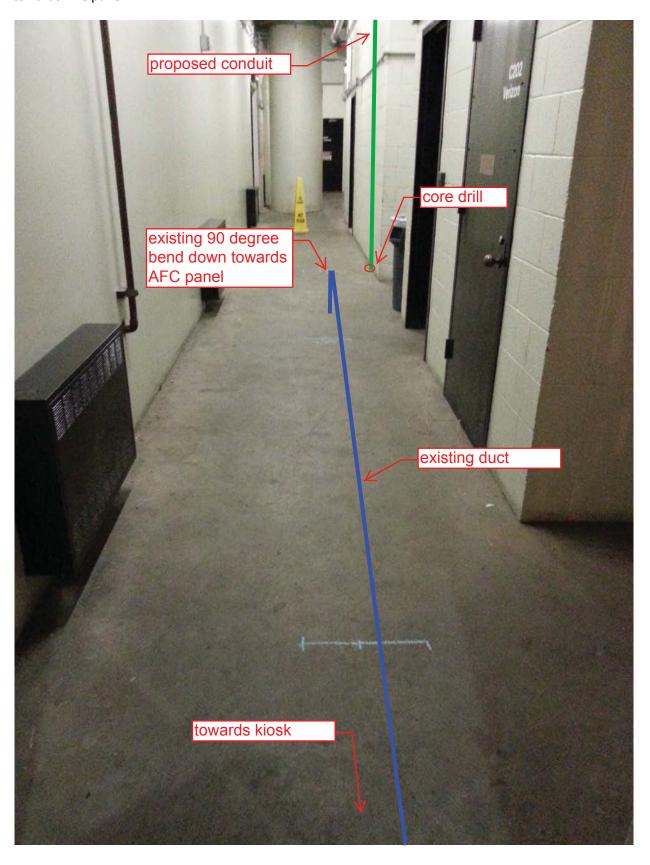
Photo #5 – C13 King Street South: Existing duct and proposed conduit drop in floor to lower level towards AFC panel

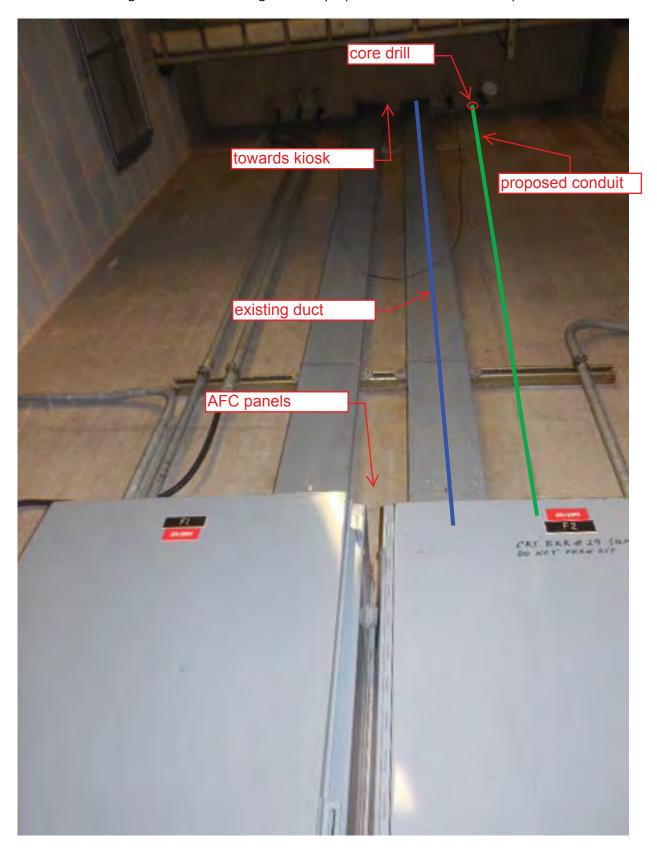
Photo #6 – C13 King Street South: Existing duct and proposed conduit towards AFC panel on lower level

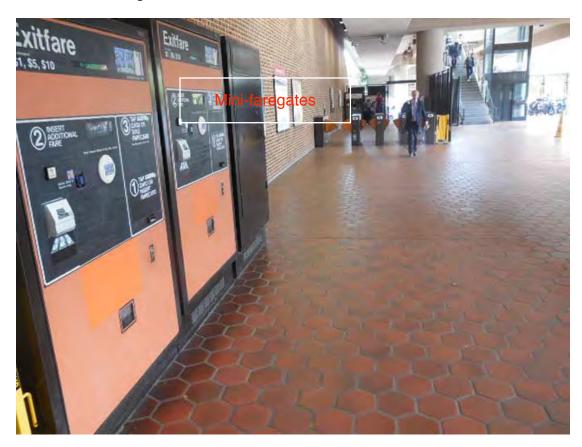
Video scoping was attempted in communication duct for mini-faregate on mezzanine floor, however there was an obstruction in duct at 5' from the Kiosk. Refer to Photo #7-8 and as-built drawing for location

Photo #7 – Mini-faregates on mezzanine floor

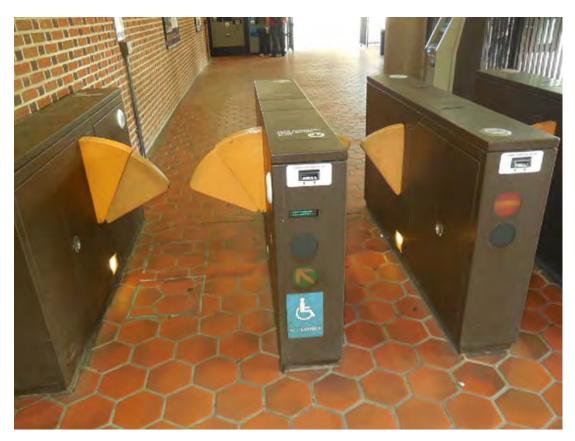
Photo #8 – Mini-faregates on mezzanine floor (close-up)
