## Mezzanine Inspection Report Date: 03/20/15 Station Name: C13 – King Street North Mezzanine #: 112 Completed By: Mike Butler Summary

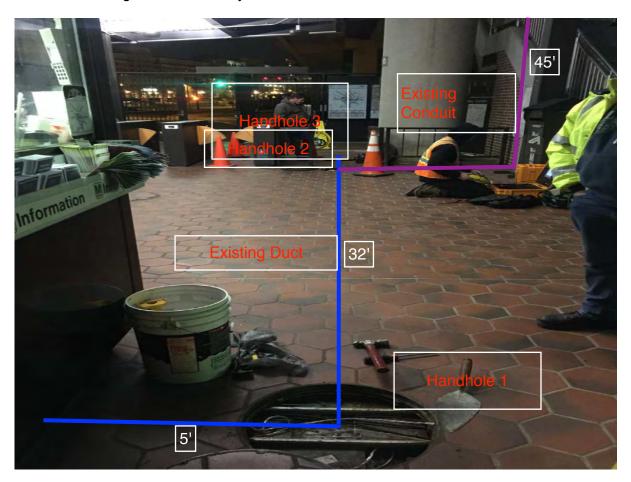
- Total distance of power route from Kiosk to AFC Panel is 82', including 37' of existing duct and 45' of existing conduit.
- The AFC Panel is located two floors above mezzanine level in Room N201.

Photo 1 – Existing duct / conduit layout on mezzanine floor

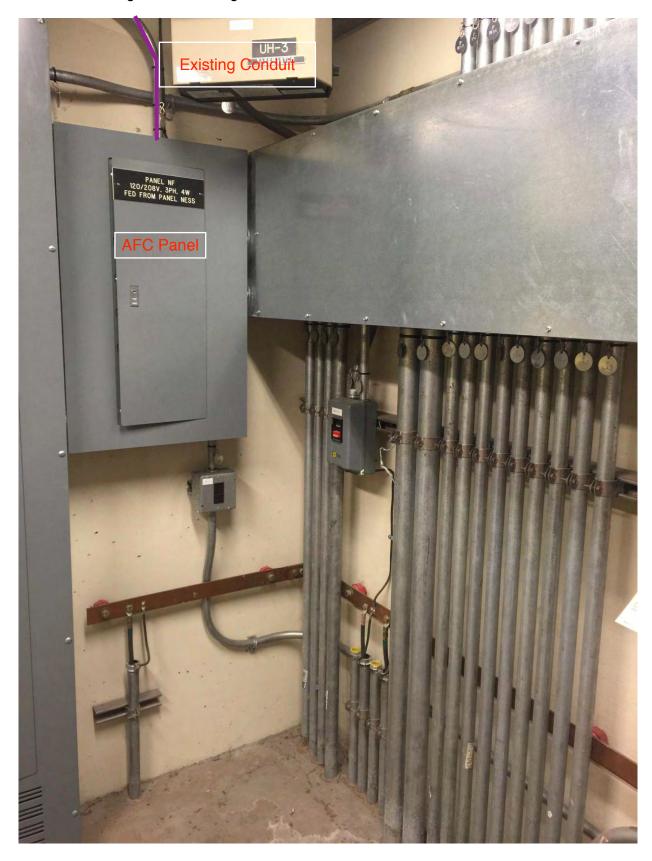
Handhole 2 to Trough to AFC Panel (Distance: 45')				
Was video scoping completed for the entire duct / conduit run?	No	Video scoping of conduits not required.		
Was pull string installed?	Yes			
Were there any obstructions or blockages? Provide details of type and specific location.	No			
Is the duct / conduit at capacity? Provide additional details about the dimensions of duct / conduit and number of wires.	No	2" conduit with less than 10 wires.		
Observations / Issues / Next Steps

Photo 2 – Existing conduit feeding AFC Panel in Room N201.
