## Mezzanine Inspection Report

Date: 11/10/2014	Station Name: C15 Huntington North	Mezzanine #: 050	Completed By: Balkis Hassane
------------------	------------------------------------	------------------	------------------------------

15-NEPP-01  
IN - FLOOR DUCT INSPECTIONS  
C15 Huntington North  
PROPOSED POWER DUCT RUN

<b>Date:</b> 12/12/2014	<b>Station Name:</b> C15 Huntington South	<b>Mezzanine #:</b> 051	<b>Completed By:</b> Balkis Hassane
-------------------------	---	-------------------------	-------------------------------------

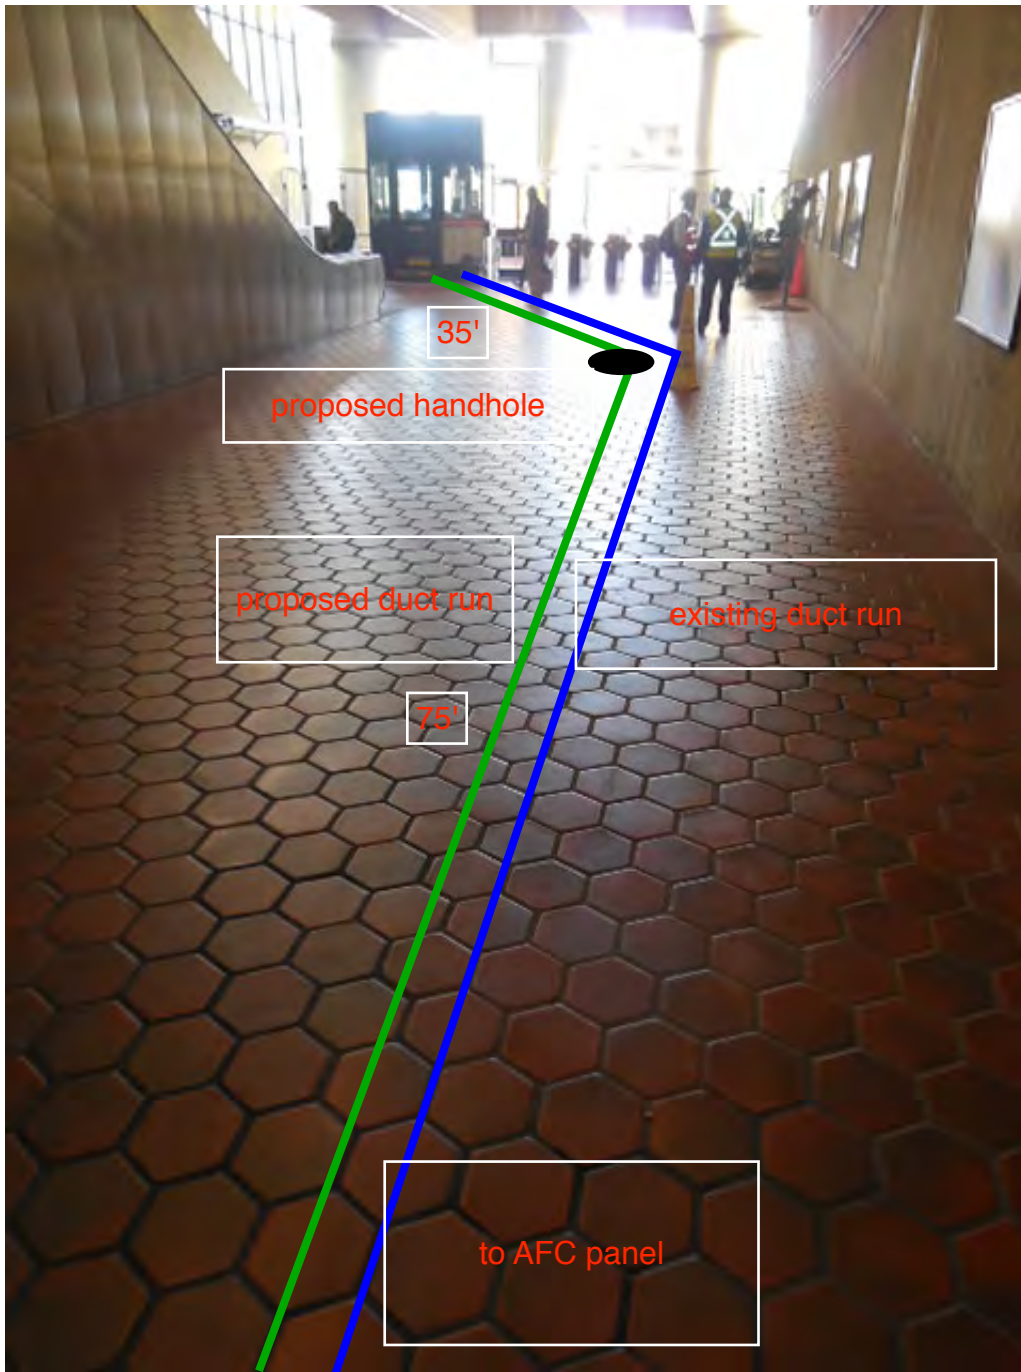
Photo #1 – C15 Huntington North: Mezzanine floor towards kiosk

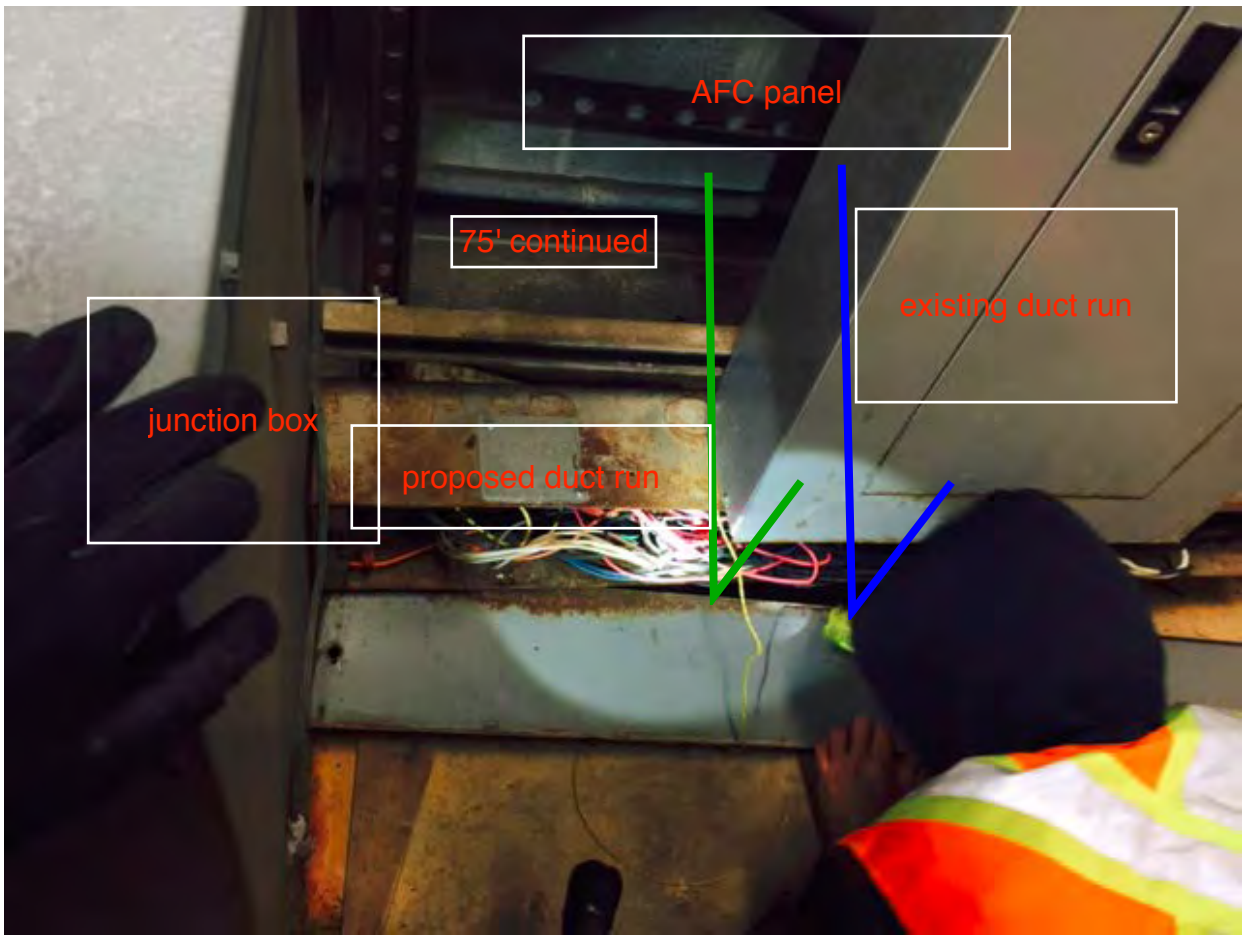
Photo #2 – C15 Huntington North: AFC panel and junction box directly below it

Scanning was performed at this station. It was found that a new duct could be installed parallel to the existing duct run from kiosk to AFC panel along the East wall. A new handhole for the 45 degree bend is proposed for access to the proposed duct near the covered 45 degree bend of the existing duct. The new duct will continue to a second proposed handhole on the mezzanine floor and then go under the wall and run vertically up into the existing junction box directly below the AFC panel.

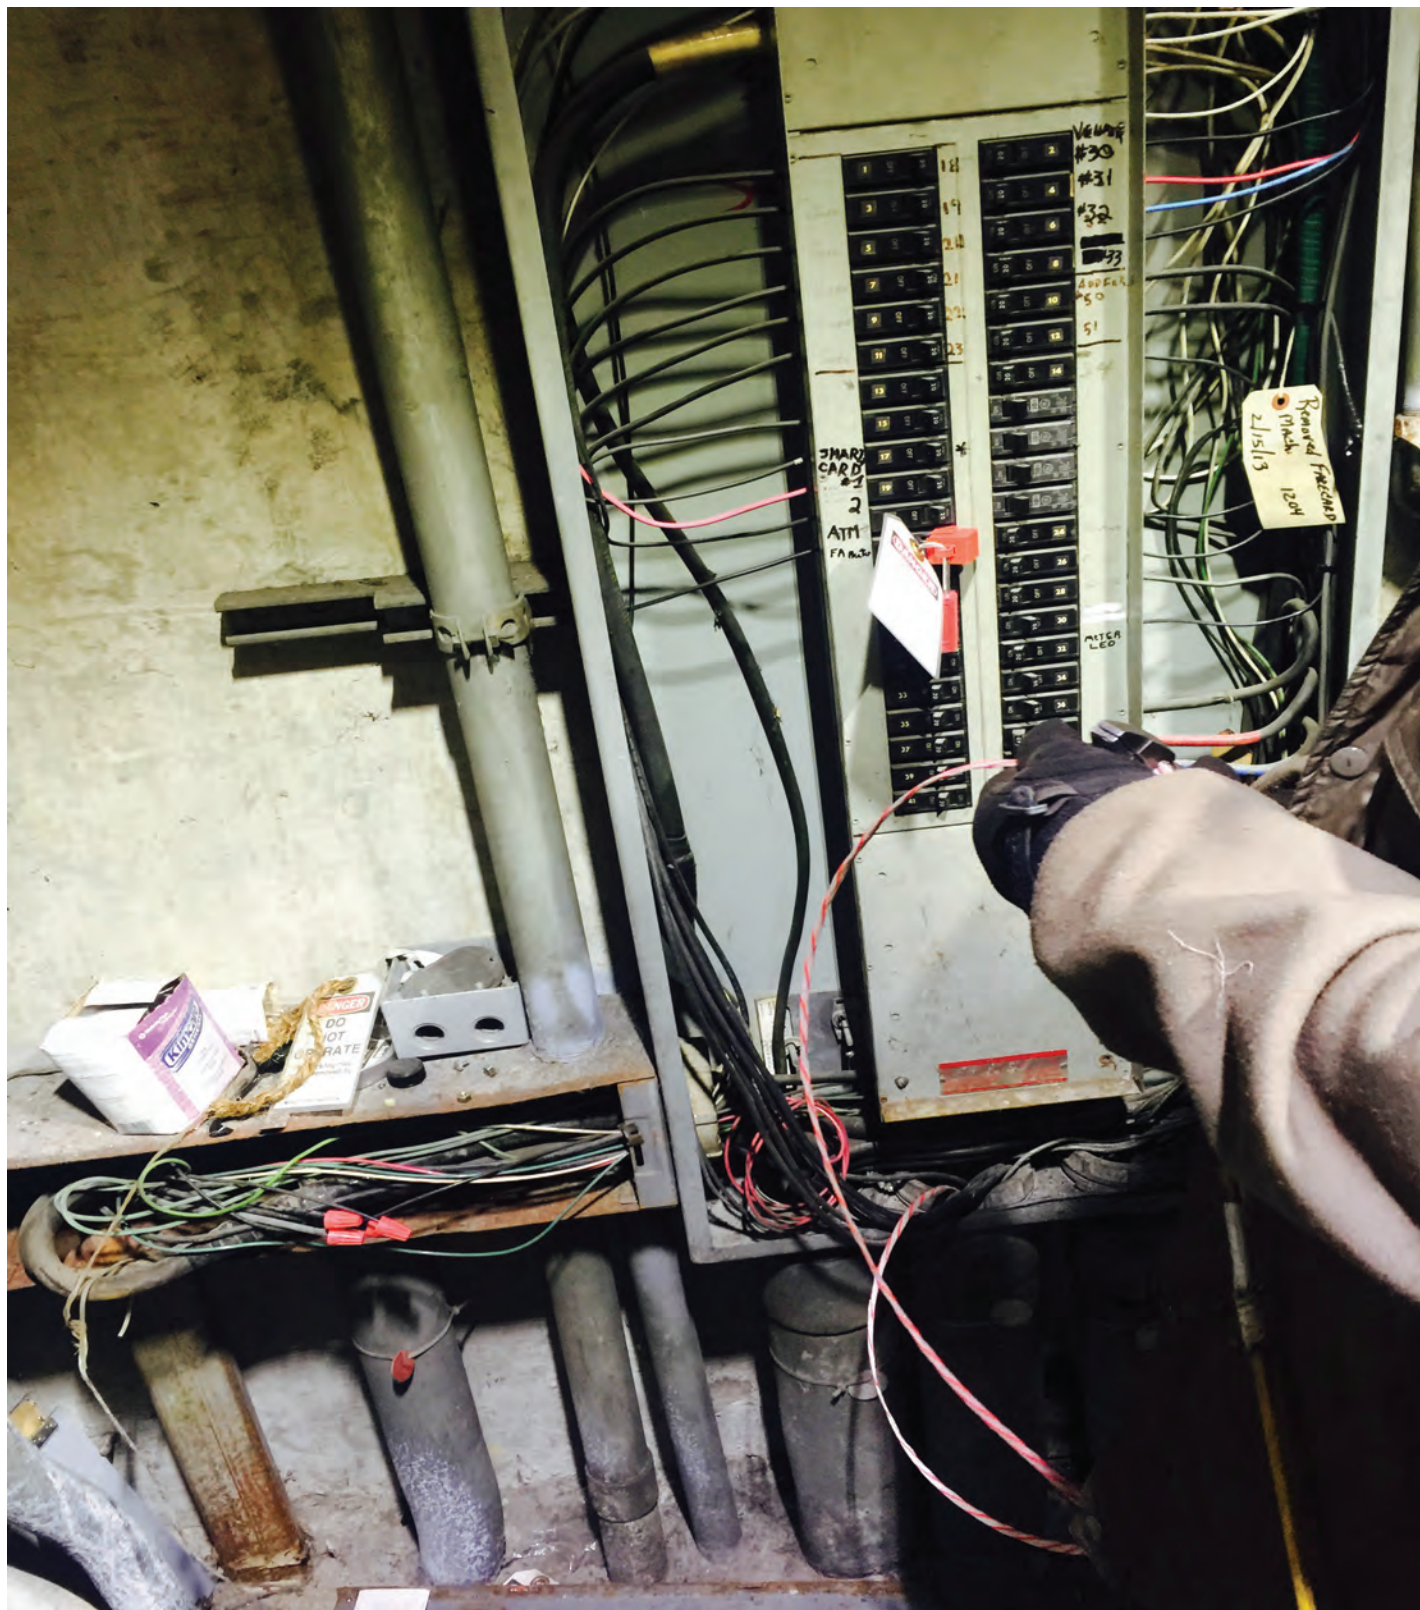
Photo 1. Pull String Installation on AFC Panel
