Mezzanine Inspection Report

Date: 10/20/14	Station Name: E01 Mount Vernon Square	Mezzanine #: 070	Completed By: Mike Butler
-----------------------	--	-------------------------	----------------------------------

15-NEPP-01
IN - FLOOR DUCT INSPECTIONS
E01 MOUNT VERNON SQUARE
PROPOSED ELECTRICAL DUCT PATH
DRAWING NO.
E01-E-100

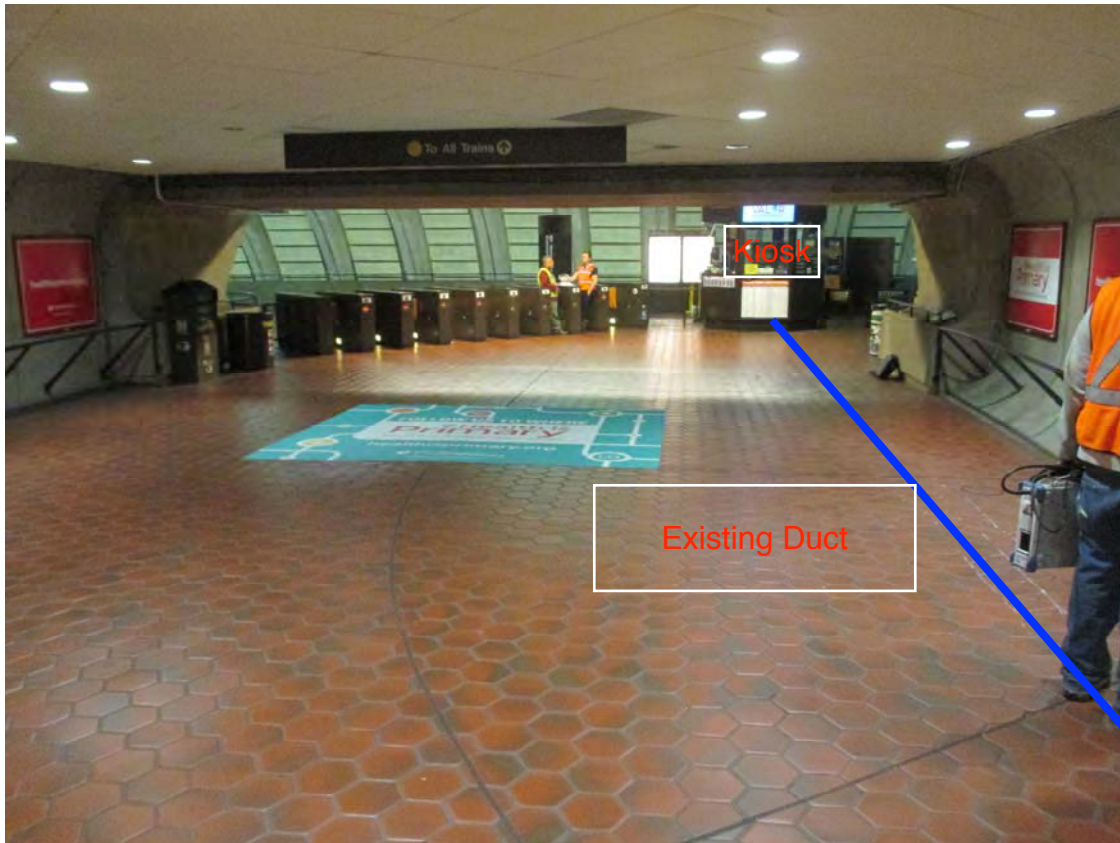
Scoping of Power Duct - Kiosk to AFC Panel		
Task	Yes/No	Notes
Kiosk to Handhole 1 (Distance: 76')		
Was video scoping completed for the entire duct / conduit run?	Yes	Refer to "WMATA Mt. Vernon Square Power Kiosk to Handhole 1 Video.avi"
Was pull string installed?	Yes	
Were there any obstructions or blockages? Provide details of type and specific location.	No	
Is the duct / conduit at capacity? Provide additional details about the dimensions of duct / conduit and number of wires.	No	6" walker duct with less than 15 wires.
Handhole 1 to Handhole 2 (Distance: 62')		
Was video scoping completed for the entire duct / conduit run?	Yes	Refer to "WMATA Mt. Vernon Square Power Handhole 1 to Handhole 2 Video.avi"
Was pull string installed?	Yes	
Were there any obstructions or blockages? Provide details of type and specific location.	Yes	Partially collapsed duct at 50' from Handhole 1. Duct is in bad condition and has extensive water damage.

Photo #1: Existing duct between Kiosk and Handhole 1

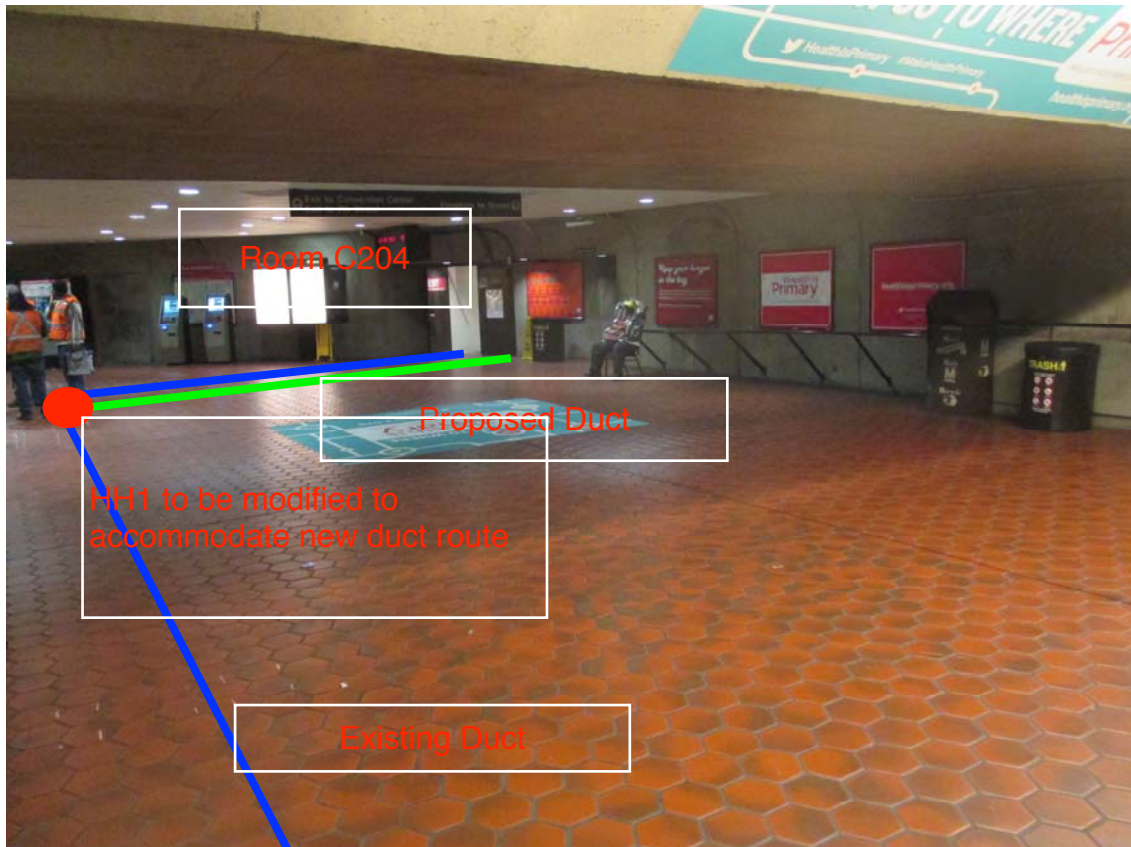
Photo #2: Existing and proposed ducts on mezzanine floor

The mezzanine floor was scanned to identify the existing ducts and new route between the Kiosk and AFC Panel. Scanning showed that there is a clear route from Handhole 1 to the AFC Panel. A new walker duct is proposed from Handhole 1 to the entrance of Room C204 - Handhole 1 will need to be modified to accommodate the connection of the new duct. Once in the back rooms, the duct will terminate at a new handhole and then transition to an overhead conduit (via a junction box) that will proceed along the top of the wall to the entrance of Electrical Room C207. The wall above the entrance to Room C207 will be core drilled to allow the new conduit to proceed overhead and feed into AFC Panel F.

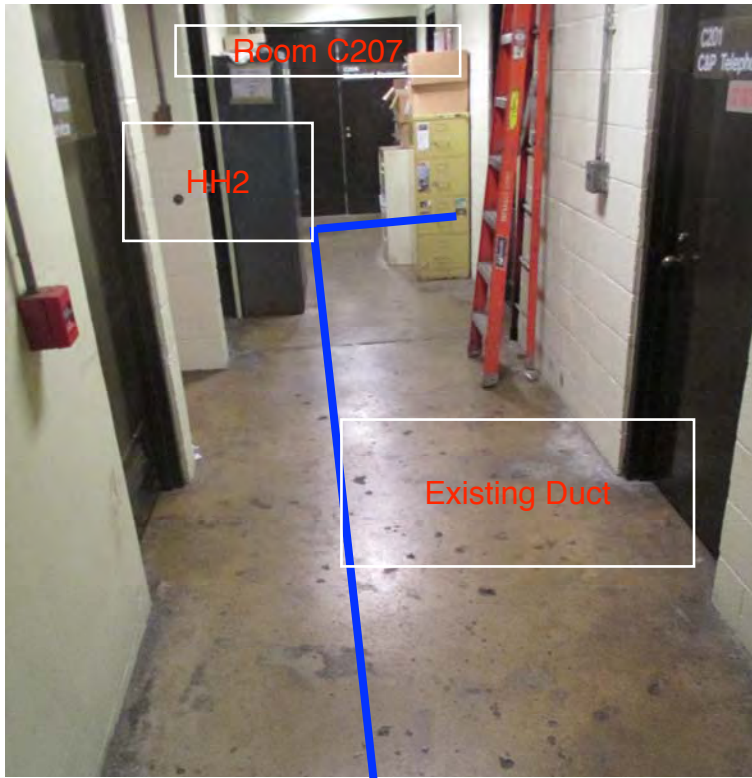
Photo #3: Existing duct route in back rooms.

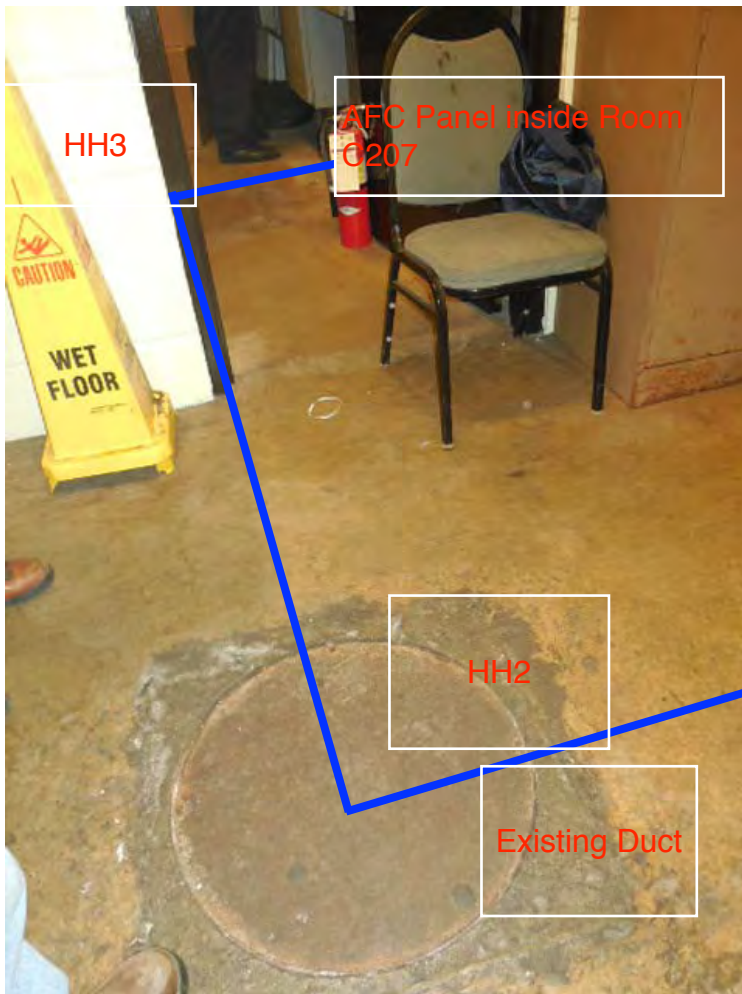
Photo #4: Existing duct route in back rooms.

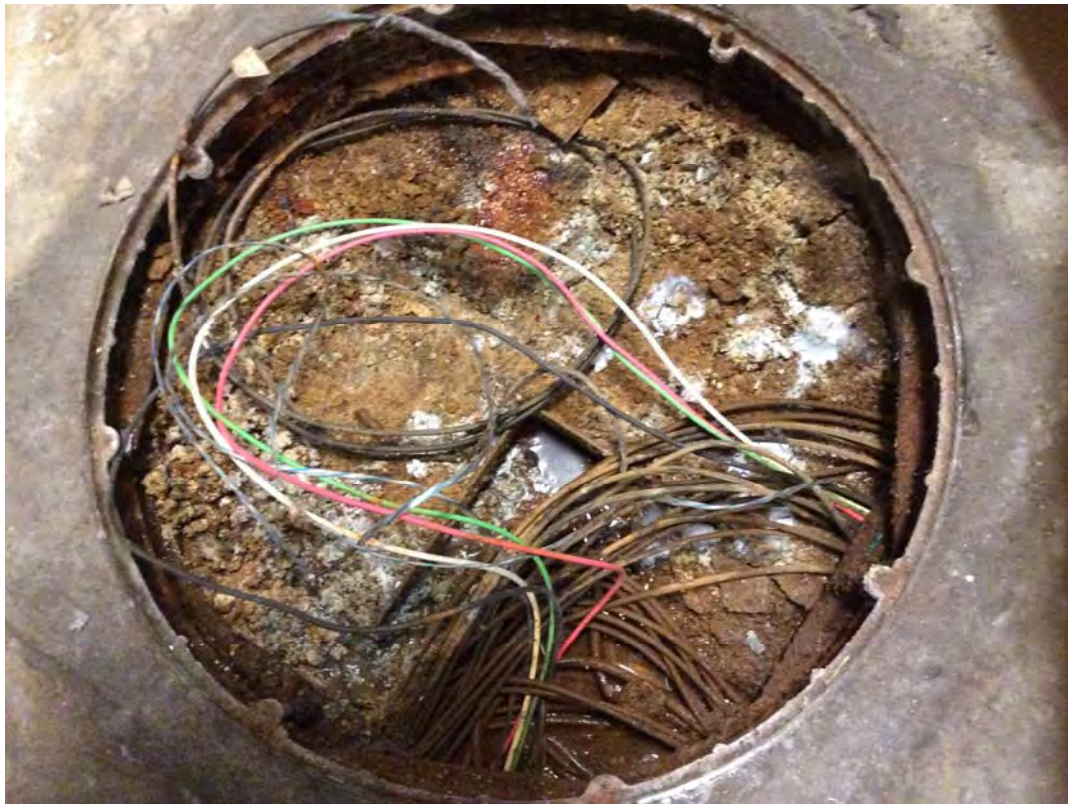
Photo #5: Condition of Handhole 2.

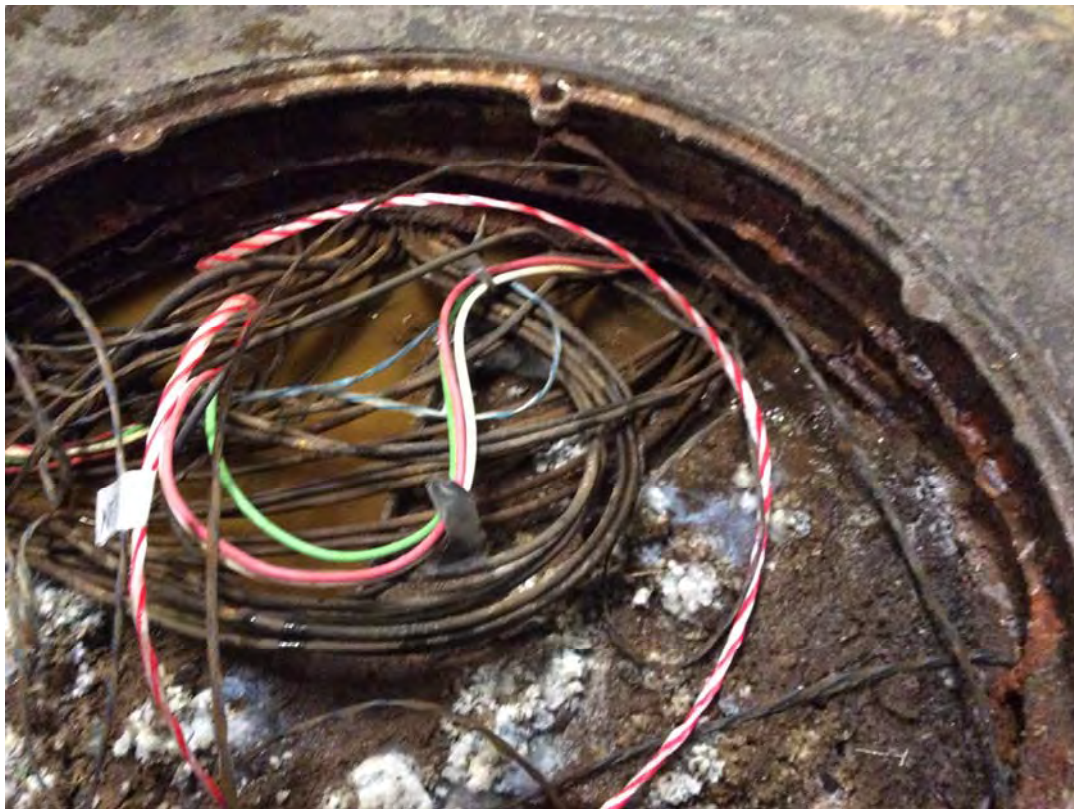
Photo #6: Condition of Handhole 3.
