Mezzanine Inspection Report

Date: 11/21/2014	Station Name: E02 Shaw-Howard U South	Mezzanine #: 071	Completed By: Dion Small
------------------	---------------------------------------	------------------	--------------------------

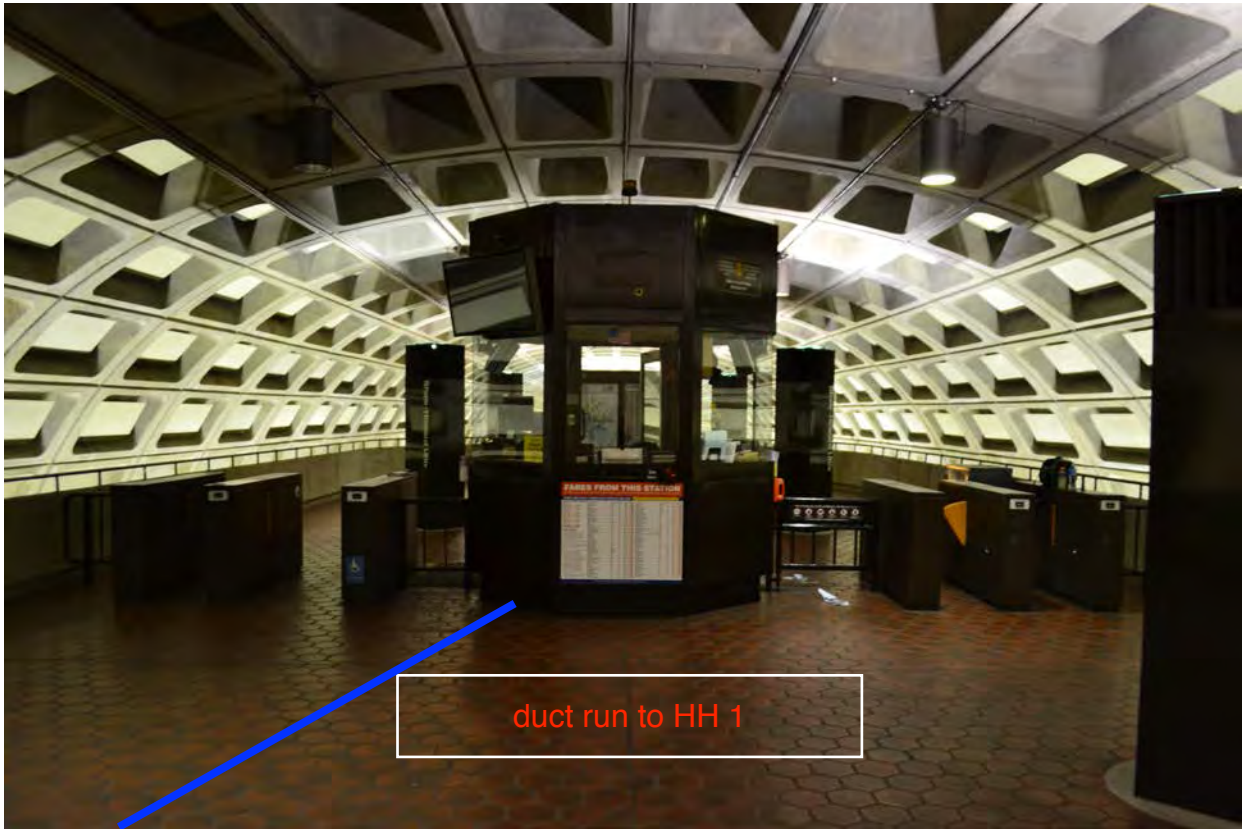
Photo #1 – E02 Shaw-Howard U South: Kiosk to Handhole 1

Scoping of Power Duct - Kiosk to AFC Panel		
Task	Yes/No	Notes
Kiosk to Handhole 1 (25' run)		
Was video scoping completed for the entire duct / conduit run?	Yes	Refer to WMATA Shaw- Howard South Power Feed Kiosk to H.H.1 Duct.avi file.
Was pull string installed?	Yes	
Were there any obstructions or blockages? Provide details of type and specific location.	No	
Is the duct / conduit at capacity? Provide additional details about the dimensions of duct / conduit and number of wires.	No	6" duct – 16 wires
Handhole 1 to Handhole 2 (20' run)		
Was video scoping completed for the entire duct / conduit run?	Yes	Refer to WMATA Shaw- Howard South Power Feed H.H.1 to H.H.2 Duct.avi file.
Was pull string installed?	Yes	
Were there any obstructions or blockages? Provide details of type and specific location.	No	
Is the duct / conduit at capacity? Provide additional details about the dimensions of duct / conduit and number of wires.	No	6" duct – 16 wires

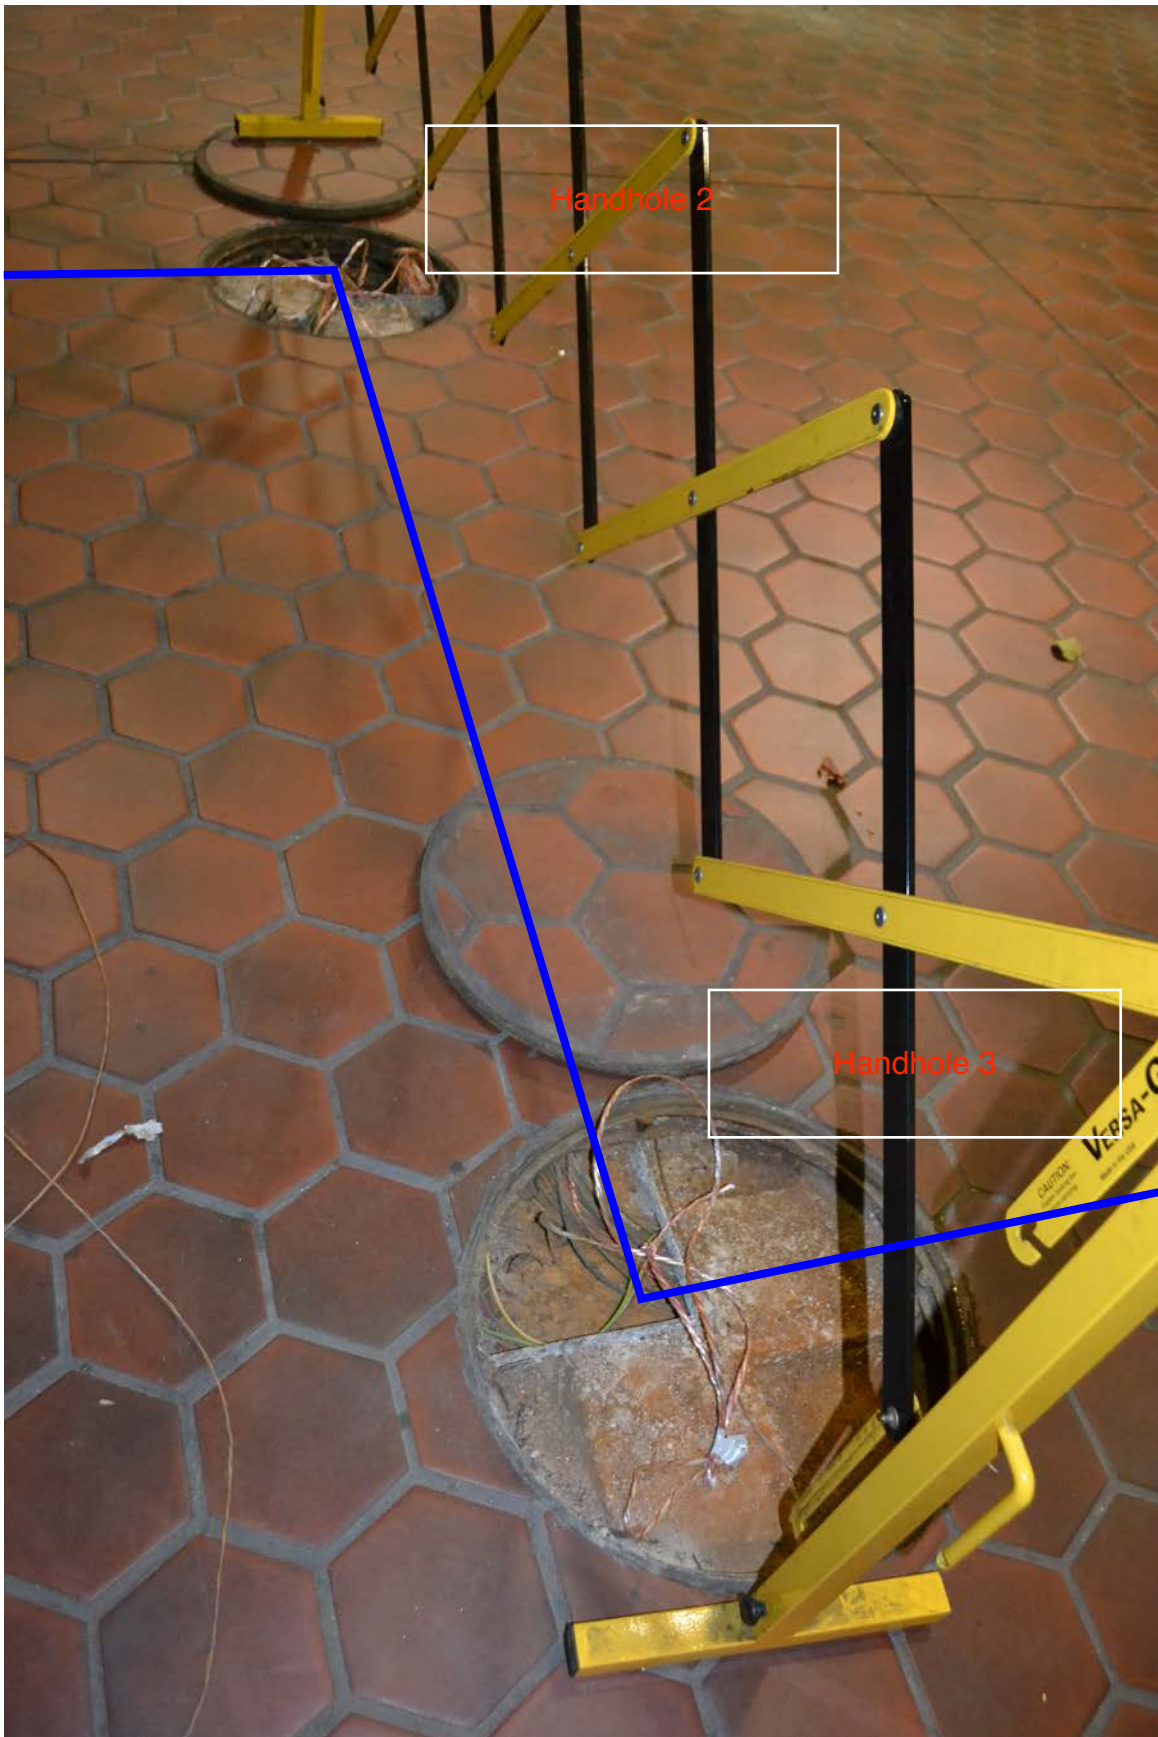
Photo #3 – E02 Shaw-Howard U South: Handhole 2 to Handhole 3

Handhole 2 to Handhole 3 (10' run)		
Was video scoping completed for the entire duct / conduit run?	No	Short run. Visual inspection completed.
Was pull string installed?	Yes	
Were there any obstructions or blockages? Provide details of type and specific location.	No	
Is the duct / conduit at capacity? Provide additional details about the dimensions of duct / conduit and number of wires.	No	6" duct – 26 wires
Handhole 3 to Handhole 4 (40' run)		
Was video scoping completed for the entire duct / conduit run?	Yes	Full scope completed by scoping both directions due to tangle of wires in duct. Refer to WMATA Shaw- Howard South Power Feed H.H.3 to H.H.4 Duct.avi and WMATA Shaw- Howard South Power Feed H.H.3 to H.H.4 Duct (2).avi files.
Was pull string installed?	Yes	
Were there any obstructions or blockages? Provide details of type and specific location.	No	Tangle of wires between handholes, but no debris

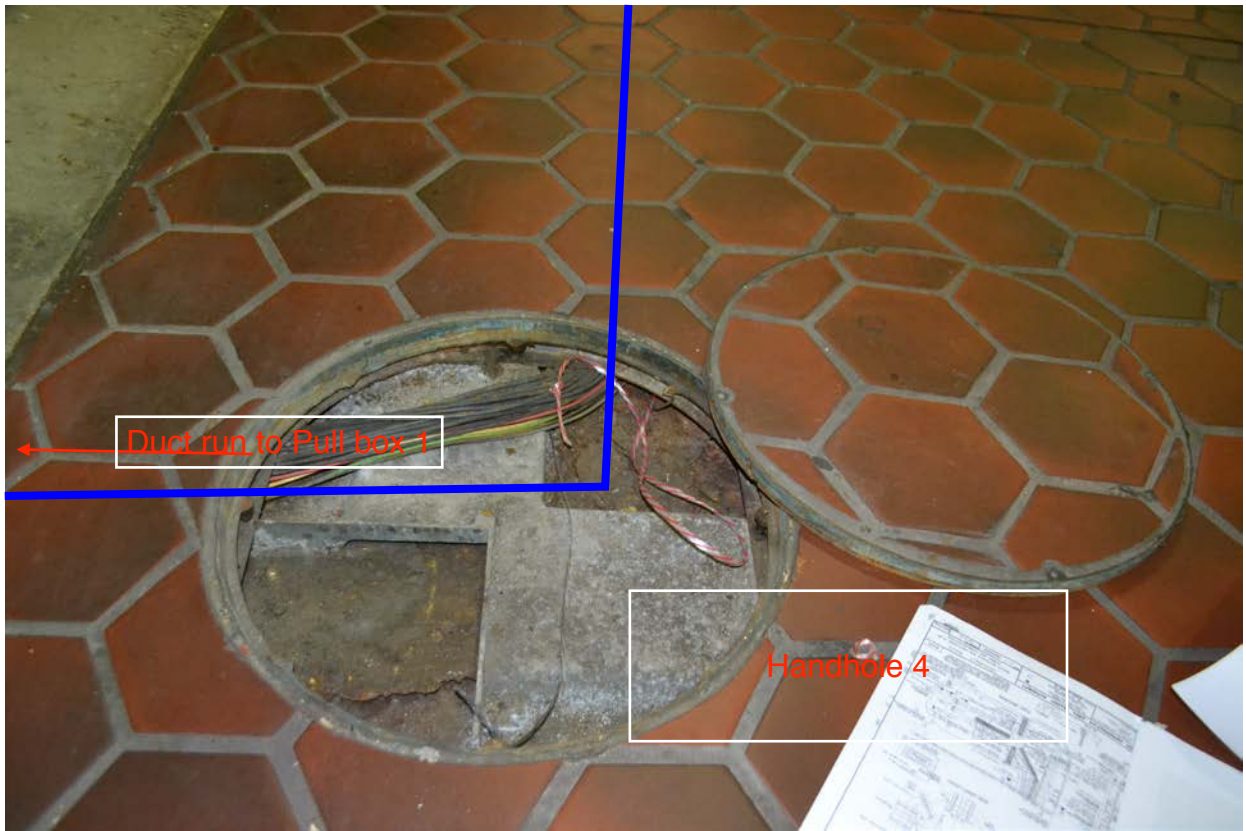
Photo #4 – E02 Shaw-Howard U South: Handhole 4 from Handhole 3

Is the duct / conduit at capacity? Provide additional details about the dimensions of duct / conduit and number of wires.	No	6" duct – 26 wires
Handhole 4 to Pull Box 1 (10' run)		
Was video scoping completed for the entire duct / conduit run?	No	90 degree vertical bend in duct and wire congestion prevented scoping
Was pull string installed?	Yes	
Were there any obstructions or blockages? Provide details of type and specific location.	No	
Is the duct / conduit at capacity? Provide additional details about the dimensions of duct / conduit and number of wires.	No	6" duct – 26 wires

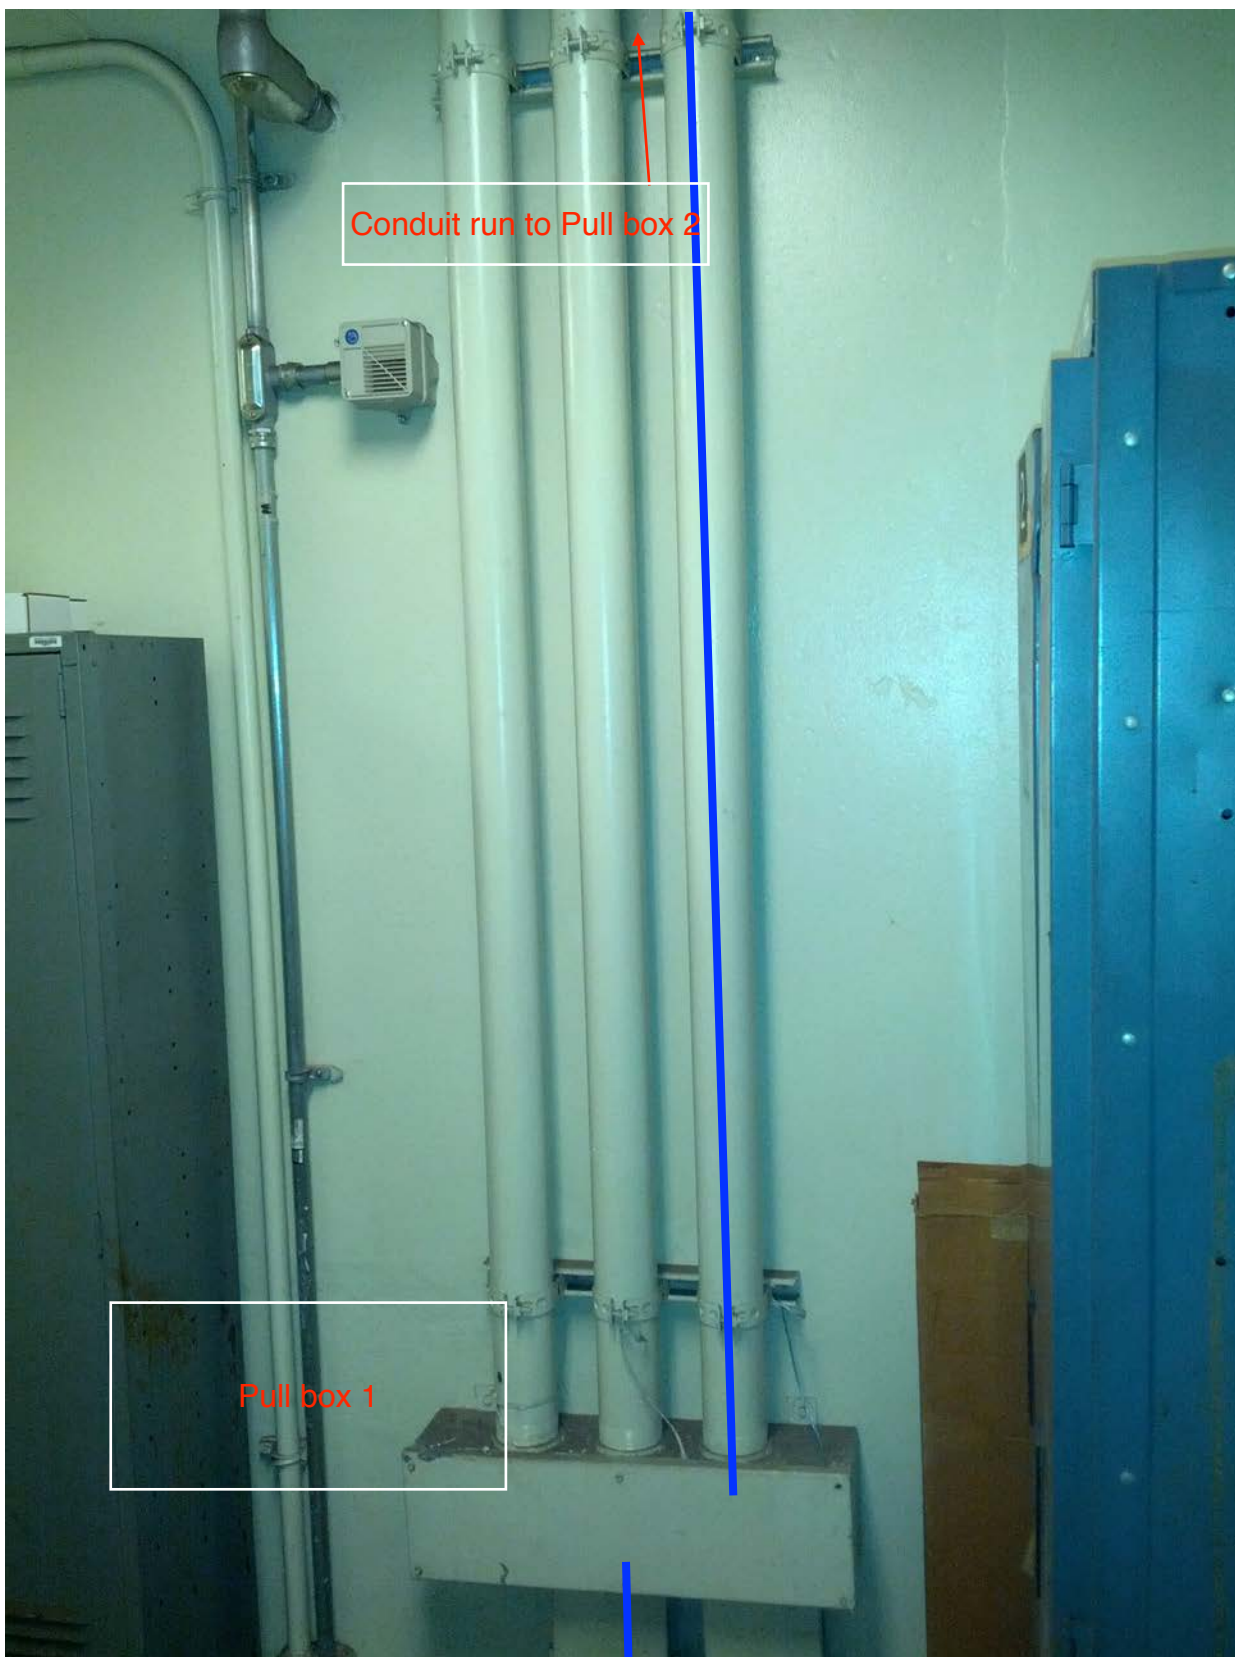
Photo #5 – E02 Shaw-Howard U South: Pull box 1 to Pull box 2

Pull Box 1 to Pull Box 2 (10' run)		
Was video scoping completed for the entire duct / conduit run?	No	Conduit – no scoping required
Was pull string installed?	Yes	
Were there any obstructions or blockages? Provide details of type and specific location.	No	
Is the duct / conduit at capacity? Provide additional details about the dimensions of duct / conduit and number of wires.	No	3" conduit – 5 wires
Pull Box 2 to Pull Box 3 (30' run)		
Was video scoping completed for the entire duct / conduit run?	No	Conduit – no scoping required
Was pull string installed?	Yes	
Were there any obstructions or blockages? Provide details of type and specific location.	No	
Is the duct / conduit at capacity? Provide additional details about the dimensions of duct / conduit and number of wires.	No	3" conduit – 5 wires
Pull Box 3 to AFC Panel (5' run)		
Was video scoping completed for the entire duct / conduit run?	No	Conduit – no scoping required

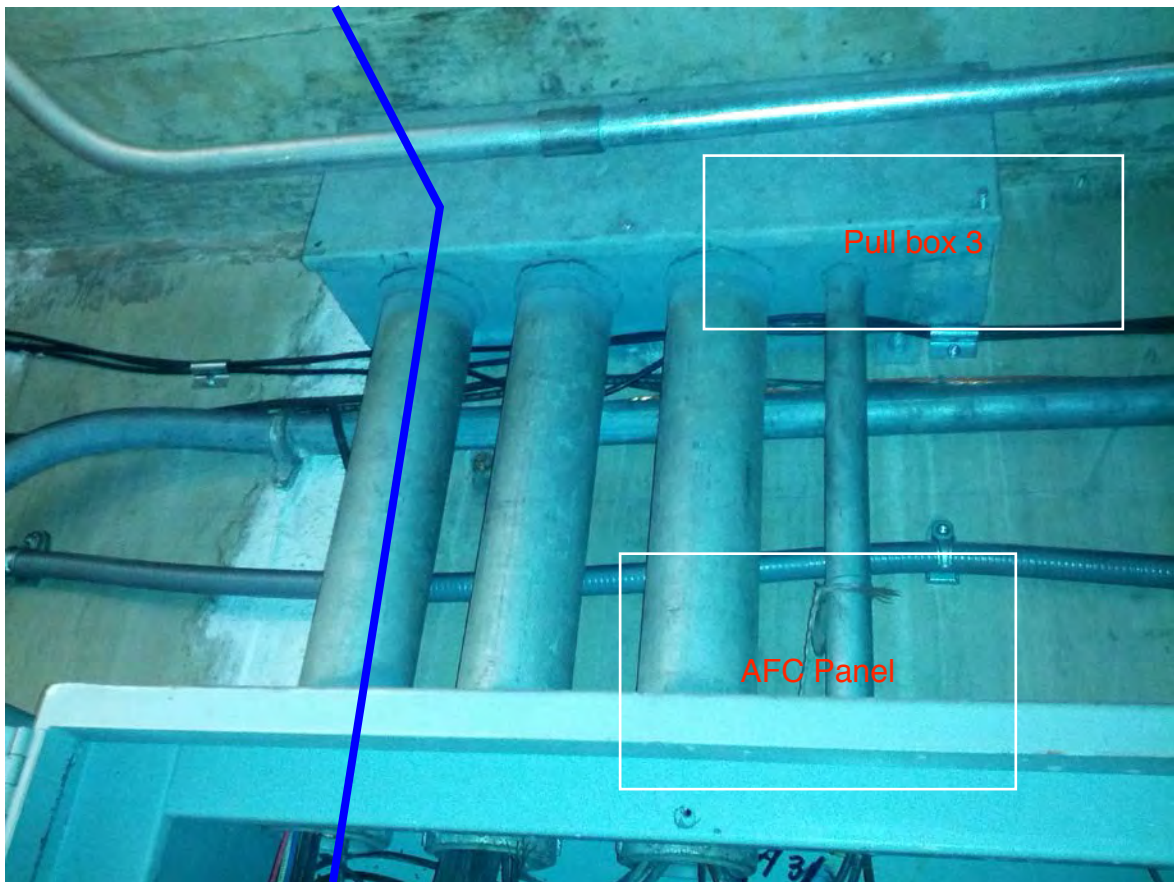
Photo #7 – E02 Shaw-Howard U South: Pull box 3 to AFC Panel

Was pull string installed?	Yes	
Were there any obstructions or blockages? Provide details of type and specific location.	No	
Is the duct / conduit at capacity? Provide additional details about the dimensions of duct / conduit and number of wires.	No	3" conduit – 5 wires
Observations / Issues / Next Steps		
Sign Off		
	GFP Representative	WMATA PRGM
Name:	Dion Small	
Signature:	<i>Dion Small</i>	
Date:	11/21/2014
