Mezzanine Inspection Report

Date: 11/19/2014	Station Name: E02 - Shaw/Howard U (North)	Mezzanine #: 072	Completed By: Mike Butler
------------------	---	------------------	---------------------------

15-NEPP-01
IN - FLOOR DUCT INSPECTIONS
E02 Shaw-Howard U North
PROPOSED POWER ROUTE
SCALE NOT TO SCALE
DRAWING NO. E02-E-100
XXX

Mezzanine Inspection Report (Scoping)

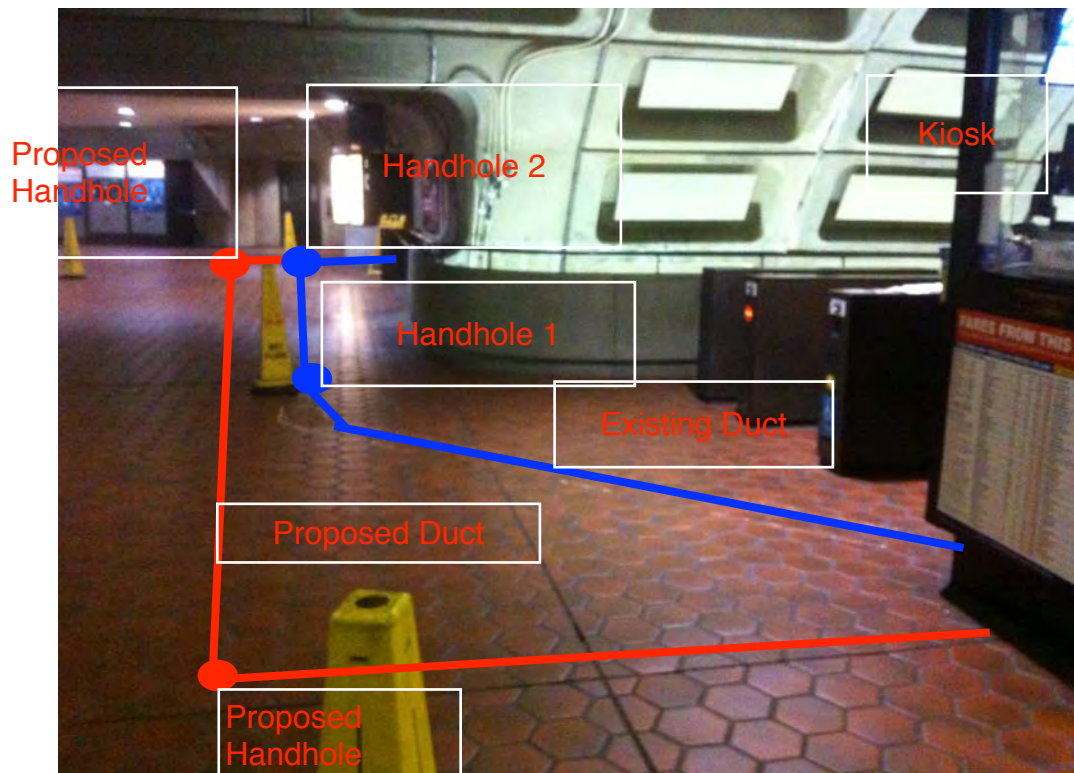
- Video scoping and pull string installation in power duct between Kiosk, Handhole 1, Handhole 2 and Junction Box could not be completed due to multiple collapses. It should be noted that all ducts are in very bad condition and have been subjected to extensive water damage. In addition, pull string installation could not be completed in conduit between Junction Box and AFC Panel due to obstructions / bends.

Photo #1: Existing and proposed ducts on mezzanine floor

- It is recommended to install a proposed duct, which will run parallel to the outside of existing duct from Kiosk to Handhole 2. A new handhole is proposed adjacent to Handhole 2, where the proposed duct will connect perpendicular. There is an empty 6" duct running from Handhole 2 to Junction Box, which is partially collapsed. It is recommended to repair / replace the empty duct and utilize the existing run from Handhole 2 to Junction Box (Room 217). It is assumed that the three existing 2.5" conduits (two of which are empty) have a continuous route from the Junction Boxes (Room 217) to the Junction Box (Room 205) to the AFC Panel. It is recommended to utilize one of the two empty conduits as part of the proposed run. If that is not possible, it is recommended to run a proposed conduit from Junction Box to AFC Panel by running up wall, across ceiling and core drilling through CMU wall into Room 205 where the AFC Panel is located.

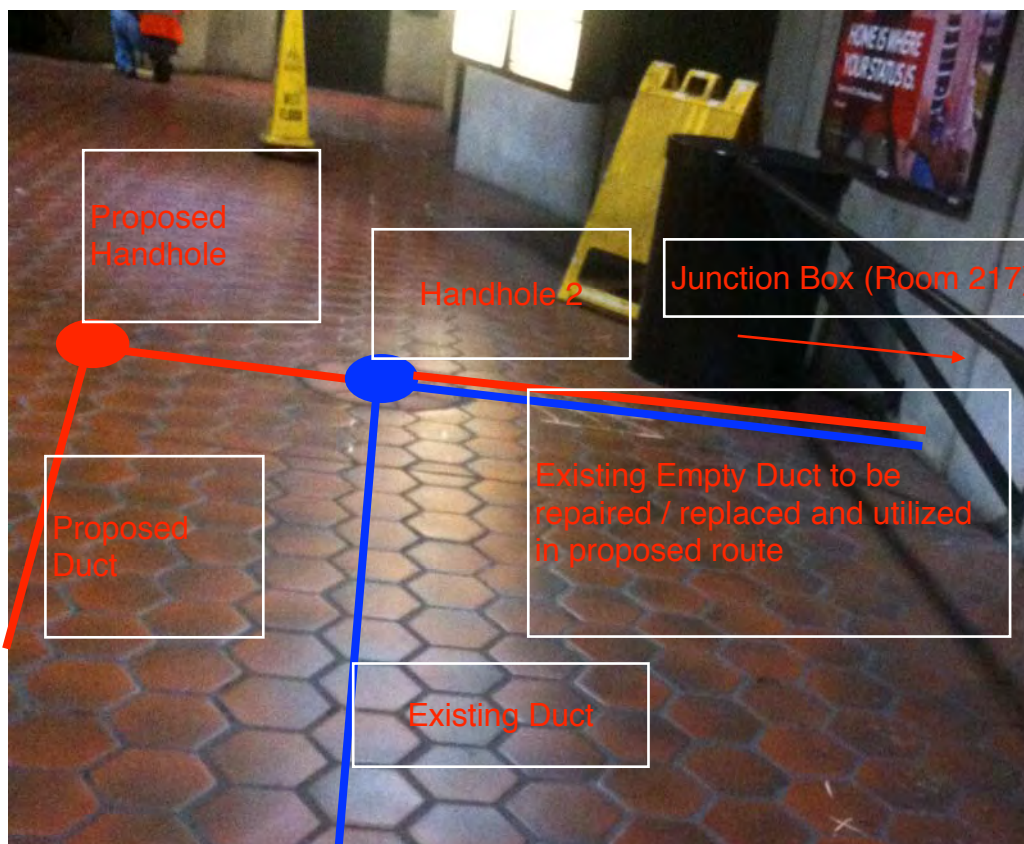
Photo #2: Existing and proposed ducts on mezzanine floor

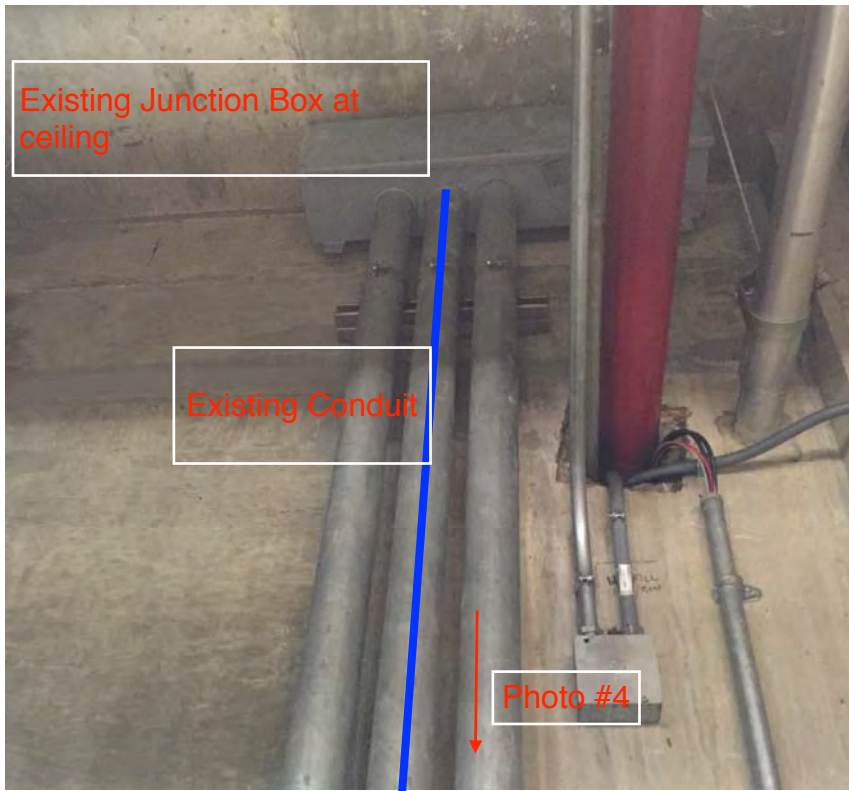
Handhole 2 to Junction Box in Room 217 (10')		
Was video scoping completed for the entire duct / conduit run?	No	
Was pull string installed?	No	
Were there any obstructions or blockages? Provide details of type and specific location.	Yes	The duct is collapsed just beyond Handhole 2; water damage evident.
Is the duct / conduit at capacity? Provide additional details about the dimensions of duct / conduit and number of wires.	No	6" duct with less than 12 wires.
Junction Boxes at floor and ceiling in Room 217 to Junction Box at ceiling in Room 205 and AFC Panel in Room 205 (60' assumed)		
Was video scoping completed for the entire duct / conduit run?	No	Scoping of conduits not required.
Was pull string installed?	No	
Were there any obstructions or blockages? Provide details of type and specific location.	No	It is assumed that the conduit runs are not obstructed, and the visible portions of the runs look to be in good condition. However, the conduit run between the two junction boxes on the ceiling was not visible.

Photo #3: Existing and proposed conduits in Room 217

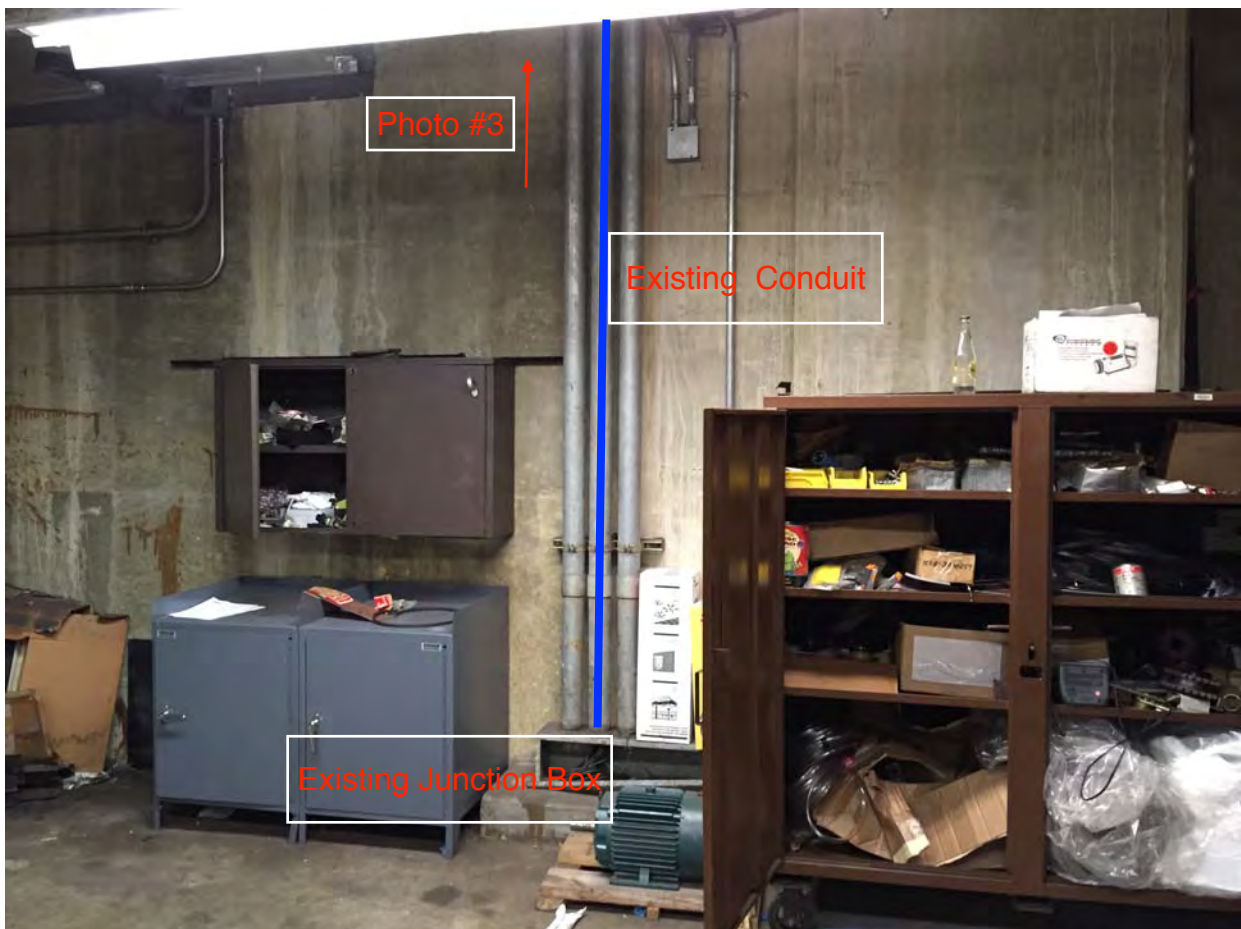
Photo #4: Existing and proposed conduits in Room 217

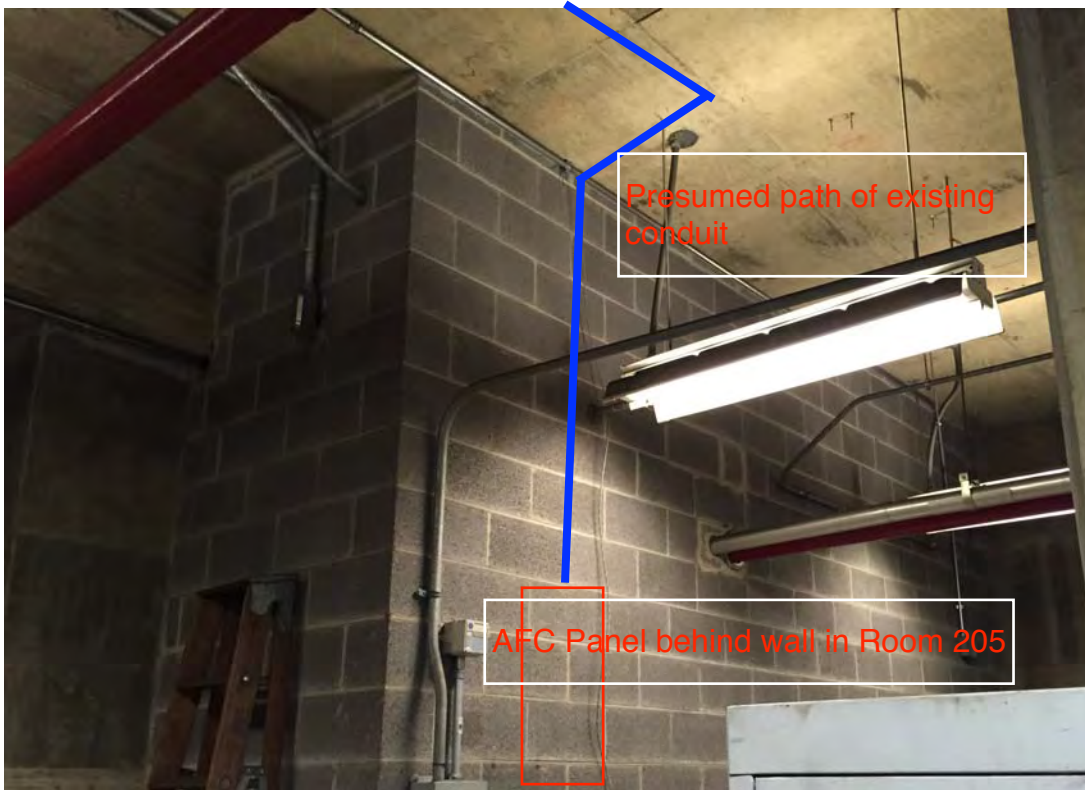
Photo #5: Existing and proposed conduits in Room 217

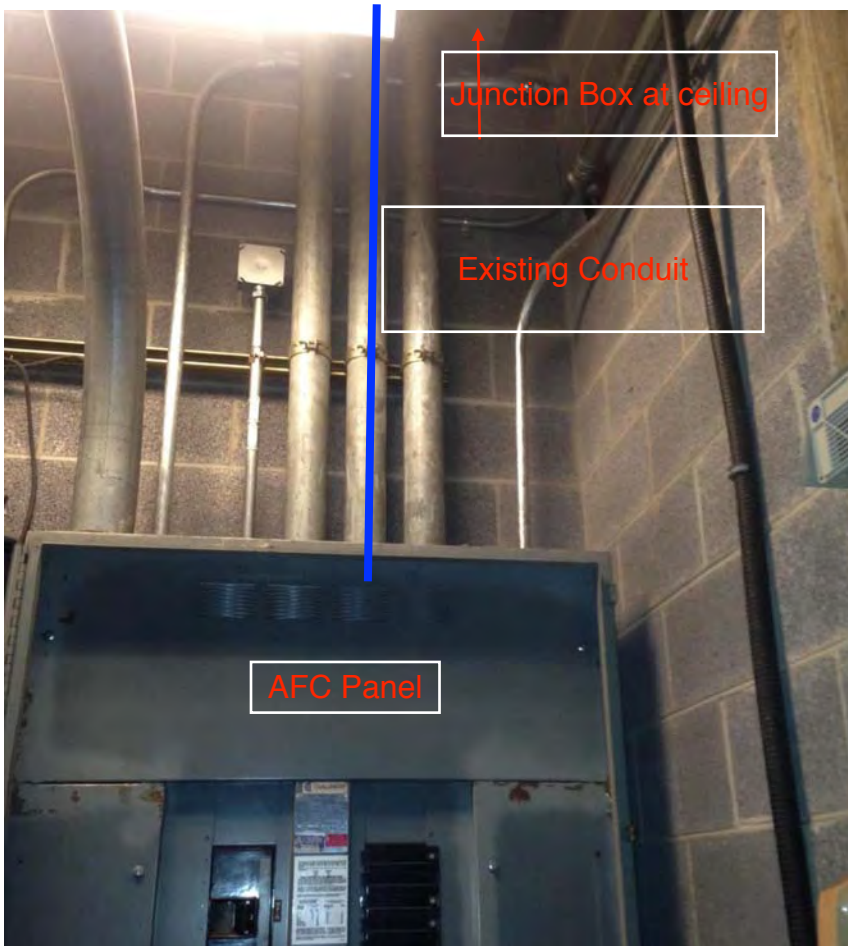
Photo #6: Existing and proposed conduits in Room 205

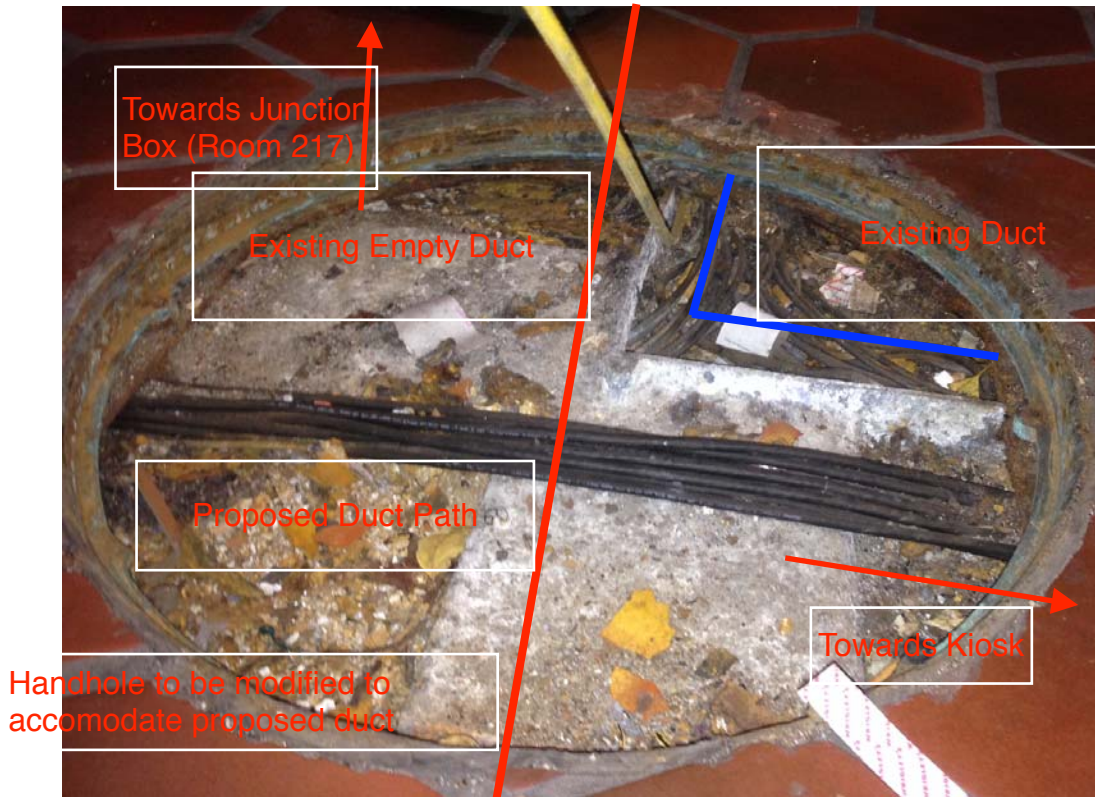
Photo #7 – Existing Handhole 2 (close-up)

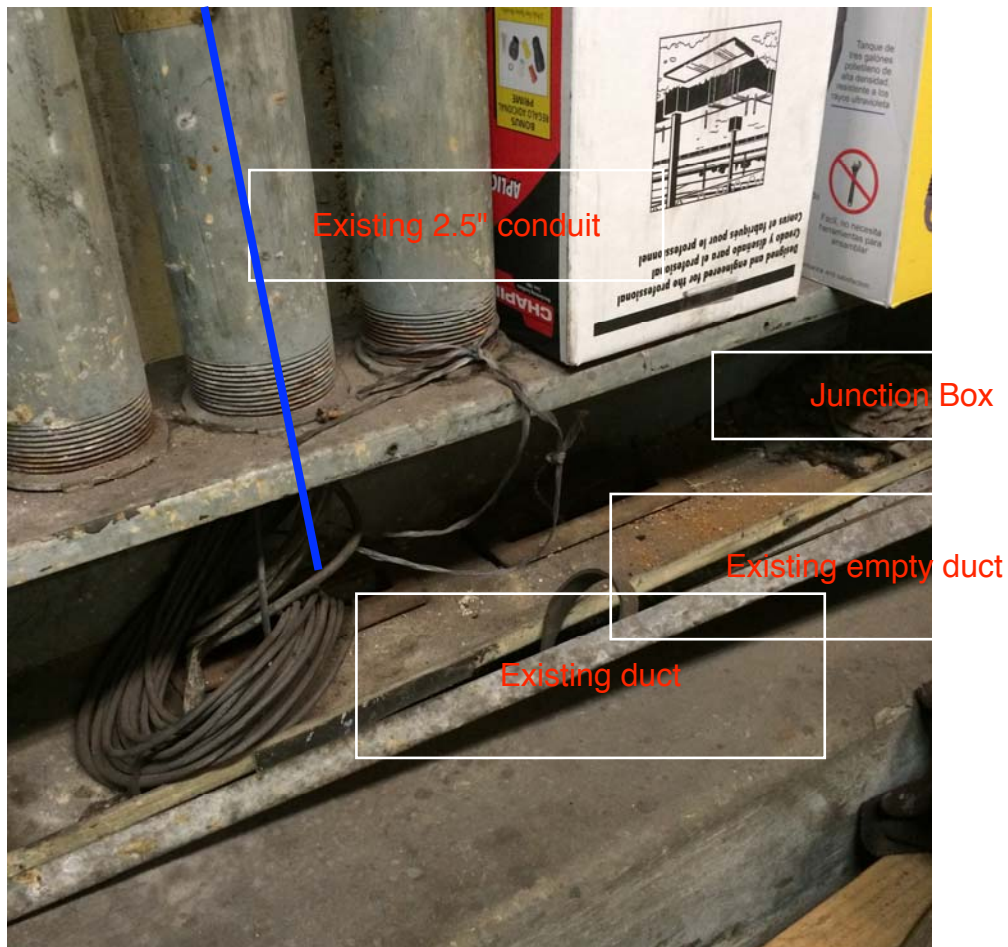
Photo #8 – Existing Open Junction Box in Room 217 (close-up)

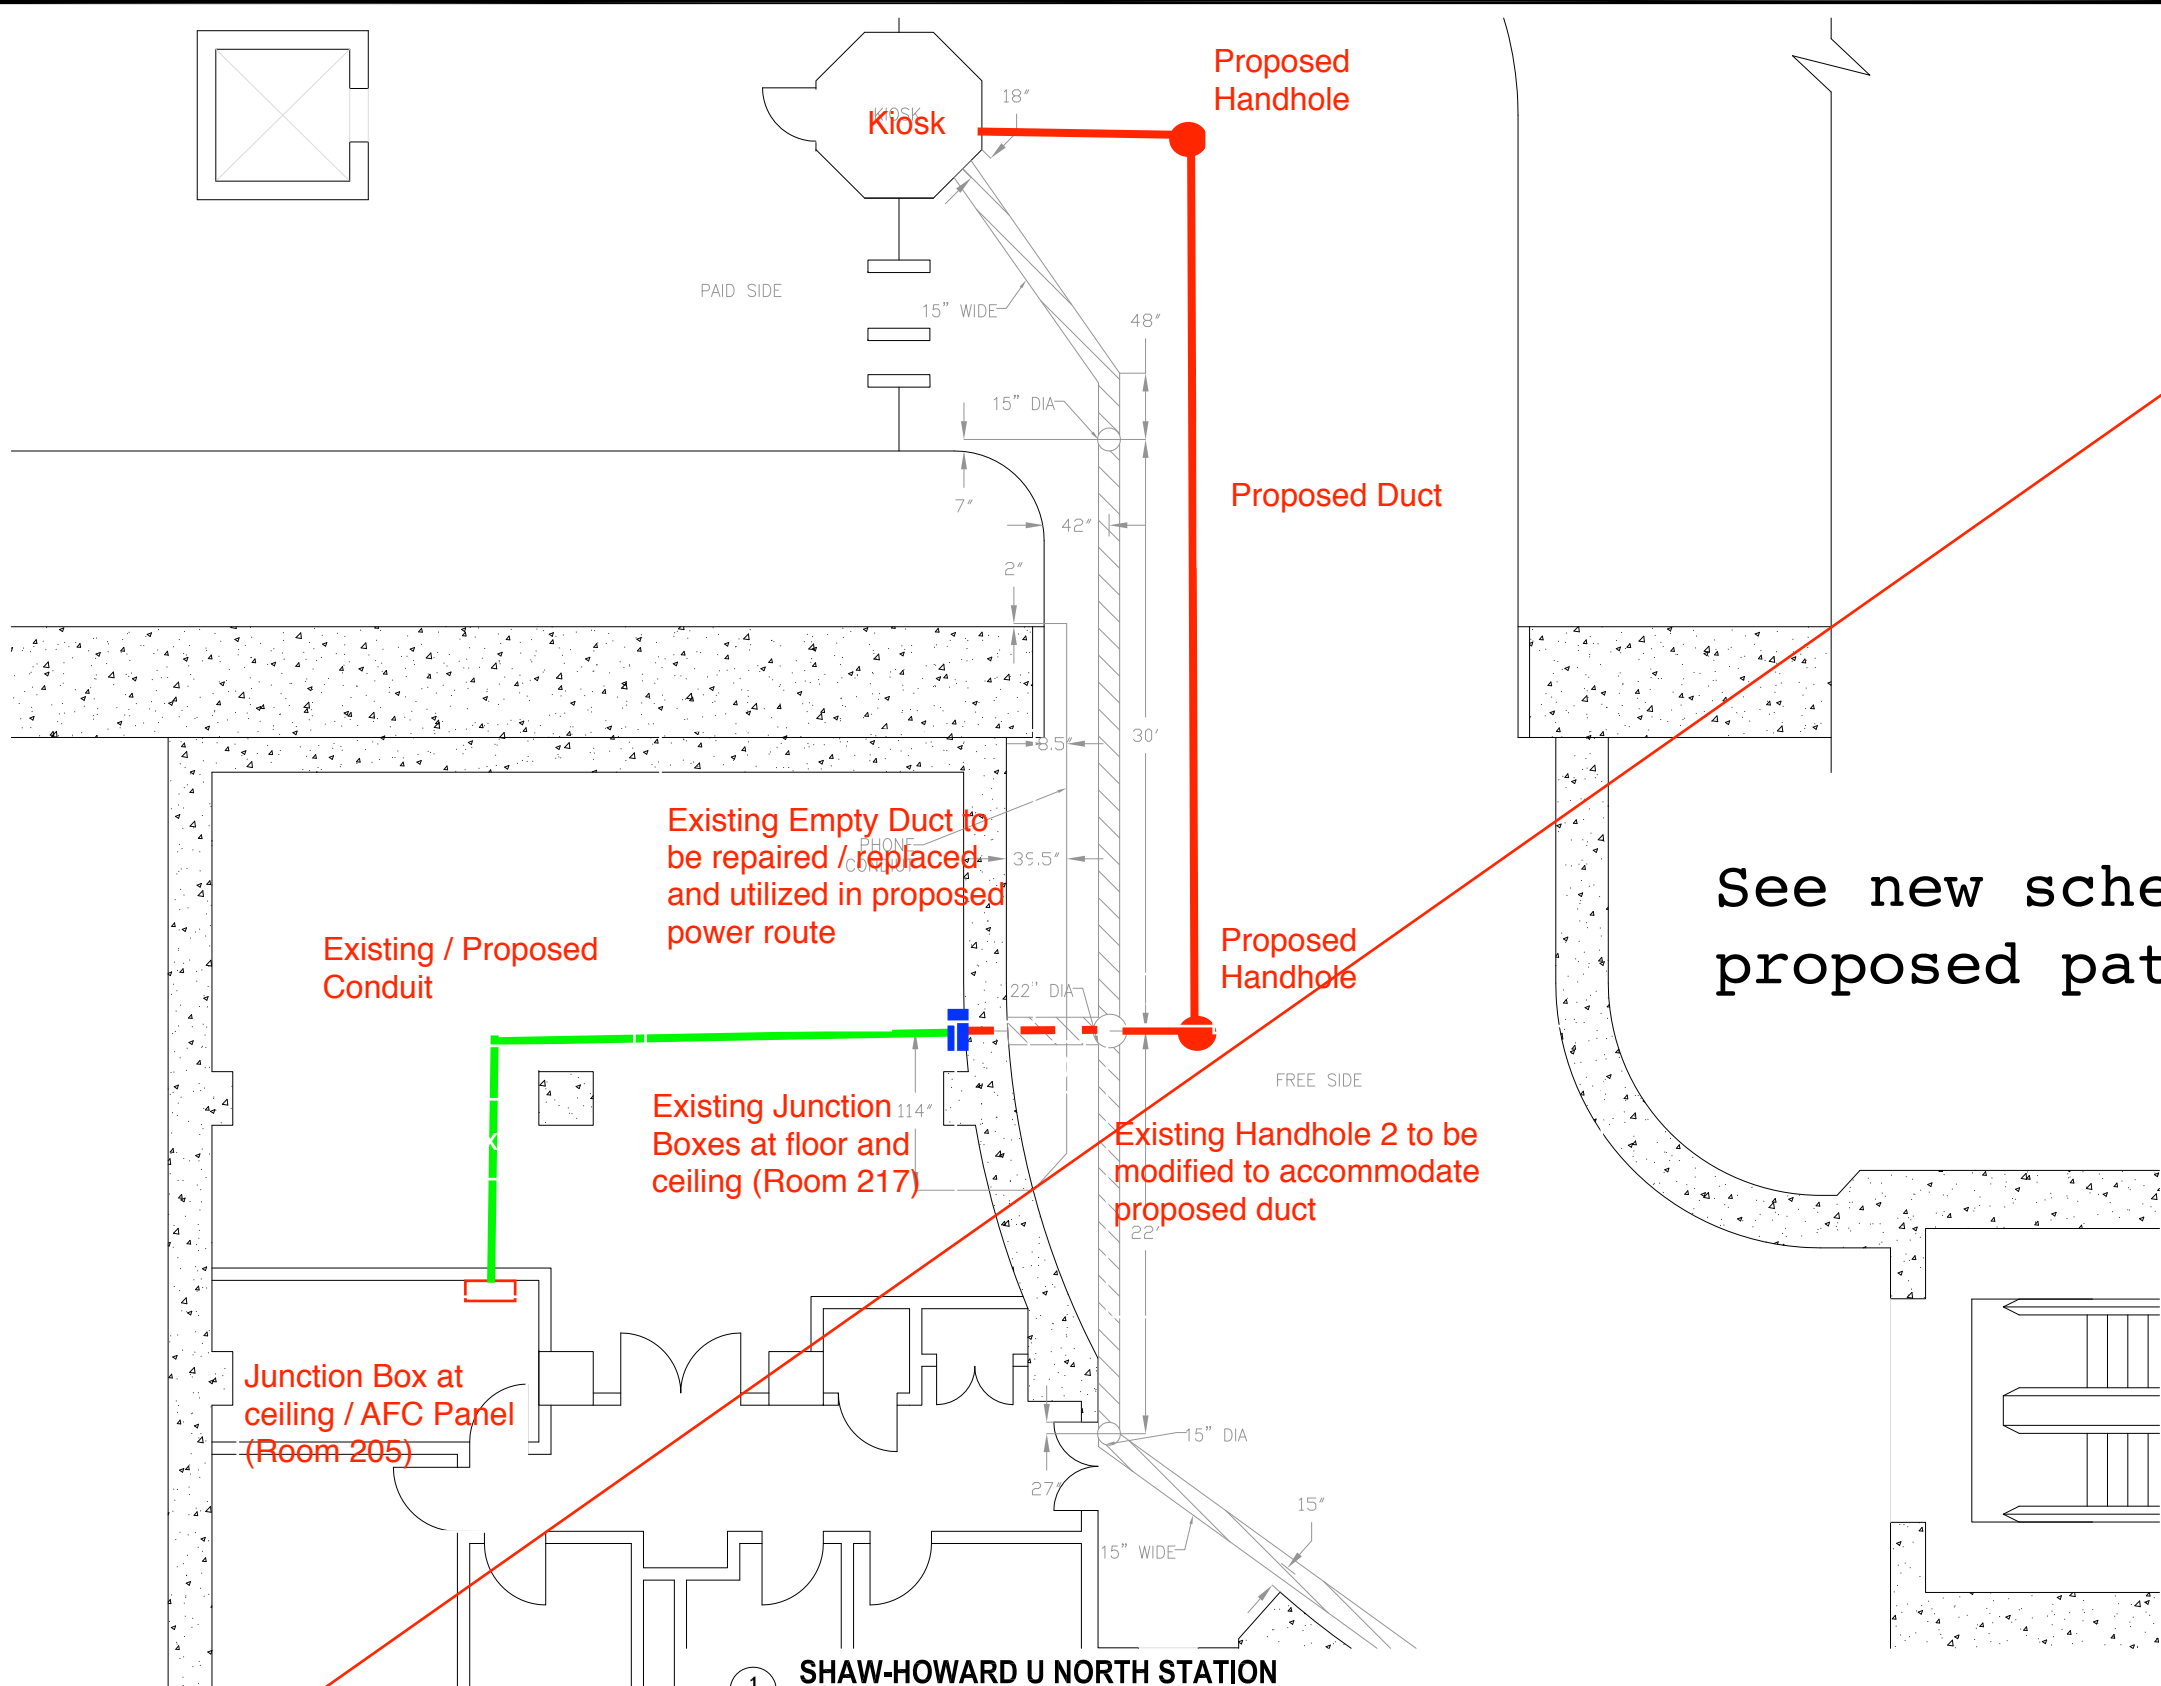
- Scanning of the mezzanine was completed to identify a new power route from the Kiosk to AFC Panel. The scanning results confirmed that there is no direct path to the AFC panel without crossing existing ducts / conduit or having to core drill through structural wall.

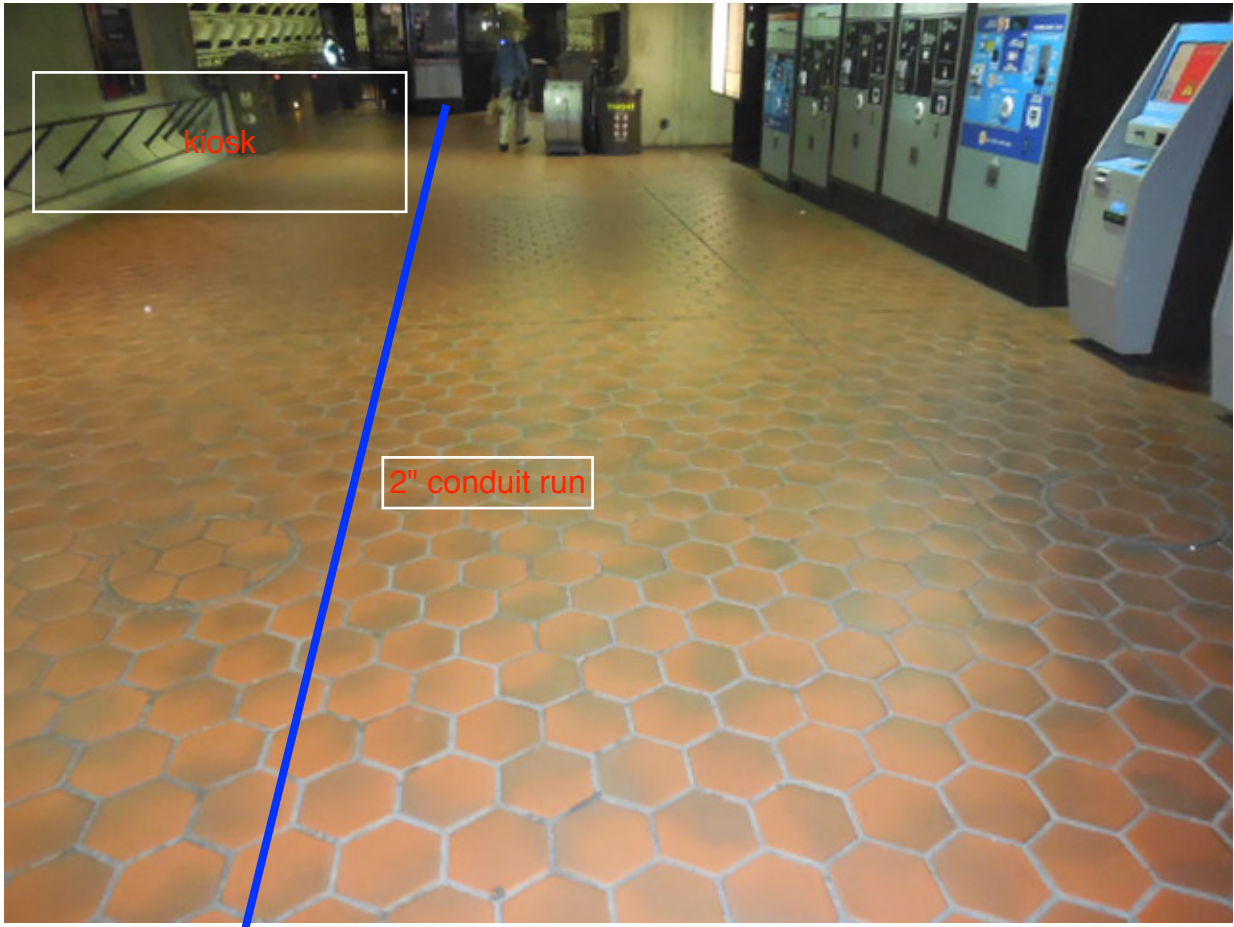
Photo #1 – E02 U Street East: existing conduit run from Kiosk towards junction box

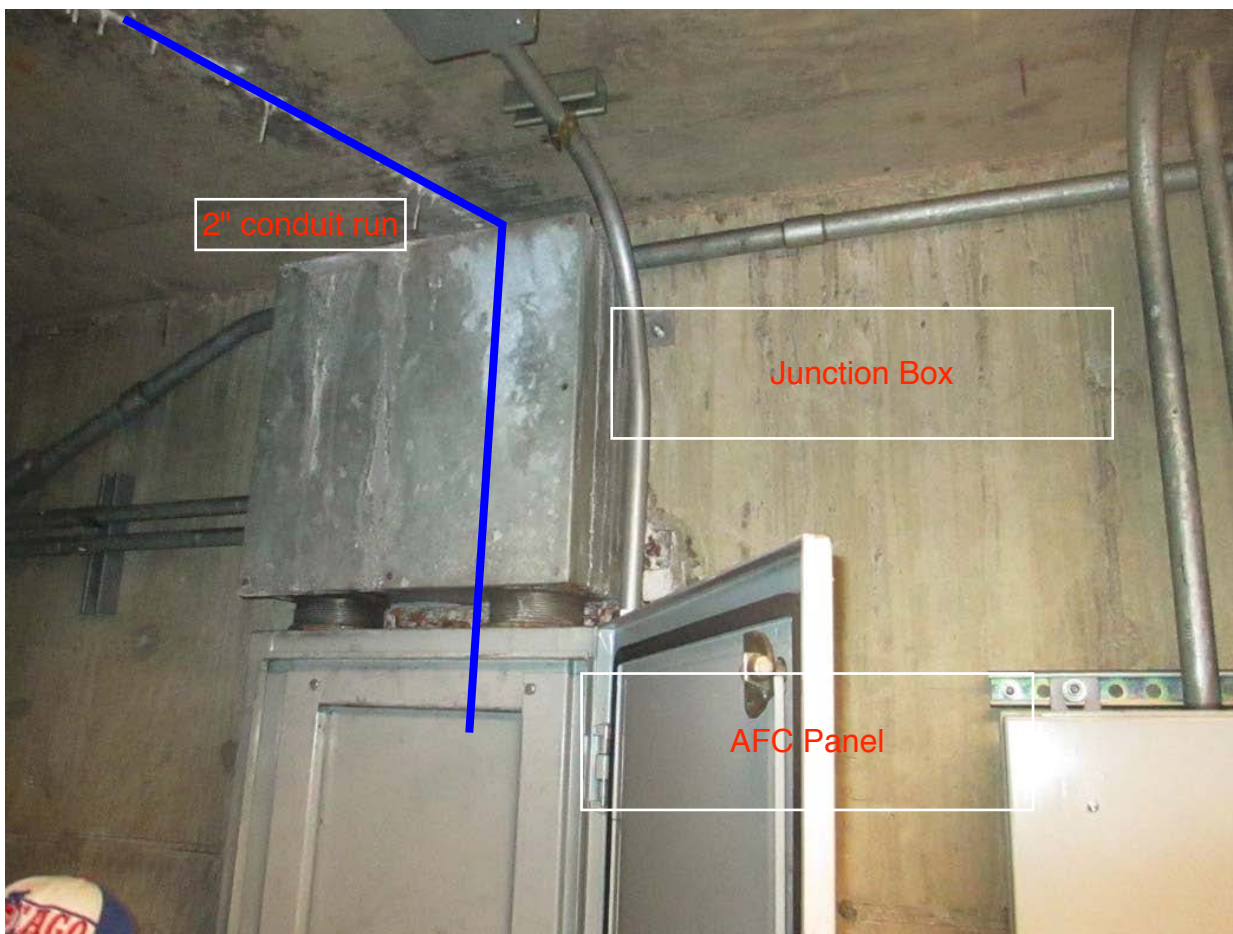
Photo #2 – E03 U Street East: Junction box directly above AFC panel in room #213
