## Mezzanine Inspection Report

<b>Date:</b> 11/26/2014	<b>Station Name:</b> E03 – U Street West	<b>Mezzanine #:</b> 074	<b>Completed By:</b> Mike Butler
-------------------------	--	-------------------------	----------------------------------

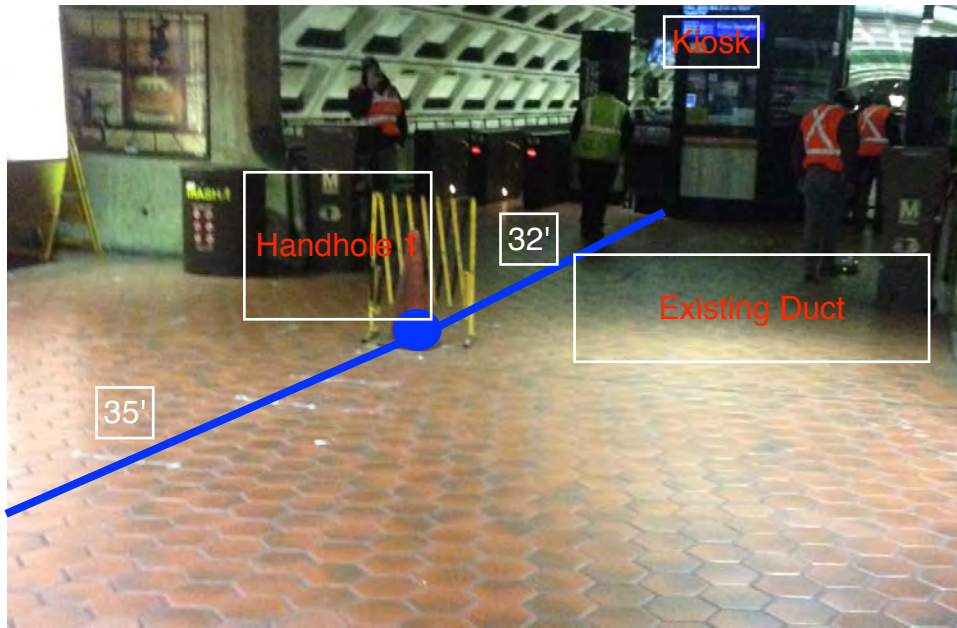
Photo #1 – Existing duct run on mezzanine floor

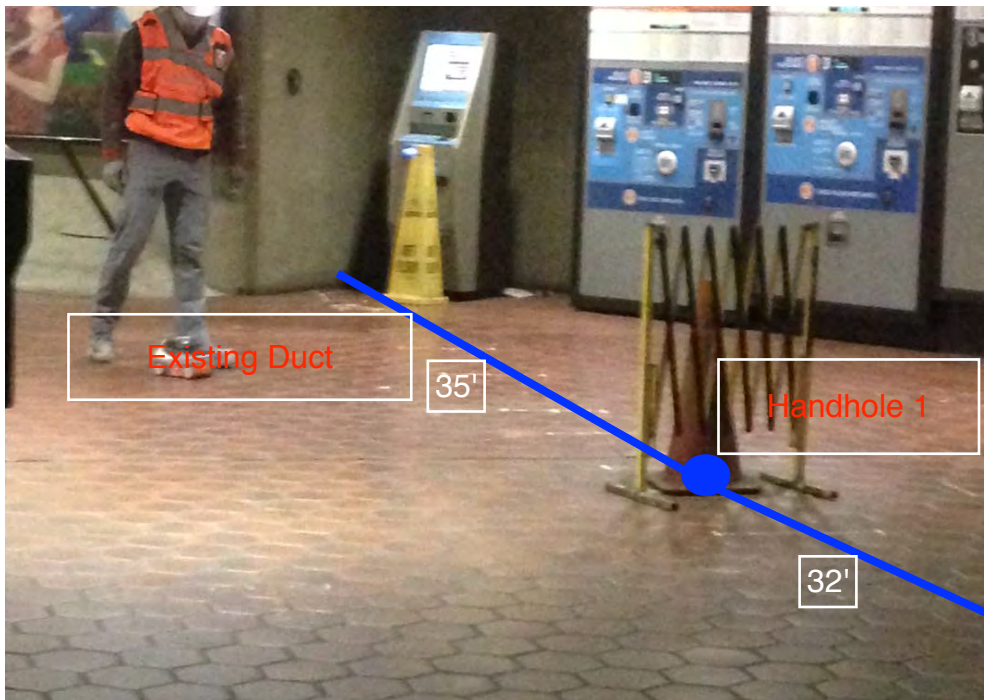
Photo #2 – Existing duct run on mezzanine floor

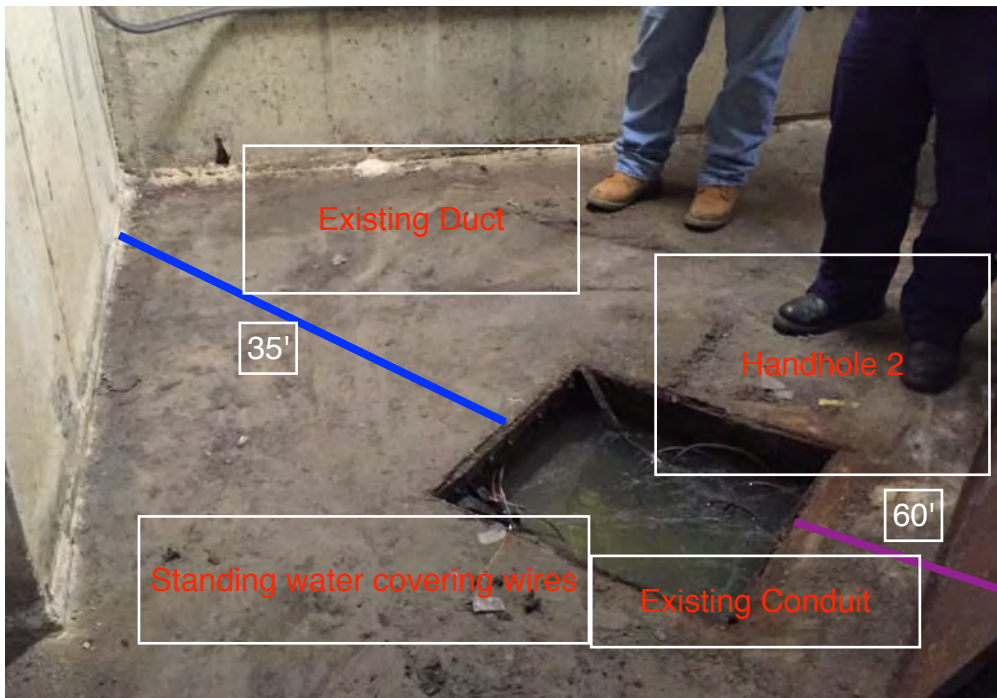
Photo #3 – Existing duct / conduit run in Room 214

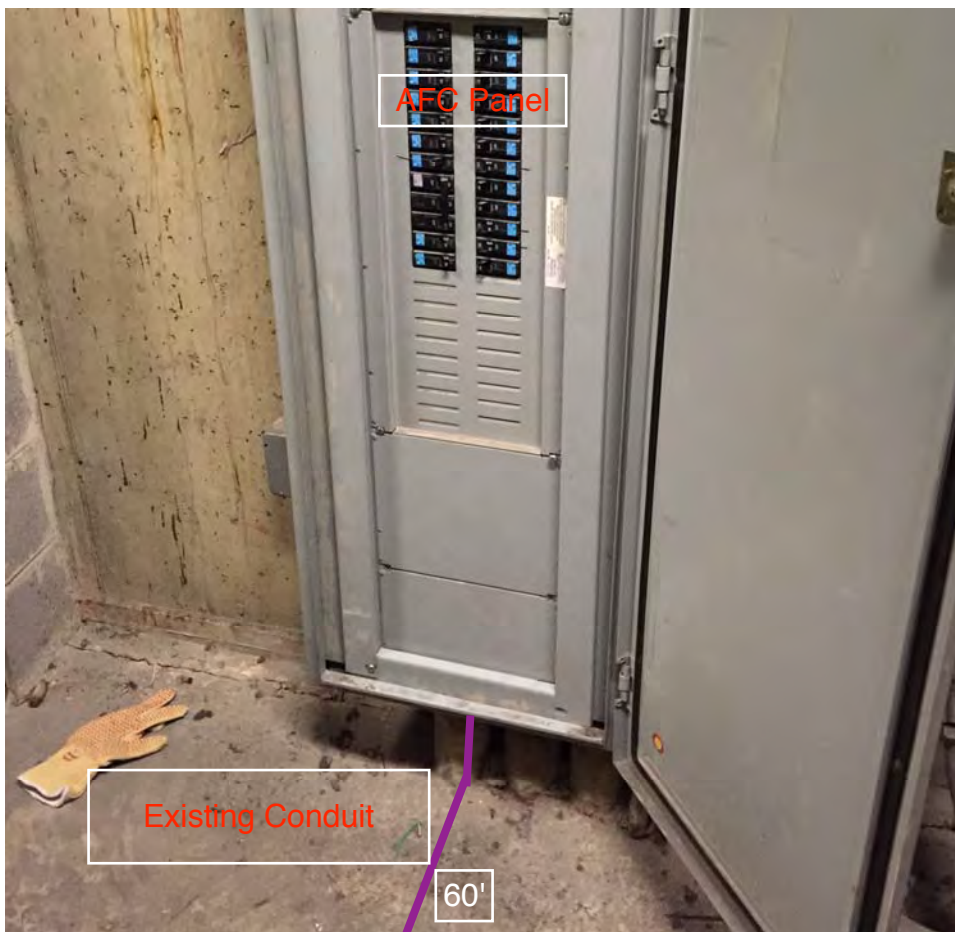
<b>Handhole 2 to AFC Panel (Distance: 60')</b>		
Was video scoping completed for the entire duct / conduit run?	No	Scoping not required in conduit.
Was pull string installed?	No	
Were there any obstructions or blockages? Provide details of type and specific location.	Yes	There was an obstruction 30' from AFC panel towards Handhole 2.
Is the duct / conduit at capacity? Provide additional details about the dimensions of duct / conduit and number of wires.	No	2" conduit with less than 8 wires.
<b>Observations / Issues / Next Steps</b>		
<p>This station is known to flood regularly leaving in-floor ducts vulnerable to water intrusion and corrosion. The total distance of proposed overhead conduit from Kiosk to AFC Panel is 182'.</p>		
<b>Sign Off</b>		
	<b>GFP Representative</b>	<b>WMATA PRGM</b>
<b>Name:</b>	Mike Butler	
<b>Signature:</b>

Photo #4 – Existing conduit run to AFC Panel in Room 212

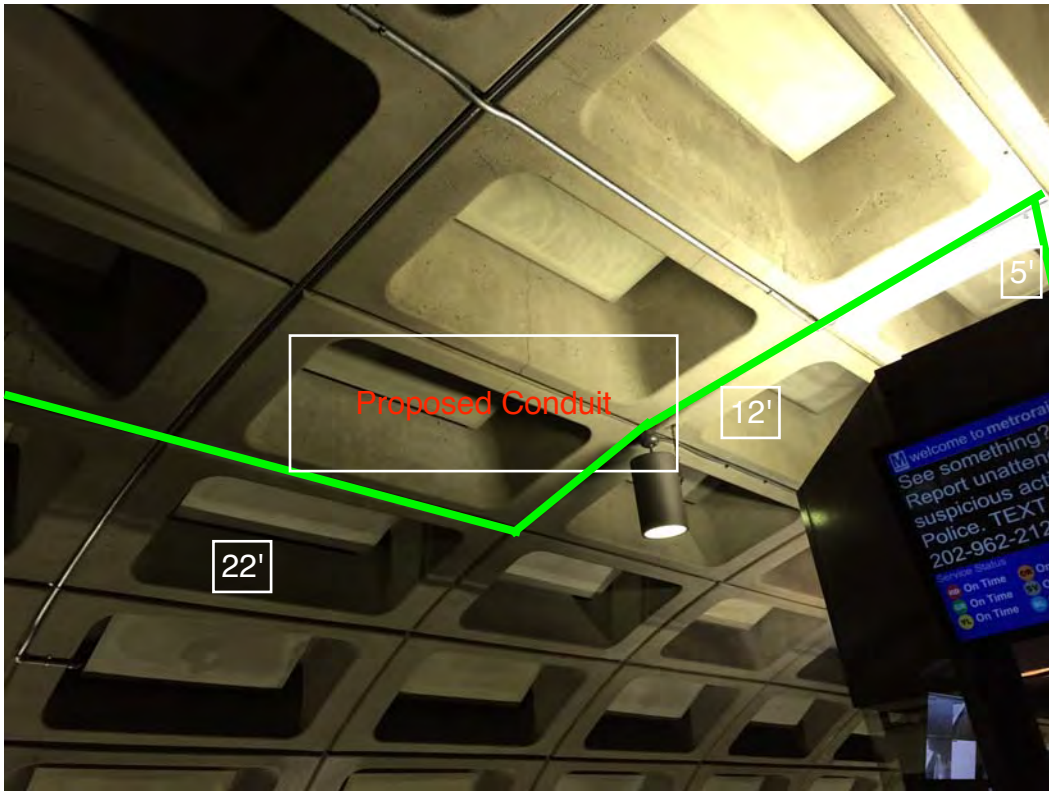
Photo #5 – Proposed overhead conduit at mezzanine

Scanning was conducted to identify a new power route from the Kiosk to AFC Panel. The results showed that there is no viable path for an in-floor duct, therefore a proposed overhead conduit is recommended between the Kiosk and AFC Panel. The proposed conduit will rise up vertically from the Kiosk and run along the recessed part of the vaulted ceiling towards the head wall. The proposed conduit will then pass under passageway's arch and run up into the ceiling plenum. The proposed conduit will run for a short distance along the passageway's ceiling plenum and then will core drill through wall into Room 214. Once inside Room 214, the conduit will snake around the wall, core drill through the CMU wall into Room 212 and then feed into the AFC Panel.

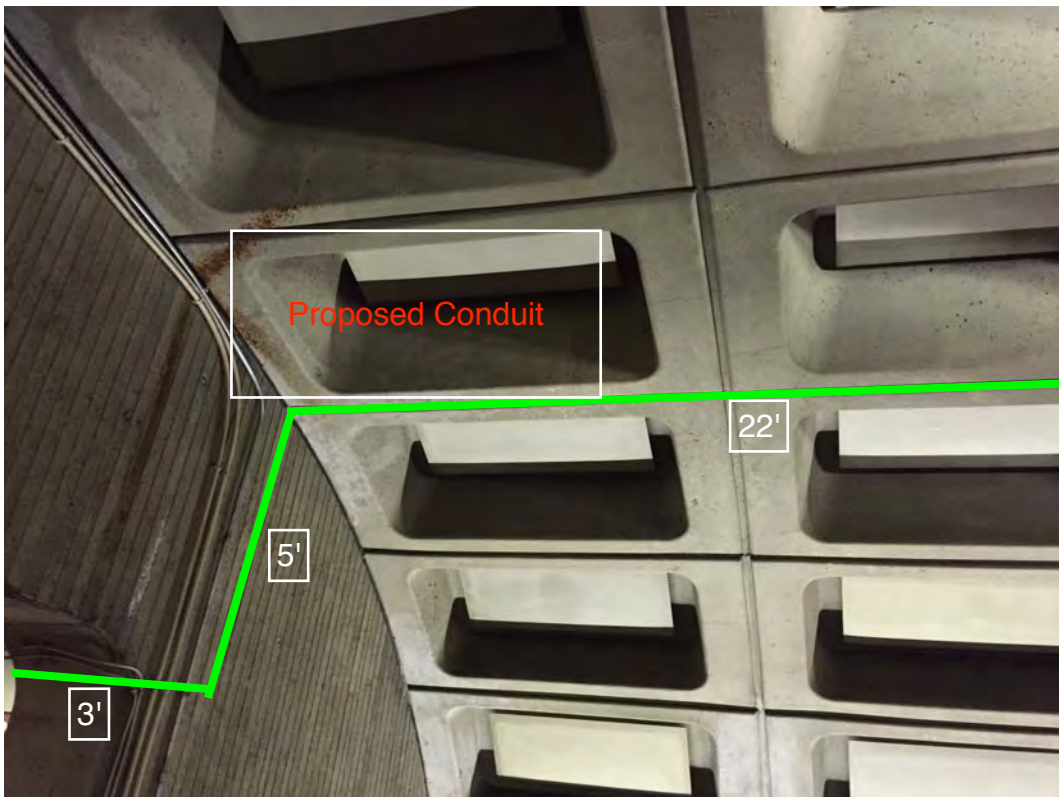
Photo #6 – Proposed overhead conduit at mezzanine
