## Mezzanine Inspection Report (Scoping)

Date: 01/16/2015	Station Name: E05 Georgia Avenue	Mezzanine #: 076	Completed By: Byron Williams
------------------	----------------------------------	------------------	------------------------------

NEW ELECTRONIC PAY PROGRAM (NEPP)  
IN METRORAIL STATIONS  
GEORGIA AVENUE  
MEZZANINE KIOSK - POWER

Date: 1/21/2015	Station Name: E07 West Hyattsville	Mezzanine #: 077	Completed By: Mike Butler
-----------------	------------------------------------	------------------	---------------------------

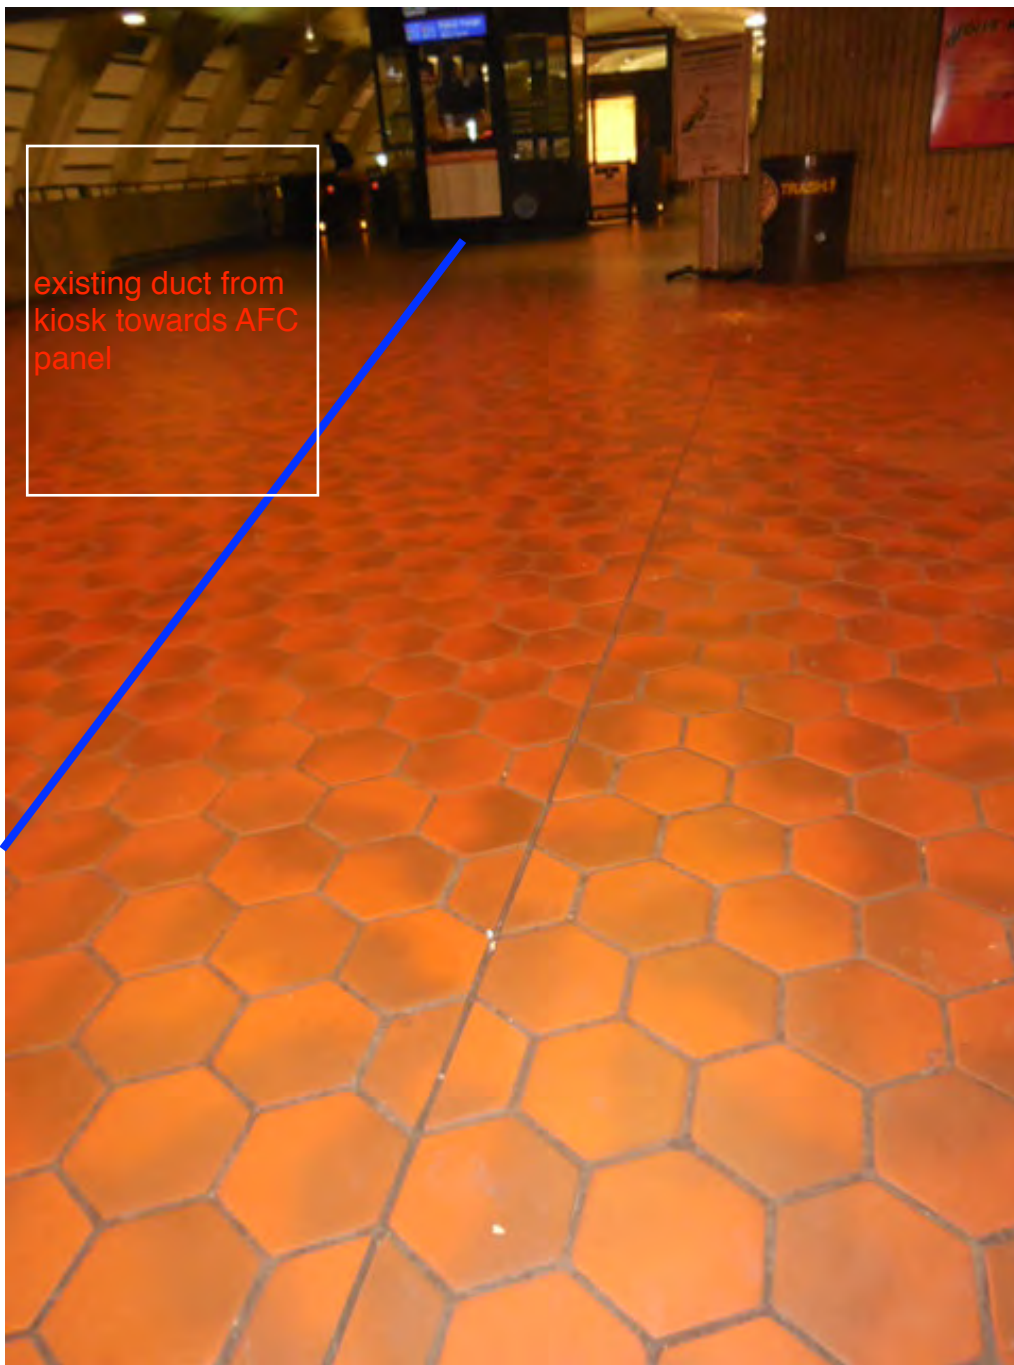
Photo #1 – E05 Georgia Avenue: Duct run from kiosk towards handhole 1

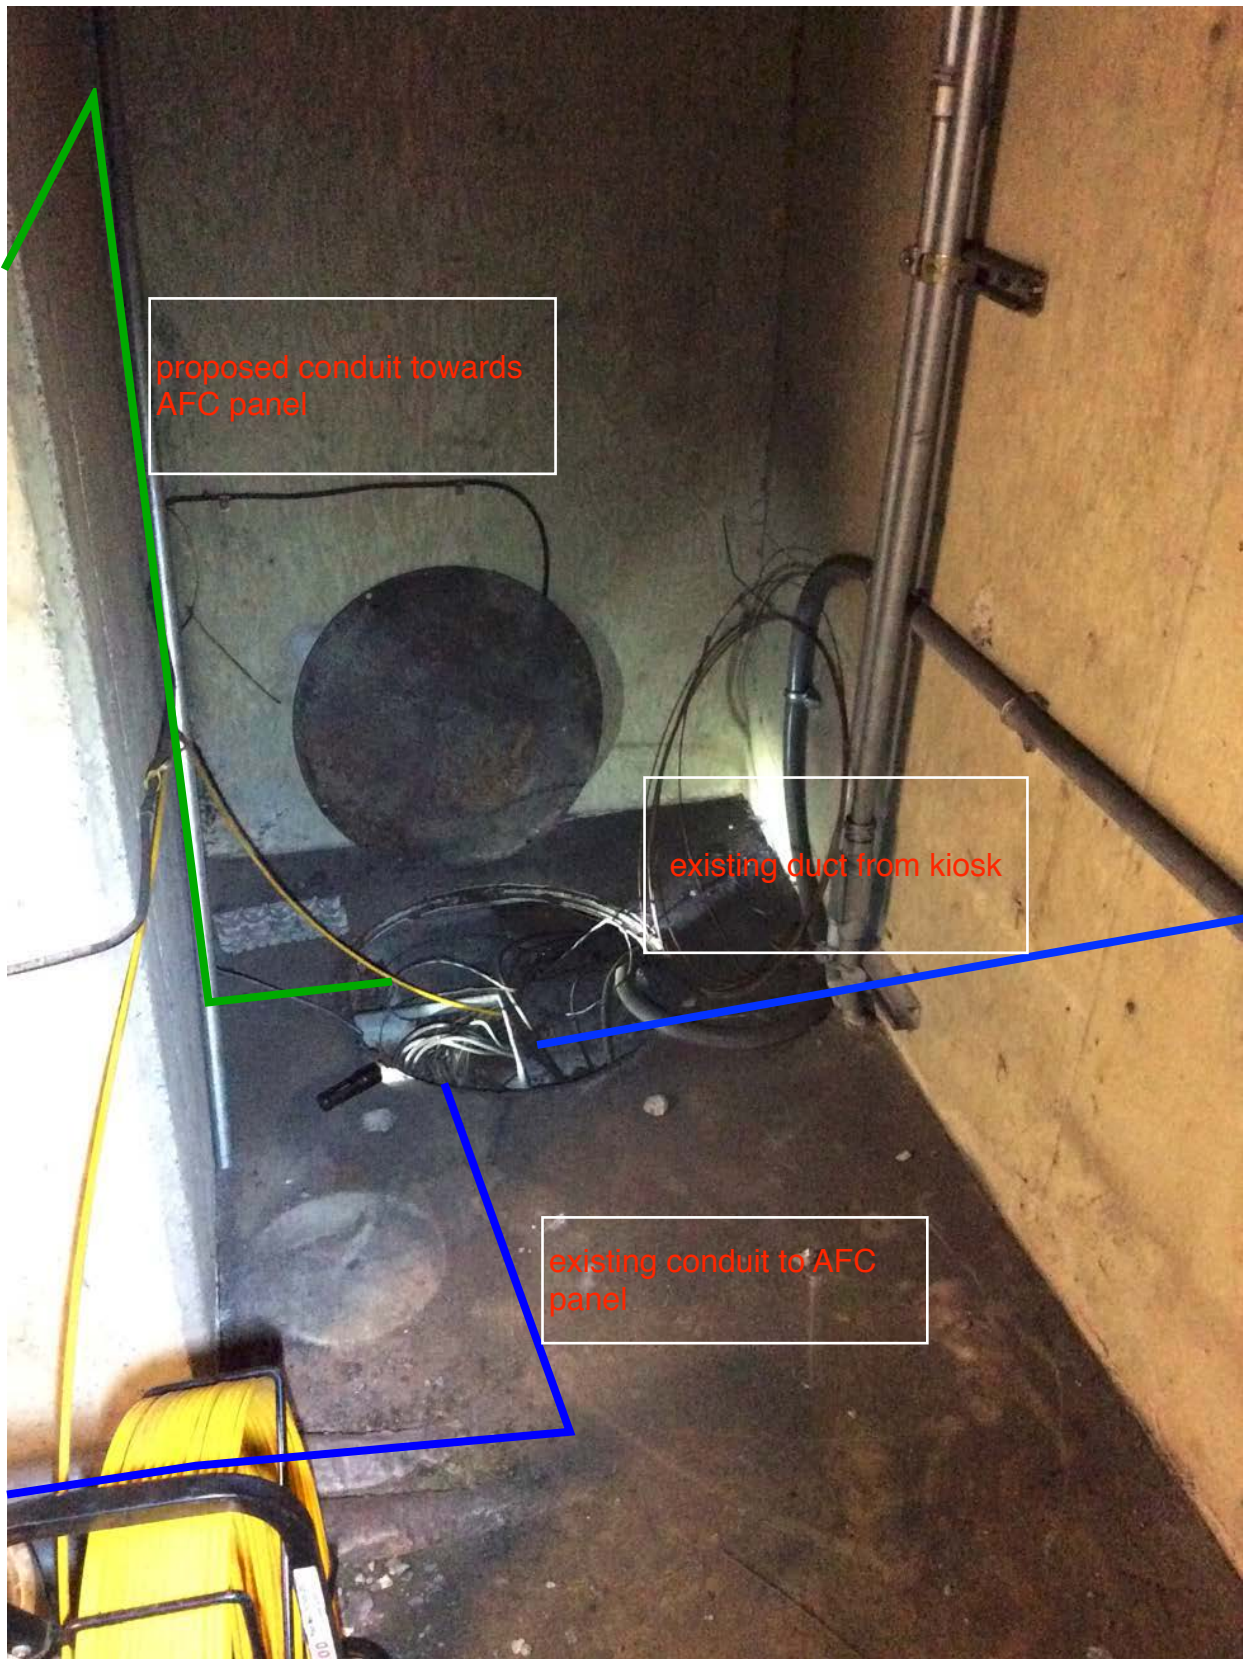
Photo #2 – E05 Georgia Avenue: Duct run into handhole 1 and conduit from handhole 1 to AFC panel

<b>Observations / Issues / Next Steps</b>		
<p>Existing power run from kiosk to AFC panel is approximately 75 feet.</p> <p>Proposed run would use existing duct from kiosk to handhole 1 of 55 feet and a new conduit run of 20 feet for a new total run from kiosk to AFC panel of approximately 75 feet.</p>		
<b>Sign Off</b>		
	<b>GFP Representative</b>	<b>WMATA PRGM</b>
<b>Name:</b>	Byron Williams	
<b>Signature:</b>

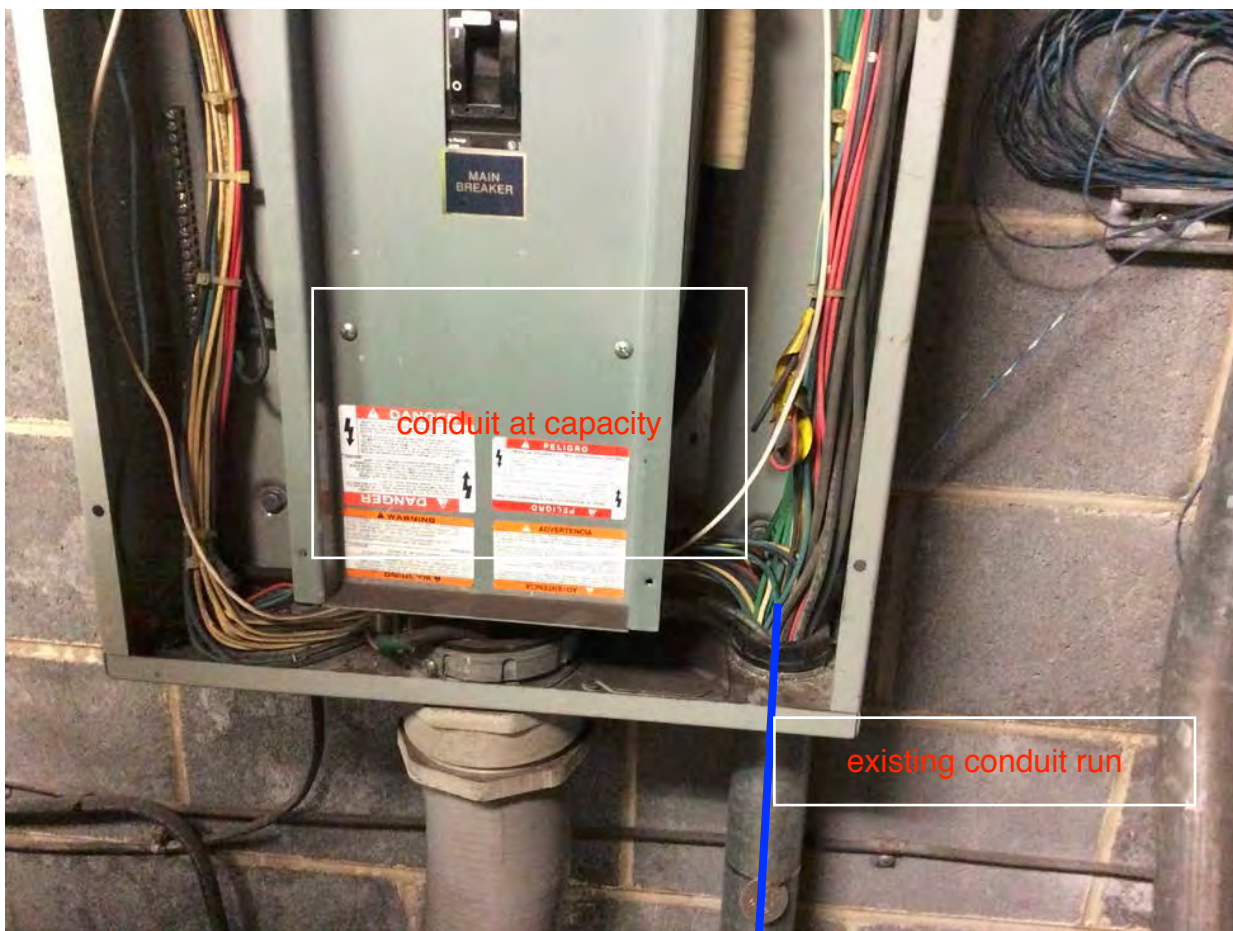
Scoping of Power Duct - Kiosk to AFC Panel		
Task	Yes/No	Notes
<b>Kiosk to Handhole 1 (55' run)</b>		
Was video scoping completed for the entire duct / conduit run?	Yes	Refer to WMATA Georgia Ave Power Kiosk to Floor Box.avi file.
Was pull string installed?	Yes	
Were there any obstructions or blockages? Provide details of type and specific location.	No	
Is the duct / conduit at capacity? Provide additional details about the dimensions of duct / conduit and number of wires.	No	6" duct, less than 15 wires
<b>Handhole 1 to AFC Panel (20' run)</b>		
Was video scoping completed for the entire duct / conduit run?	No	2" conduit – no scoping required
Was pull string installed?	No	
Were there any obstructions or blockages? Provide details of type and specific location.	No	
Is the duct / conduit at capacity? Provide additional details about the dimensions of duct / conduit and number of wires.	Yes	2" conduit has more than 20 wires and is at capacity

Photo #3 – E05 Georgia Avenue: AFC panel with existing at capacity conduit

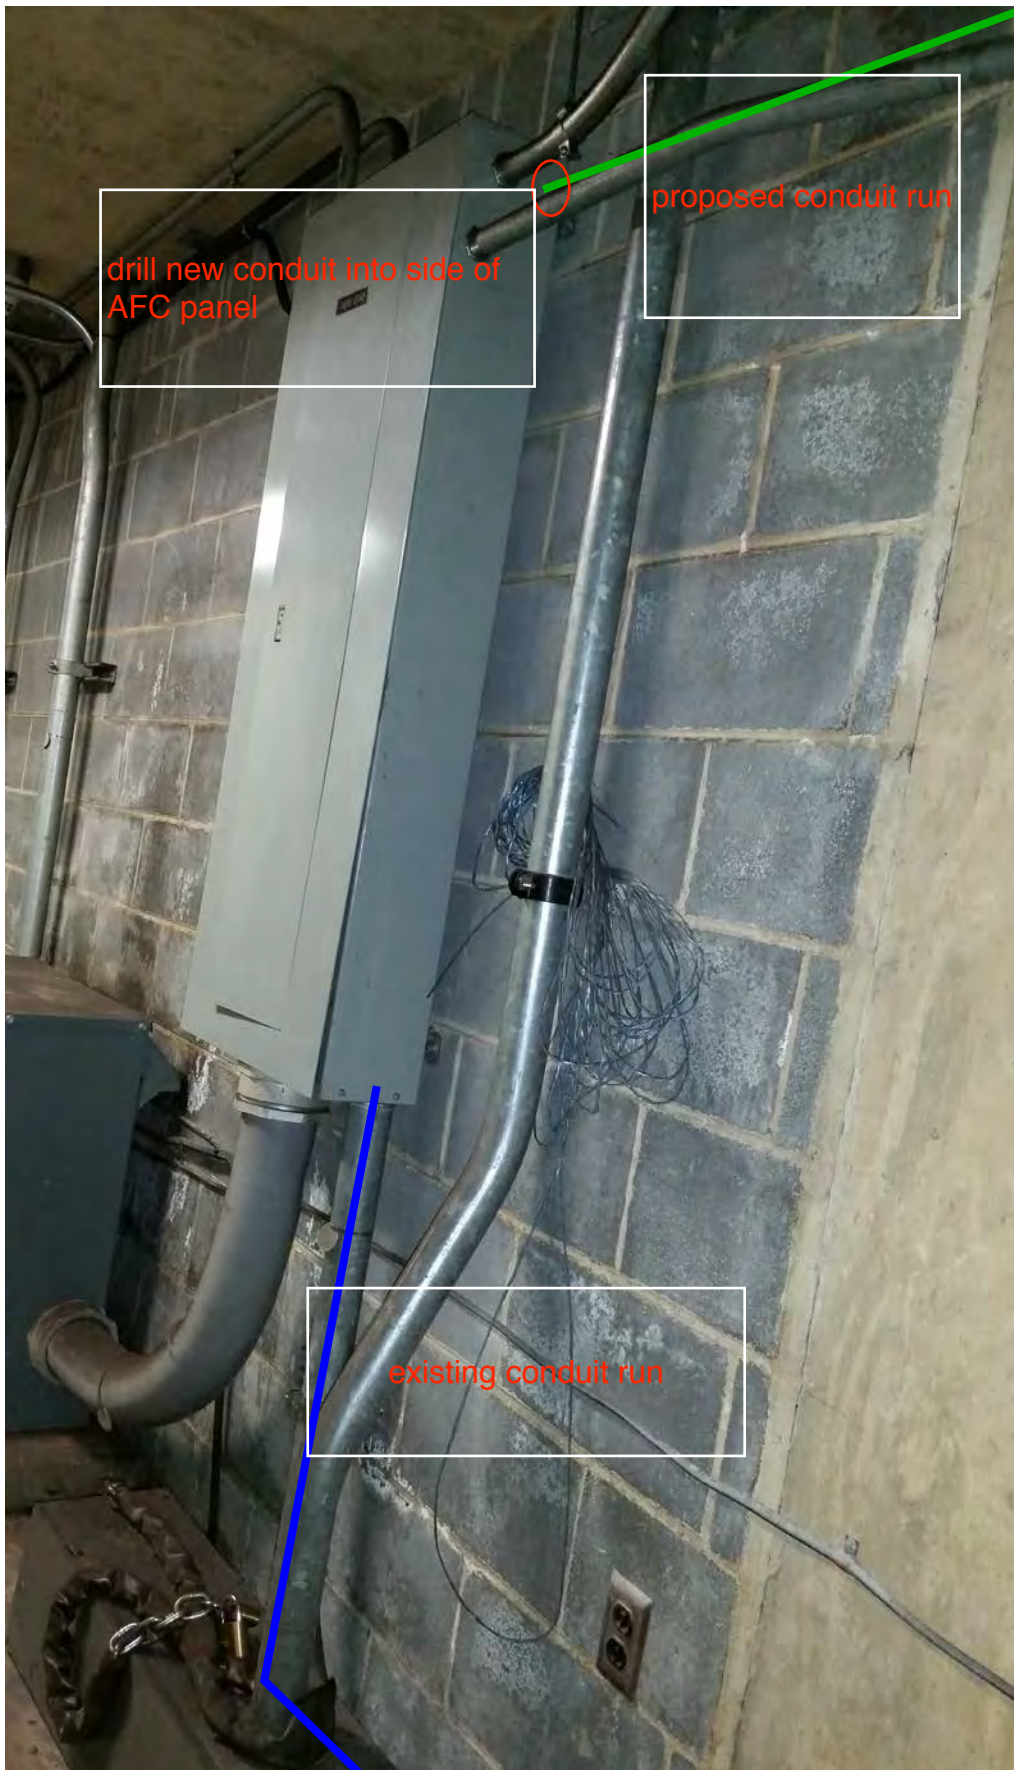
Photo #4: E05 Georgia Avenue: AFC panel with proposed conduit run from handhole 1

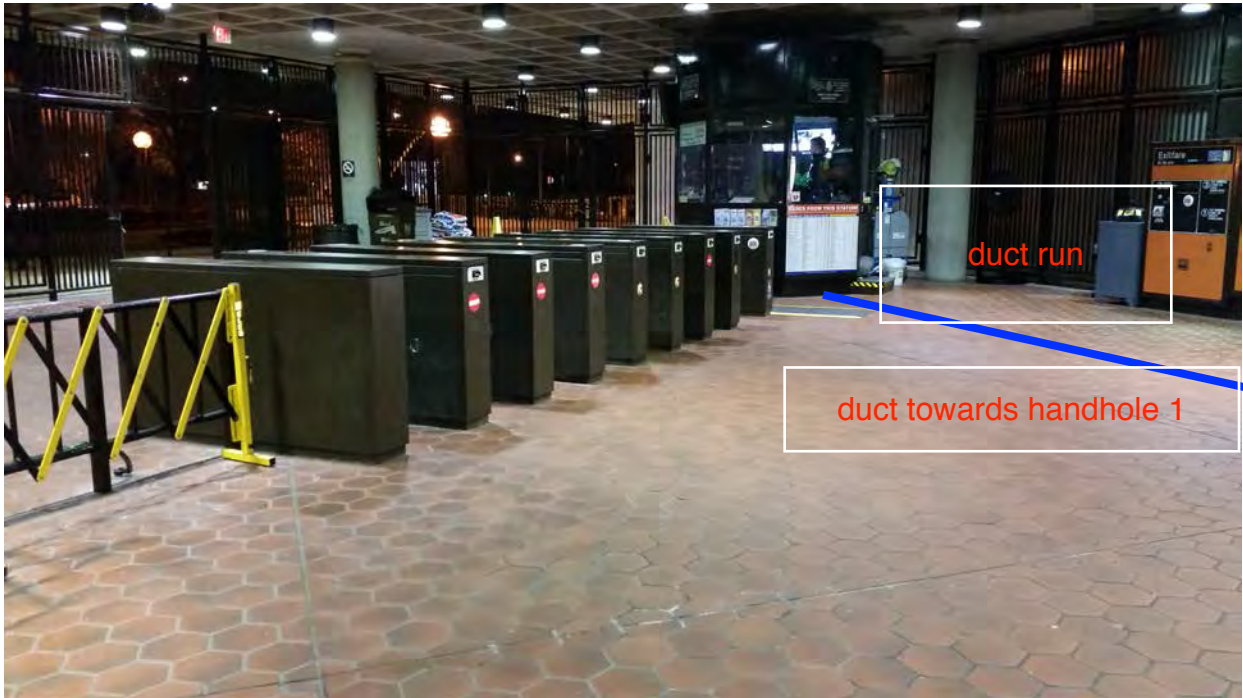
Photo #1 – E07 West Hyattsville: Duct run from kiosk towards handhole 1

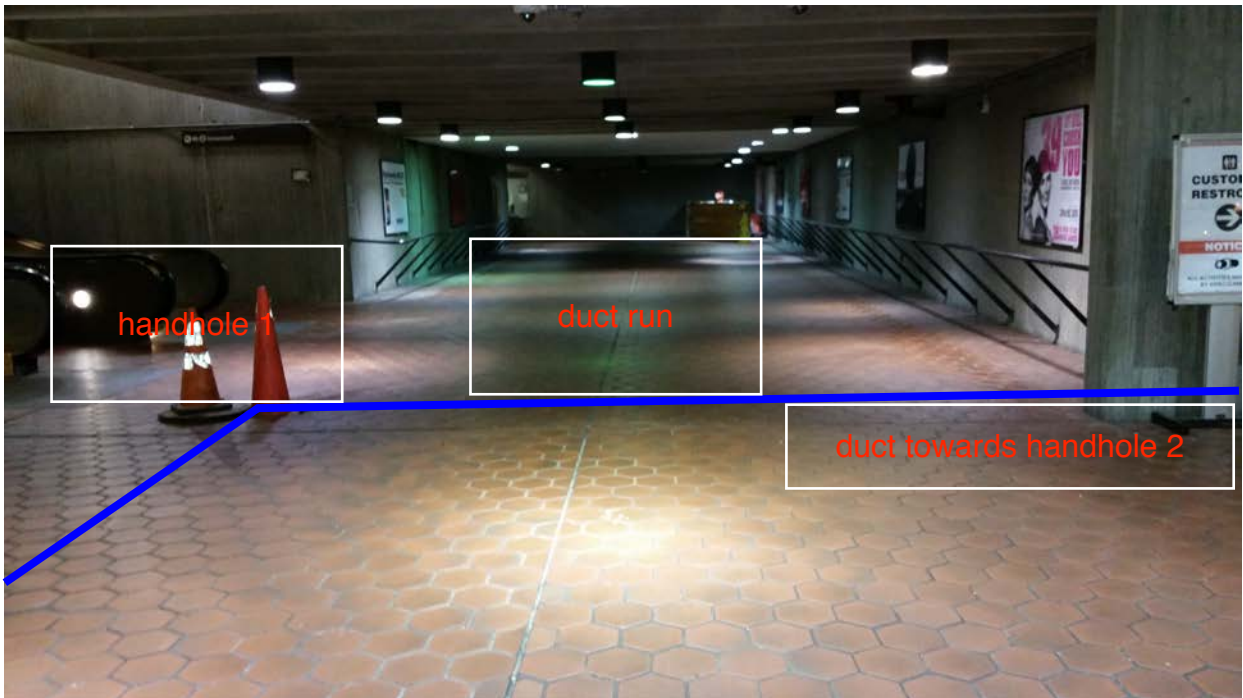
Photo #2 – E07 West Hyattsville: Duct run from handhole 1 to handhole 2

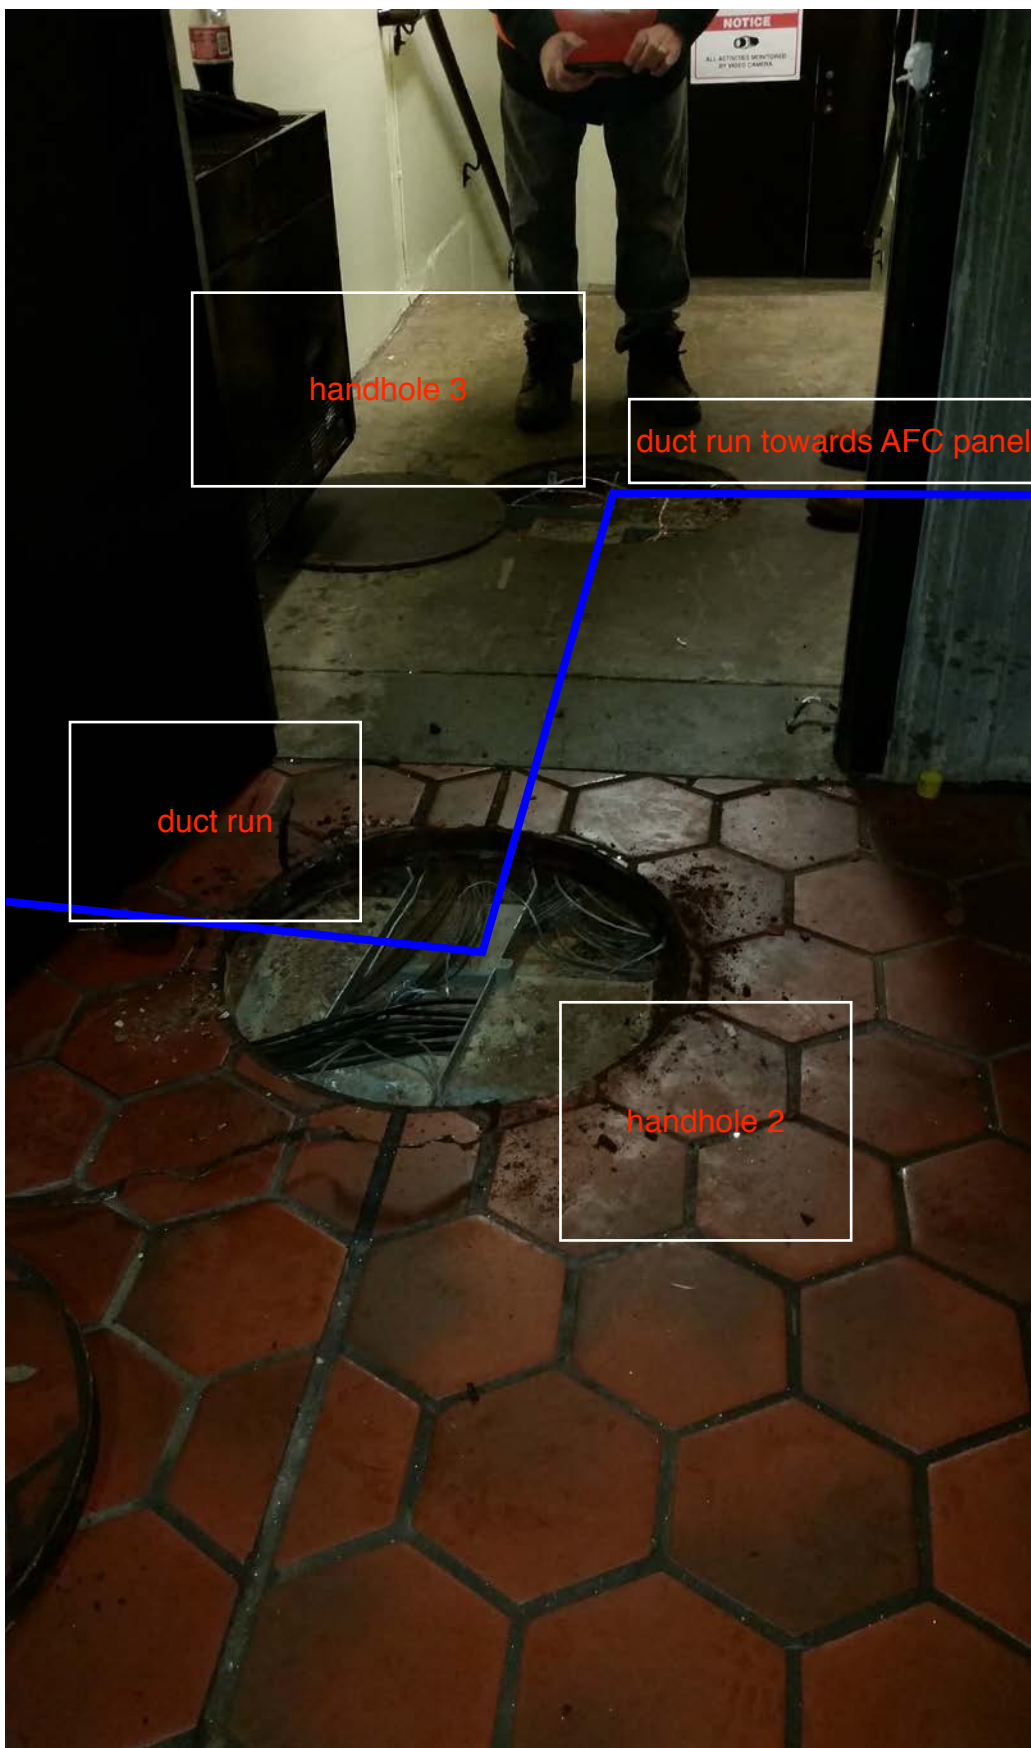
<b>Handhole 2 to Handhole 3 (5' Run)</b>		
Was video scoping completed for the entire duct / conduit run?	Yes	Refer to "WMATA West Hyattsville 6inch Power H.H.2 to H.H.3 Video.avi"
Was pull string installed?	Yes	
Were there any obstructions or blockages? Provide details of type and specific location.	No	Minor dust and rust
Is the duct / conduit at capacity? Provide additional details about the dimensions of duct / conduit and number of wires.	No	6" duct less than 10 wires
<b>Handhole 3 to AFC Panel (20' Run)</b>		
Was video scoping completed for the entire duct / conduit run?	Yes	Refer to "WMATA West Hyattsville 6inch Power H.H.3 to AFC Panel J-box Video.avi"
Was pull string installed?	Yes	
Were there any obstructions or blockages? Provide details of type and specific location.	No	Minor dust and rust
Is the duct / conduit at capacity? Provide additional details about the dimensions of duct / conduit and number of wires.	No	6" duct less than 10 wires

Photo #3 – E07 West Hyattsville: Duct run from handhole 2 to handhole 3

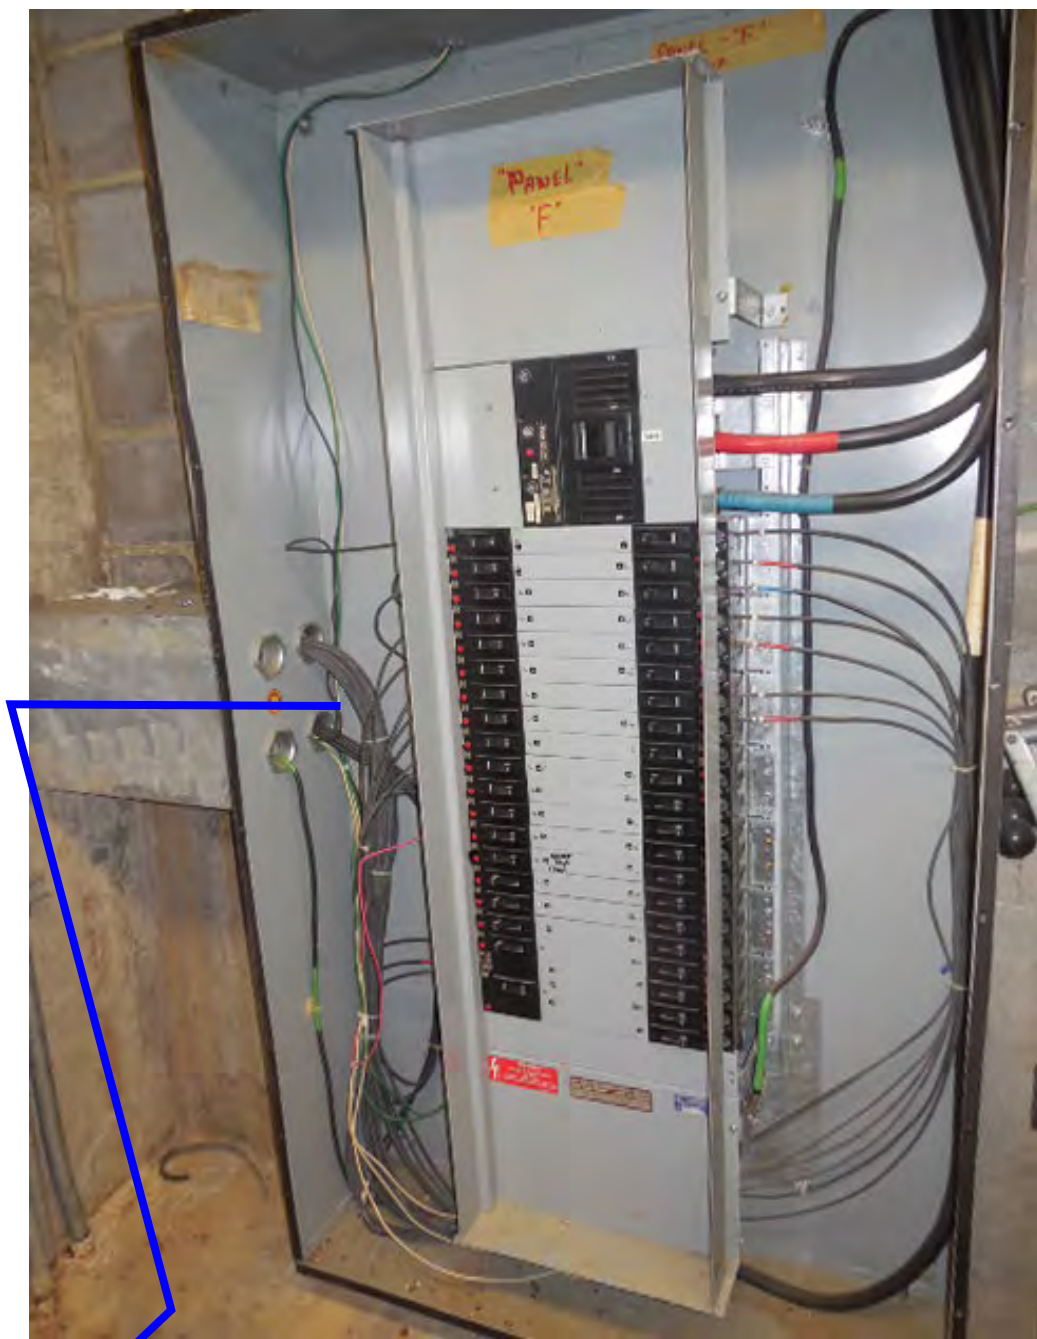
Photo #4 – E07 West Hyattsville: Duct run to AFC panel from handhole 3
