Mezzanine Inspection Report (Scoping)

Date: 11/7/144 Station Name: E08 - PG Plaza Mezzanine #: 078 Completed By: Mike Butler

| Mezzanine Inspection Report (Scoping) | | | | |
|--|---|---|---|---|
| Date: 11/06/2014 | Station Name: E09 College | e Park | Mezzanine #: 079 | Completed By: Dion Small |

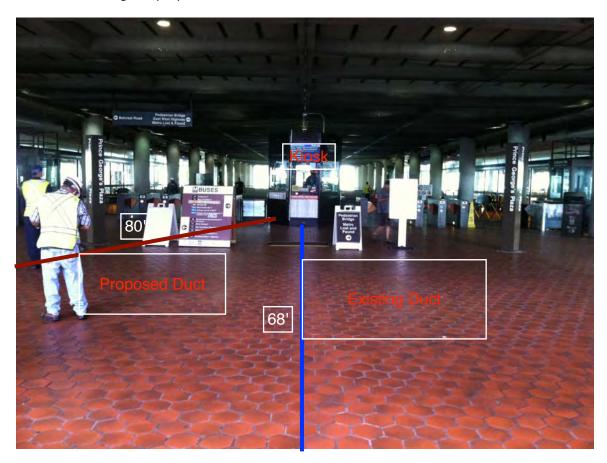
Photo #1 – Existing and proposed ducts on mezzanine floor

Scanning was conducted to identify a new power route between the Kiosk and AFC Panel. A new power duct is proposed to run directly from Kiosk to Room 210 where the AFC Panel is situated. The duct will require two new handholes and a new junction box. A new conduit is proposed to run overhead from the junction box where it will go up the wall, across the ceiling and then feed into the AFC Panel. Refer to photos and drawings for further details.

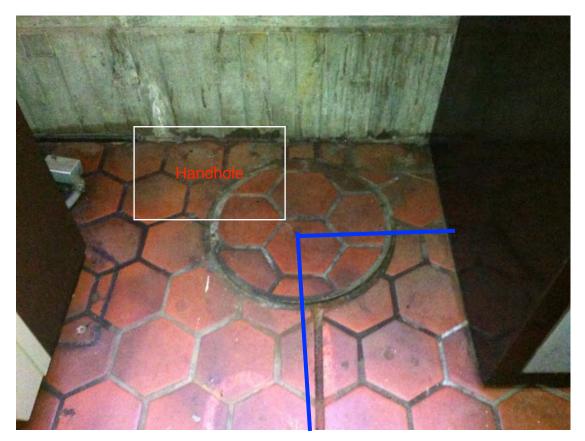
Photo #2 – Handhole adjacent to fare vending machines on mezzanine floor

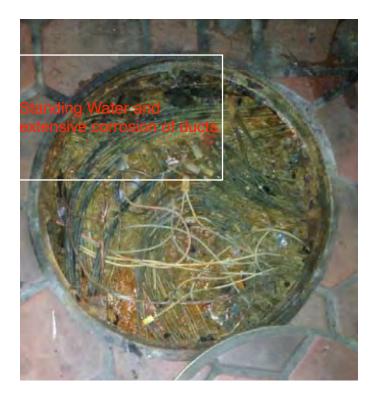
| Scoping of Power Duct - Kiosk to AFC Panel | | | | |
|---|---|---|---|--|
| Was video scopir conduit run? | ng completed for the entire duct / | No | Video sco inside ha | oping could not be completed due to standing water ndhole. |
| Were there any ol details of type and | ostructions or blockages? Provide d specific location. | Yes | The duct | was blocked near handhole. |

Photo #3 – Condition of Handhole.

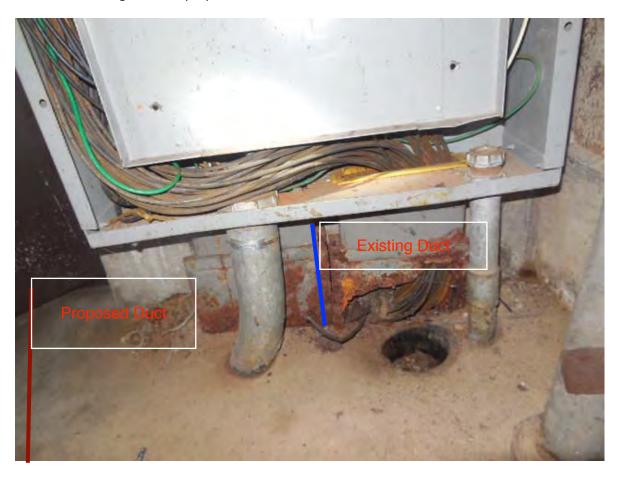
Photo #4 – Existing duct and proposed duct in Room 210

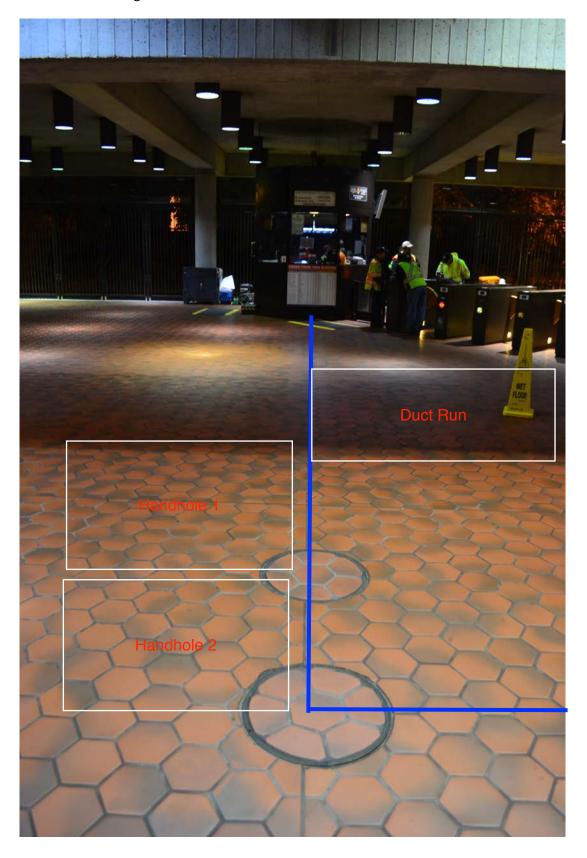
Photo #1: E09 College Park – Power duct run between Kiosk and Handhole 1 and Handhole 2

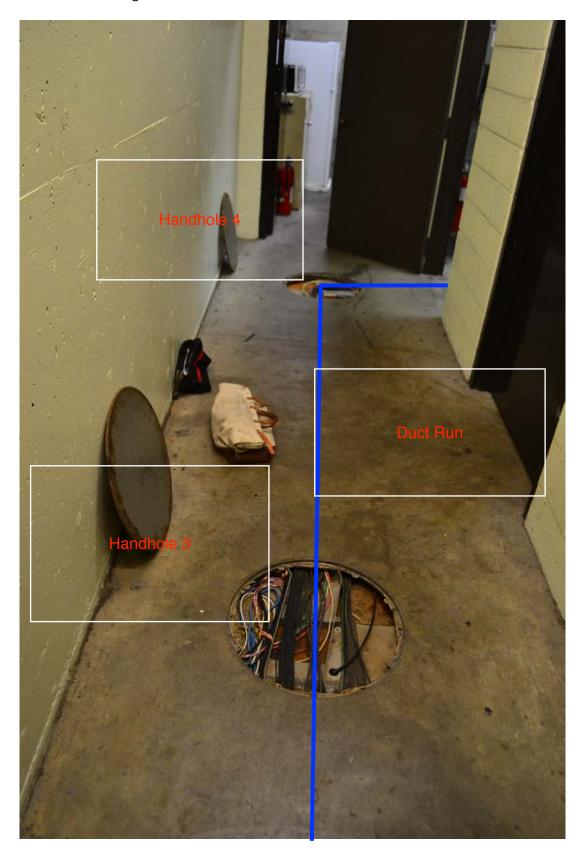
Photo #2: E09 college Park – Power duct run between Kiosk and Handhole 3 and Handhole 4

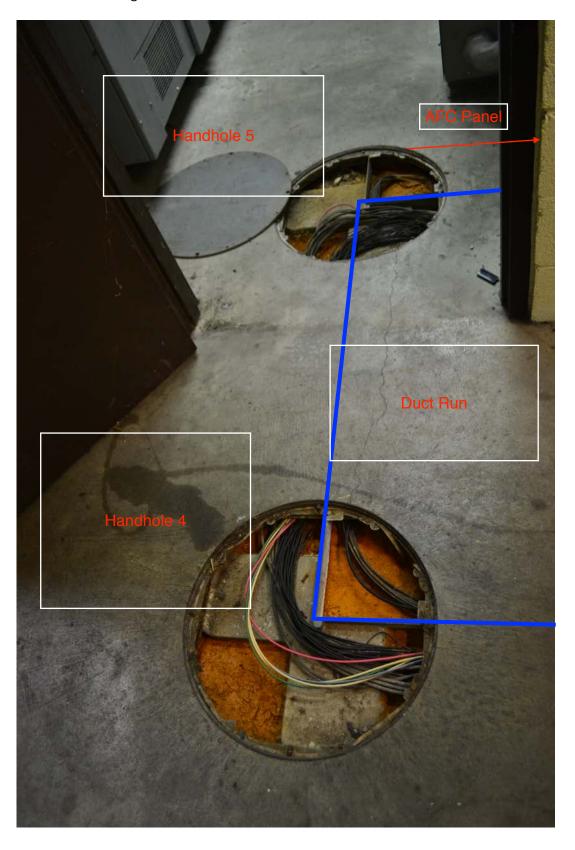
Photo #3: E09 College Park – Power duct run between Kiosk and Handhole 4 and Handhole 5
