## Mezzanine Inspection Report

Date: 10/27/14	Station Name: E10 Greenbelt	Mezzanine #: 080	Completed By: Mike Butler
----------------	-----------------------------	------------------	---------------------------

15-NEPP-01  
IN - FLOOR DUCT INSPECTIONS  
E10 GREENBELT  
EXISTING/PROPOSED DUCT & CONDUIT ROUTE

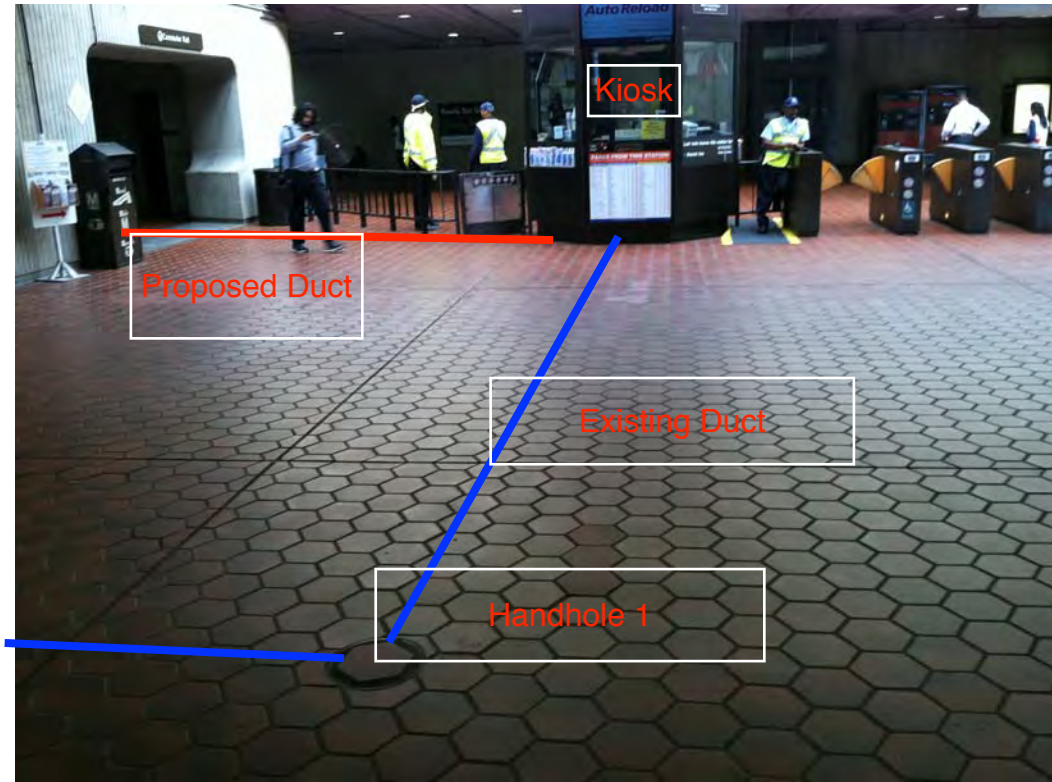
Photo #1 – Existing and Proposed Duct Route

Scanning was conducted to identify a new route for power between Kiosk and AFC Panel. Based on the scanning results, a new power duct is proposed between the Kiosk to Room C100. Before entering Room C100, the duct will change direction through a proposed handhole and then will transition to an overhead conduit through a second proposed handhole and new junction box. The conduit will continue overhead to the end of the hallway and pass through the end wall (by core drilling) to Room C106 before feeding into the AFC Panel.

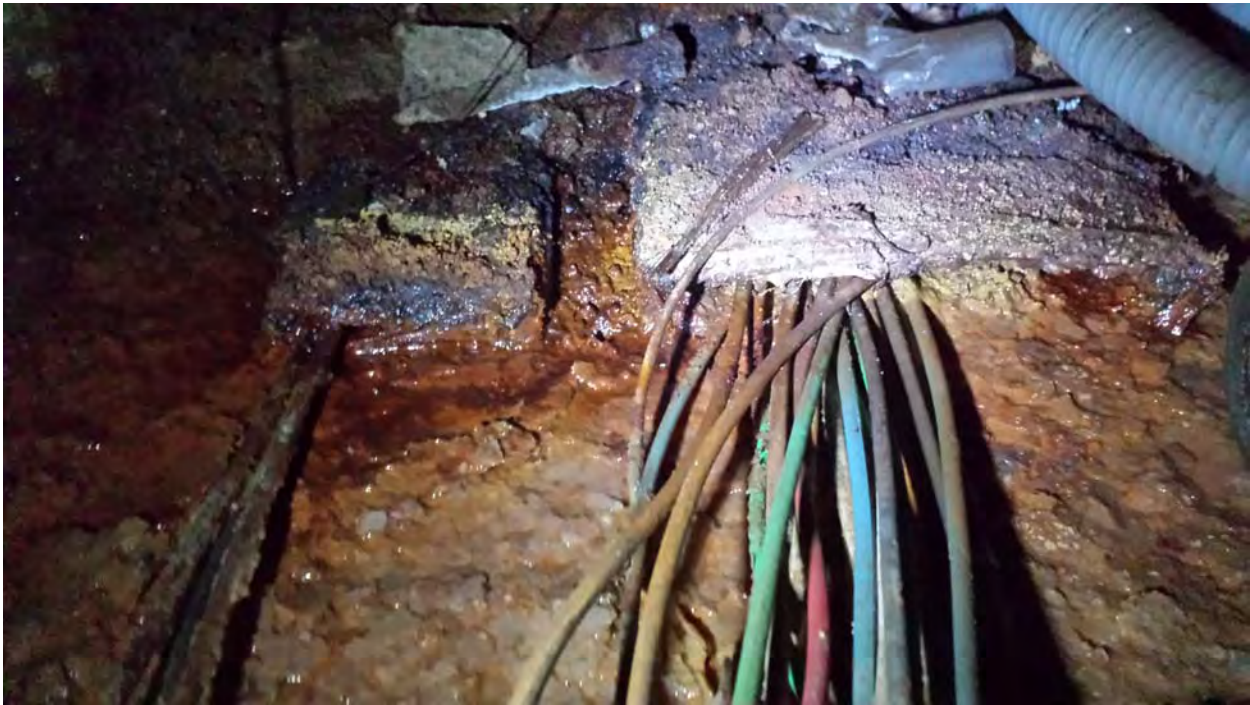
Scoping of Power Duct - Kiosk to AFC Panel		
Task	Yes/No	Notes
<b>Kiosk to Handhole 1 (Distance: 40')</b>		
Was video scoping completed for the entire duct / conduit run?	No	
Was pull string installed?	No	
Were there any obstructions or blockages? Provide details of type and specific location.	Yes	Not possible due to water intrusion, muck build up, and collapsed duct at entry points.
Is the duct / conduit at capacity? Provide additional details about the dimensions of duct / conduit and number of wires.	N/A	6" walker duct.
<b>Handhole 1 to Handhole 2 (Distance: 17')</b>		
Was video scoping completed for the entire duct / conduit run?	No	
Was pull string installed?	No	
Were there any obstructions or blockages? Provide details of type and specific location.	Yes	Not possible due to water intrusion, muck build up, and collapsed duct at entry points.
Is the duct / conduit at capacity? Provide additional details about the dimensions of duct / conduit and number of wires.	N/A	6" walker duct.

Photo #6 – Condition of Existing Duct inside Kiosk
