Mezzanine Inspection Report

Date: 06/04/15	Station Name: F02 Archives	Mezzanine #: M081	Completed By: Mike Butler
----------------	----------------------------	-------------------	---------------------------

15-NEPP-01
IN - FLOOR DUCT INSPECTIONS
F02 ARCHIVES
PROPOSED POWER ROUTE
DRAWING NO.
F02-E-100

Date: 06/24/15	Station Name: F03 L'Enfant Plaza North	Mezzanine #: 082	Completed By: Mike Butler
----------------	--	------------------	---------------------------

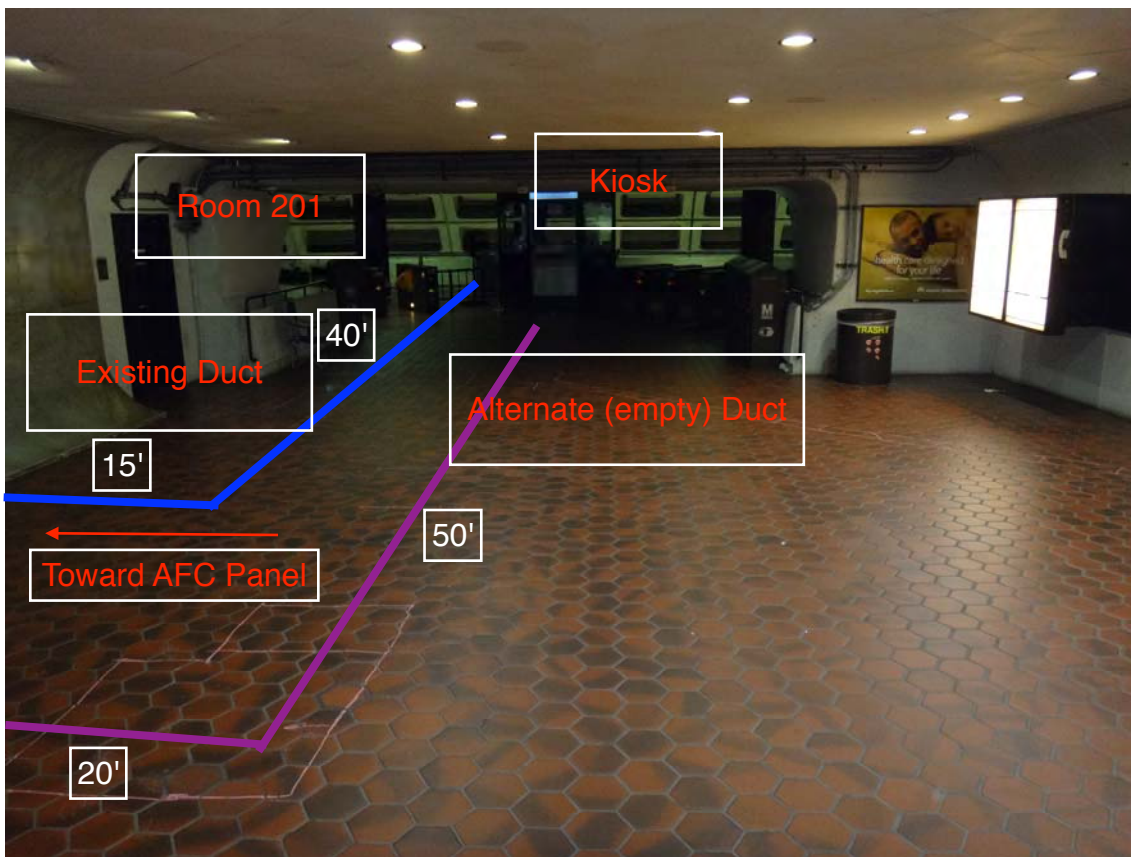
Photo # 1 – Existing and alternate duct layout on mezzanine floor

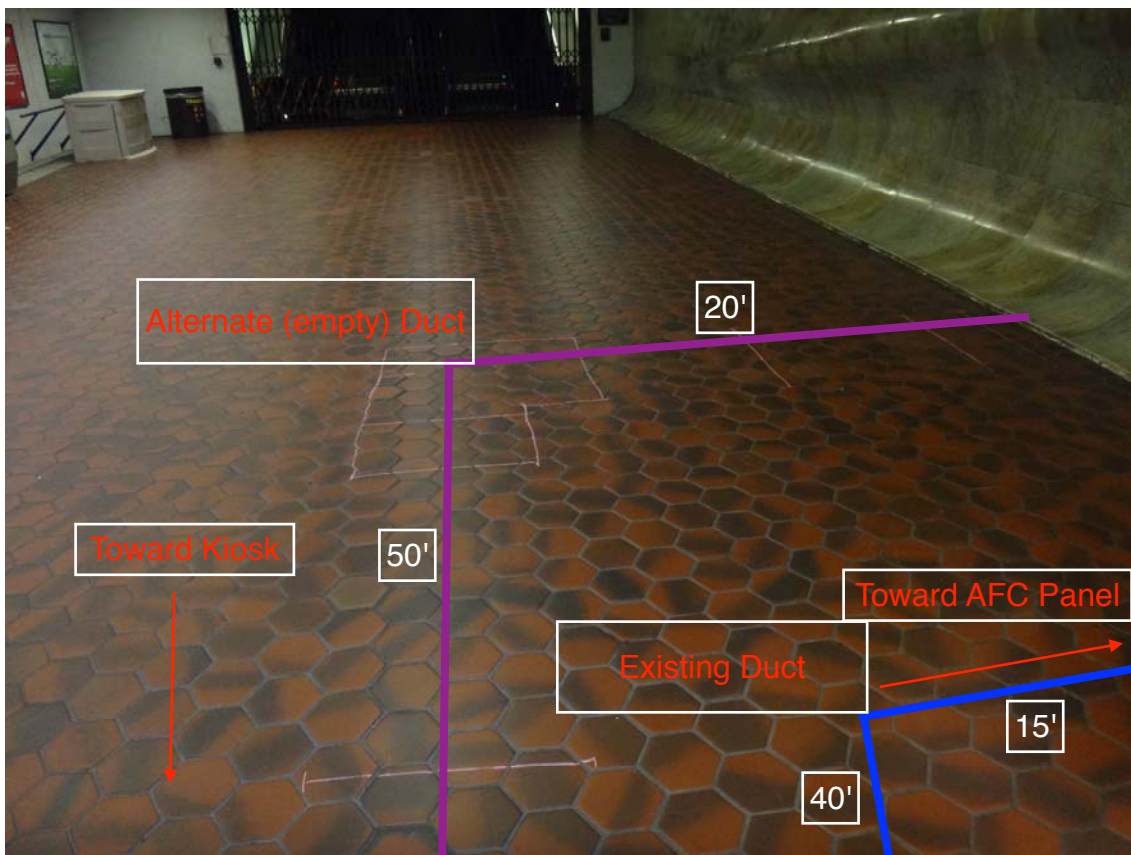
Photo # 2 – Existing and alternate duct layout on mezzanine floor

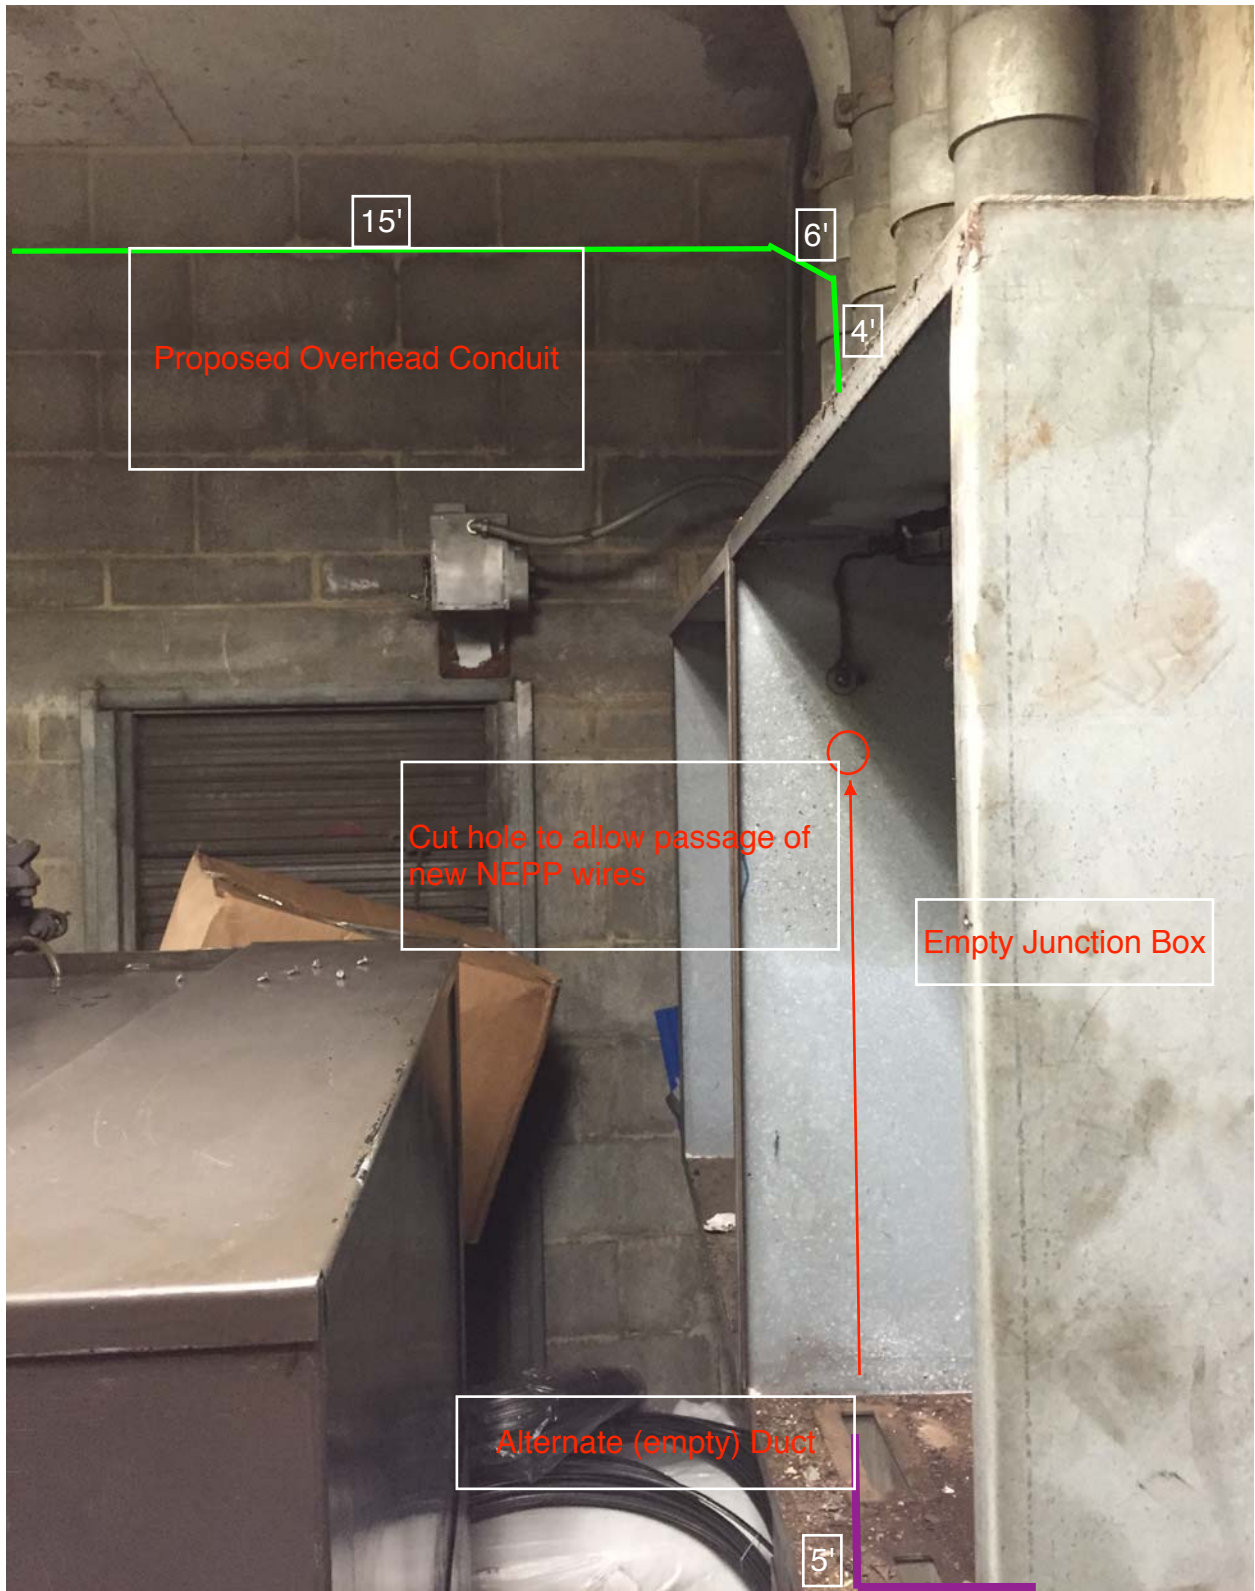
Photo #3 – Alternate (empty) duct and proposed conduit in Elevator Machine Room 205

NEPP-02: Video scoping and pull string installation was completed in an empty alternate duct that runs from the Kiosk to an empty junction box in Elevator Machine Room 205 (refer to photos). An overhead conduit is proposed from junction box (Room 205) to AFC Panel (Room 203). The proposed conduit will rise up from the junction box and snake around the internal wall until it reaches the outside wall of Room 203. The conduit will then core drill through the wall into Room 203 and proceed around the internal wall before connecting with the AFC Panel.

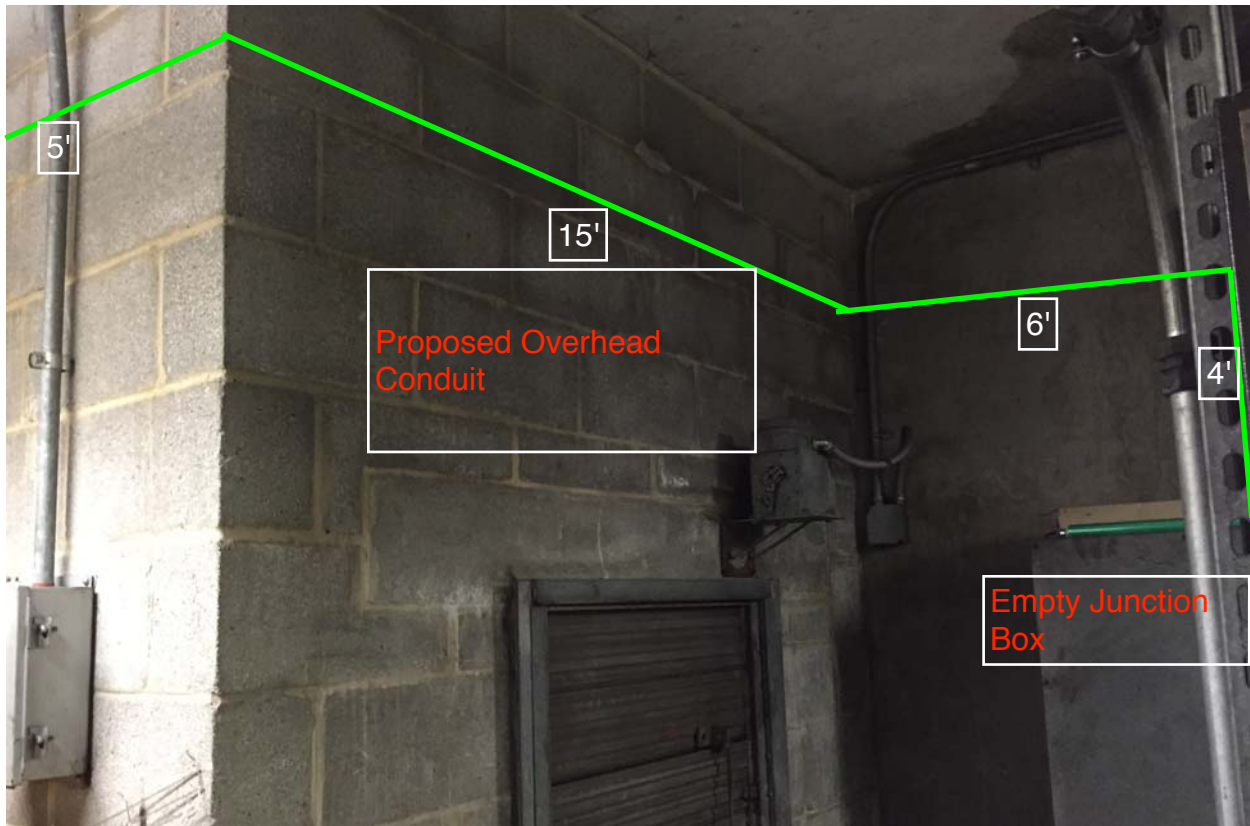
Photo #4 – Proposed overhead conduit in Elevator Machine Room 205

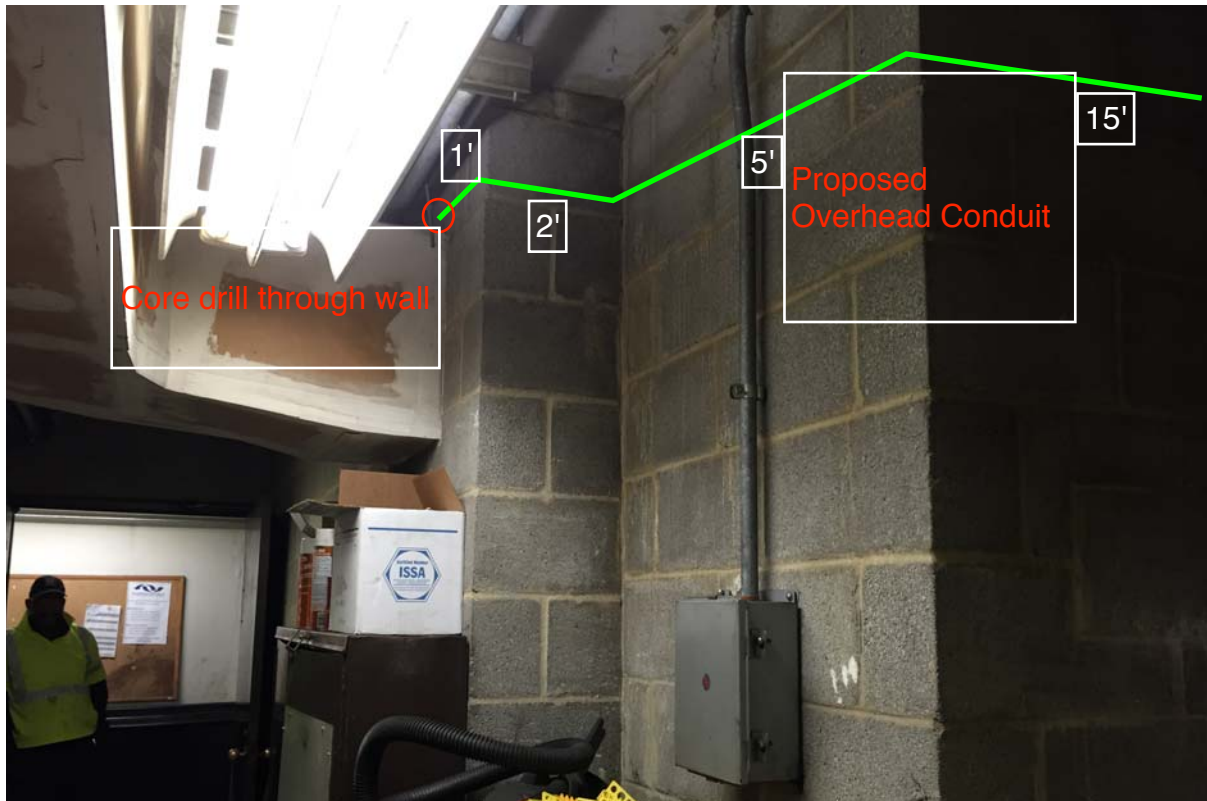
Photo #5 – Proposed overhead conduit in Elevator Machine Room 205

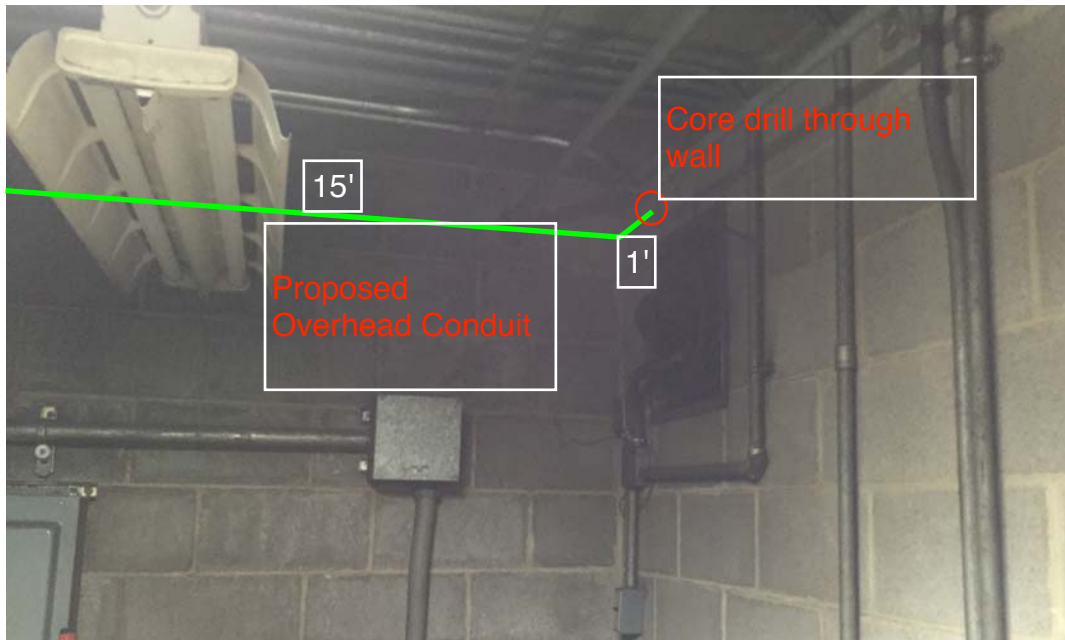
Photo #6 – Proposed overhead conduit in Electrical Room 203

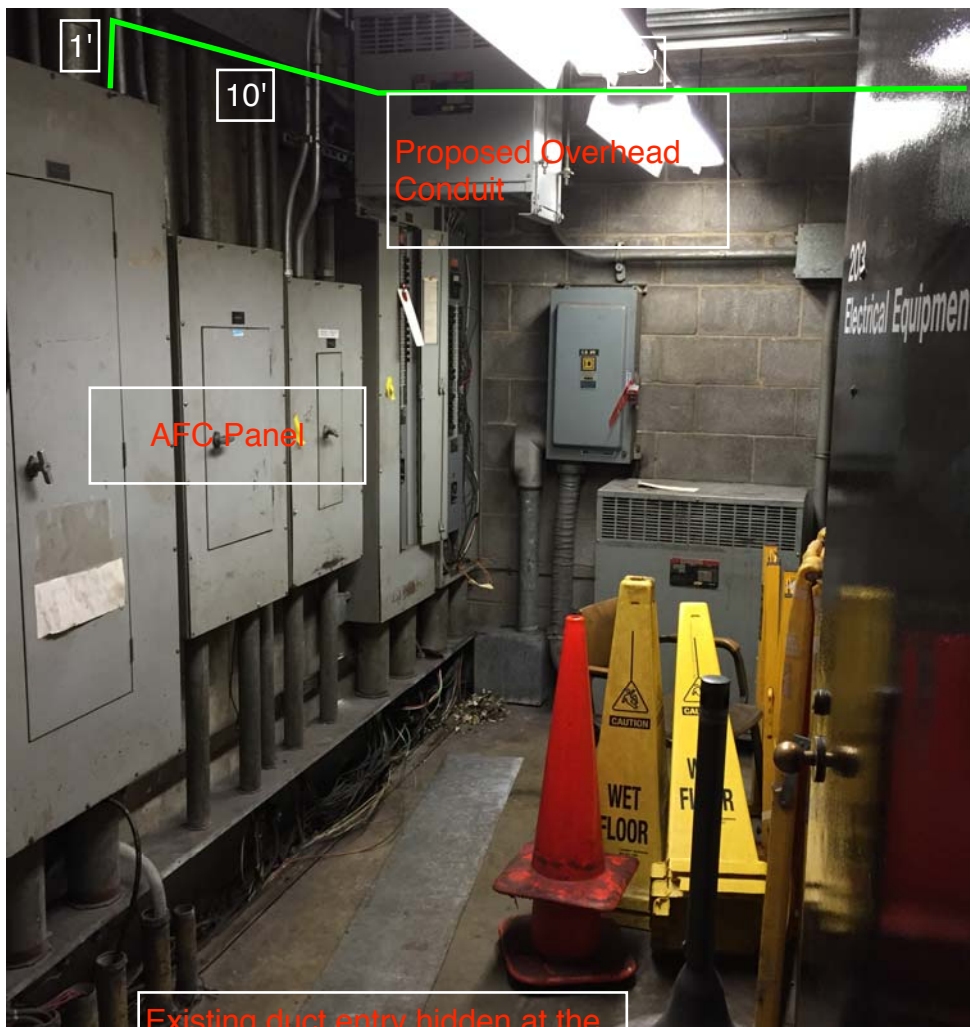
Photo #7 – Existing duct and proposed overhead conduit in Electrical Room 203

Existing duct entry hidden at the bottom of shared trough

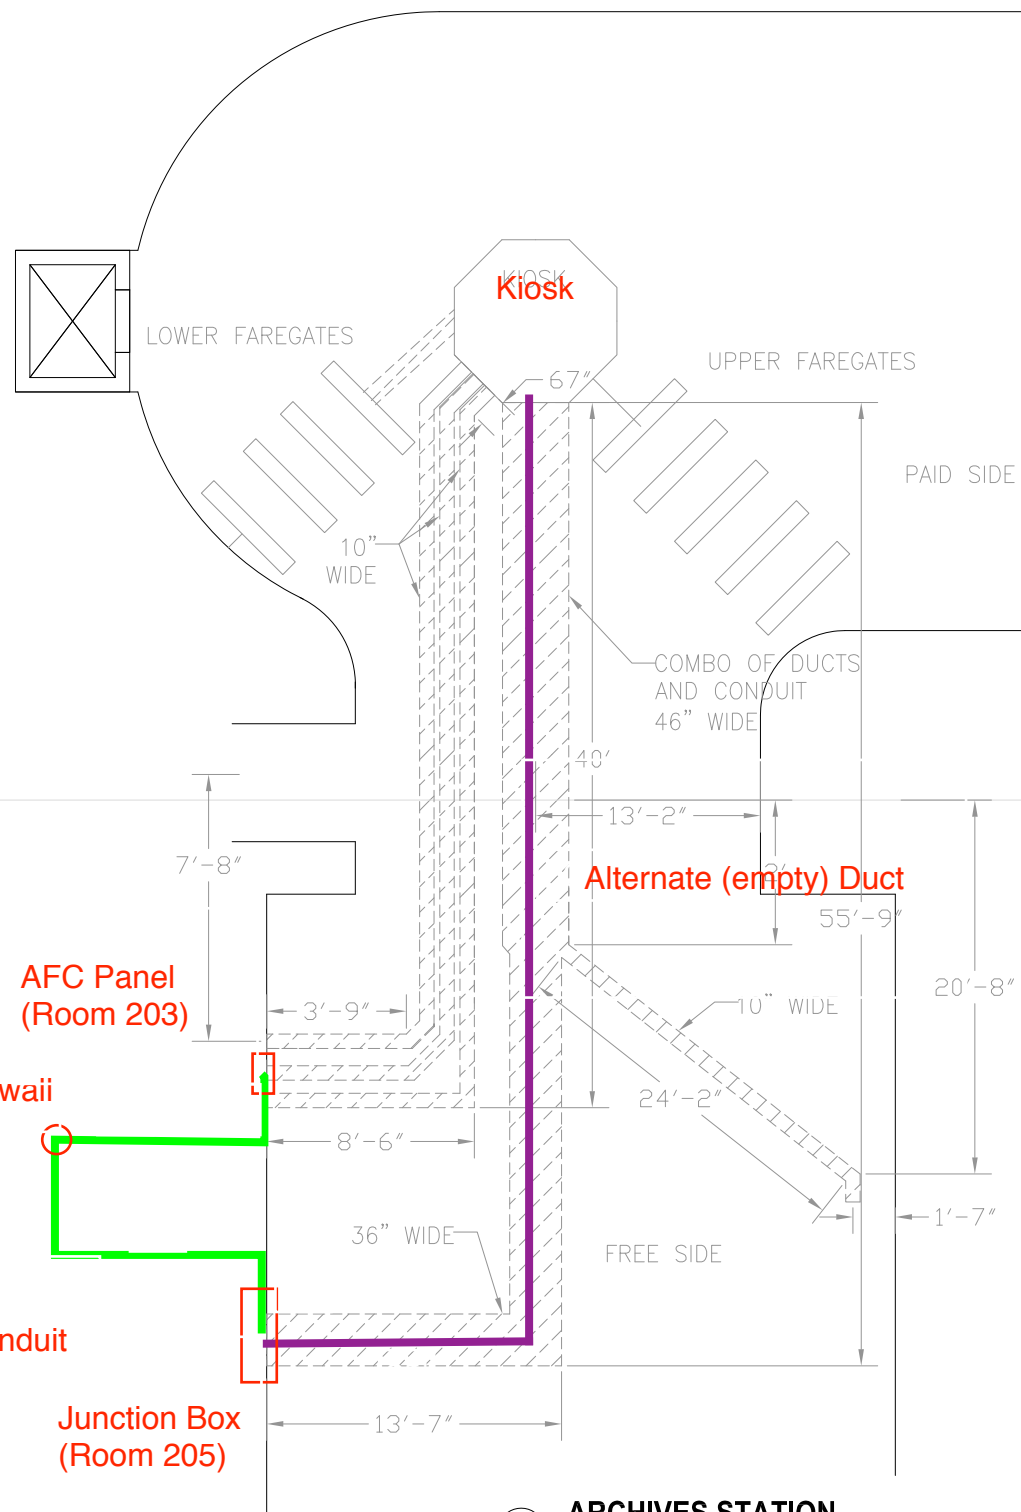
Scanning was conducted to identify new power route between the Kiosk and AFC Panel. The scanning results showed that the mezzanine floor is very congested with existing walker ducts and there is no clear path for a new duct between the Kiosk and AFC Panel. However, alternate ducts running into the back rooms were identified.

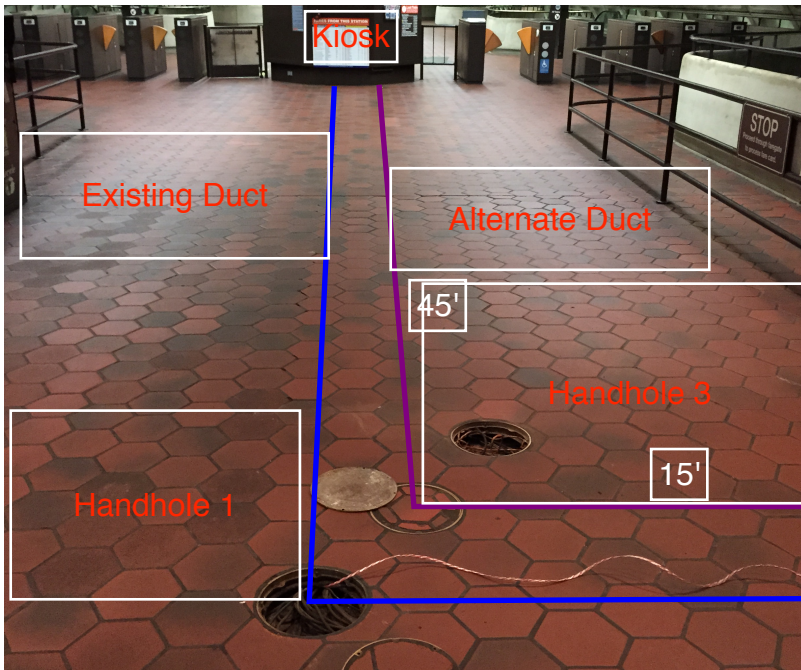
Photo 1 – Existing / Alternate Ducts on mezzanine floor.

Recommendation: It is recommended to utilize the alternate duct for the installation of new wires. Although there is pull string installed in both existing and alternate ducts/ conduit between Kiosk and AFC Panel, it is preferred to use the alternate duct because the duct has more capacity. Refer to attached photos and drawings for further information.

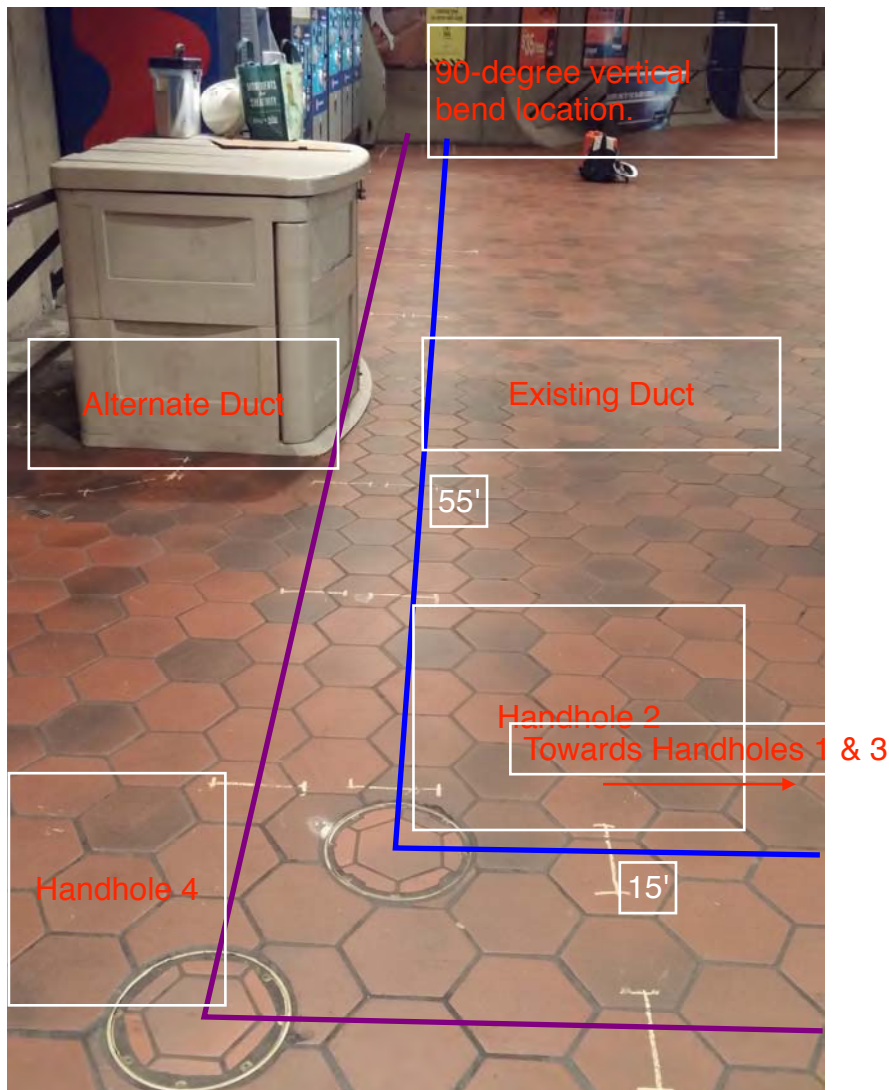
Photo 2 – Existing / Alternate Ducts on mezzanine floor.

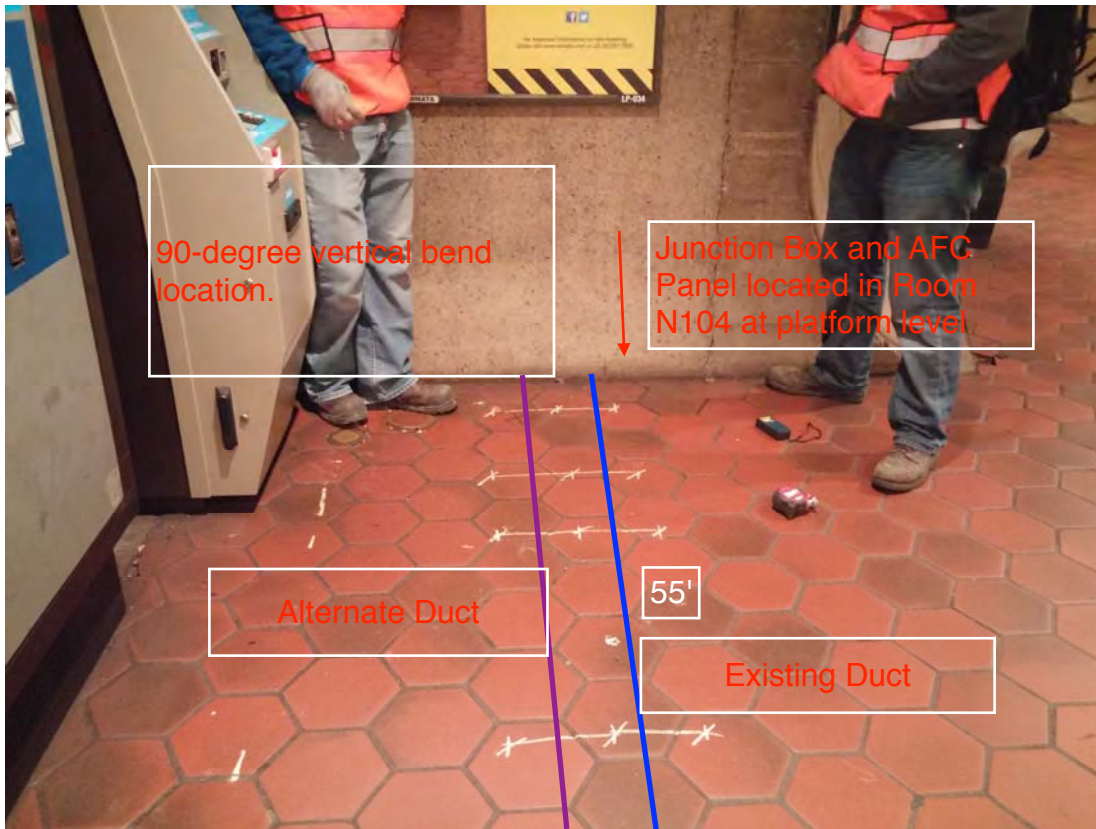
Photo 3 – Existing / Alternate Ducts on mezzanine floor.

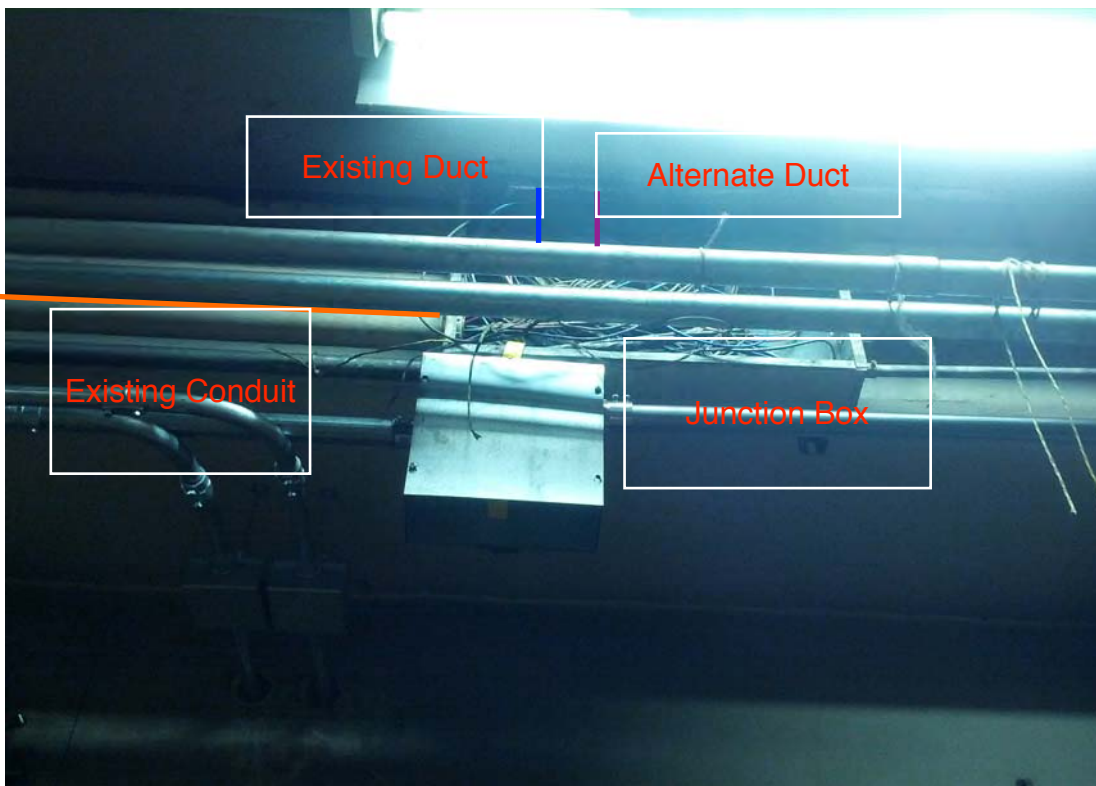
Photo 4 – Junction Box and Existing Conduit in Room N104.

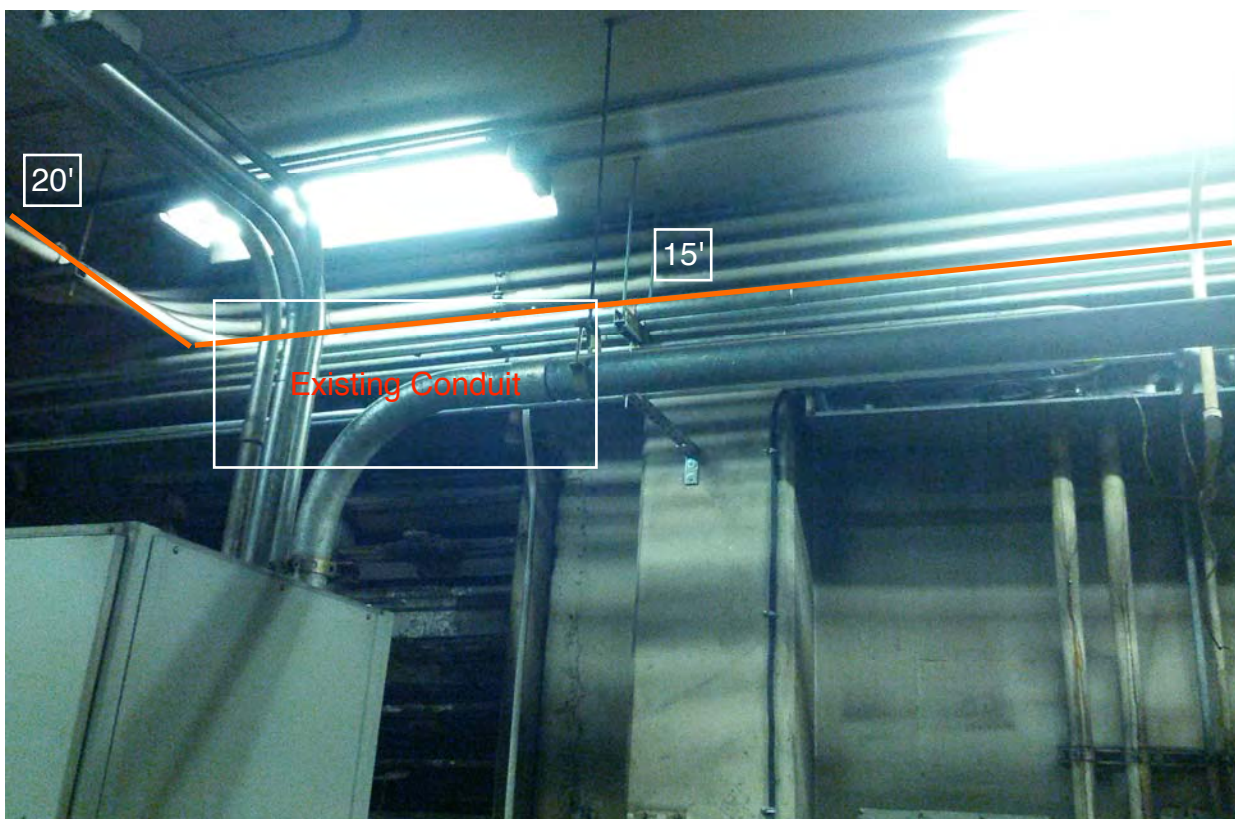
Photo 5 – Existing Conduit run in Room N104.

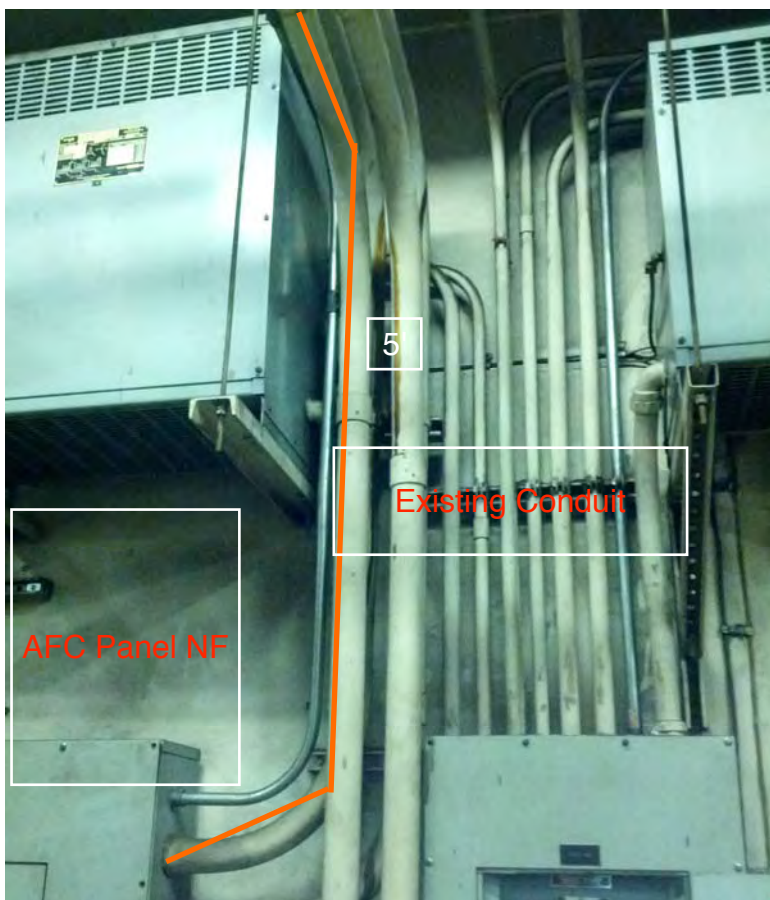
Photo 6 – Existing Conduit run in Room N104.

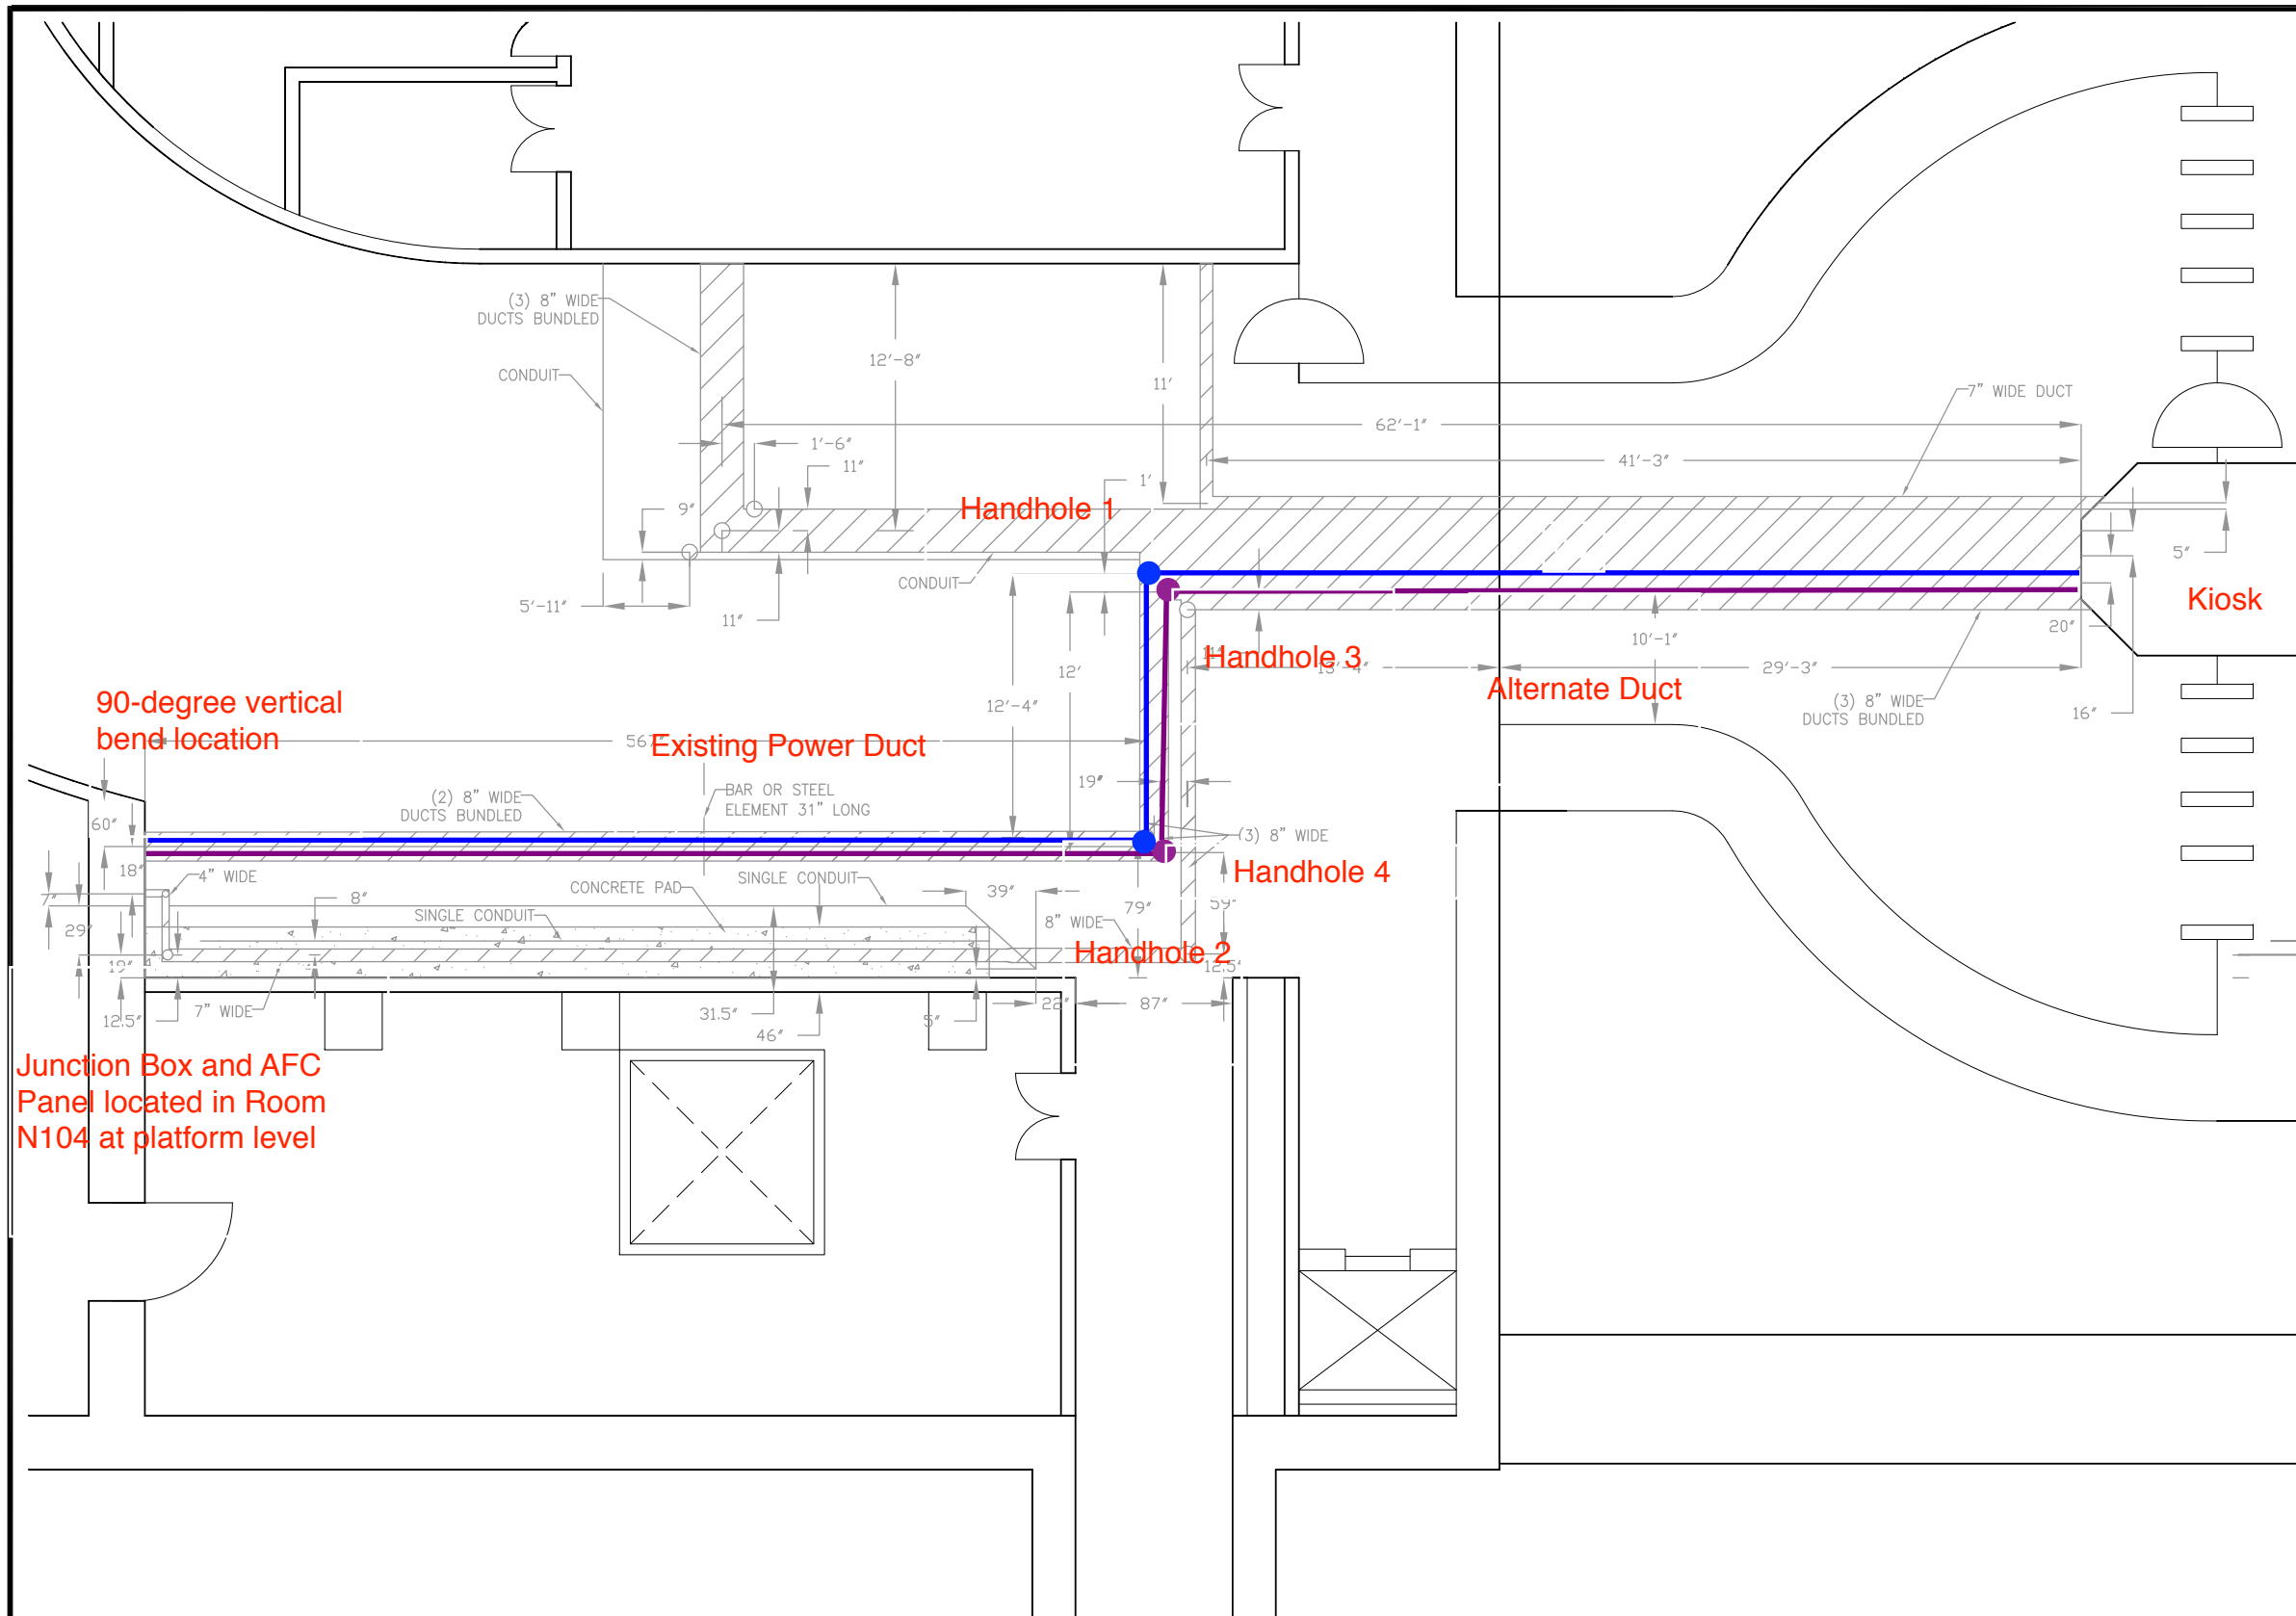
DRAWING NO.
F03-E-100

Is the duct / conduit at capacity? Provide additional details about the dimensions of duct / conduit and number of wires.	No	2" conduit with less than 8 wires.
NEPP-01: Scanning of Mezzanine Floor (12/09/14 & 05/12/15)		
<p>Scanning of the mezzanine was conducted to identify a suitable power route between the Kiosk and AFC Panel.</p> <p>The results of the scanning confirmed that there are multiple ducts running from the Kiosk and there is also an alternate duct running parallel to existing power duct.</p> <p>Both existing duct and alternate duct have a vertical 90-degree bend just beyond the mezzanine wall where the duct goes down to platform level.</p>

90-degree vertical bend location

Junction Box and AFC Panel located in Room N104 at platform level
