Mezzanine Inspection Report (Scoping)

Date: 12/01/2014	Station Name: F04 Waterfront	Mezzanine #: 083	Completed By: Chris Loose
Summary			
<p>All scoping was completed for the communications and power ducts in the faregate arrays. Pull string was successfully installed in the upper and lower communication ducts in the faregate arrays. Scoping and pull string was successfully installed in the power duct run from the kiosk to the AFC panel.</p> <p>No scanning is required at this mezzanine.</p>			
Scoping of Faregate Array(s)			
Task	Yes/No	Notes	
Communications Duct – Upper Faregate Array (4 Gates)			
Was video scoping completed for the entire duct run?	Yes	Refer to WMATA Waterfront 3inch Upper Comm Duct Video (1).avi and WMATA Waterfront 6inch Upper Comm Duct Video.avi files.	
Were pull strings installed at all faregates in the array?	Yes		
Were there any obstructions or blockages? Provide details of type and specific location.	No		
Is the duct at capacity? Provide additional details about the dimensions of ducts and number of wires.	No	4" duct, less than 15 wires

Date: 01/26/2015	Station Name: F05 Navy Yard West	Mezzanine #: 105	Completed By: Chris Loose
------------------	-------

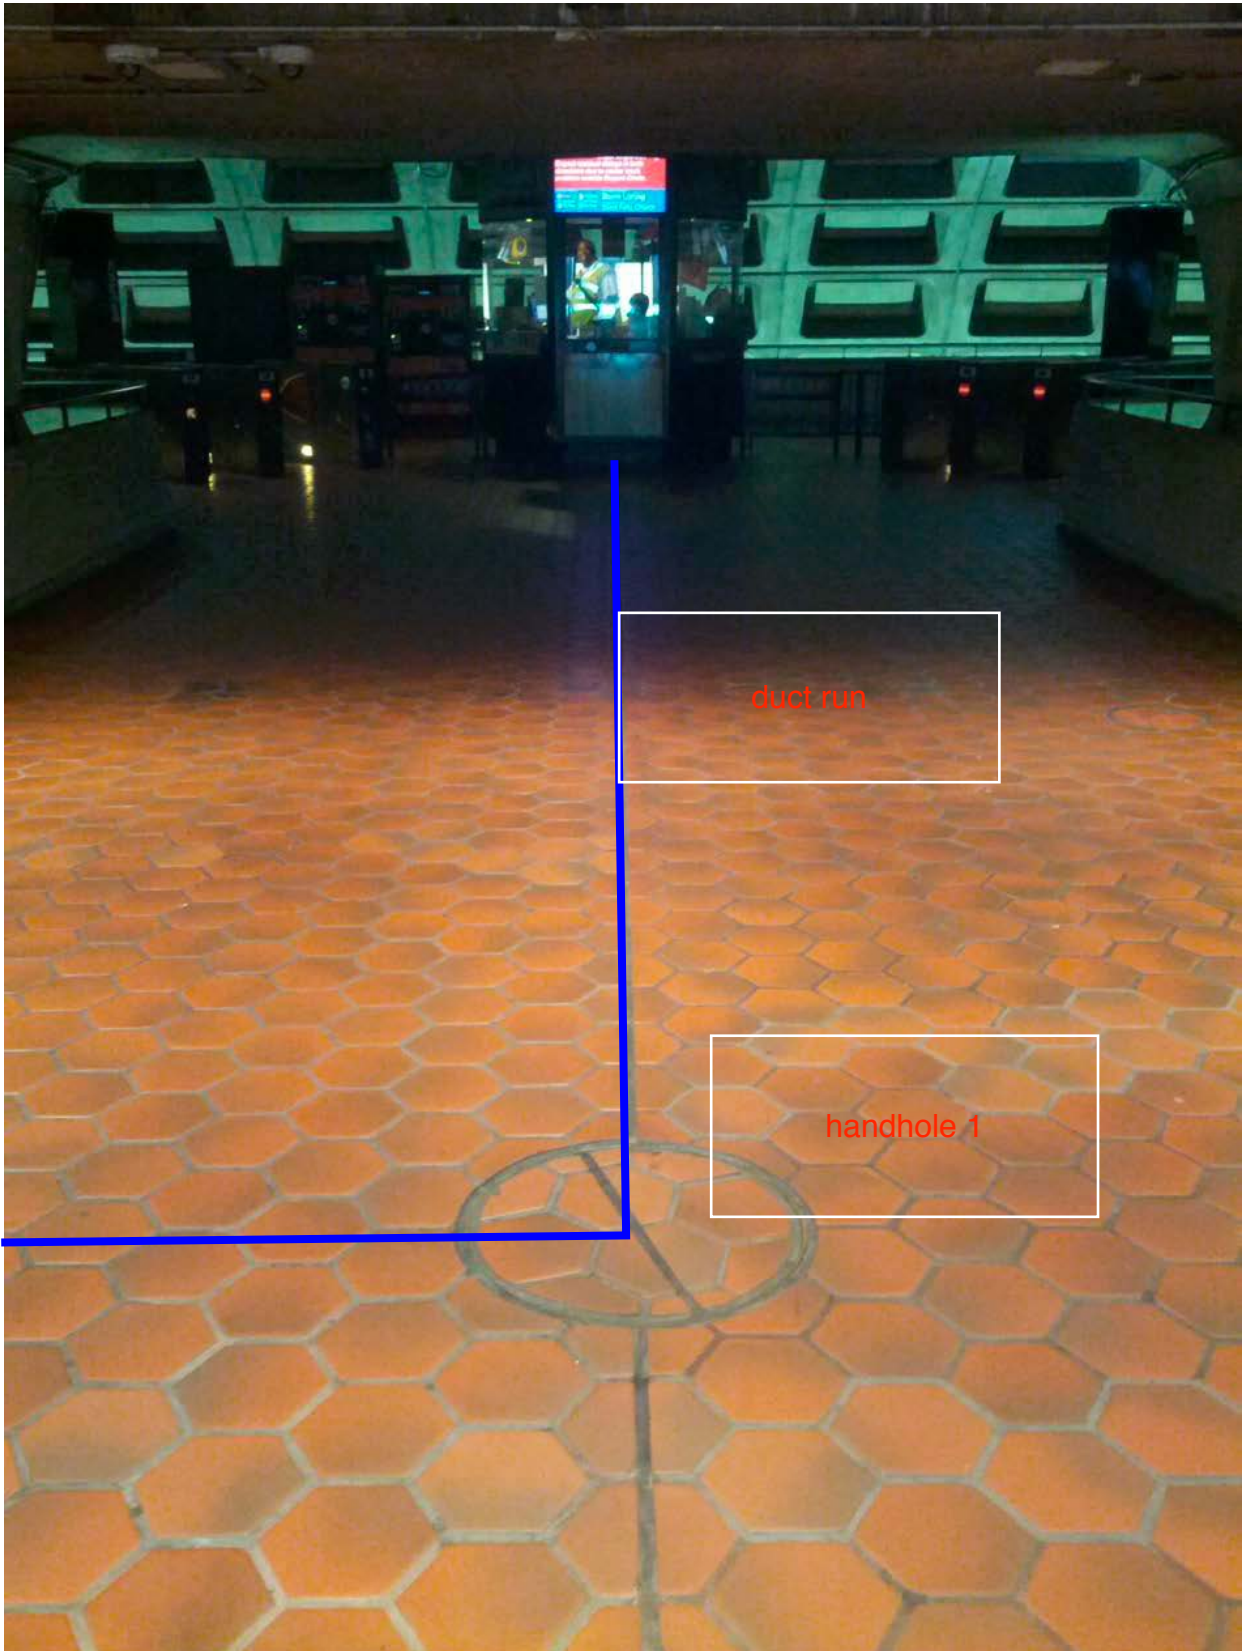
Photo #1 – F04 Waterfront: Kiosk to handhole 1

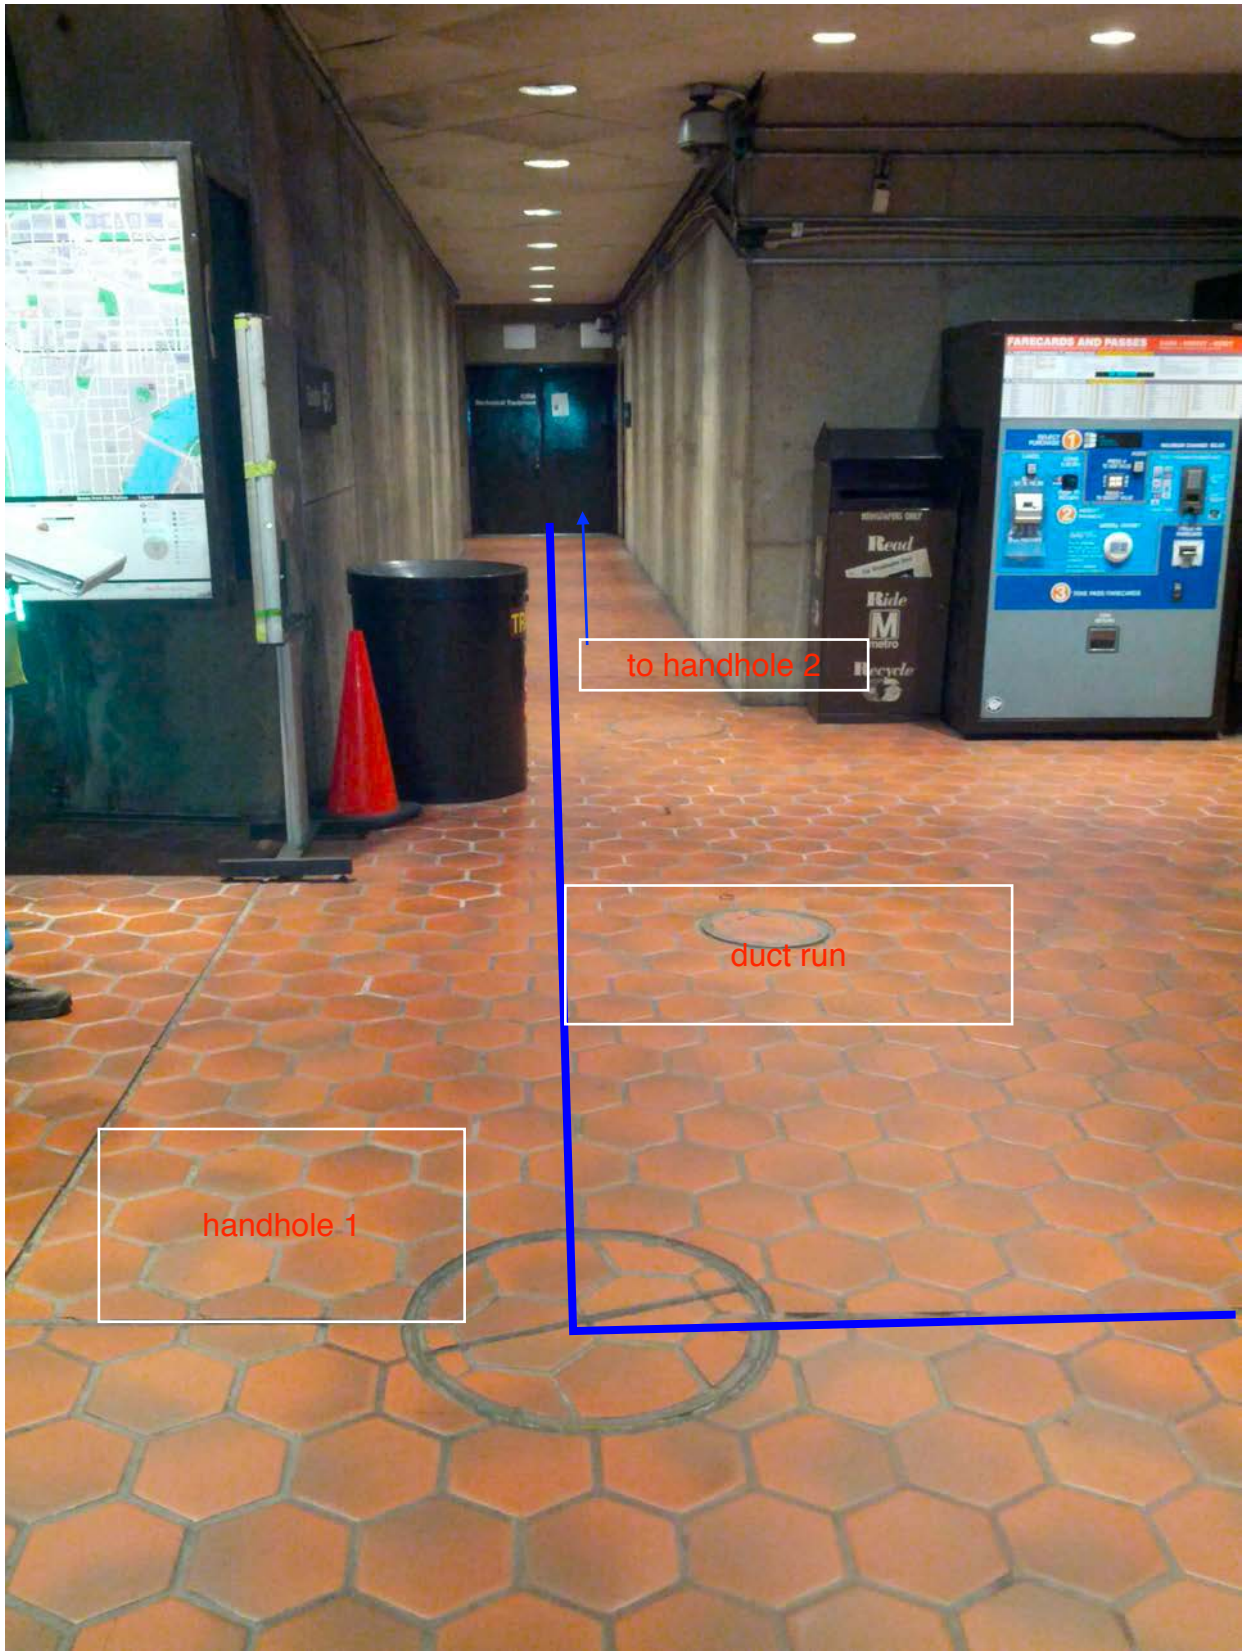
Photo #2 – F04 Waterfront: Handhole 1 to handhole 2

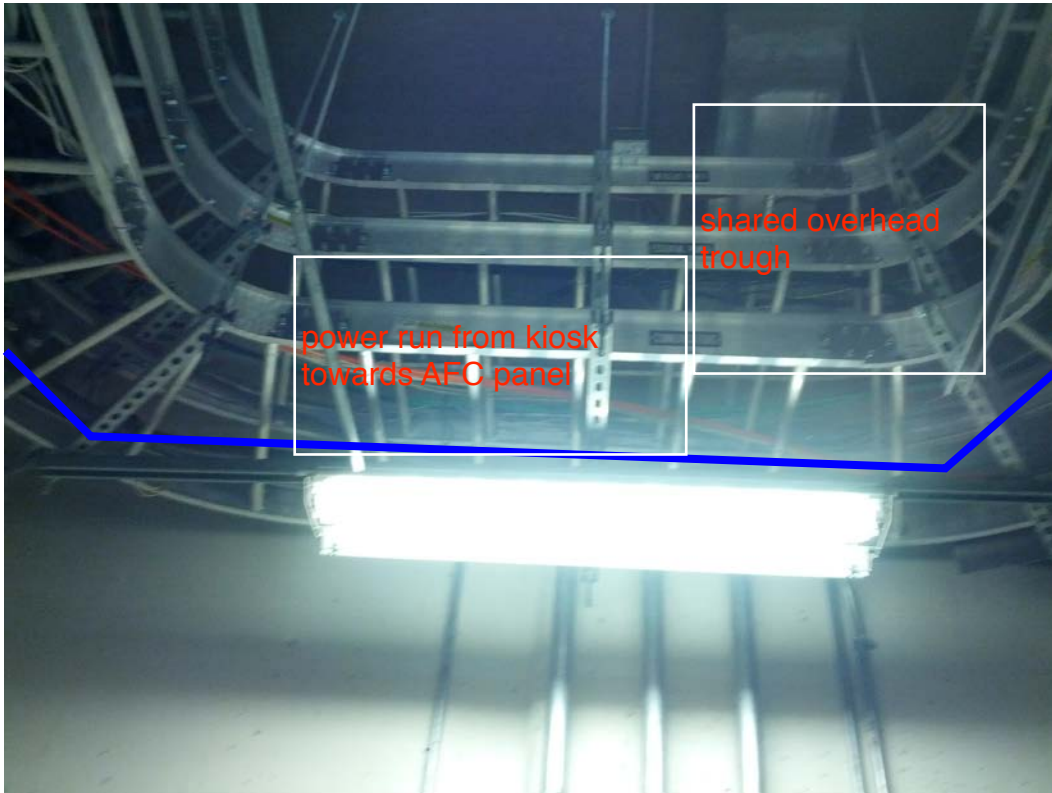
Photo #1 – F05 Navy Yard West: Shared overhead trough in AFC panel room

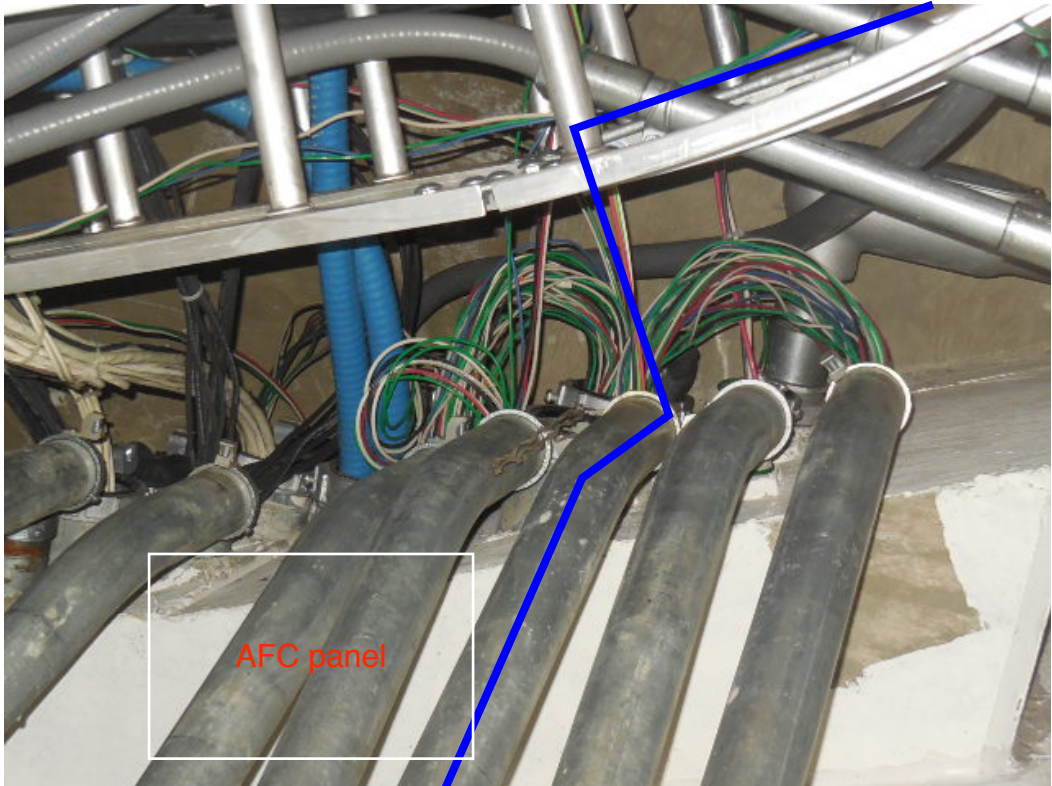
Photo #2 – Navy Yard West: Wire transition from shared overhead trough to 2" conduit to AFC panel

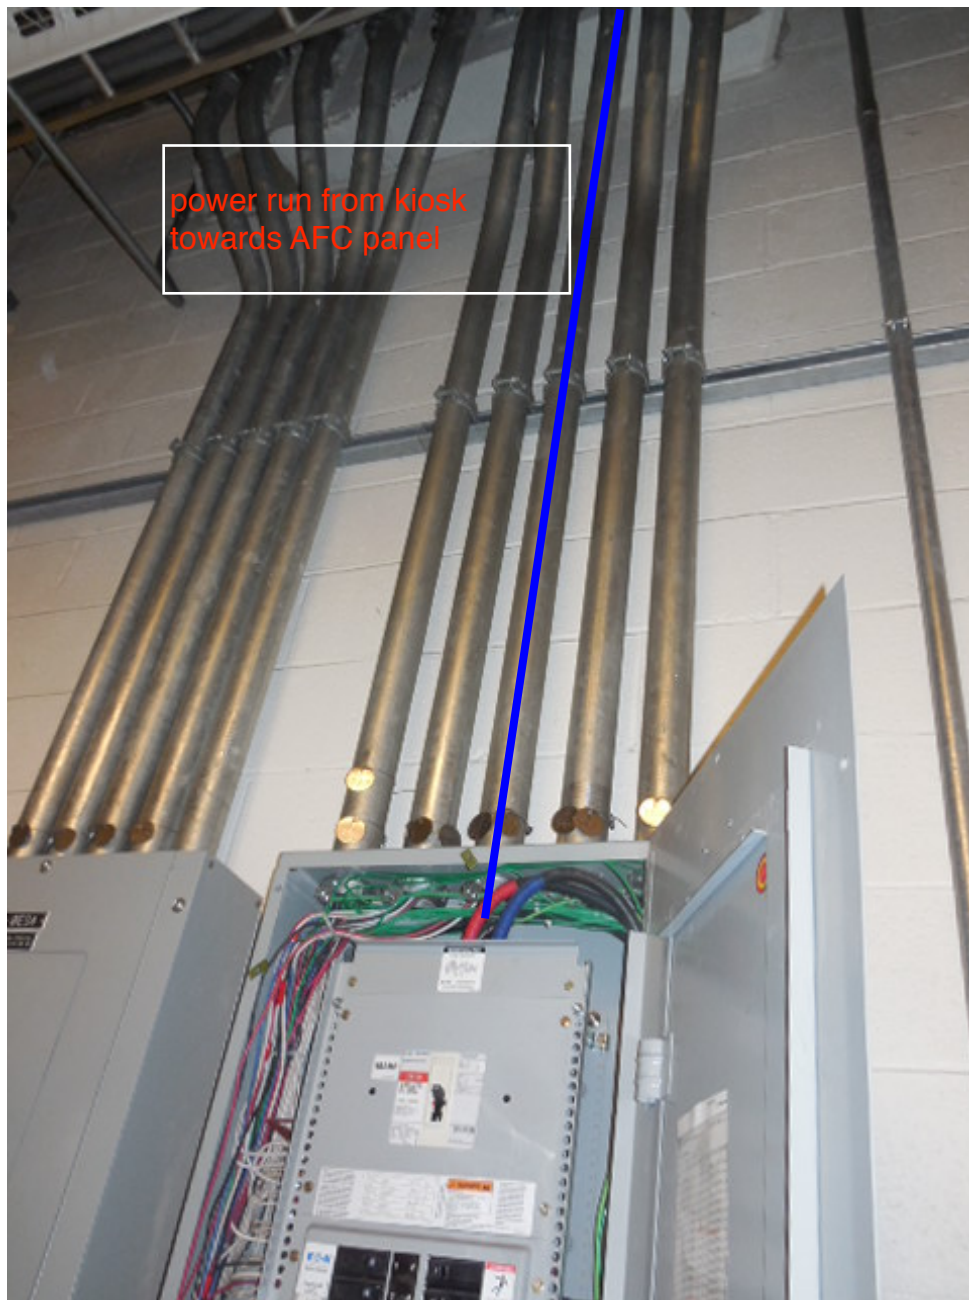
Photo #3 – F05 Navy Yard West: 2" conduit into AFC panel

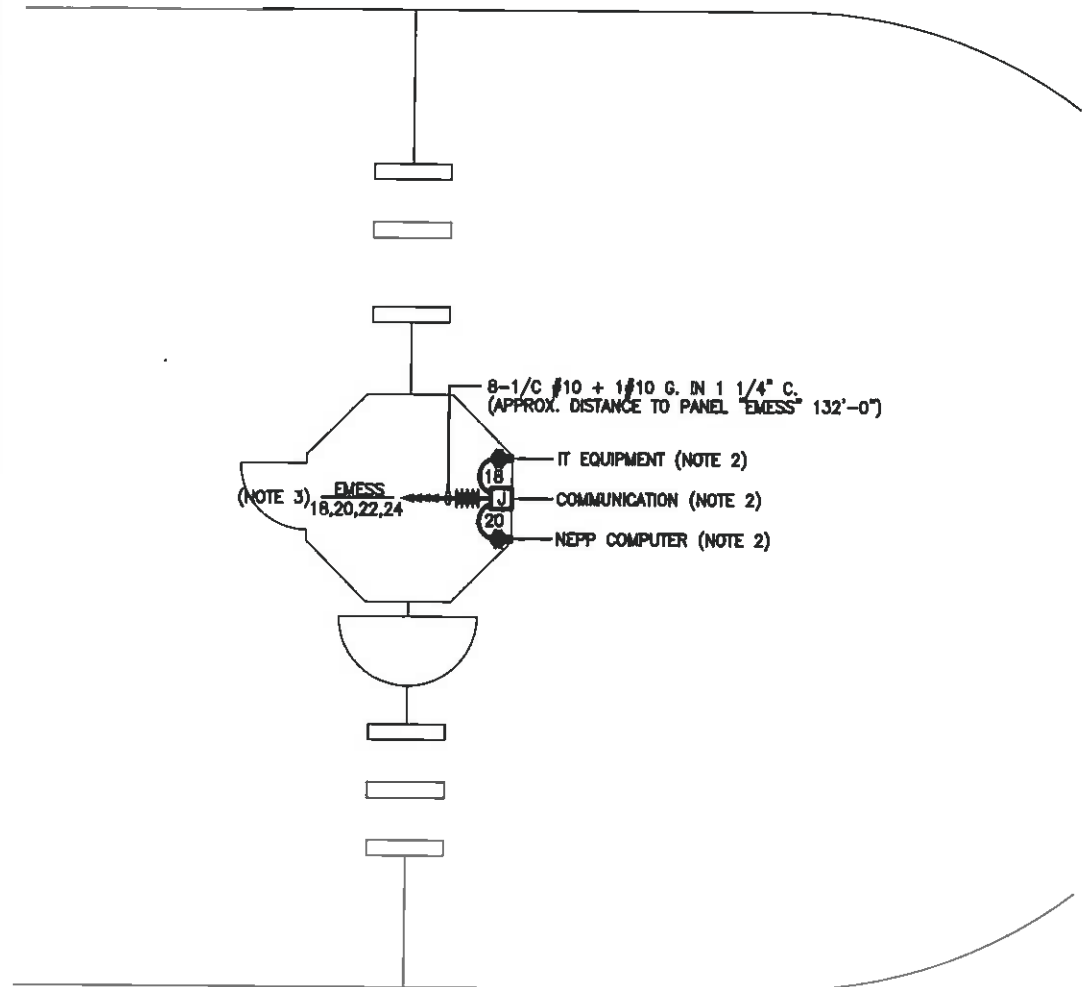
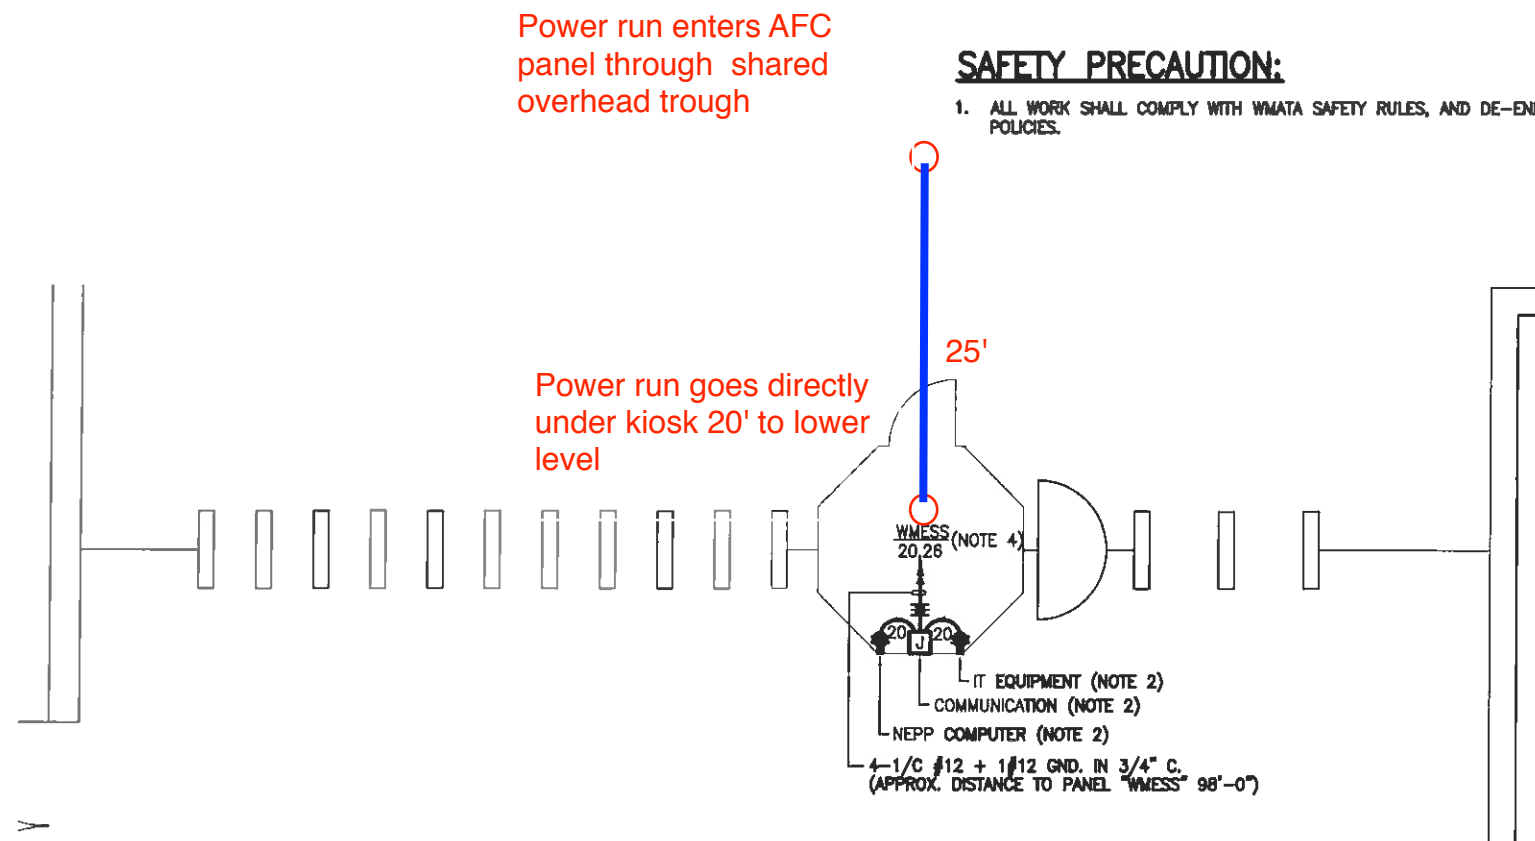
SCALE: AS SHOWN DRAWING NO. F05-E-101

Power run enters AFC panel through shared overhead trough

Power run goes directly under kiosk 20' to lower level

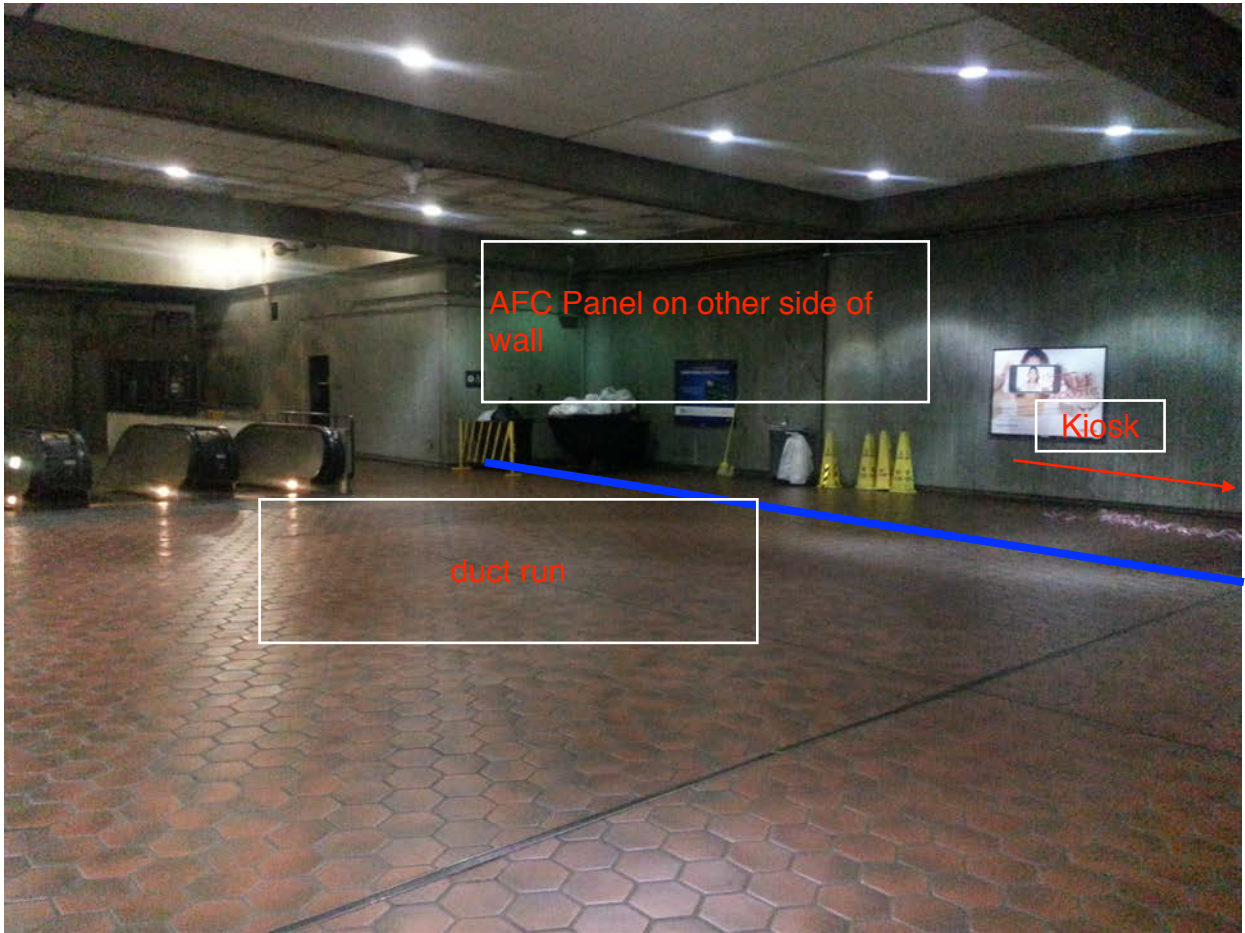
Photo #1 – F06 Anacostia North: Run from Kiosk to Room #301 AFC Panel NSF

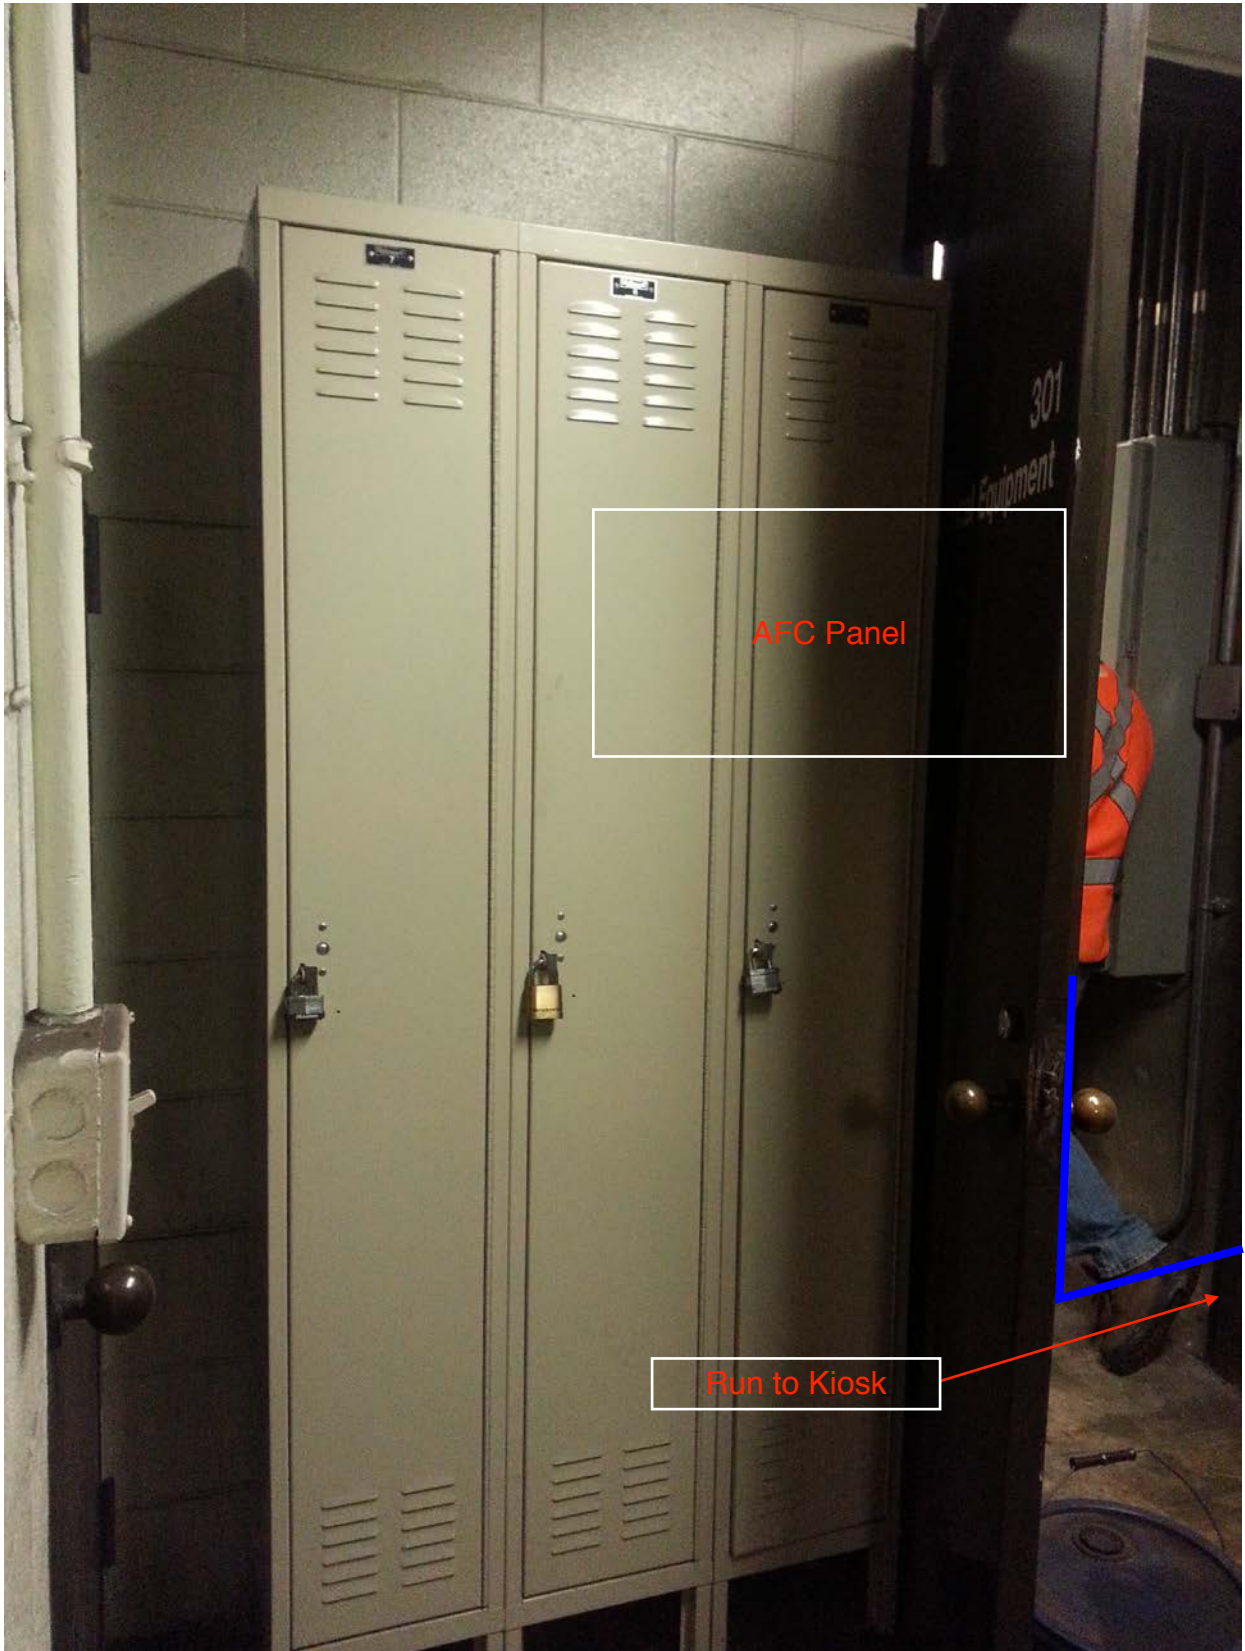
Photo #2 – F06 Anacostia North: Room 301 with AFC Panel NSF

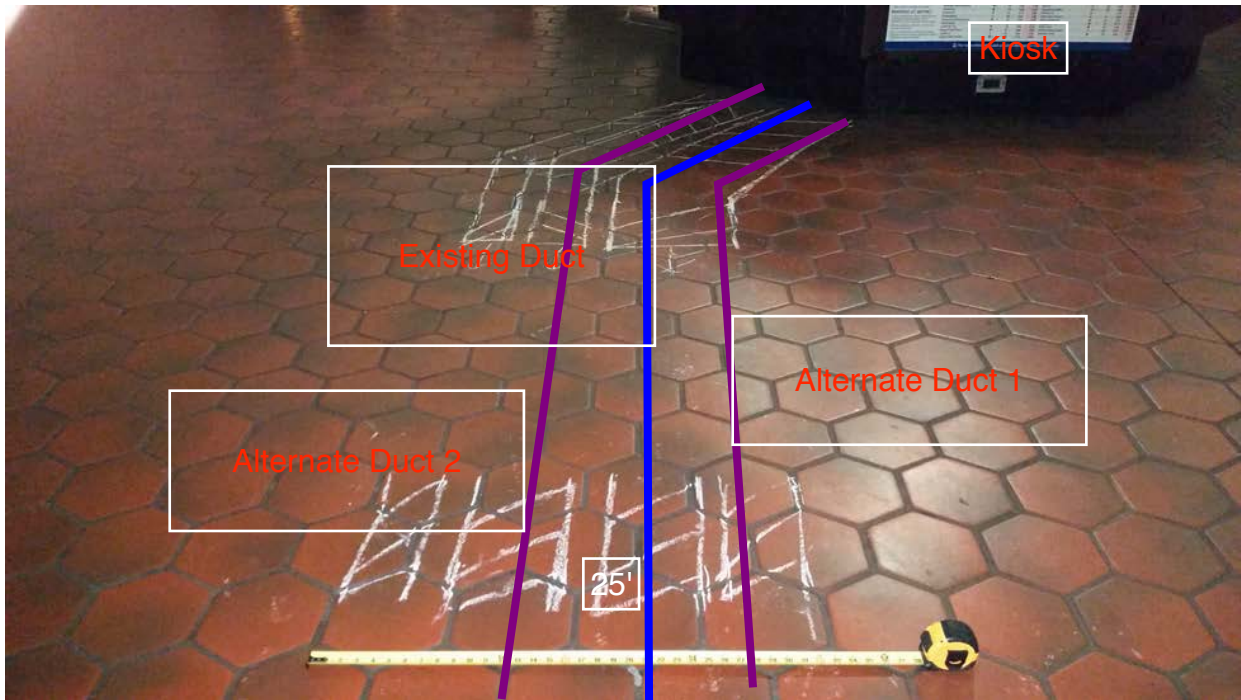
Were there any obstructions or blockages? Provide details of type and specific location.	Yes	The duct is blocked and likely collapsed at the vertical 90-degree bend beneath the AFC Panel – concrete intrusion is evident.
Is the duct / conduit at capacity? Provide additional details about the dimensions of duct / conduit and number of wires.	No	Empty 6" walker duct.
Observations / Issues / Next Steps		
<ul style="list-style-type: none"> - Alternate Duct 1 and Alternate Duct 2 both run parallel to the existing power duct between Kiosk and AFC Panel. - The only blockage in alternate ducts occurs at the vertical 90-degree bend beneath the AFC Panel – scoping was successful up to this point and empty ducts appear to be in good condition. - The length of remaining alternate duct is 35' and removed/replaced duct is 5' (including a new 90-degree vertical bend). 5' of proposed conduit is also proposed to connect the shared trough to the AFC Panel. - Refer to attached photos and drawings for further information. - There is no existing as-built drawing for this mezzanine.

Photo #1 – Existing and alternate ducts on mezzanine floor

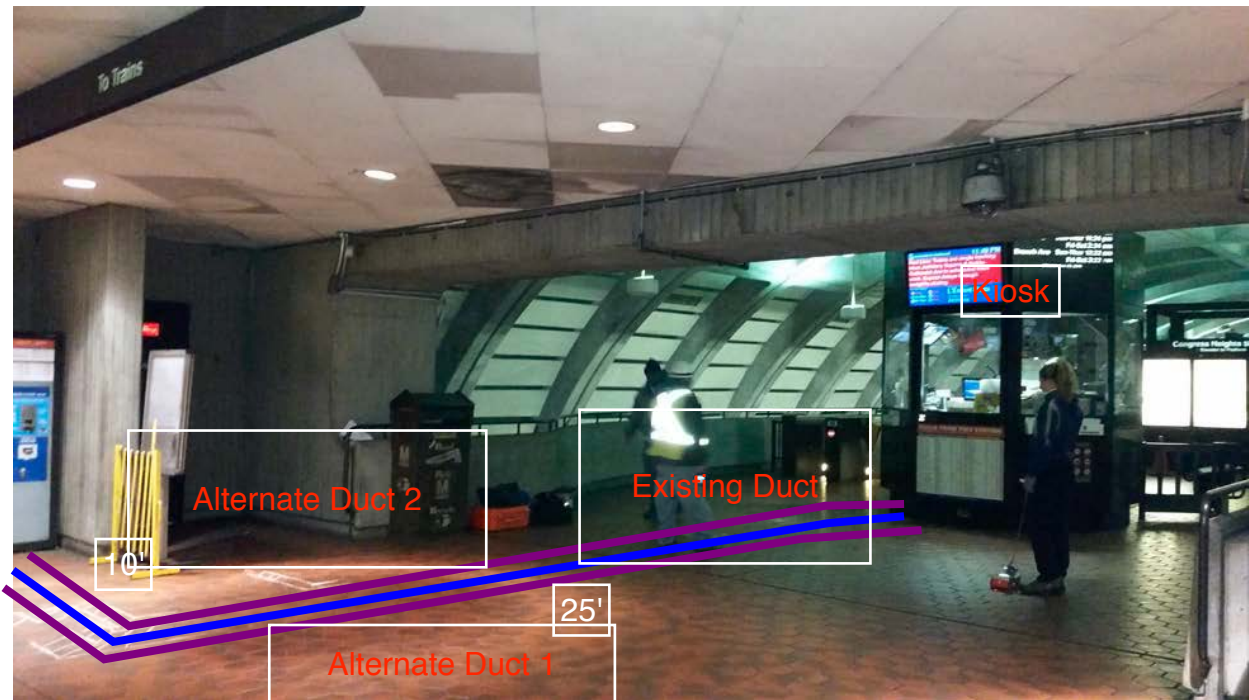
Photo #2 – Existing and alternate ducts on mezzanine floor

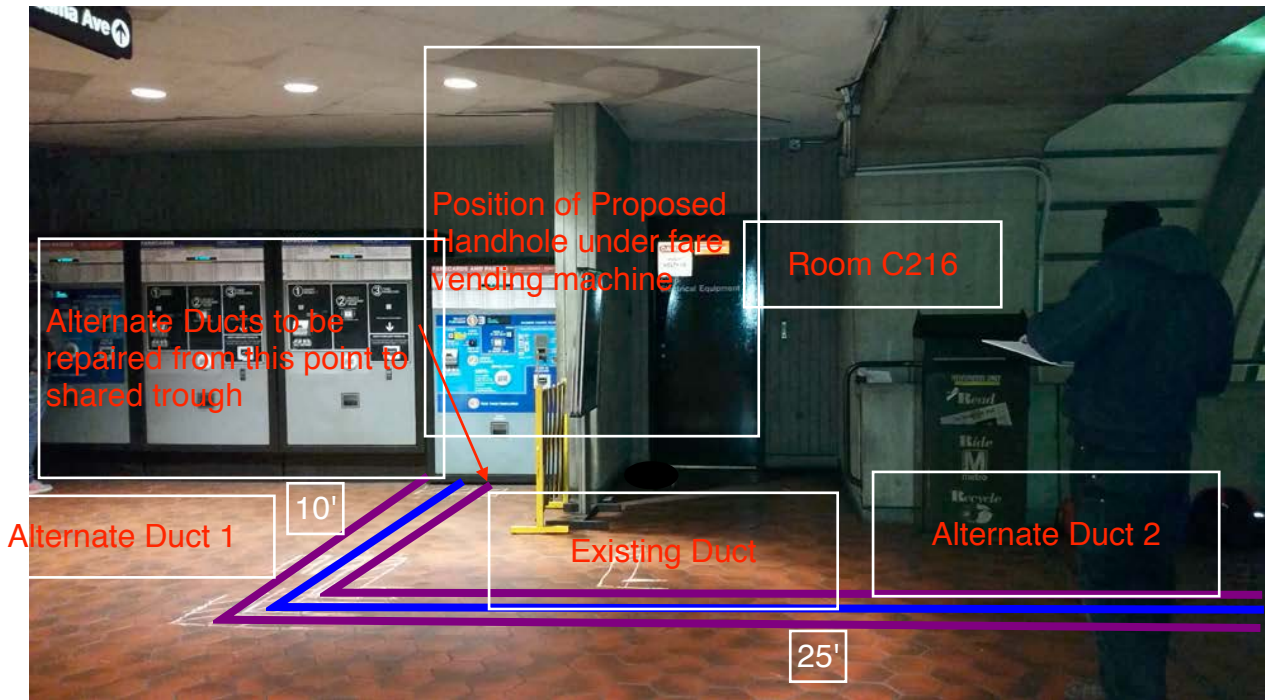
Photo #3 – Existing and alternate ducts on mezzanine floor

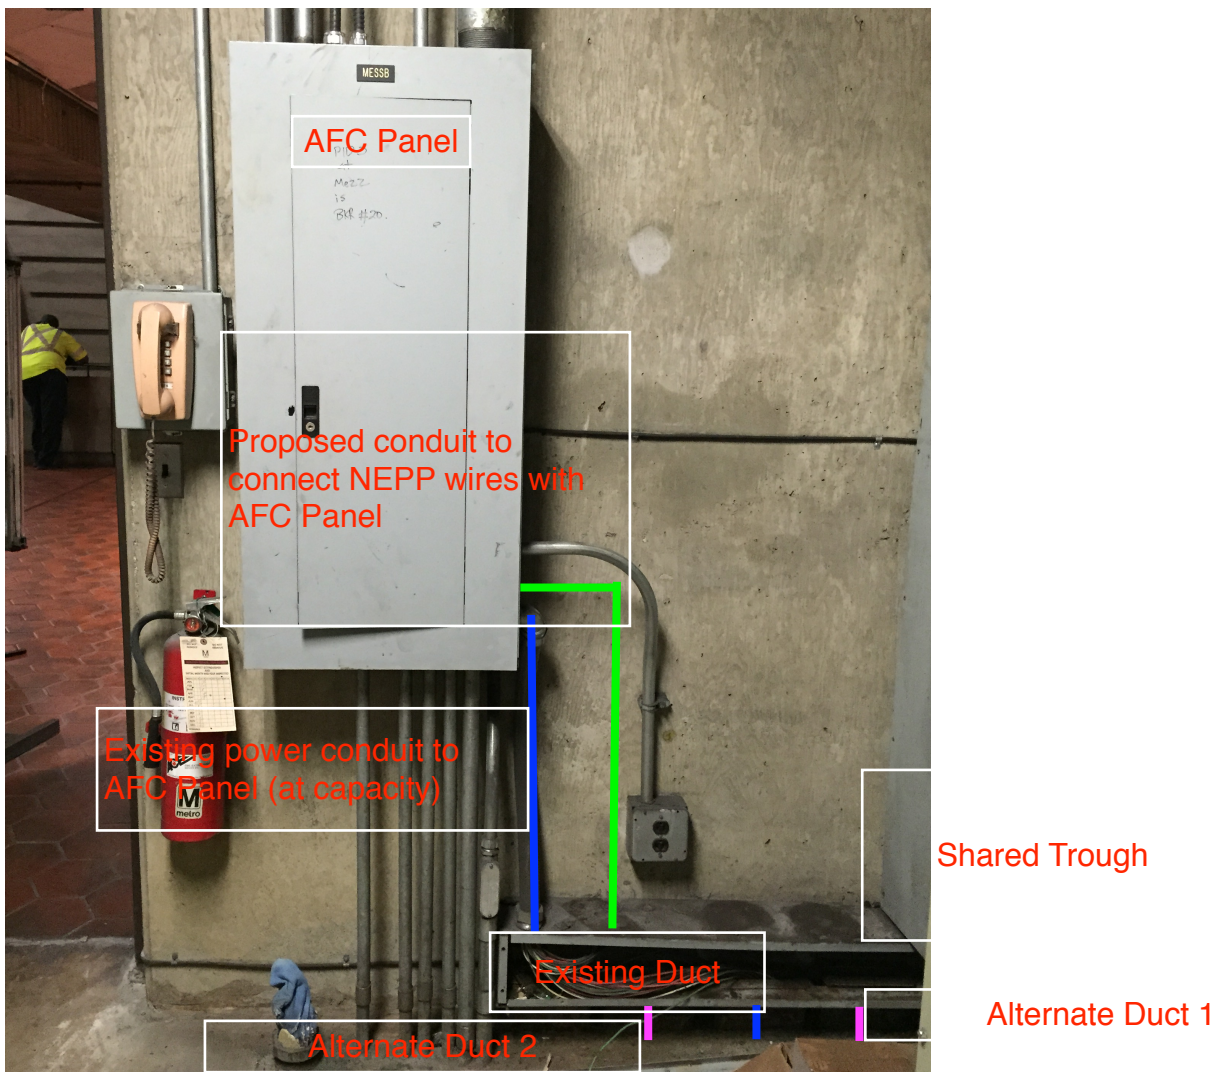
Photo #4 – AFC Panel and Shared Trough in Room C216

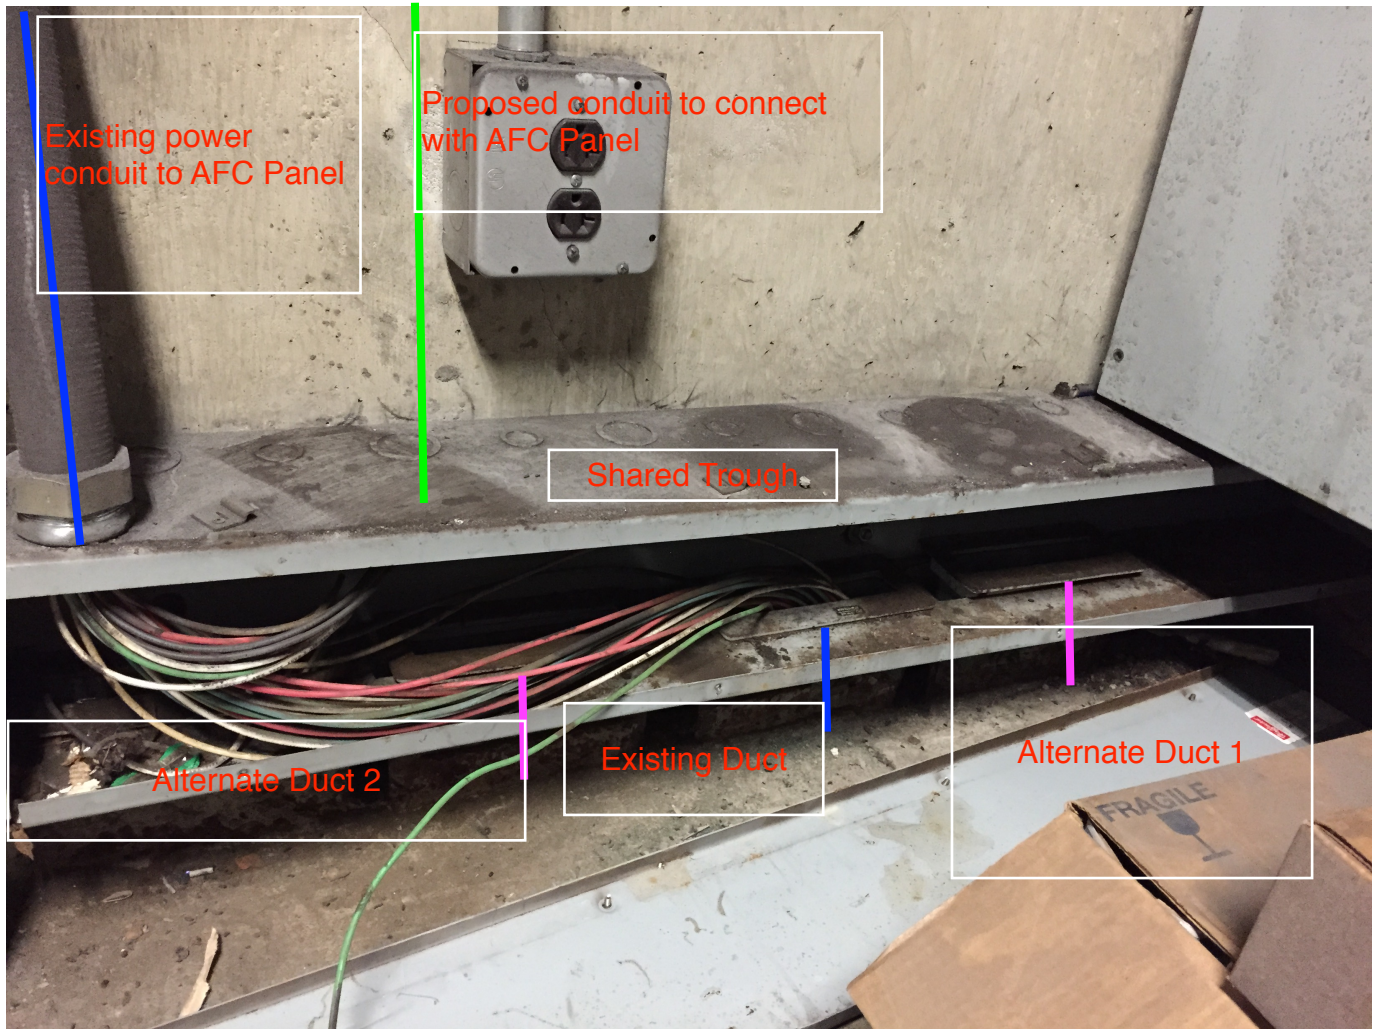
Photo #5 – Close-up of Existing / Alternate Ducts feeding Shared Trough in Room C216
