Mezzanine Inspection Report (Scoping)

Date: 12/01/2014	Station Name: F04 Waterfront	Mezzanine #: 083	Completed By: Chris Loose
Summary			
<p>All scoping was completed for the communications and power ducts in the faregate arrays. Pull string was successfully installed in the upper and lower communication ducts in the faregate arrays. Scoping and pull string was successfully installed in the power duct run from the kiosk to the AFC panel.</p> <p>No scanning is required at this mezzanine.</p>			
Scoping of Faregate Array(s)			
Task	Yes/No	Notes	
Communications Duct – Upper Faregate Array (4 Gates)			
Was video scoping completed for the entire duct run?	Yes	Refer to WMATA Waterfront 3inch Upper Comm Duct Video (1).avi and WMATA Waterfront 6inch Upper Comm Duct Video.avi files.	
Were pull strings installed at all faregates in the array?	Yes		
Were there any obstructions or blockages? Provide details of type and specific location.	No		
Is the duct at capacity? Provide additional details about the dimensions of ducts and number of wires.	No	4" duct, less than 15 wires

Date: 01/26/2015	Station Name: F05 Navy Yard West	Mezzanine #: 105	Completed By: Chris Loose
------------------	-------

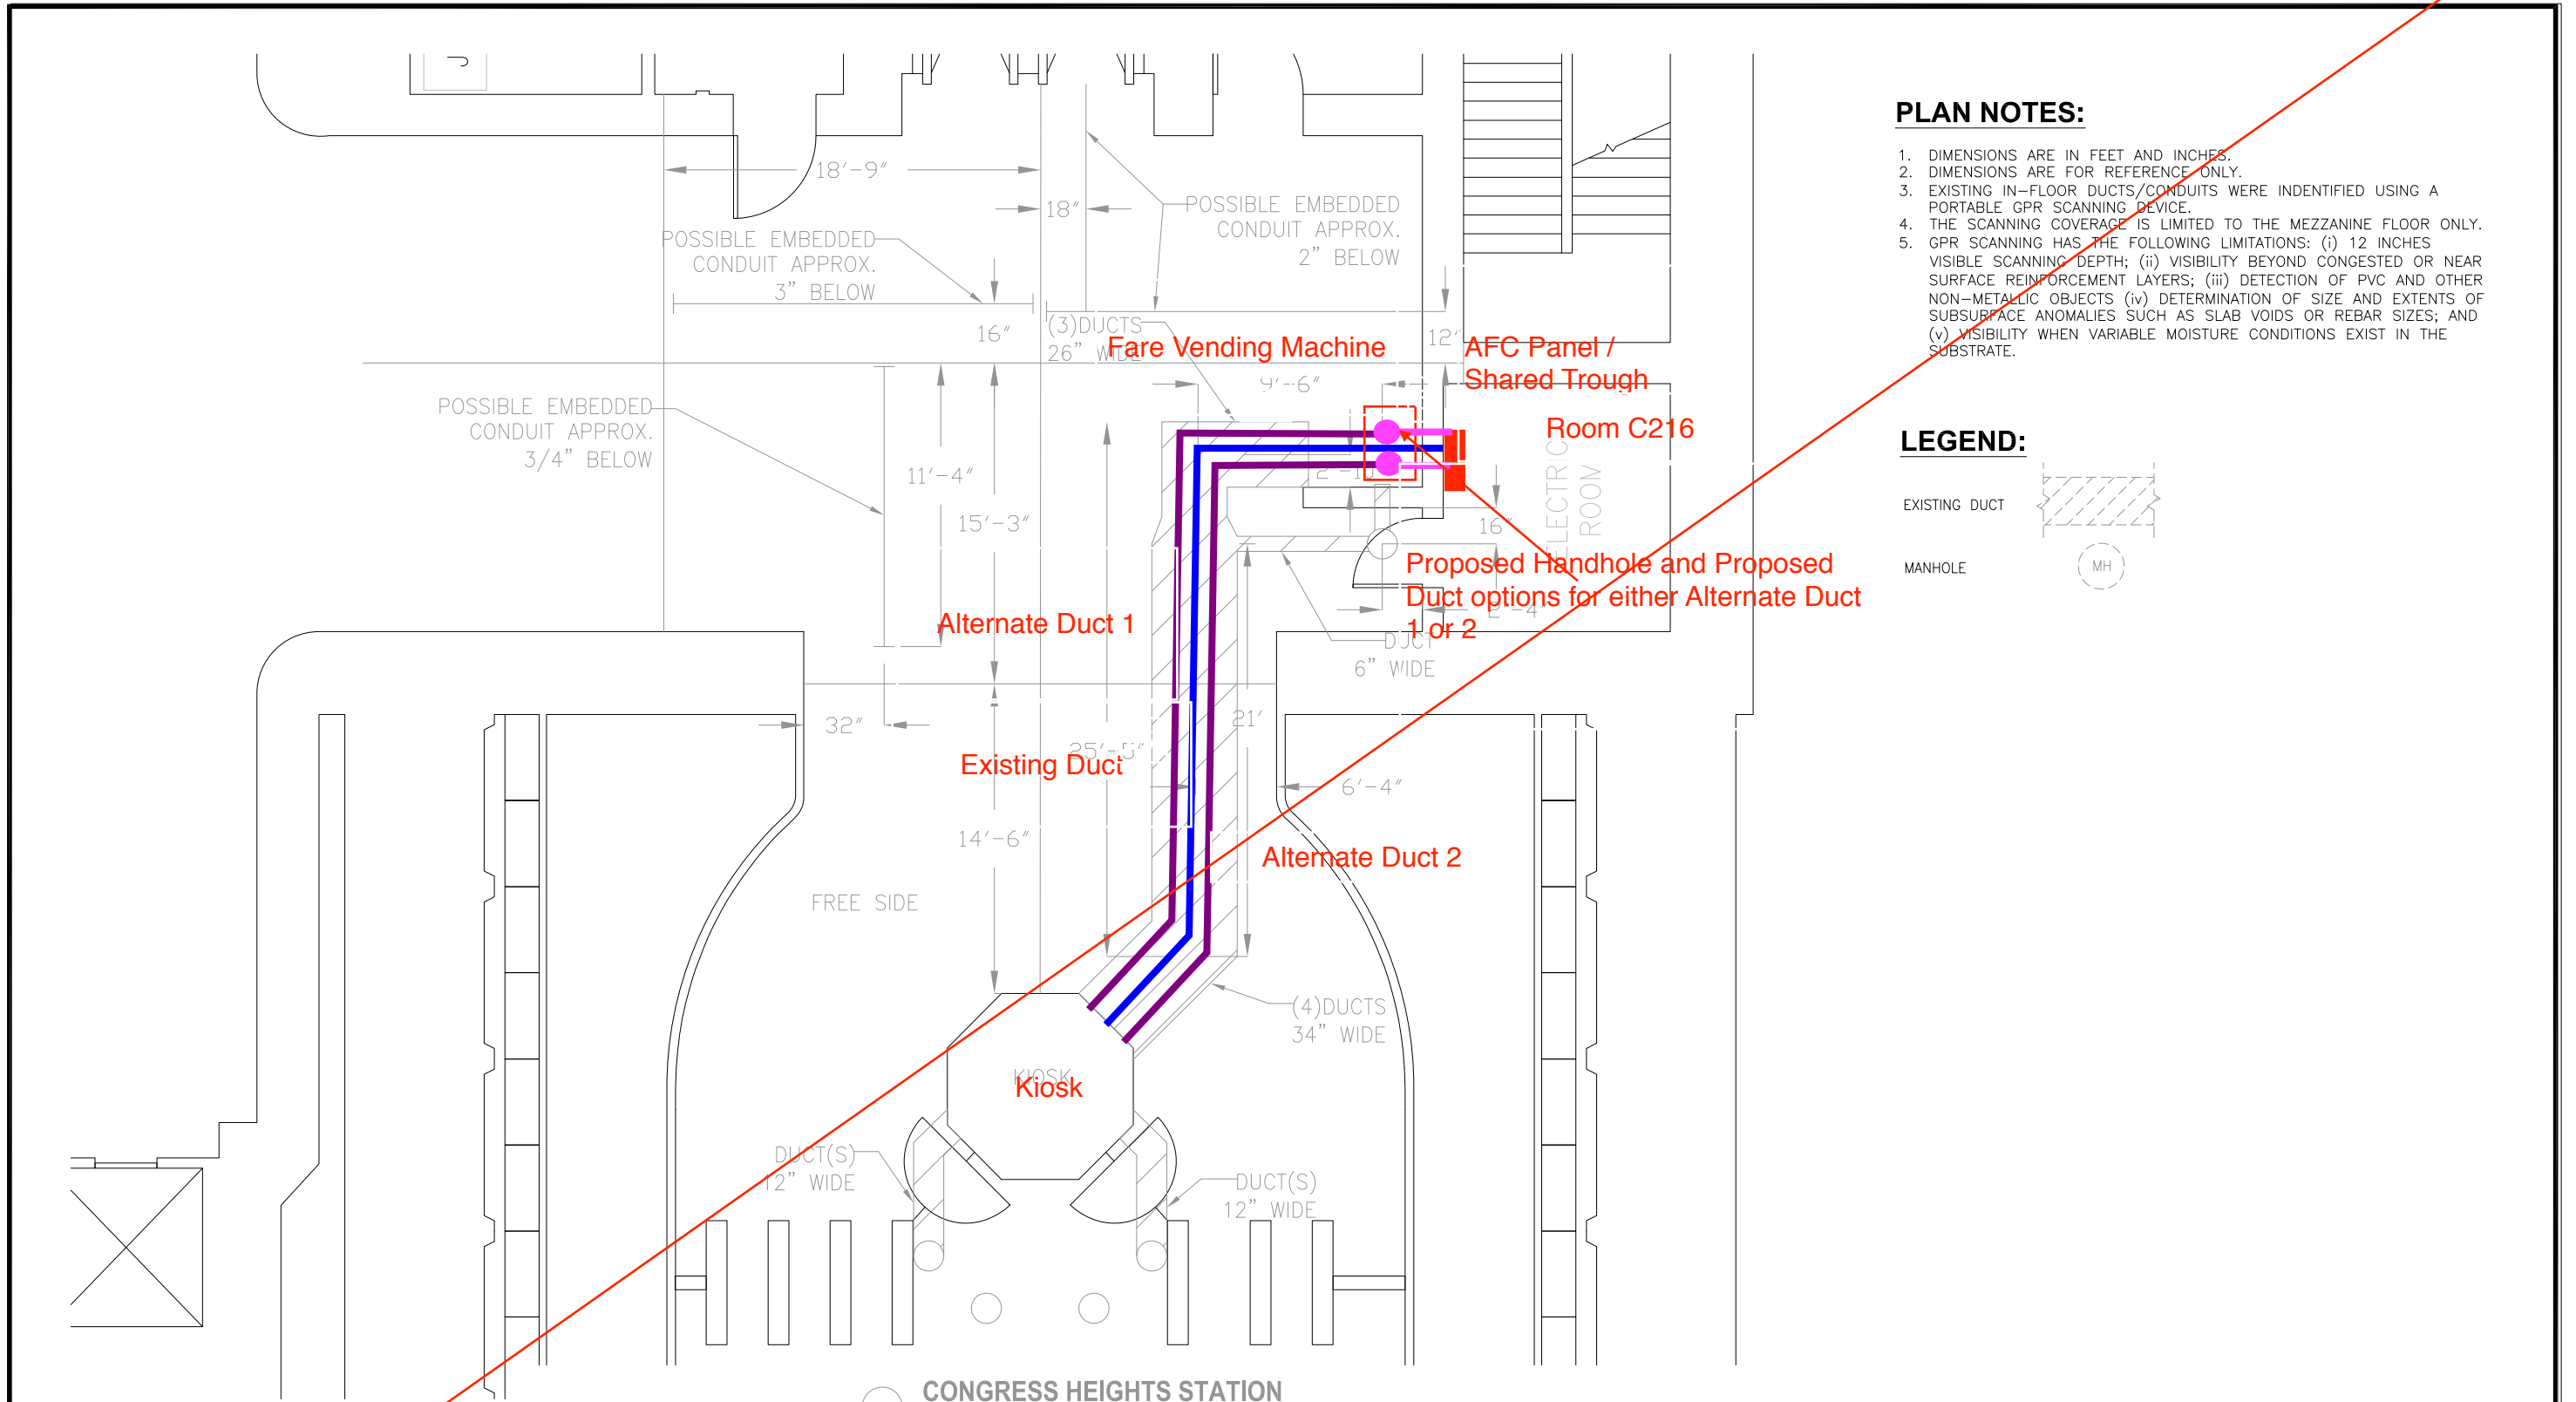
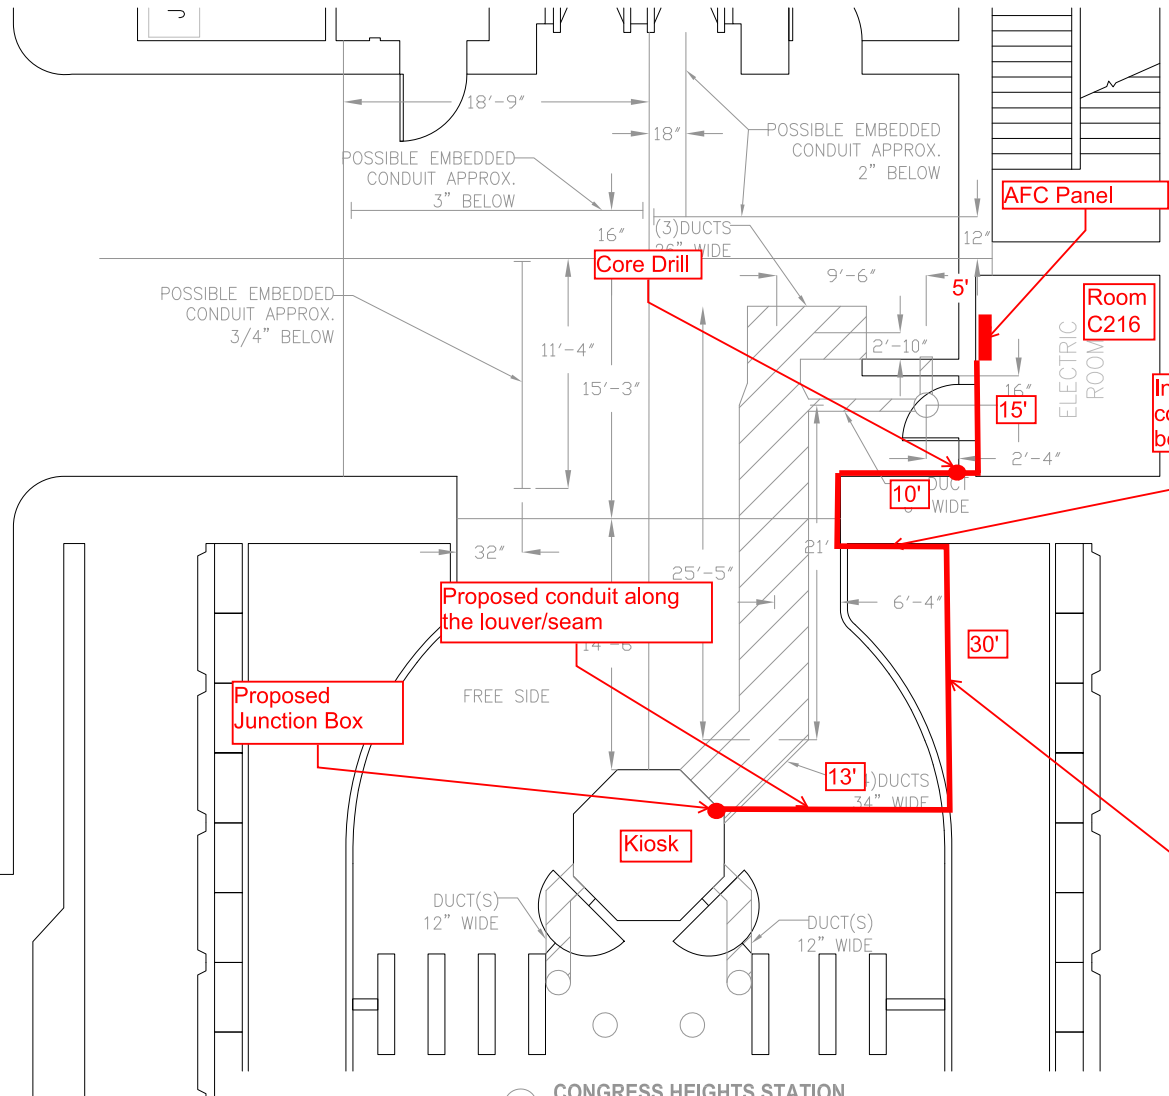
15-NEPP-01
IN - FLOOR DUCT INSPECTIONS
F07 Congress Heights
PROPOSED POWER ROUTE
SCALE: NOT TO SCALE
DRAWING NO.: F07-E-100
XXX

NEPP-02: Video scoping and pull string installation was attempted in two empty alternate ducts that run parallel with the existing power duct. Scoping was completed in both alternate ducts up to the 90-degree vertical bends below the AFC Panel. However, scoping could not be completed all the way to the AFC Panel, and pull string was not installed, due to obstructions at the 90-degree bends. It is recommended to remove the damaged part of either alternate duct between mezzanine side (beneath the existing fare vending machine) up to the shared trough beneath the AFC Panel. A new duct is proposed to replace the damaged section by utilizing the existing duct path through the wall. A new handhole is also proposed on the mezzanine side (beneath the existing fare vending machine) at the start of the new section. Refer to photos and drawings for further information.

See new schematic drawing/proposed pathway on last page
