## Mezzanine Inspection Report (Scoping)

Date: 11/24/2014	Station Name: F08 Southern Avenue	Mezzanine #: 107	Completed By: Byron Williams
------------------	-----------------------------------	------------------	------------------------------

# Mezzanine Inspection Report

Date: 06/29/15	Station Name: F09 Naylor Road	Mezzanine #: 087	Completed By: Mike Butler
----------------	-------------------------------	------------------	---------------------------

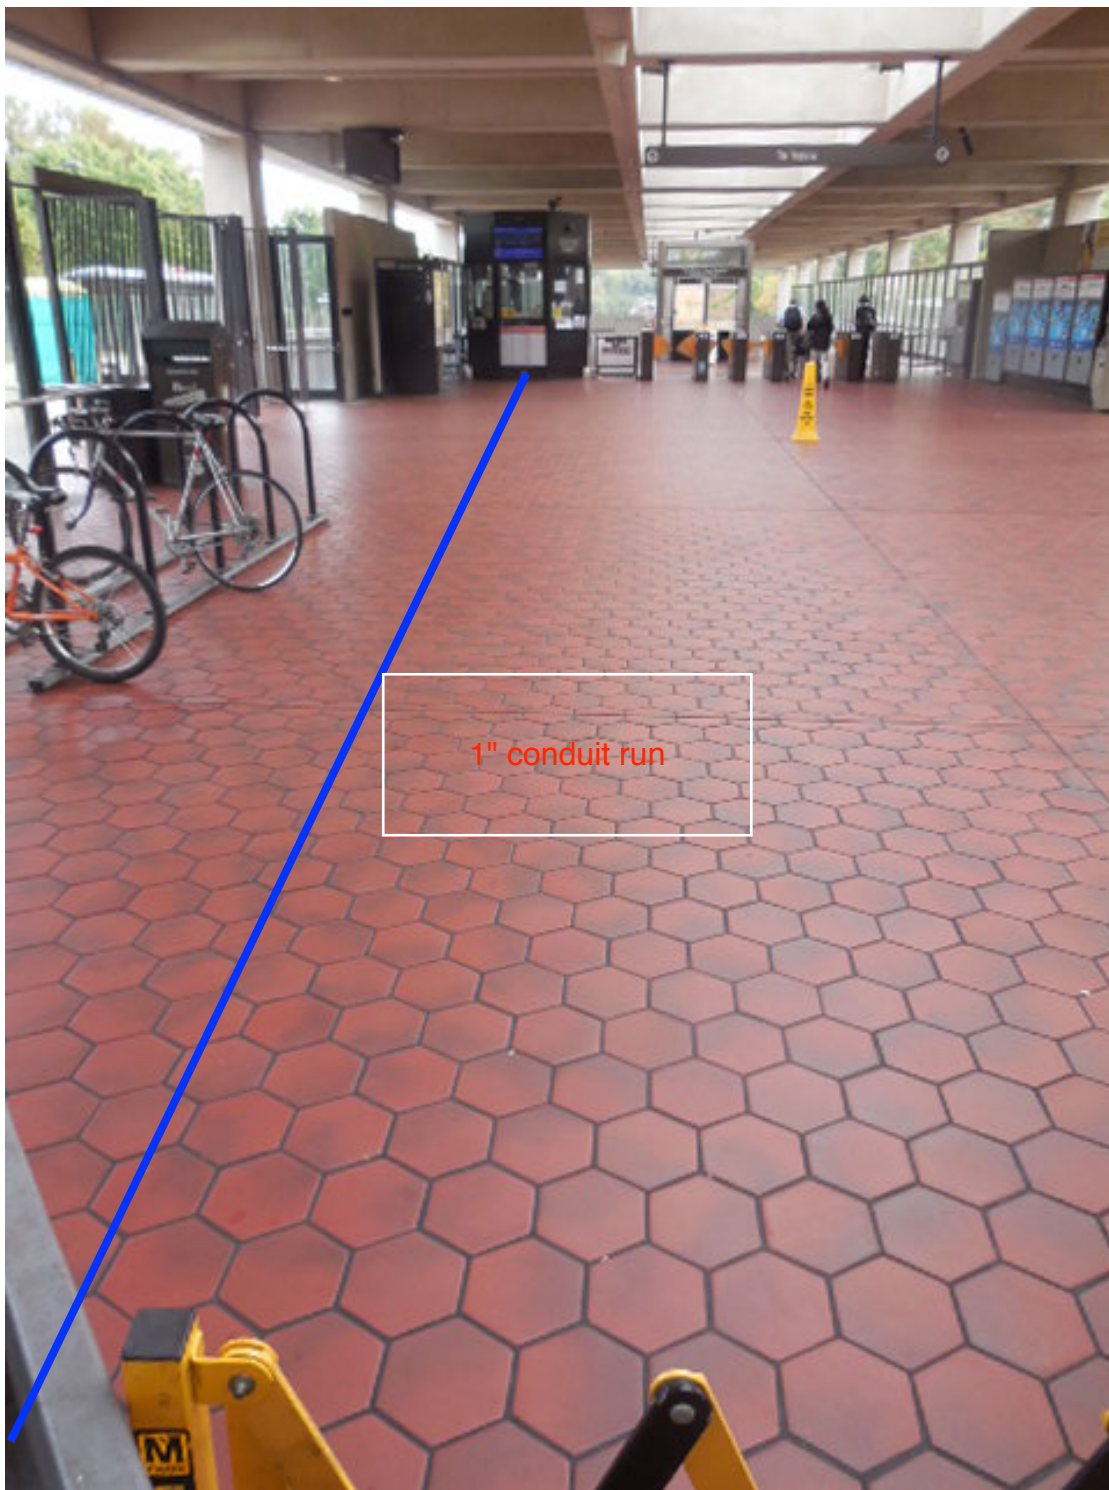
Video scoping was completed for the communications and power duct in the faregate array. Pull strings were installed in the communications duct for the faregate array. Video scoping of the double 6" duct run from the kiosk to the AFC panel was attempted, but both ducts were collapsed. Pull string was installed in the 1" conduit from the kiosk to the AFC panel.

Photo #1 – F08 Southern Avenue: Duct run from Kiosk to AFC panel

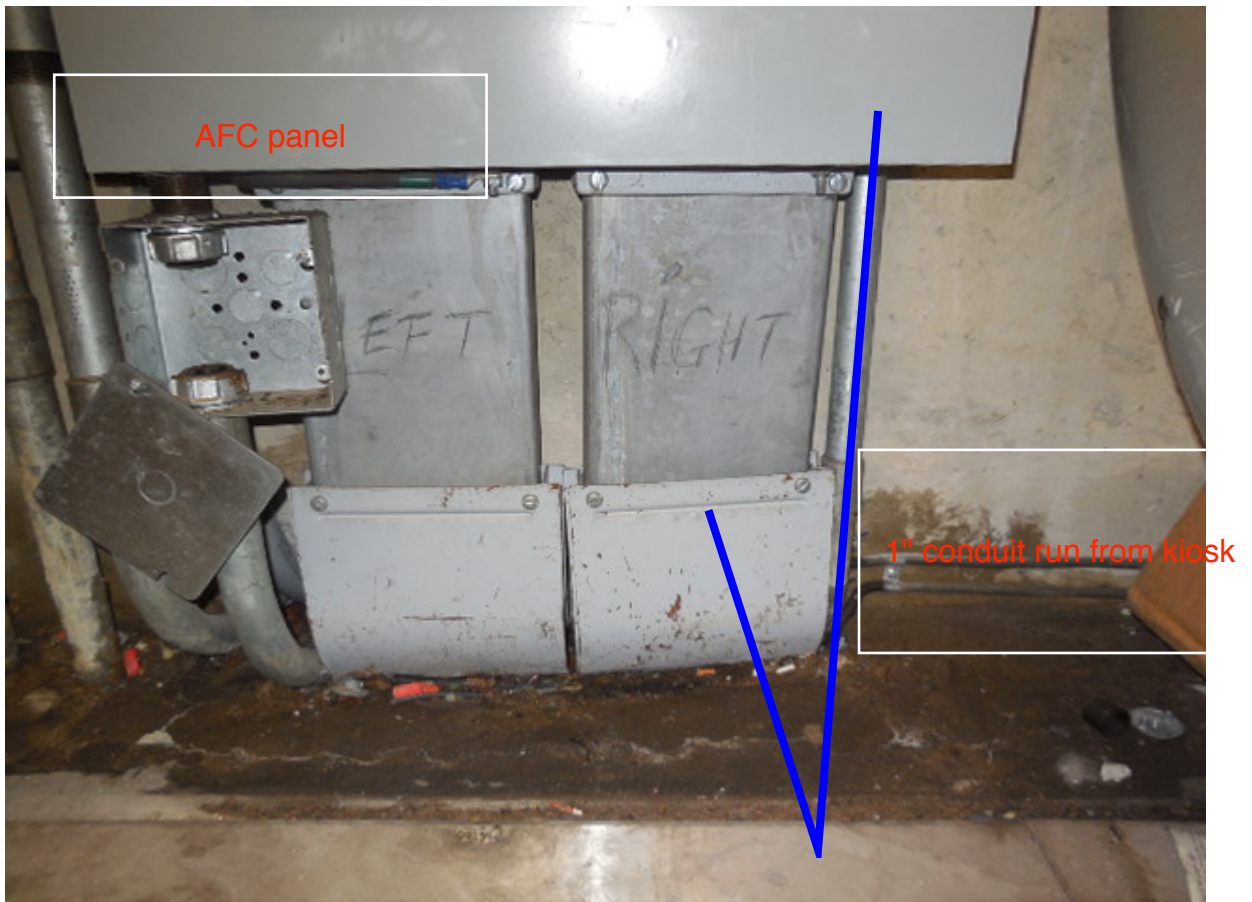
Photo #2 – F08 Southern Avenue: Ducts and conduit from kiosk into AFC panel

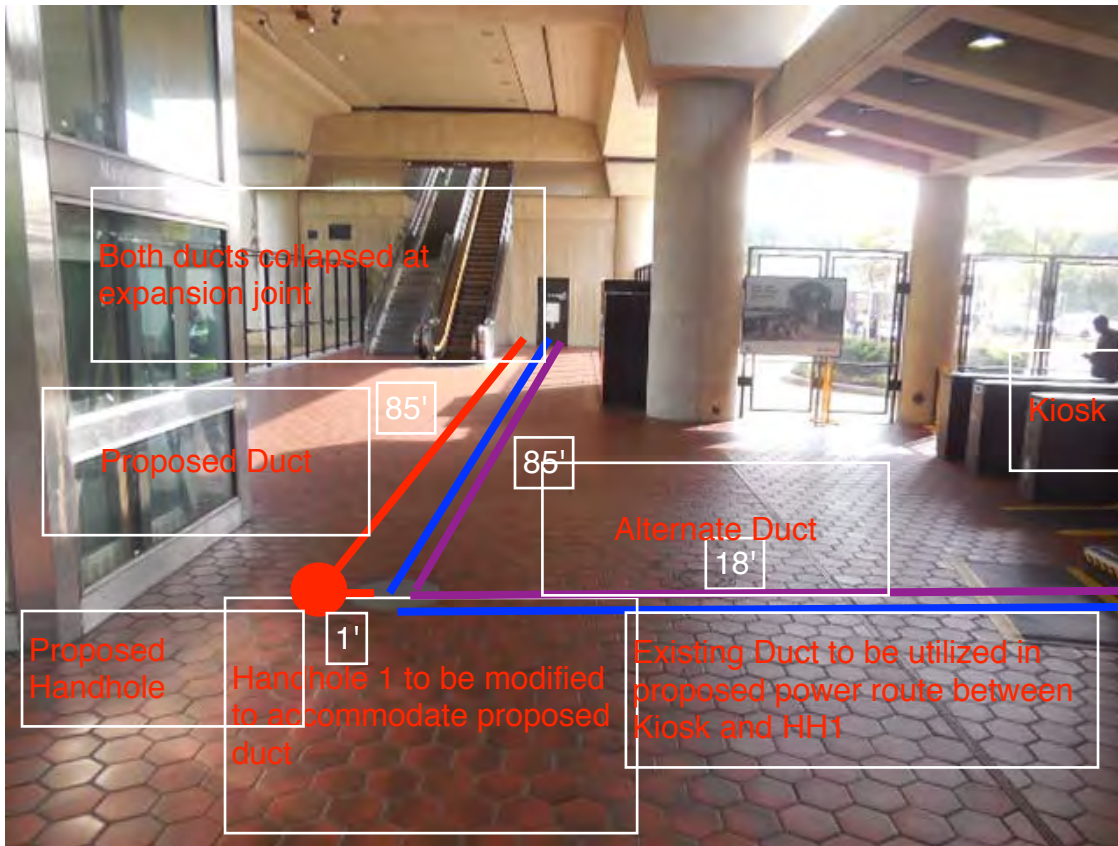
Photo 1 – Existing, alternate and proposed ducts on mezzanine floor

It is recommended to avoid using the existing or alternate duct between Handhole 1 and Handhole 2 due to collapses. A new duct is proposed between Handhole 1 and Handhole 3. The proposed duct will connect to the upper side of Handhole 1 and run up to a new handhole directly adjacent to Handhole 1. The duct will then run parallel to existing duct towards the back rooms. The duct will pass under the wall adjacent to the entrance to back rooms (by core drilling under wall) and then feed into Handhole 3. The proposed route will utilize the existing power duct between Kiosk and Handhole 1; and Handhole 3, Handhole 4 and AFC Panel. Handhole 1 and Handhole 3 will need to be modified to accommodate the proposed duct accordingly. Refer to photos and drawings for further information.

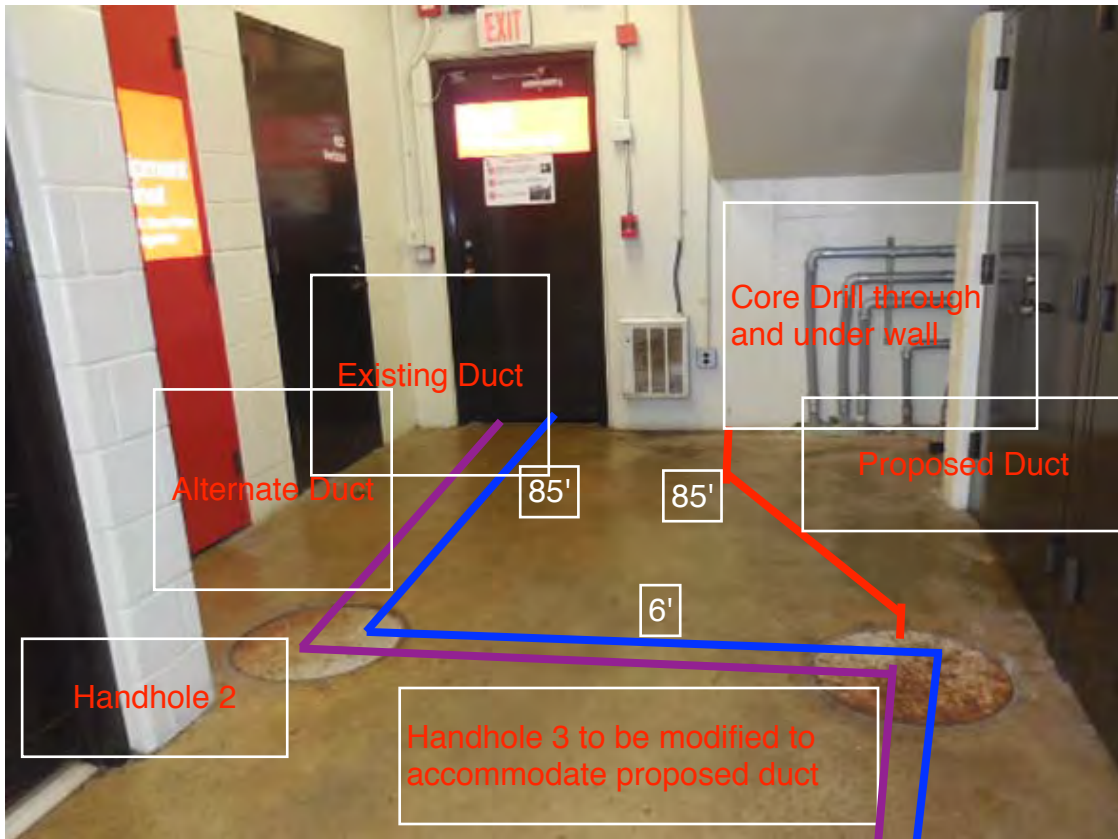
Photo 2 – Existing, alternate and proposed ducts in back room corridor.

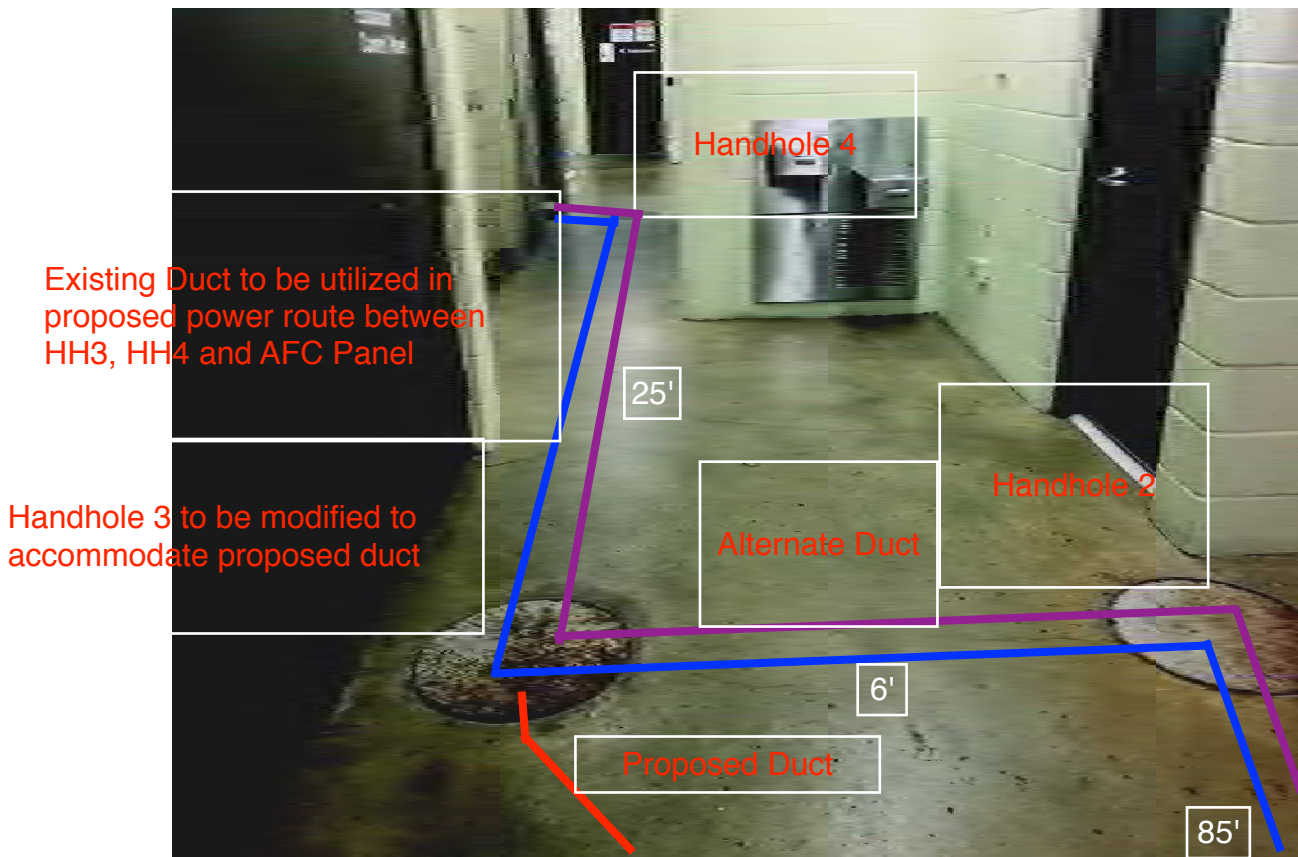
Photo 3 – Existing, alternate and proposed ducts in back room corridor.

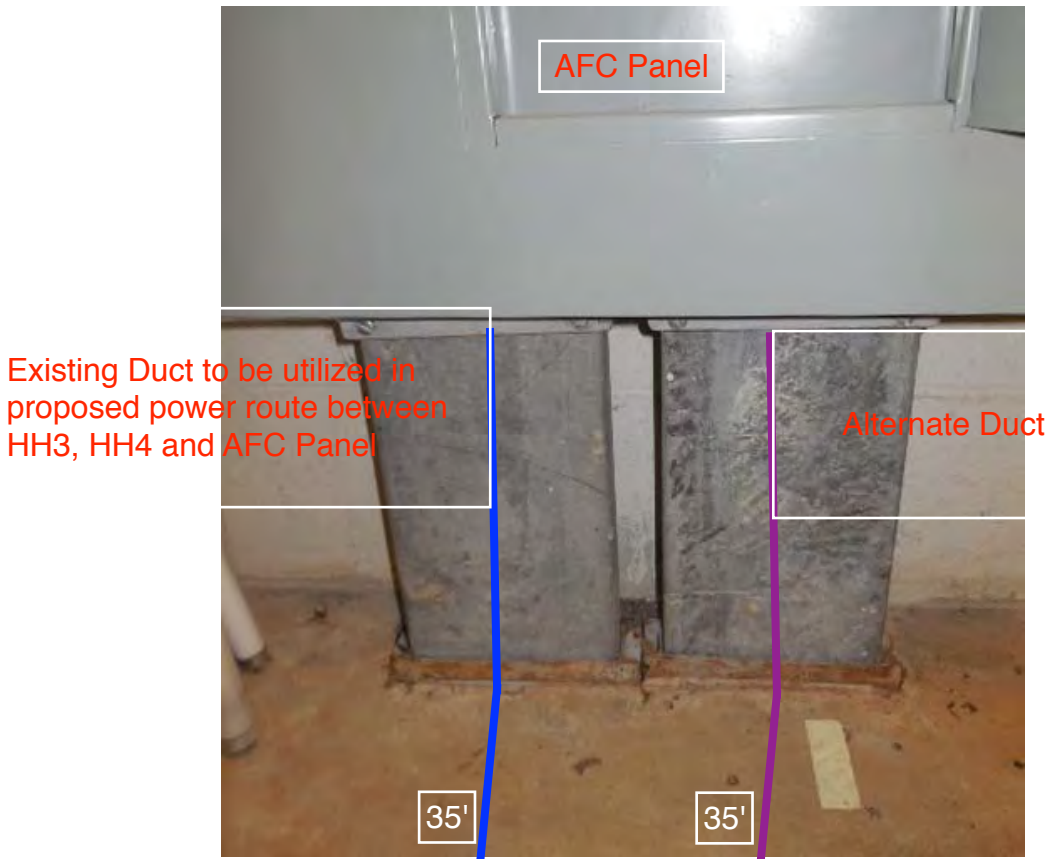
Photo 4 – Existing and alternate duct feeding AFC Panel in Room 126
