Mezzanine Inspection Report							
Date: 3/9/2015	Station Name: F11 Branch Av	enue/	Mezzanine #: 089	Completed By: Mike Butler			
Summary							
Pull string installation completed for communication duct in faregate array, however video scoping could only be partially completed due to an obstruction. Video scoping was completed for power duct in faregate array. Video scoping and pull string installation was completed in an alternate empty walker duct between the Kiosk and wall opening in Room C203 (see photos). The alternate empty duct was identified after scanning of the mezzanine. Pull string was also installed in the overhead power conduit between wall opening and AFC Panel in Room C203. Refer to drawings and photos for additional information.							
Scoping of Faregate Array(s)

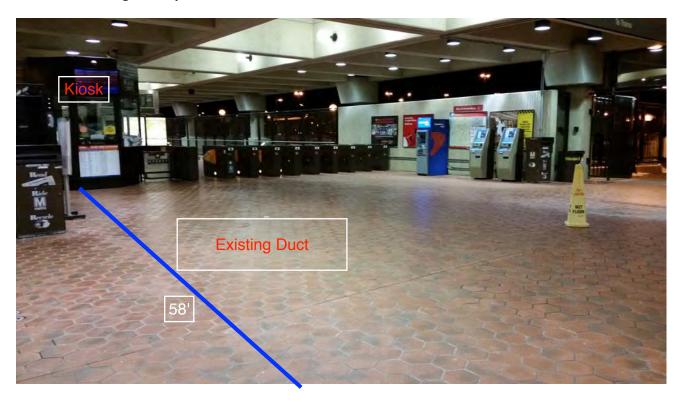
Photo #1 – Existing duct layout on mezzanine floor

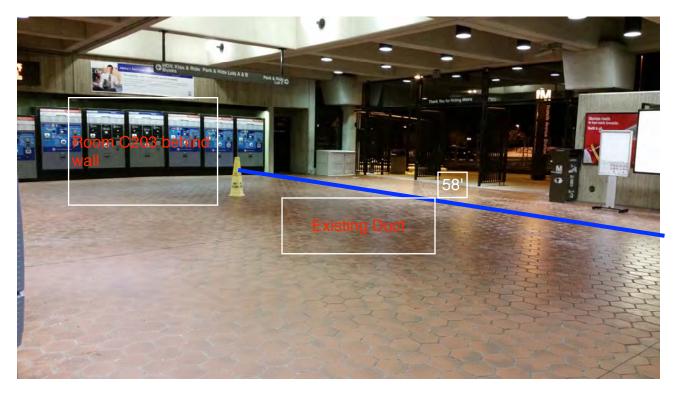
Photo #2 – Existing duct layout on mezzanine floor

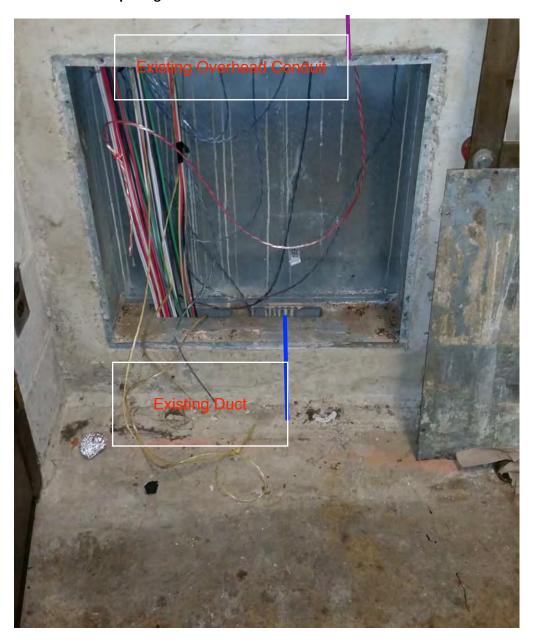
Photo #3 – Wall opening inside Room C203

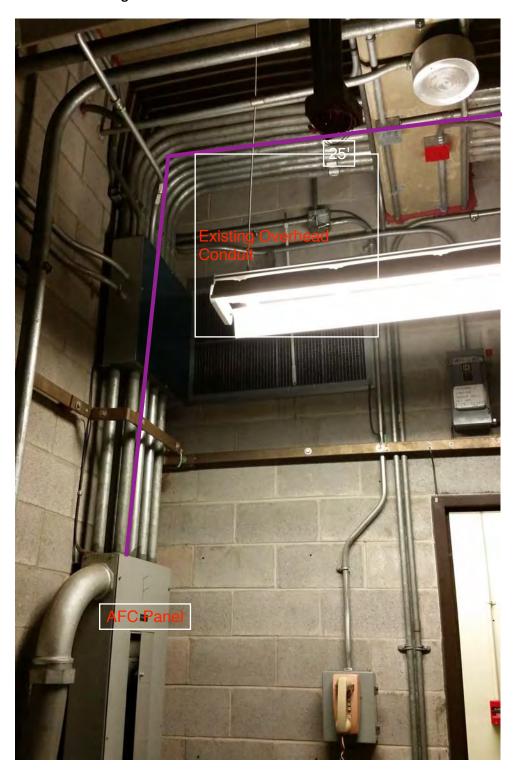
Photo #4 – Existing conduit run to AFC Panel
