Mezzanine Inspection Report

Date: 06/15/15	Station Name: C02 McPherson Square	Mezzanine #: 037	Completed By: Mike Butler
-----------------------	---	-------------------------	----------------------------------

15-NEPP-01
IN - FLOOR DUCT INSPECTIONS
C02 McPherson Square
PROPOSED POWER RUN

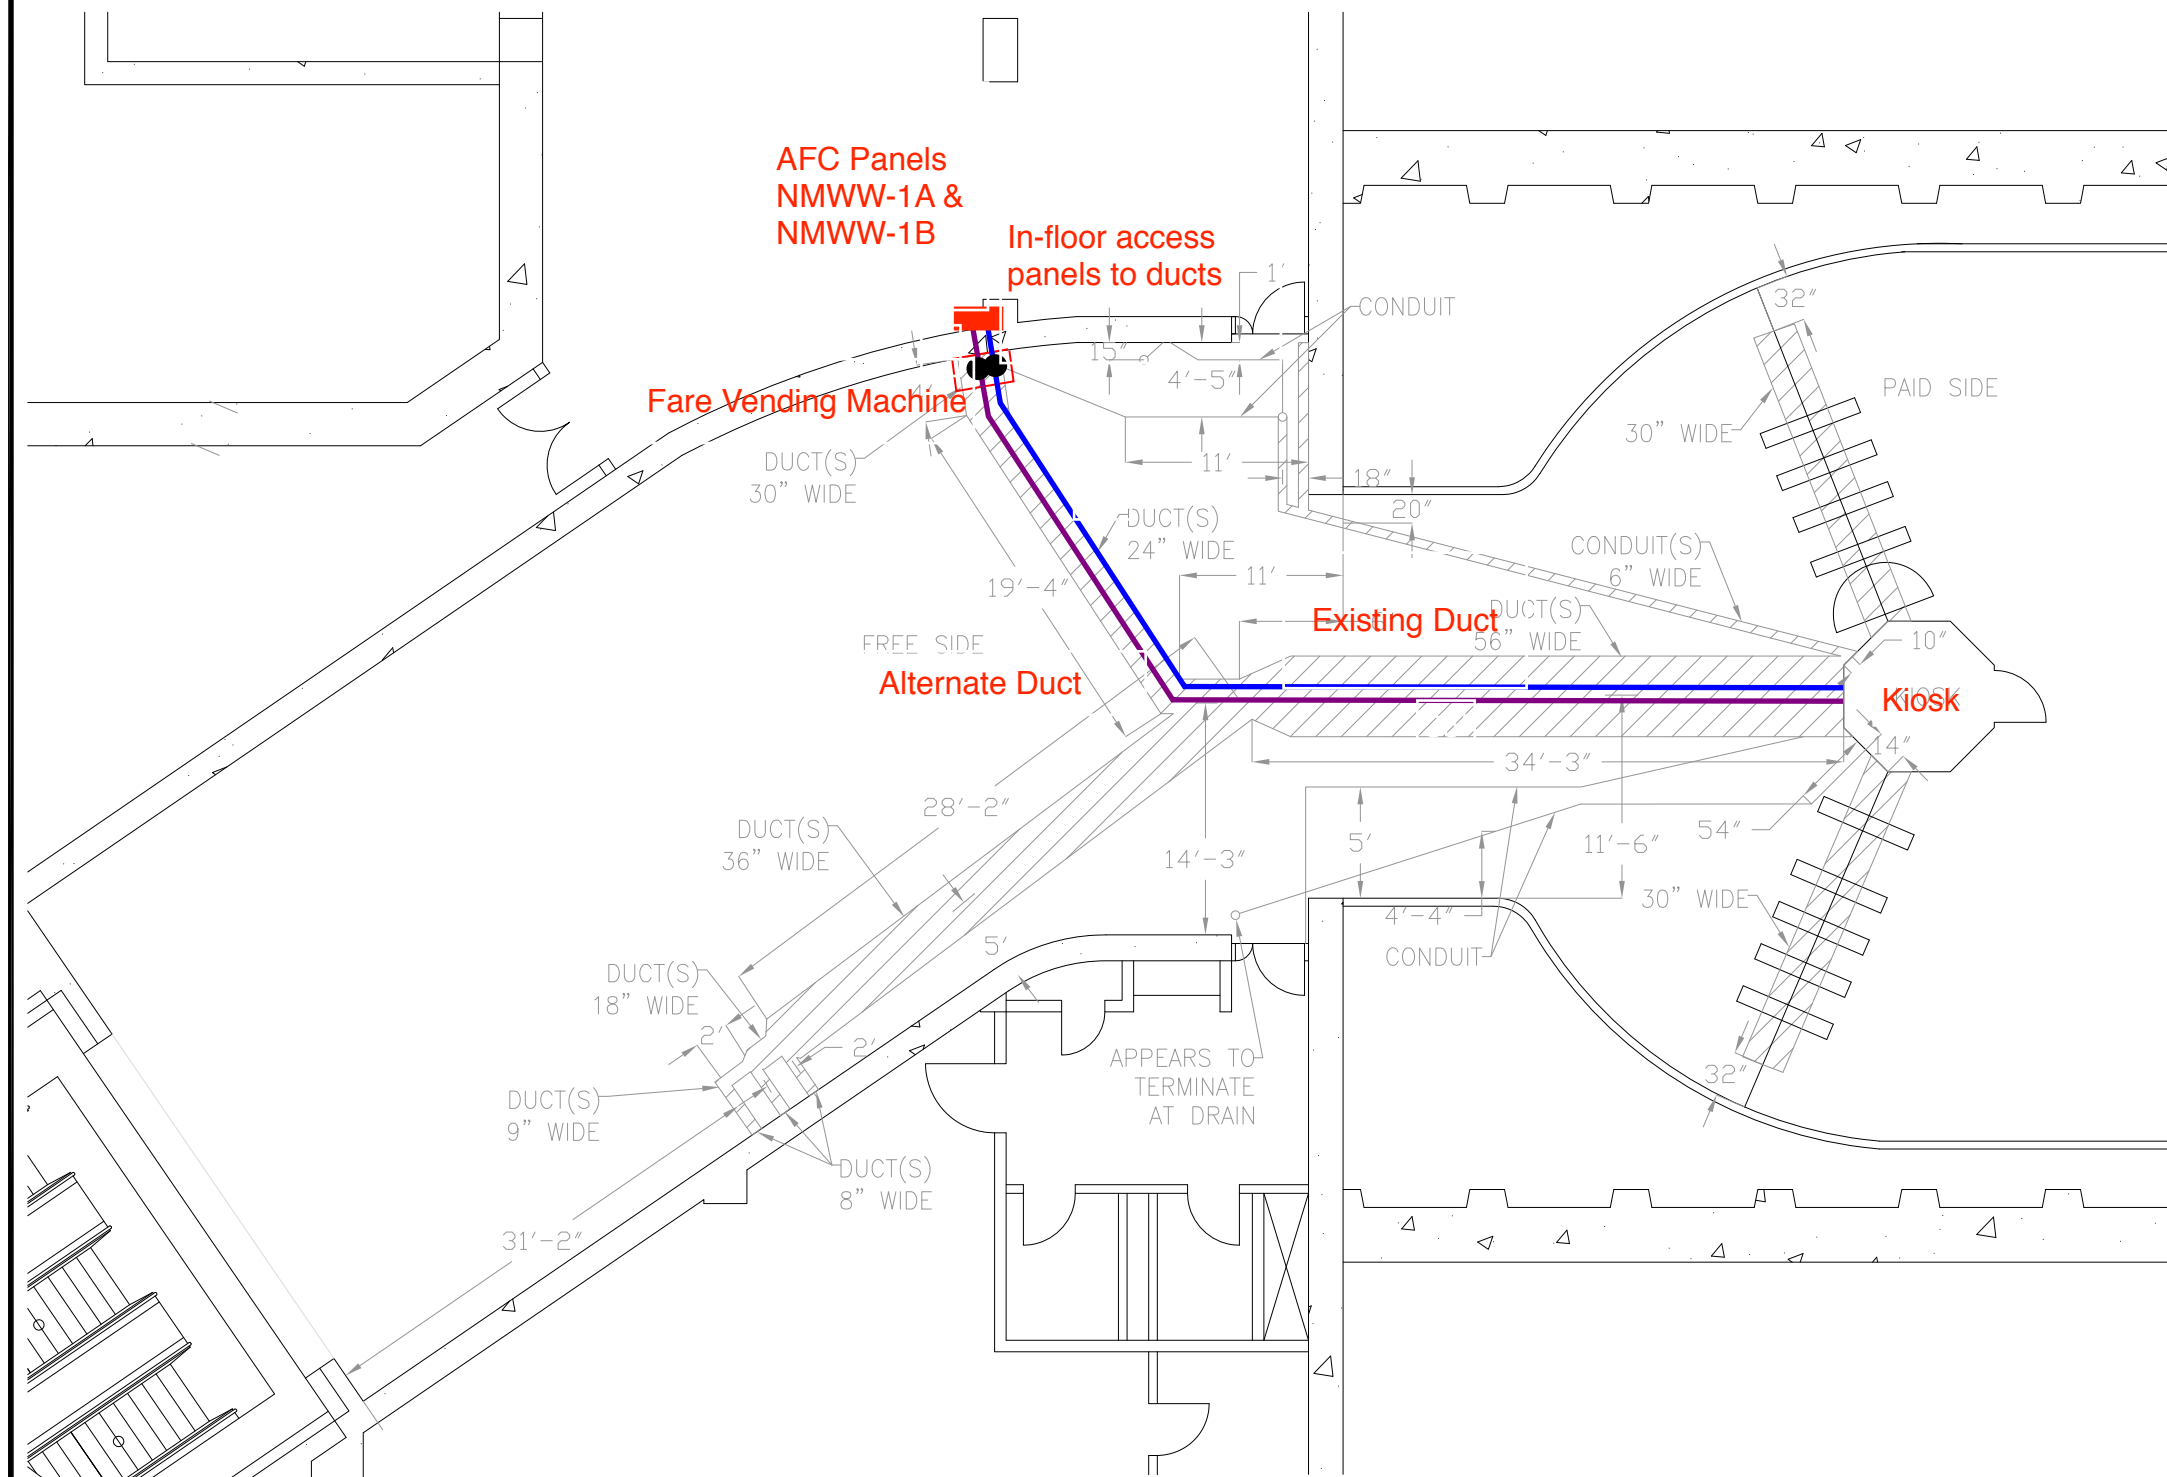
NEPP-01: Video scoping and pull string installation was completed for communication ducts in upper / lower faregate arrays; respective power ducts were also video scoped. It was not possible to complete video scoping and pull string installation in existing power duct between Kiosk and AFC Panel because the duct is at capacity. Scanning was conducted to identify a proposed power route between the Kiosk and AFC Panel. There are multiple ducts running from the Kiosk to AFC Panel, and there is no clear path for a new in-floor duct. However, an alternate existing duct was identified.

NEPP-02: Video scoping and pull string installation was attempted in an alternate duct that runs parallel with existing power duct from Kiosk to AFC Panel. Video scoping was completed from Kiosk to an in-floor access panel, and from AFC Panel to the same in-floor access panel. However, it was not possible to install pull string due to access issues to the in-floor access panel. A fare vending machine (Express Vendor #37; SN:FV1880) is currently blocking access to the in-floor access panel and will need to be moved to complete the pull string installation. The alternate duct appears to be in good condition and is at minimal capacity. The alternate duct leads to Panel NMWW-1A (Room 212), which is adjacent to the existing AFC Panel NWMM-1B. Panel NWMM-1A could be used as a potential power source for the new wires, or the new NEPP wires could be routed to AFC Panel NMWW-1B.
