## Mezzanine Inspection Report (Scoping)

<b>Date:</b> 01/29/2015	<b>Station Name:</b> D05 Capitol South	<b>Mezzanine #:</b> 059	<b>Completed By:</b> Chris Loose
-------------------------	--	-------------------------	----------------------------------

15-NEPP-01  
IN - FLOOR DUCT INSPECTIONS  
D05 Capitol South  
PROPOSED POWER CONDUIT RUN

15-NEPP-01  
IN - FLOOR DUCT INSPECTIONS  
D06 Eastern Market  
PROPOSED POWER CONDUIT RUN

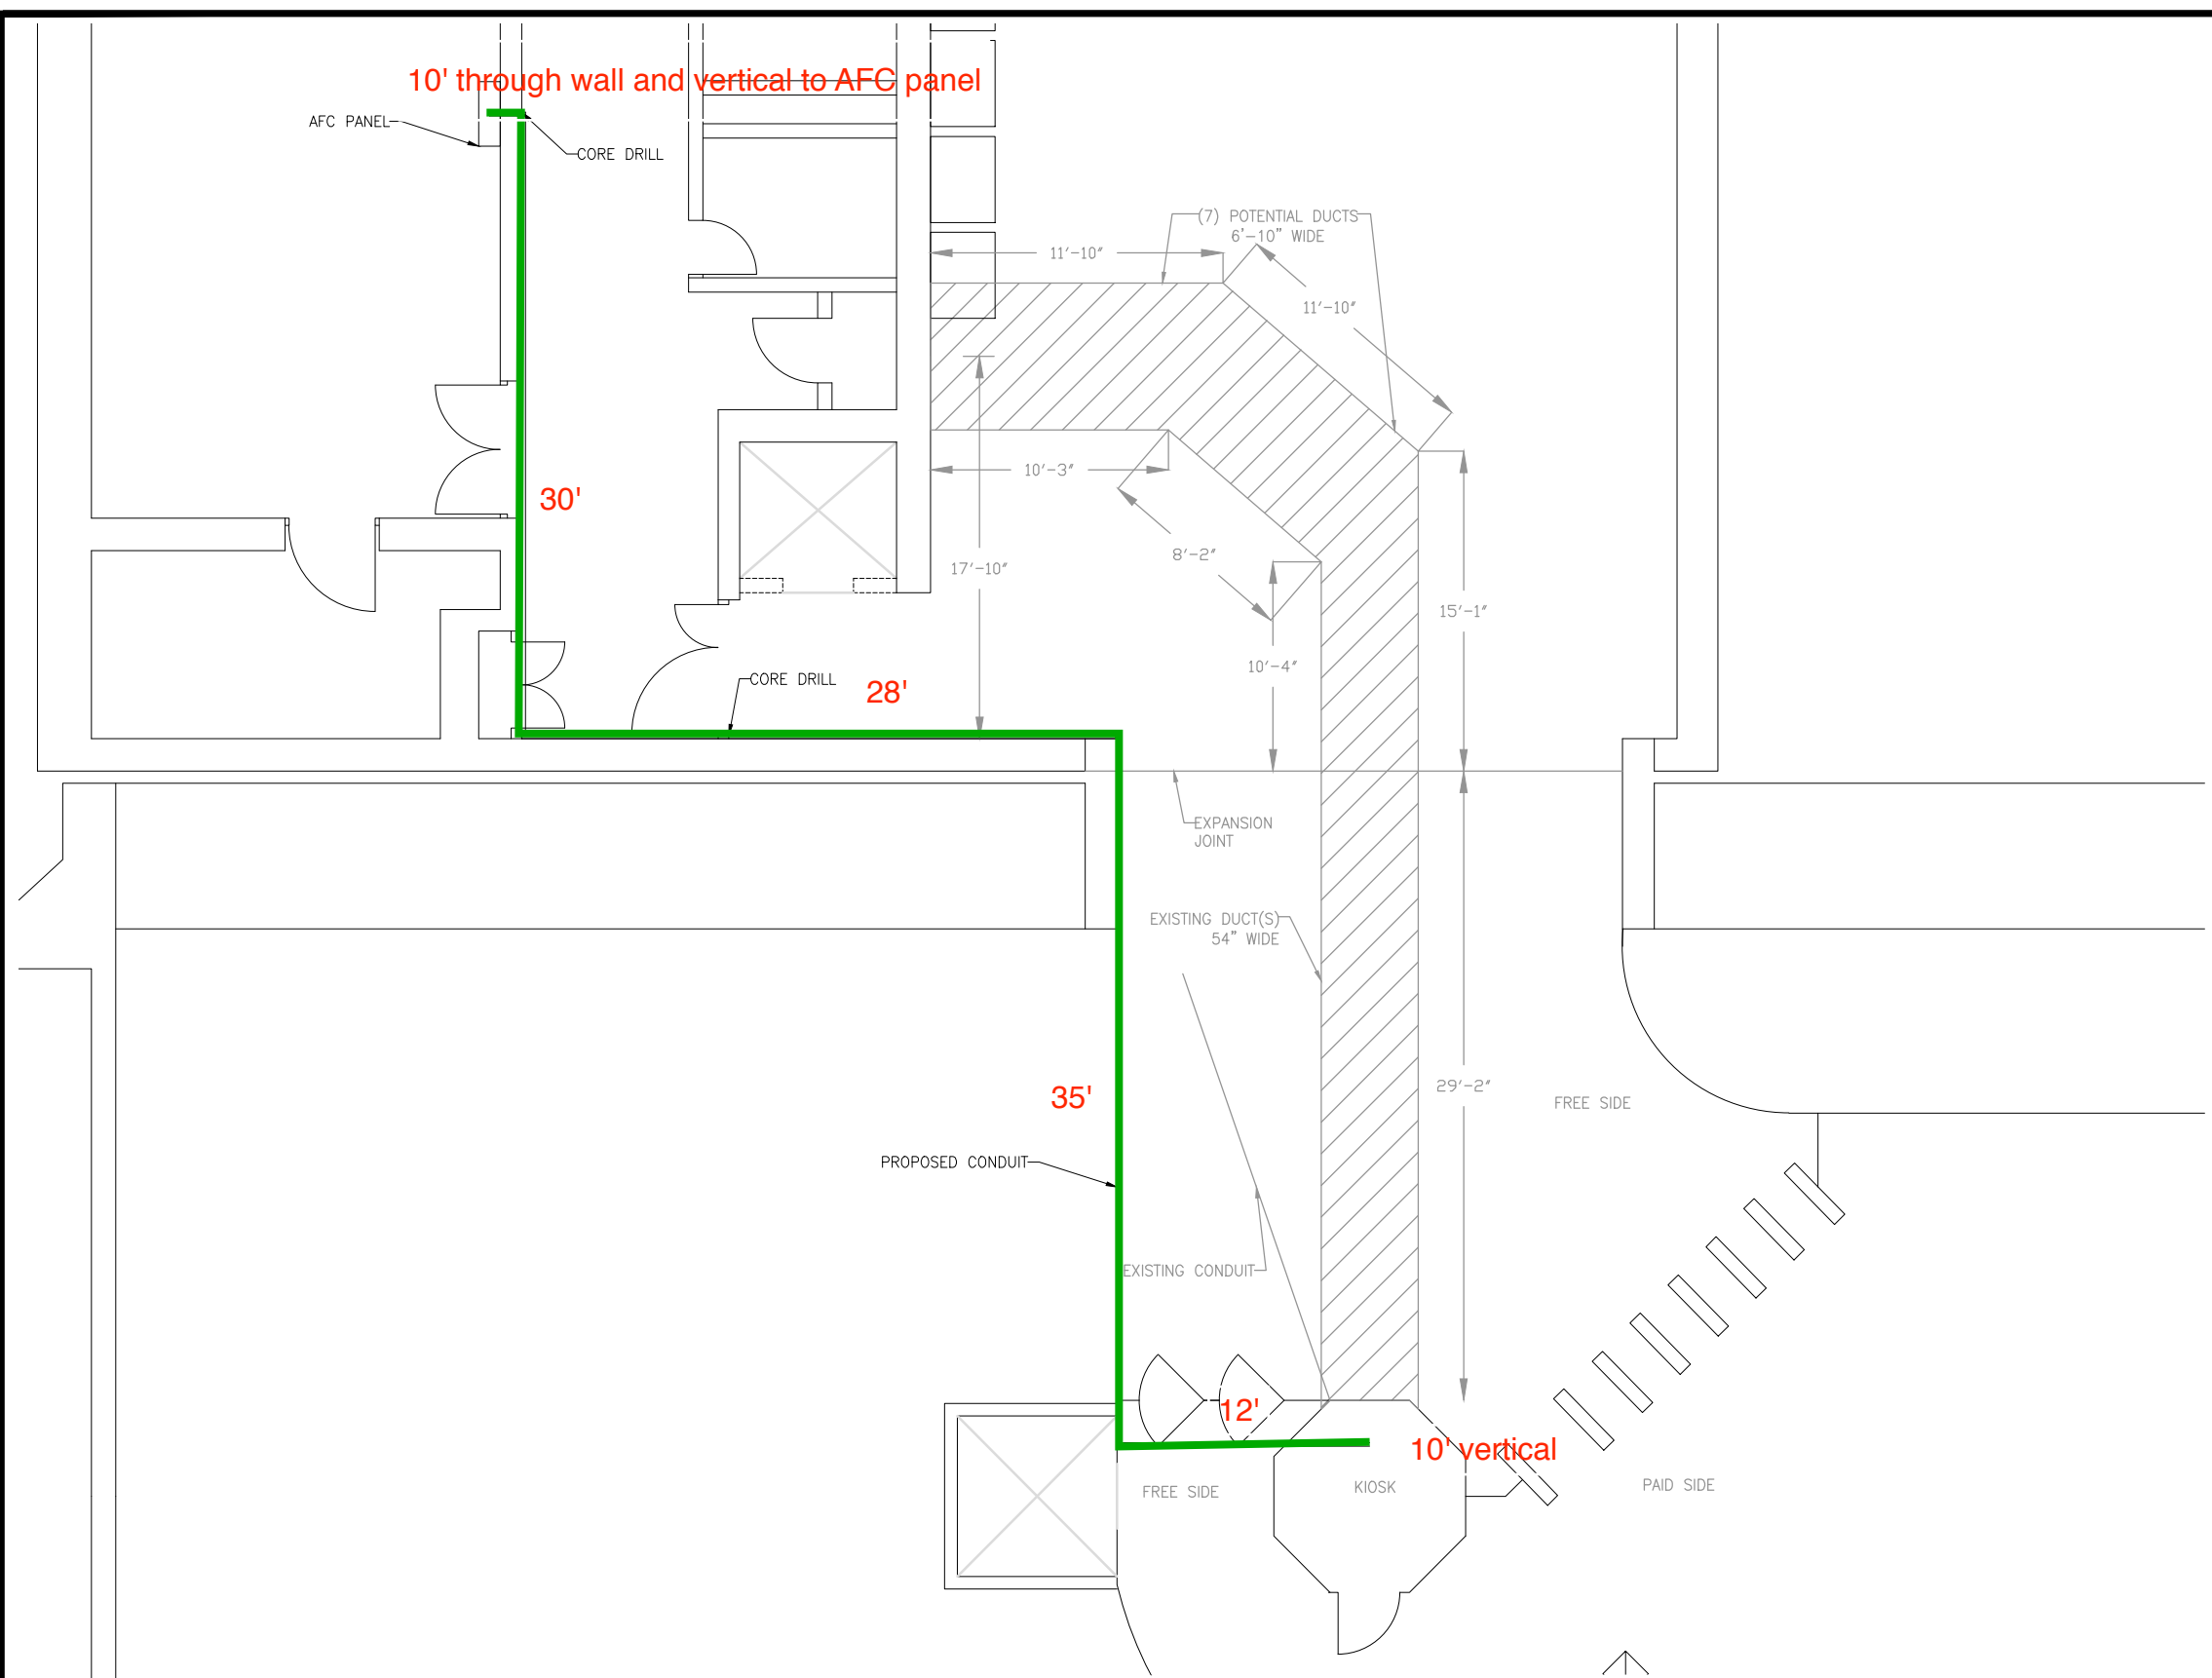
SCALE: NOT TO SCALE DRAWING NO. **D05-E-100** **XXX**

Scanning was completed at this station. Due to existing in floor conduits and ducts, no clear in-floor path is feasible, and therefore an overhead conduit run is proposed for this station. The conduit will run along the recessed channels in the mezzanine ceiling and wrap around the wall towards room #C207. The conduit will be core drilled through the wall above the door and into the backroom hallway. The conduit will continue along the ceiling of the backrooms until reaching the area in the wall in front of room #C201 where the AFC panel is. The proposed conduit will then be core drilled through the wall and drop down to the top of the AFC panel.

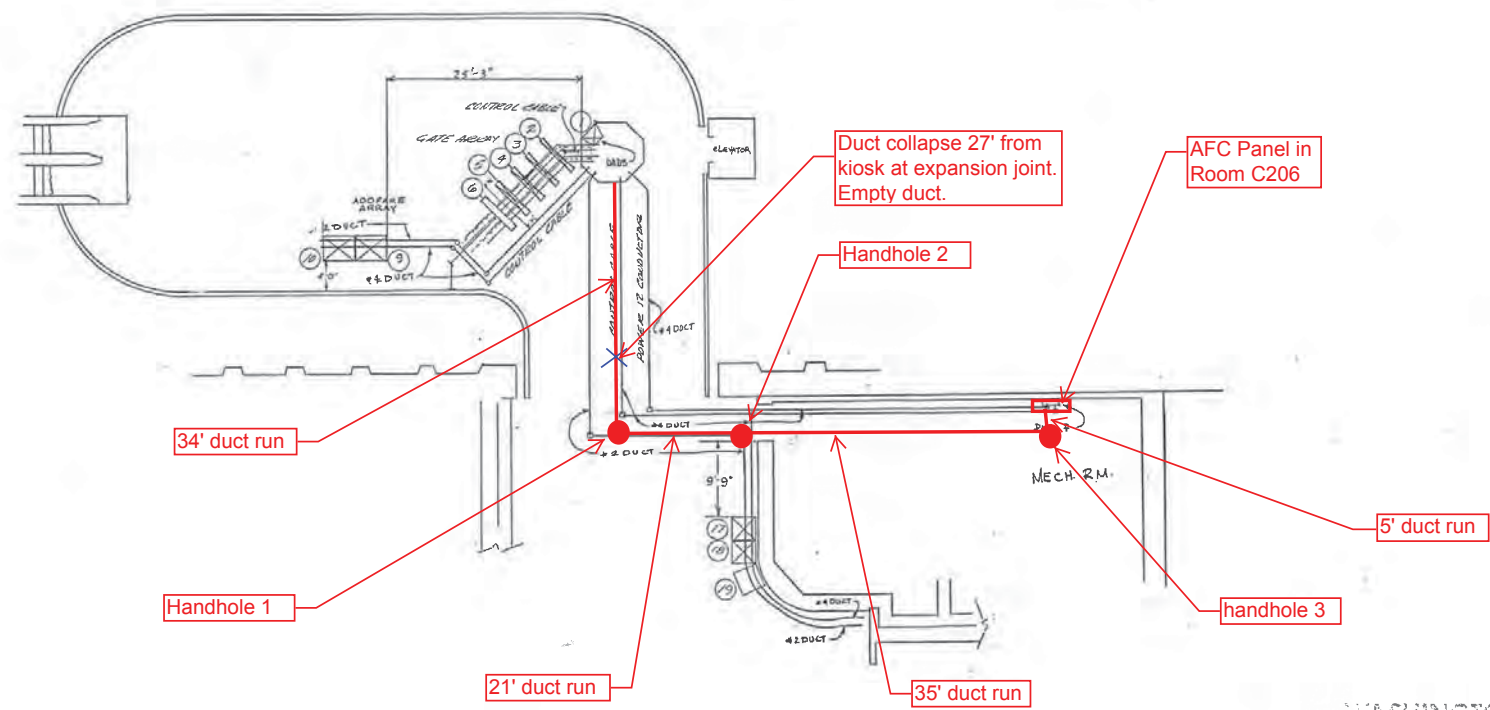
-1 INSTALLATION PLAN  
 (AS BUILT CONDITION)

<b>Observations / Issues / Next Steps</b>		
<p>Total run from kiosk to AFC Panel is approximately 95 feet.</p> <p>AFC power run duct was collapsed at expansion joint between kiosk and handhole 1. Duct was in good condition other than expansion joint collapse. Due to duct run between kiosk and hanhole 1 being empty, duct can be repaired and is viable for further usage.</p>		
<b>Sign Off</b>		
	<b>GFP Representative</b>	<b>WMATA PRGM</b>
<b>Name:</b>	Balkis Hassane	
<b>Signature:</b>

Location of proposed work to repair duct collapse at expansion joint.
