## Mezzanine Inspection Report

Date: 01/14/15	Station Name: D08 Stadium Armory South	Mezzanine #: 062	Completed By: Mike Butler
----------------	--	------------------	---------------------------

Date: 02/05/15	Station Name: D08 Stadium Armory North	Mezzanine #: 063	Completed By: Mike Butler
----------------	--	------------------	---------------------------

Date: 12/05/15	Station Name: D09 Minnesota Avenue	Mezzanine #: 064	Completed By: Mike Butler
<b>Summary</b>			
<p>The upper and lower faregate arrays were scoped and pull strings were installed in communication ducts. The video scoping and pull string installation was successfully completed in the power conduit between the Kiosk and AFC Panel.</p> <p>Scanning is not required at this mezzanine.</p>			
<b>Scoping of Faregate Array(s)</b>			
Task	Yes/No	Notes	
<b>Communications Duct – Upper Faregate Array (4 gates)</b>			
Was video scoping completed for the entire duct run?	Yes	Refer to "WMATA Minnesota Ave 3inch Comm Upper Faregate Video.avi"	
Were pull strings installed at all faregates in the array?	Yes		
Were there any obstructions or blockages? Provide details of type and specific location.	No	Some corrosion evident.	
Is the

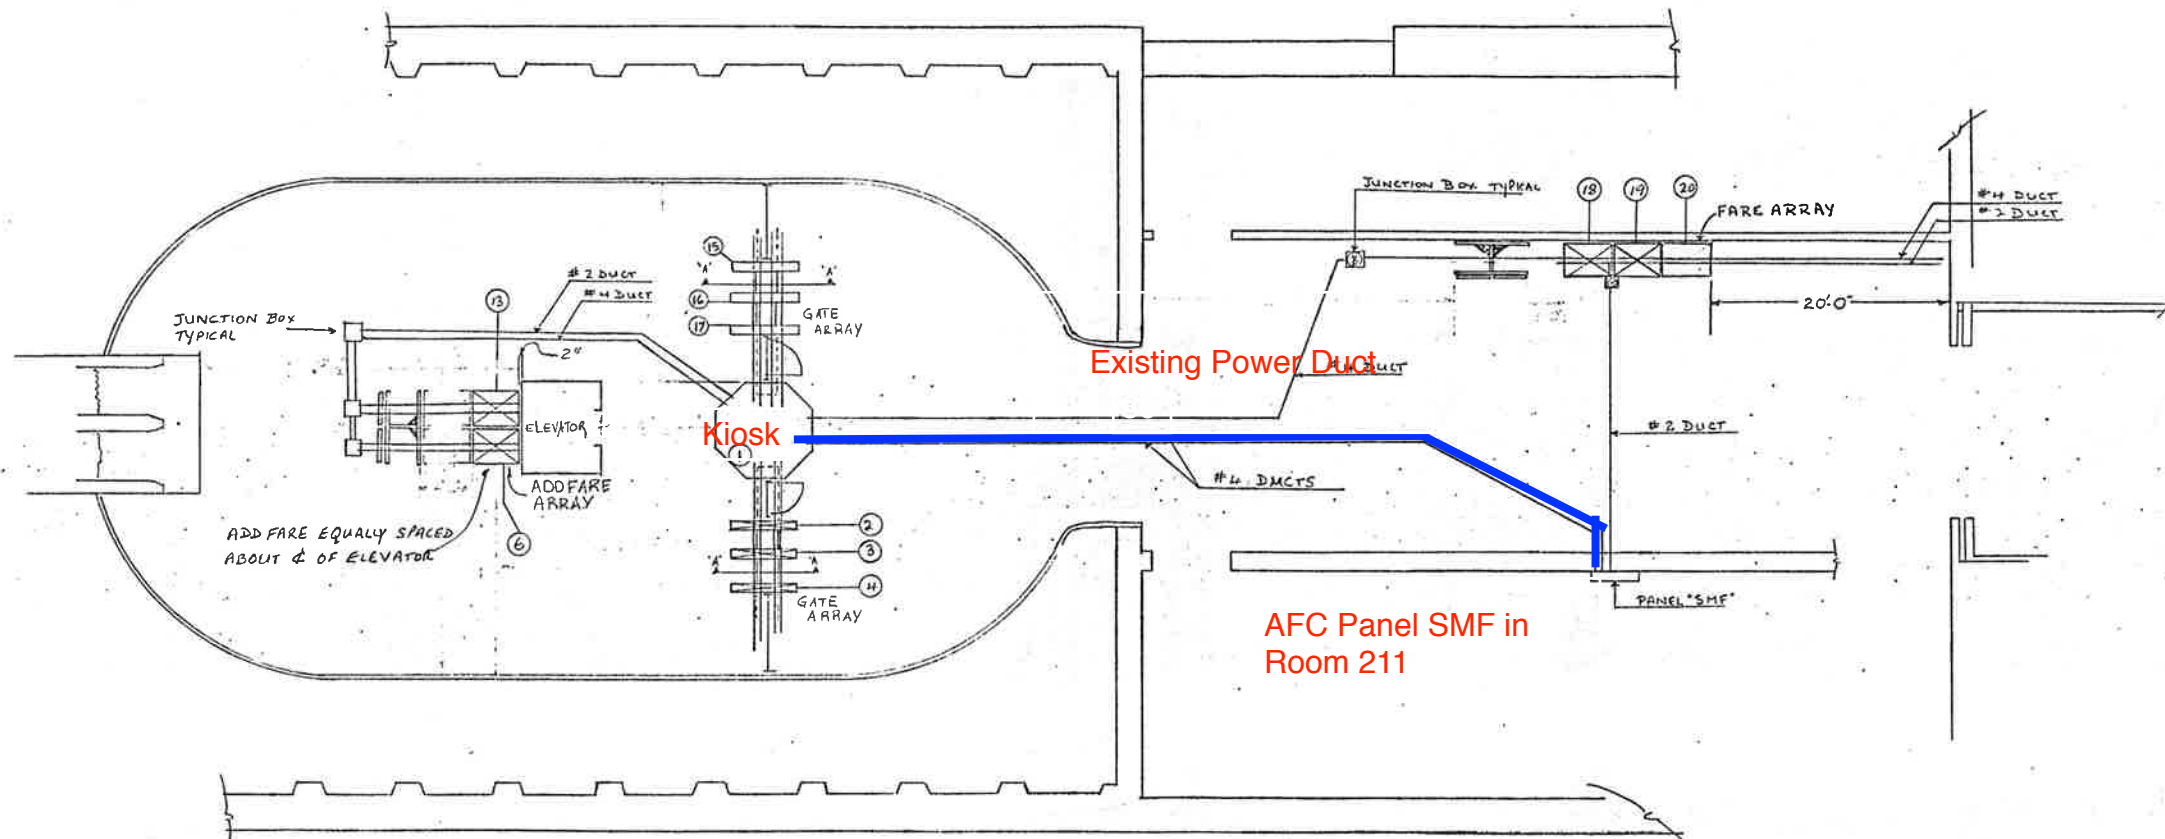
2- INSTALLATION PLAN  
(AS BUILT CONDITION)

PRIORITY REQUESTS ARE HEREBY GIVEN FOR ESCALATORS AND THE ELEVATORS THAT RUNS FROM THE STREET LEVEL TO THE MEZZANINE

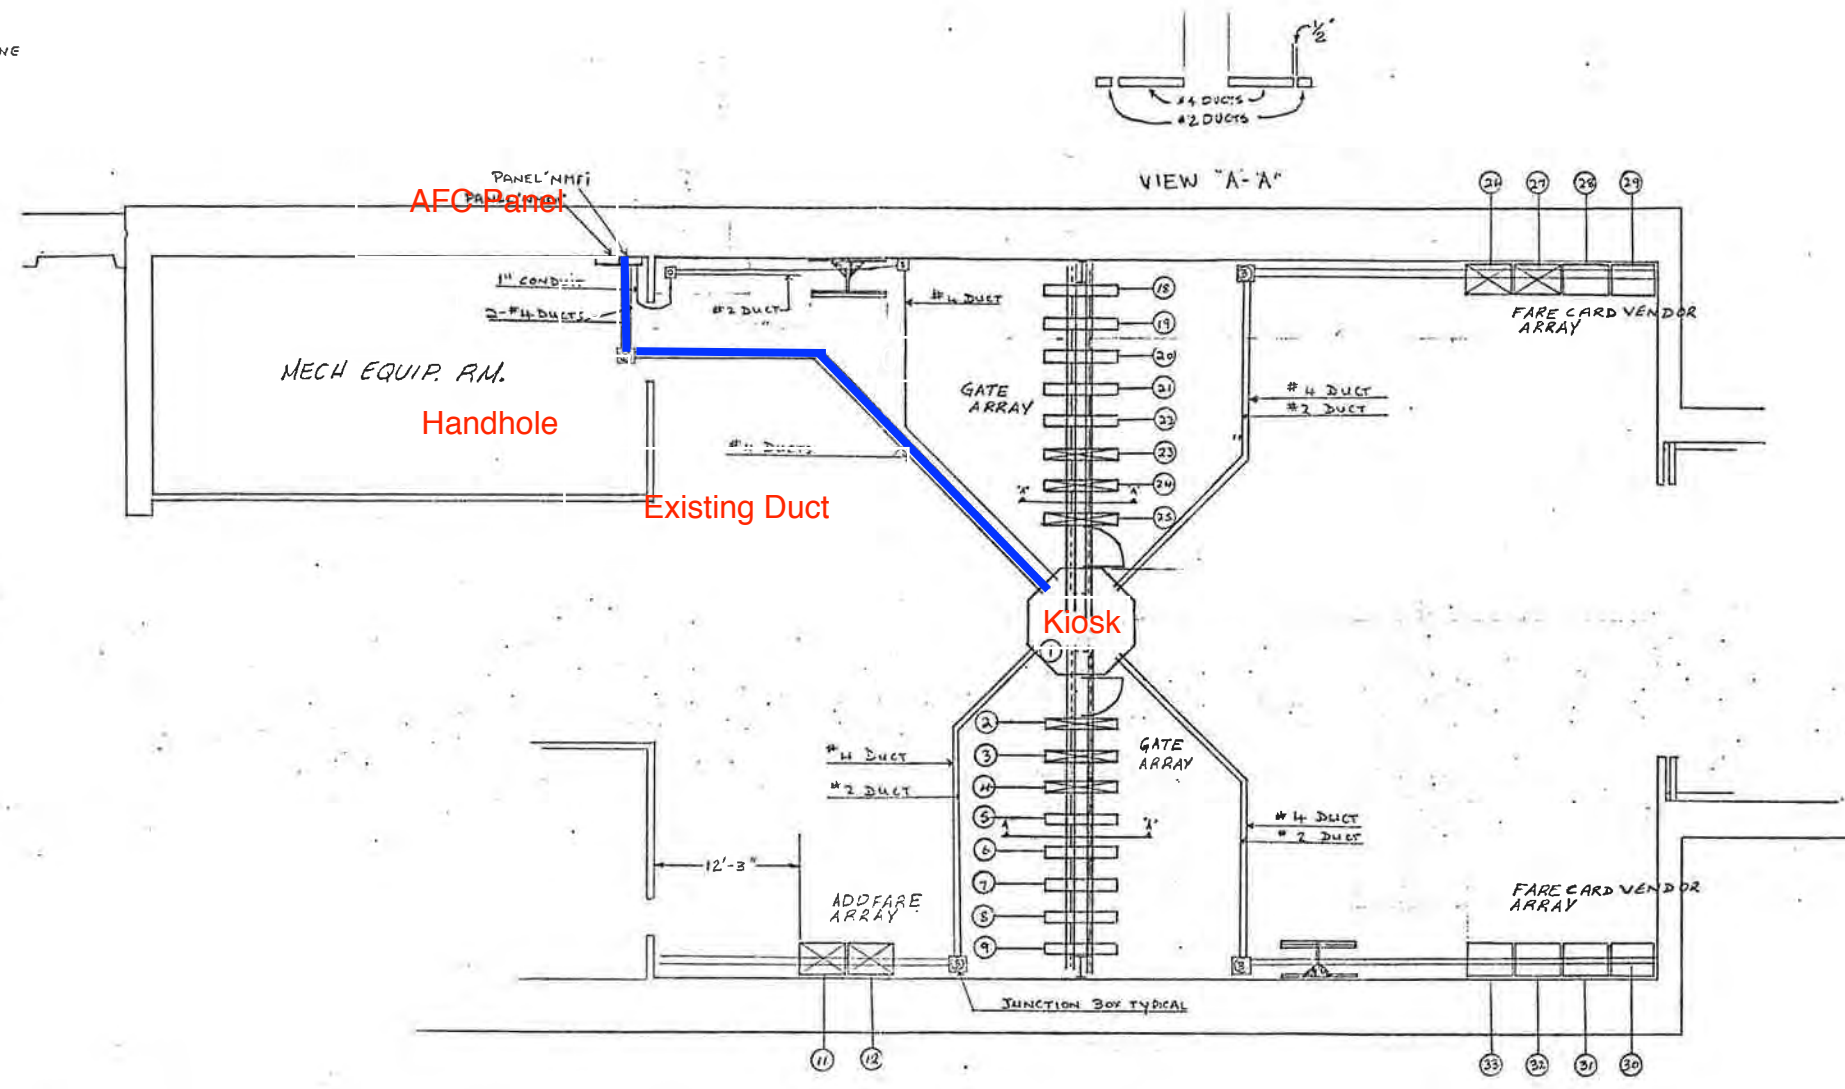
1-INSTALLATION PLAN  
(AS BUILT CONDITION)

PRIORITY REQUESTS ARE HEREBY GIVEN FOR ESCALATORS AND THE ELEVATORS THAT RUNS FROM THE STREET LEVEL TO THE MEZZANINE

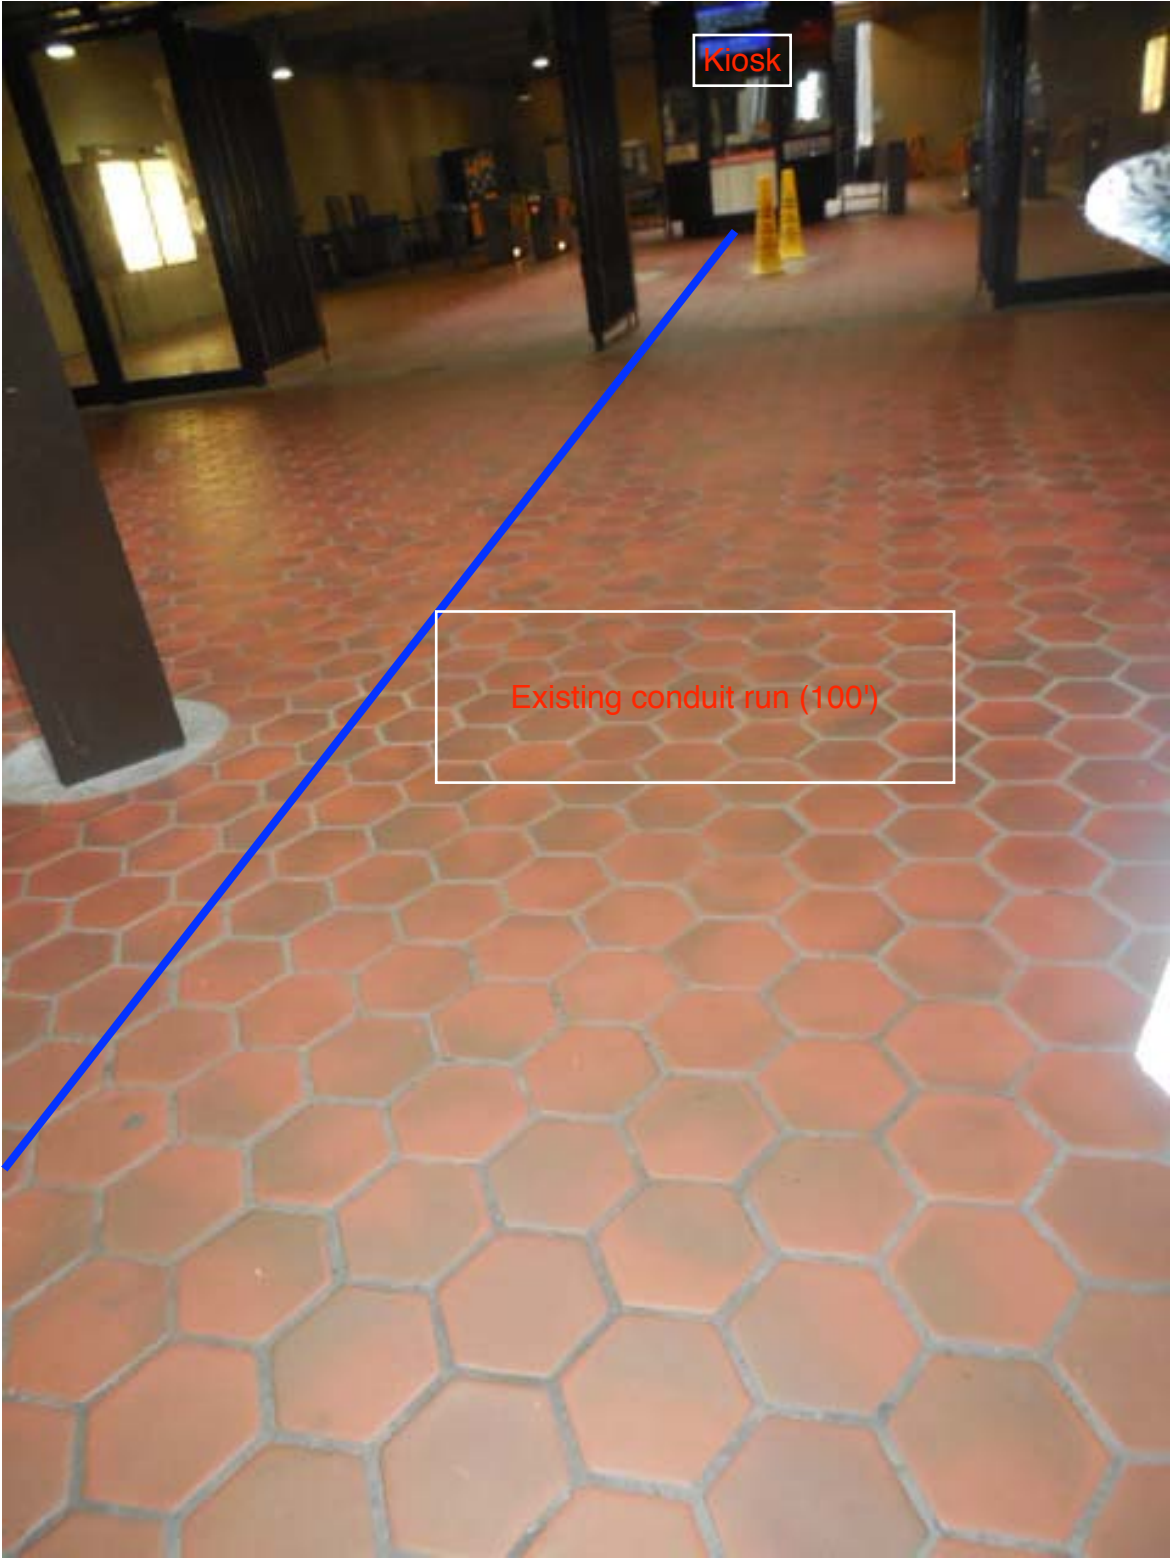
<b>Power Duct - Lower Faregate Array (3 gates)</b>			
Was video scoping completed for the entire duct run?	Yes	Refer to "WMATA Minnesota Ave 3inch Lower Power Faregate Video.avi"	
Were there any obstructions or blockages? Provide details of type and specific location.	No	Some corrosion and debris evident.	
Is the duct at capacity? Provide additional details about the dimensions of ducts and number of wires.	No	6" walker duct, not at capacity (< 10 wires).

Photo #1 – Mezzanine Layout
