Mezzanine Inspection Report (Scoping)

Date: 03/12/2015	Station Name: Court House – K01	Mezzanine #: 096	Completed By: Balkis Hassane
------------------	---------------------------------	------------------	------------------------------

Mezzanine Inspection Report

Date: 06/08/2015	Station Name: K02 - Clarendon	Mezzanine #: 097	Completed By: Mike Butler
-------------------------	--------------------------------------	-------------------------	----------------------------------

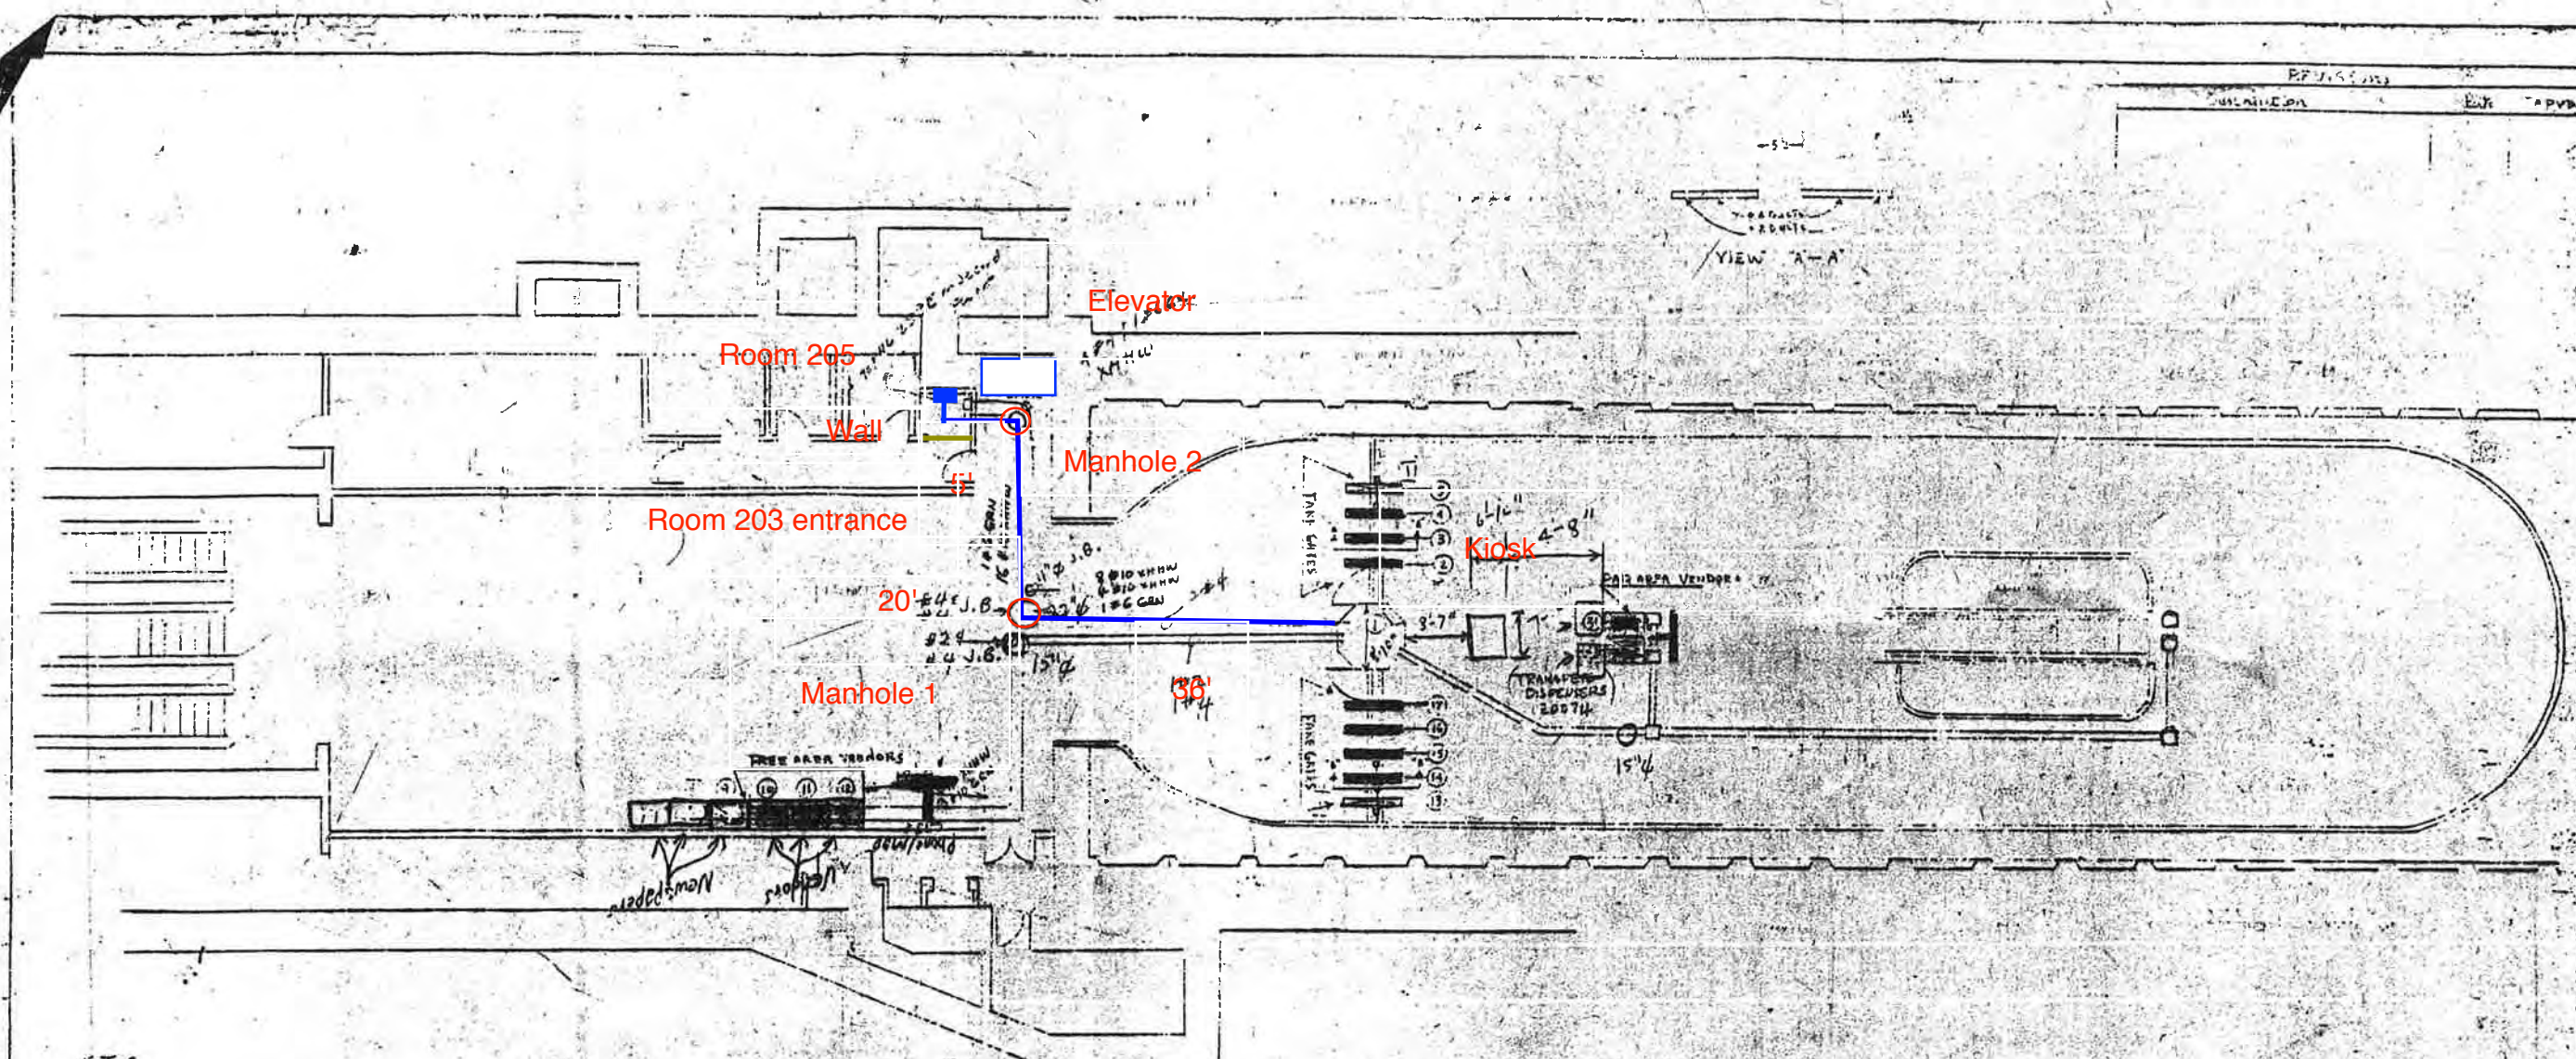
#096

Scoping and pull string installation completed for all communication ducts for the faregate arrays. Video scoping completed for power ducts for faregate arrays and duct run from kiosk to AFC Panel in Electrical Equipment Room #205. Pull string was installed in power duct from kiosk to manhole 1, manhole 1 to manhole 2, and from manhole 2 to AFC Panel.

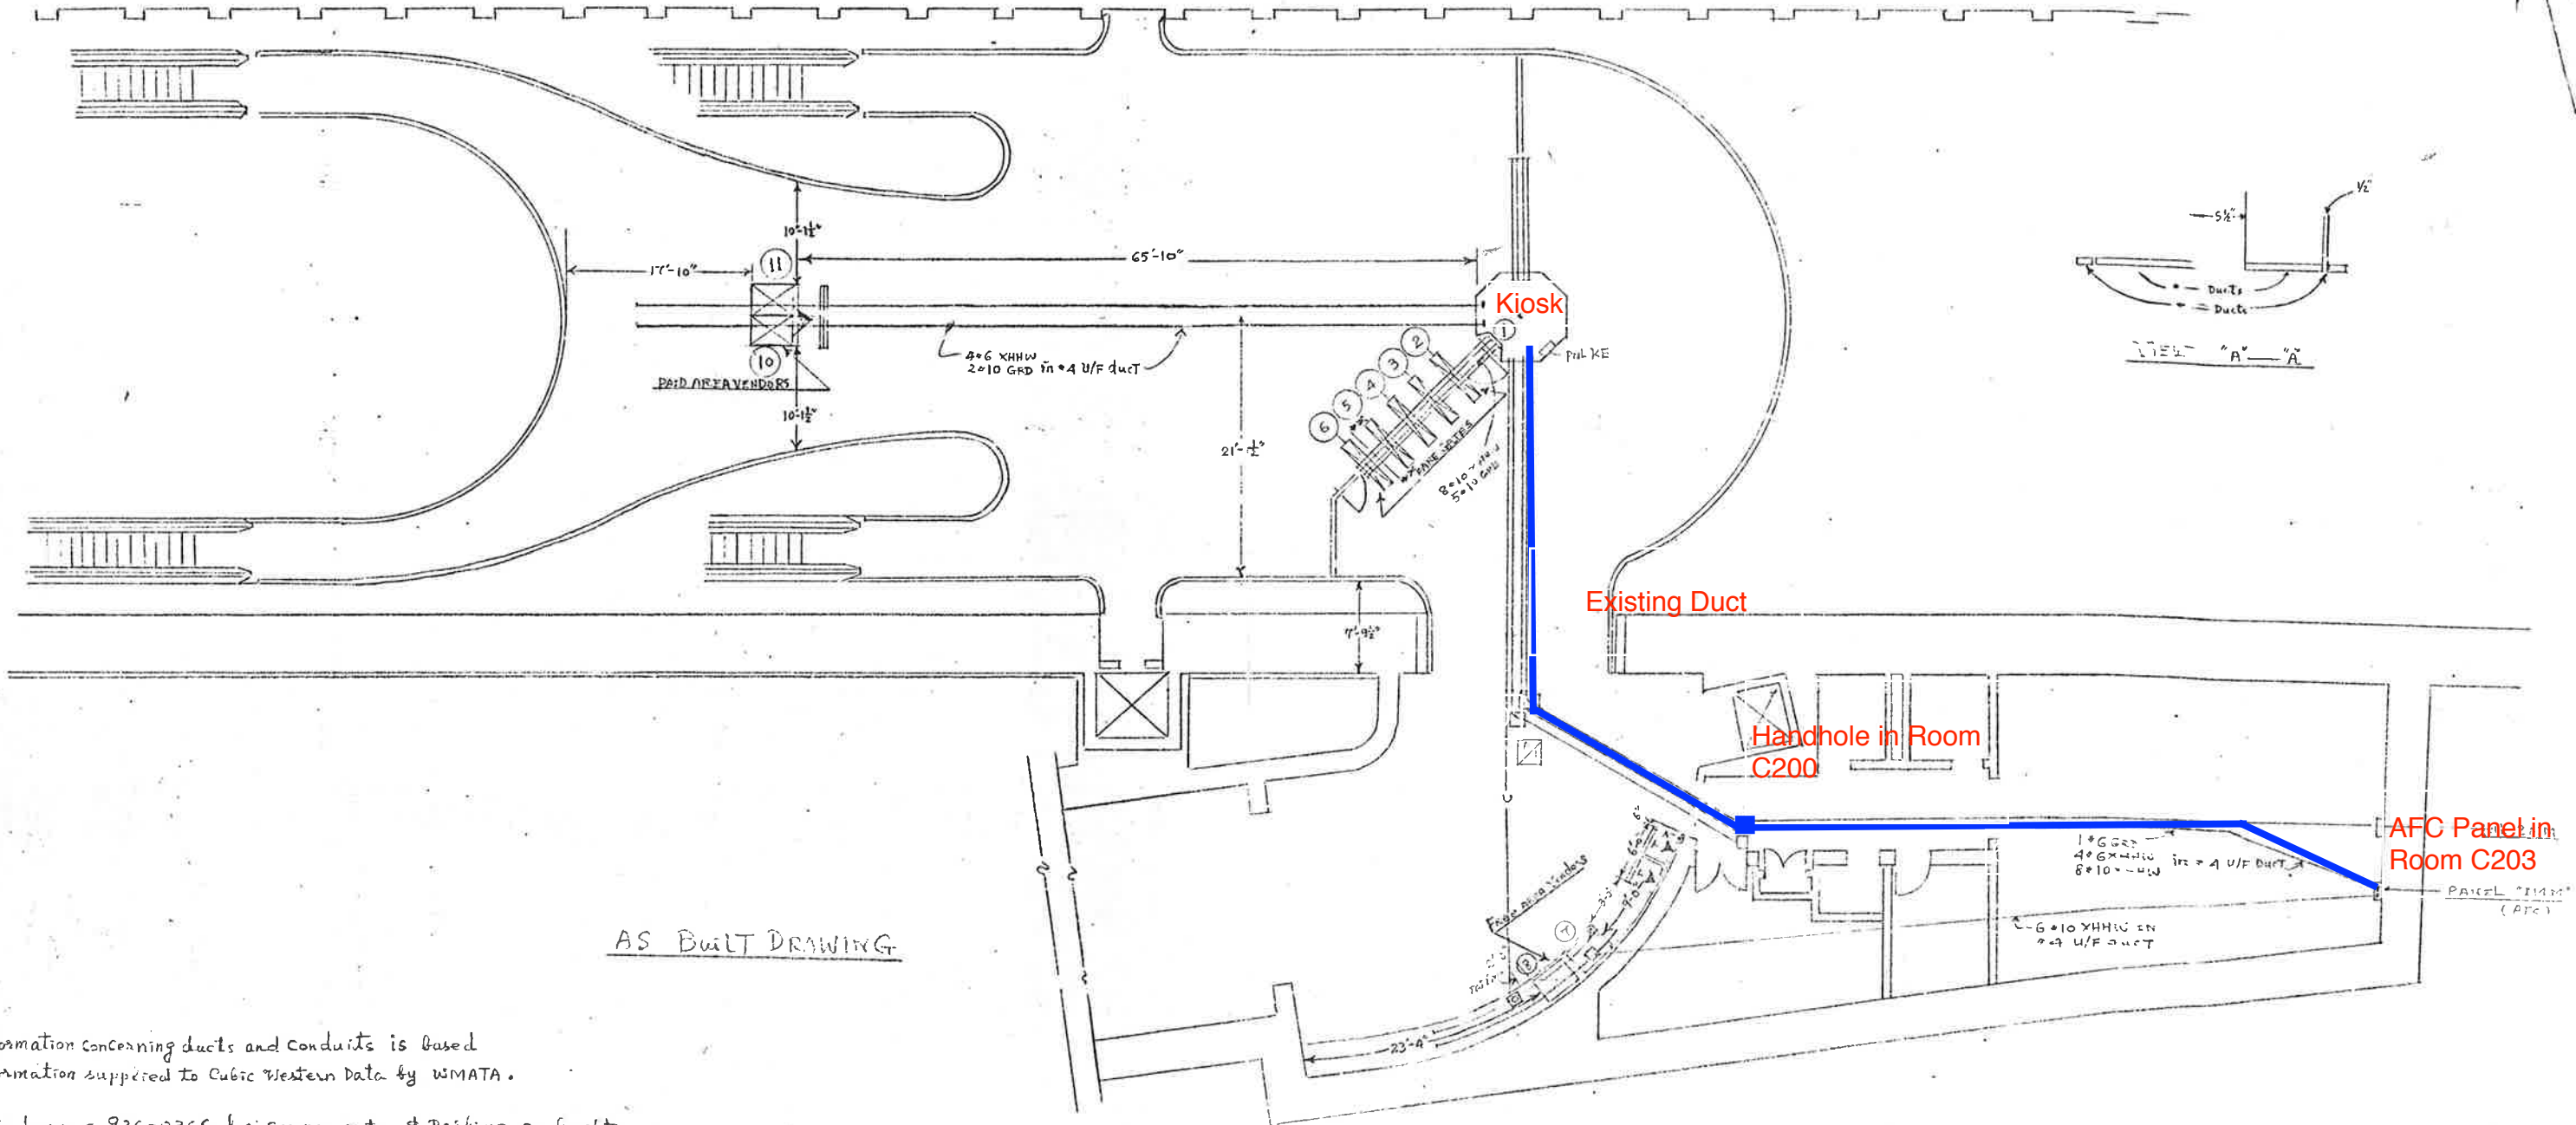
AS BUILT DRAWING

NEPP-01: Video scoping and pull string installation was completed for communication duct in single faregate array; video scoping also completed in respective power duct. However, it was not possible to complete video scoping or pull string installation in existing power duct between Kiosk, Handhole and AFC Panel due to multiple collapses in the walker duct.

Scanning was conducted to identify a new power route from the Kiosk to AFC Panel. The scanning results showed that there is space for a proposed duct run; however alternate parallel ducts between the Kiosk and AFC Panel were also identified during scanning.

NEPP-02: Video scoping and pull string installation was completed in an empty alternate duct between Kiosk and Handhole and Abandoned Communication Panel in Room C203. The alternate duct runs parallel to the existing duct from the Kiosk to the Handhole (sharing the same handhole) and then splits off and runs to an abandoned communication panel. The panel appears to have a few abandoned communication wires inside. It is recommended to utilize the alternate duct run and install a proposed overhead conduit from the abandoned communications panel to the AFC Panel.
