Mezzanin	e Inspe	ction Report (Scoping)			
Date: 11/14/2014	2014 Station Name: C10 Reagan Air		Mezzanine #: 093	Completed By: Chris Loose			
			Summary				
Scoping and pull str	ing installation was completed in a	accordance v	with the scope of work.				
	g completed for communication an not at capacity)	nd power due	cts in Upper and Lower fa	regate arrays; pull string installed in communicatior			
	g and pull string installation complete	eted from Kid	osk to handhole and from	handhole to AFC Panel (ducts			
not at capacil

Mezzanine Inspection Report (Scoping)								
	Date: 12/10/2014 Station Name: C12 – Braddock Road Mezzanine #: 047 Completed By: Chris Lo								
	Summary								
	Video scoping and pull string installation successfully completed in communications ducts in the upper and lower faregate arrays. Video scoping was not completed in the power ducts for the upper and lower faregate arrays. Video scoping was not completed in the power duct run from the kiosk to the AFC panel due to collapsed ducts. The duct was collapsed just inside the kiosk towards handhole 1 and duct was collapsed just inside handhole 1 towards the AFC panel. Scanning was completed at this mezzanine.

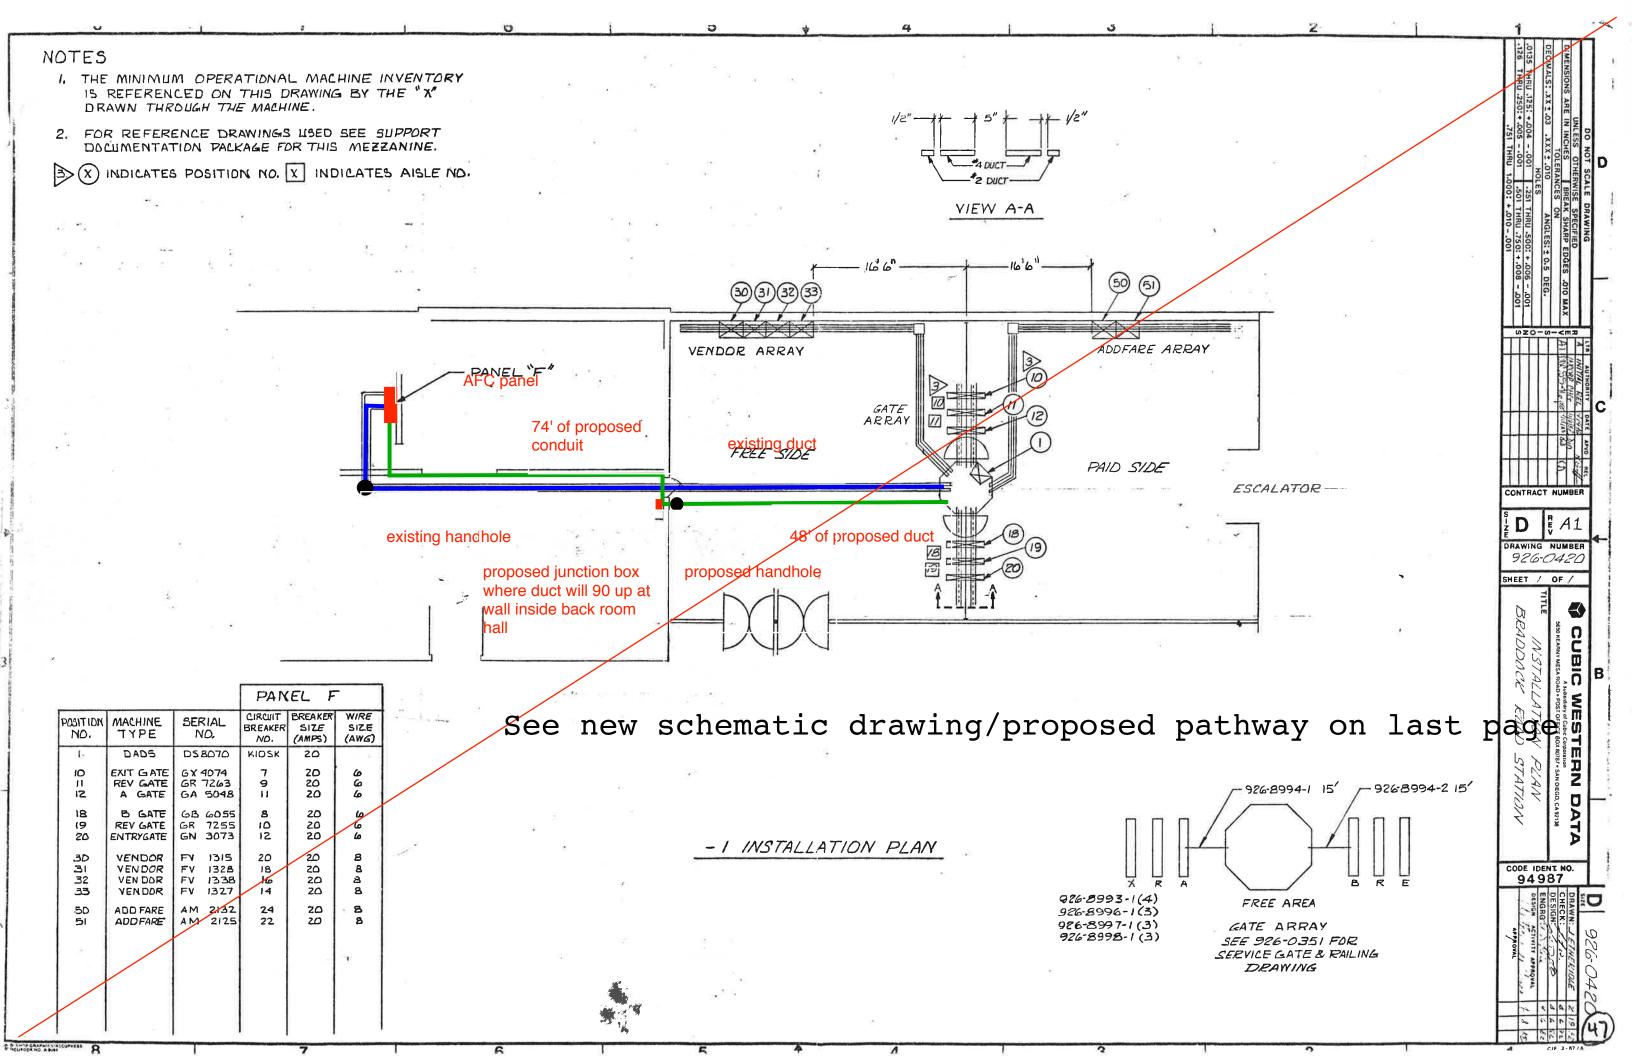
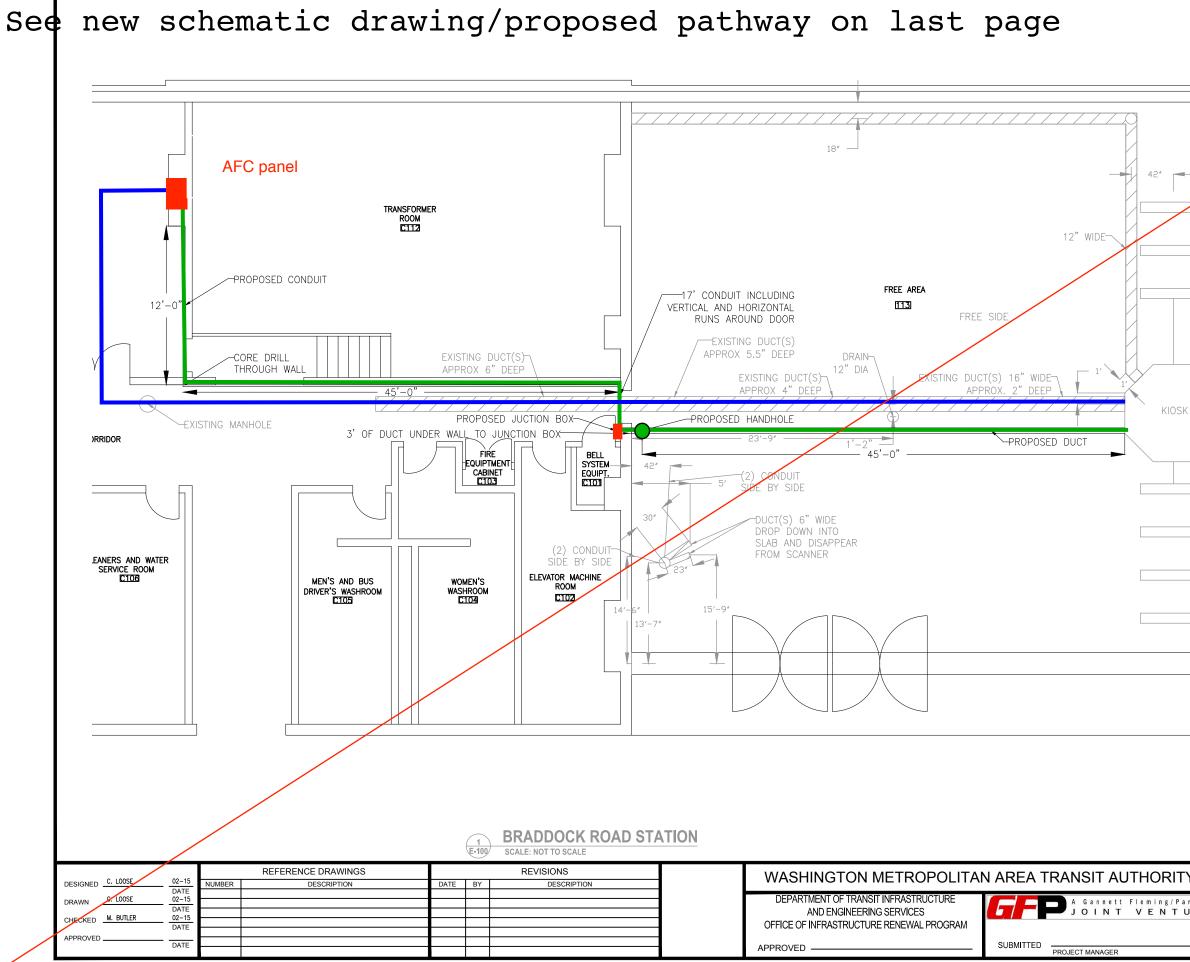
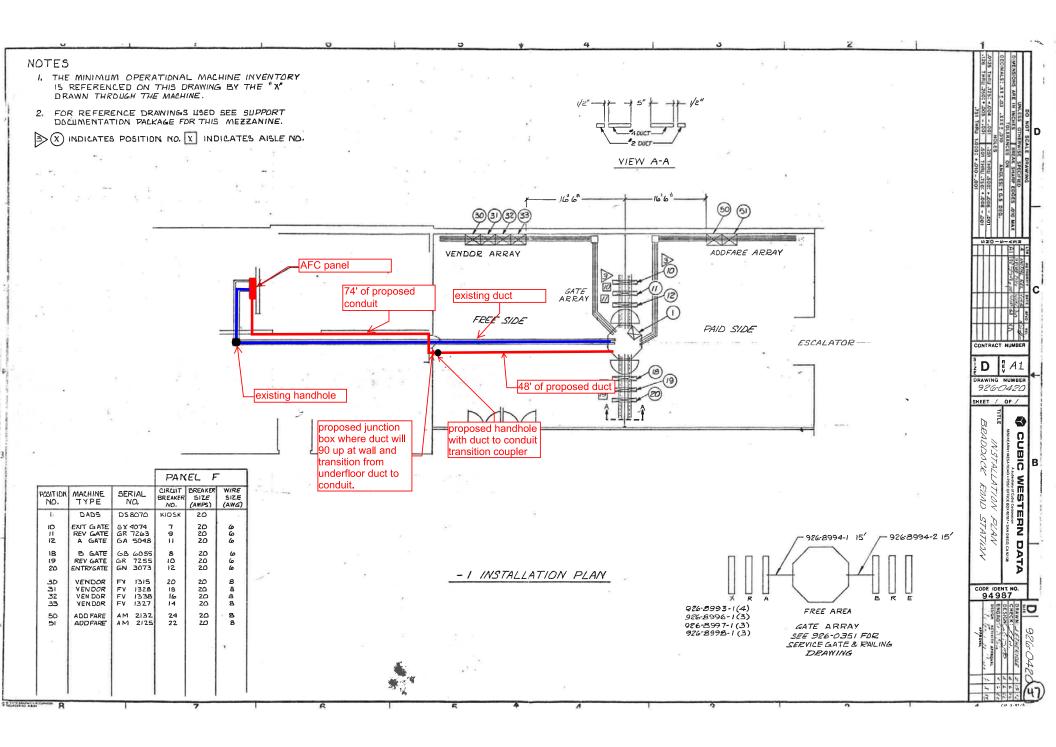
Scoping of Power Duct - Kiosk to AFC Panel							
Task	Notes						
Kiosk to Handhole 1 (95' run)							
Was video scoping completed for the entire duct / conduit run?	No	Refer to WMATA Braddock Road 6inch Left Power Feed Video.avi and WMATA Braddock Road 6inch Right Power Feed Video.avi files.					
Was pull string installed?	No						
Were there any obstructions or blockages? Provide details of type and specific location.	Yes	Duct was collapsed just inside kiosk and heavily rusted in parts that could be seen					
Is the duct / conduit at capacity? Provide additional details about the dimensions of duct / conduit and number of wires.	No	6" duct less than 15 wires					
Handhole 1 to AFC Panel (15' run)							
Was video scoping completed for the entire duct / conduit run?	No						
Was pull string installed?	No						
Were there any obstructions or blockages? Provide details of type and specific location.	Yes	Duct was collapsed less than 2' inside handhole and heavily rusted around the duct entrance at handhole 1
