Mezzanine Inspection Report

Date: 10/20/14	Station Name: E01 Mount Vernon Square	Mezzanine #: 070	Completed By: Mike Butler
-----------------------	--	-------------------------	----------------------------------

15-NEPP-01
IN - FLOOR DUCT INSPECTIONS
E01 MOUNT VERNON SQUARE
PROPOSED ELECTRICAL DUCT PATH
DRAWING NO.
E01-E-100

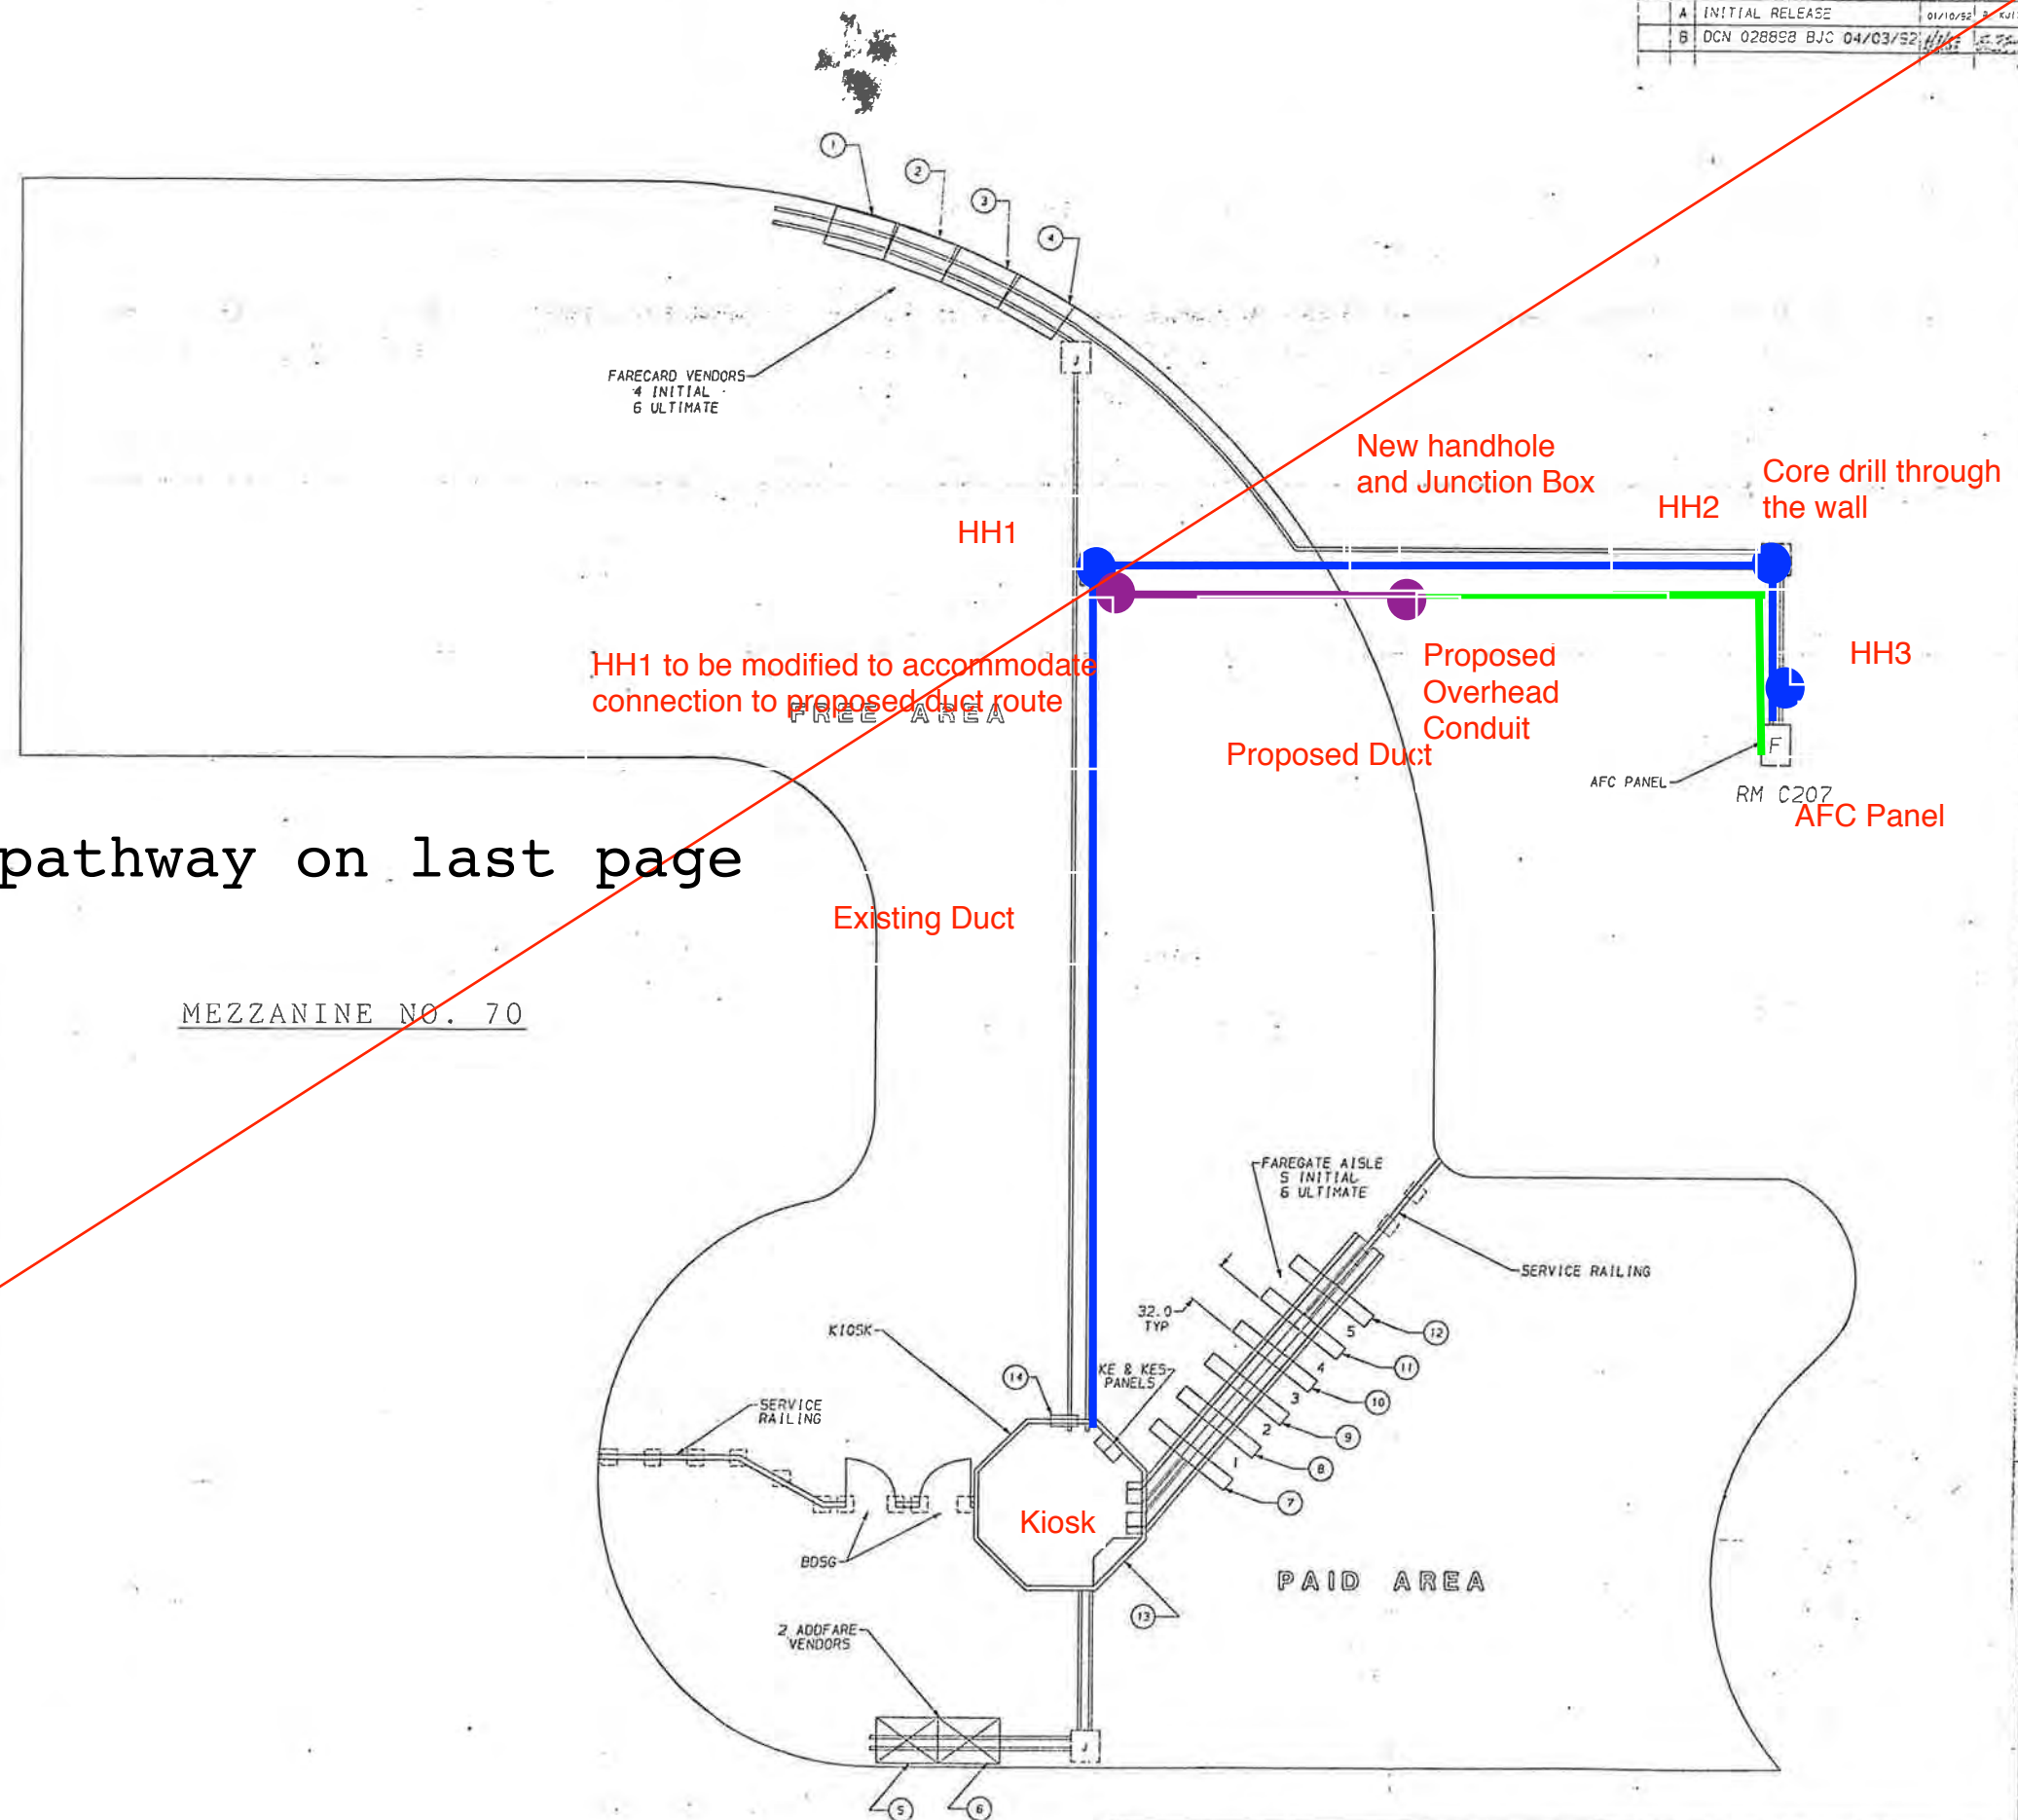
MEZZANINE NO. 70

new schematic drawing/proposed pathway on last page

The mezzanine floor was scanned to identify the existing ducts and new route between the Kiosk and AFC Panel. Scanning showed that there is a clear route from Handhole 1 to the AFC Panel. A new walker duct is proposed from Handhole 1 to the entrance of Room C204 - Handhole 1 will need to be modified to accommodate the connection of the new duct. Once in the back rooms, the duct will terminate at a new handhole and then transition to an overhead conduit (via a junction box) that will proceed along the top of the wall to the entrance of Electrical Room C207. The wall above the entrance to Room C207 will be core drilled to allow the new conduit to proceed overhead and feed into AFC Panel F.

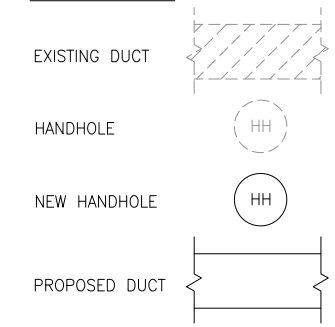
See new schematic drawing/proposed pathway on last page
