Mezzanine Inspection Report (Scoping)

Date: 11/7/144 Station Name: E08 - PG Plaza Mezzanine #: 078 Completed By: Mike Butler

| Mezzanine Inspection Report (Scoping) | | | | |
|--|---|---|---|---|
| Date: 11/06/2014 | Station Name: E09 College | e Park | Mezzanine #: 079 | Completed By: Dion Small |

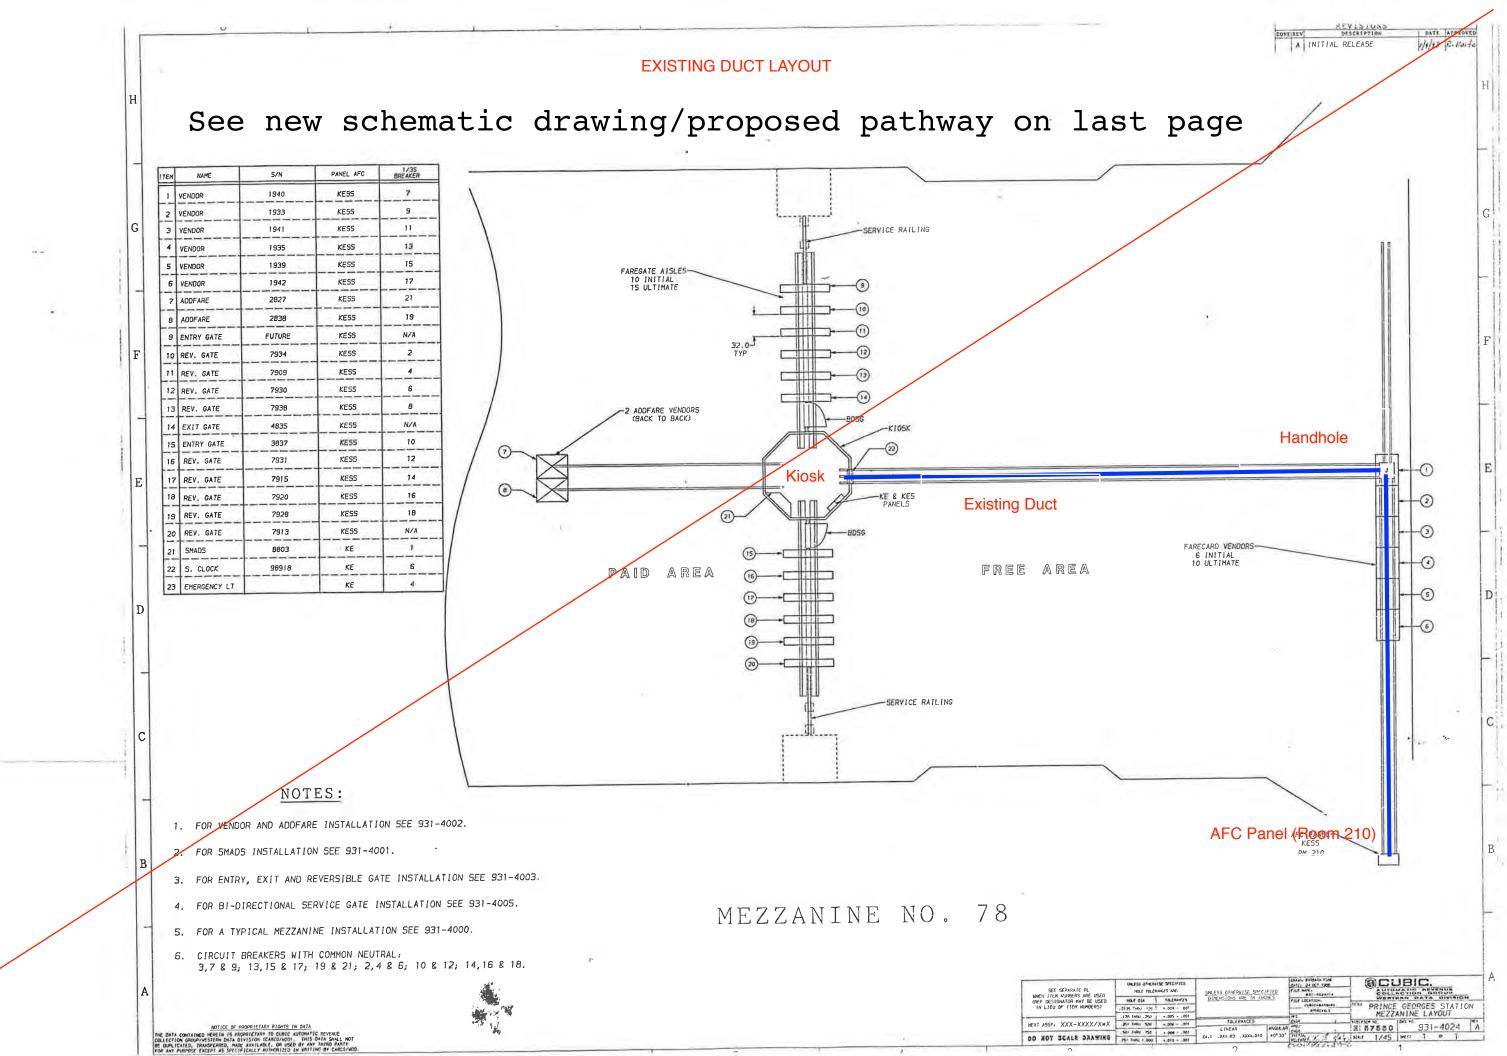
Photo #4 – Existing duct and proposed duct in Room 210

Scanning was conducted to identify a new power route between the Kiosk and AFC Panel. A new power duct is proposed to run directly from Kiosk to Room 210 where the AFC Panel is situated. The duct will require two new handholes and a new junction box. A new conduit is proposed to run overhead from the junction box where it will go up the wall, across the ceiling and then feed into the AFC Panel. Refer to photos and drawings for further details.
