Mezzanine Inspection Report

Date: 06/04/15	Station Name: F02 Archives	Mezzanine #: M081	Completed By: Mike Butler
----------------	----------------------------	-------------------	---------------------------

15-NEPP-01
IN - FLOOR DUCT INSPECTIONS
F02 ARCHIVES
PROPOSED POWER ROUTE
DRAWING NO.
F02-E-100

Date: 06/24/15	Station Name: F03 L'Enfant Plaza North	Mezzanine #: 082	Completed By: Mike Butler
----------------	--	------------------	---------------------------

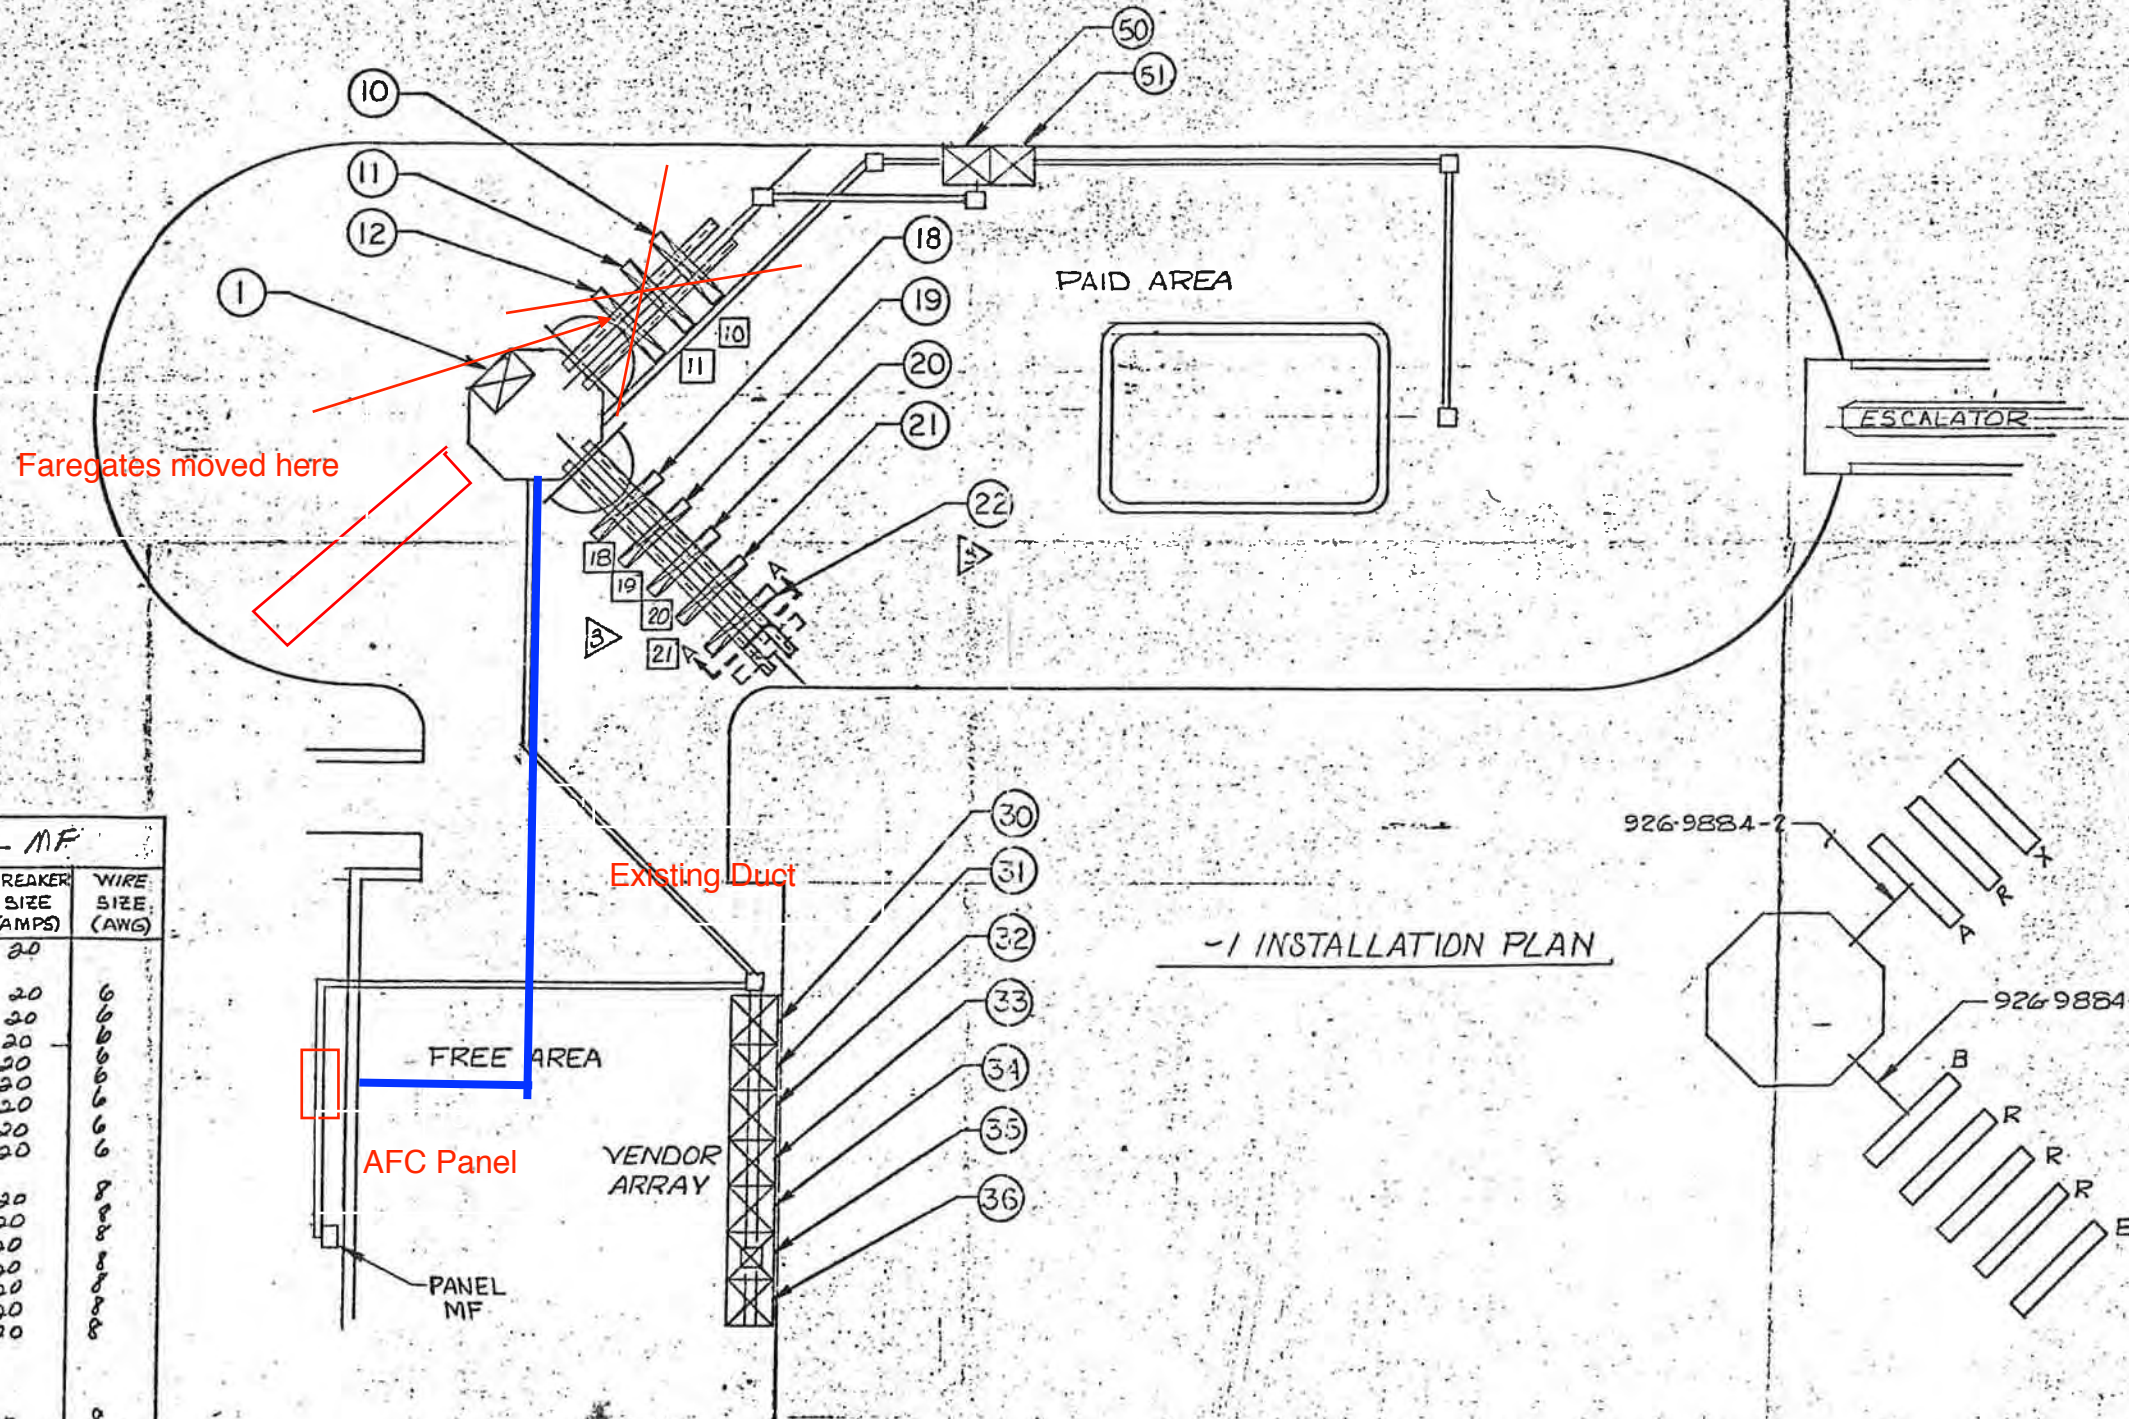
EXISTING LAYOUT

Scanning was conducted to identify new power route between the Kiosk and AFC Panel. The scanning results showed that the mezzanine floor is very congested with existing walker ducts and there is no clear path for a new duct between the Kiosk and AFC Panel. However, alternate ducts running into the back rooms were identified.

NEPP-01: Video scoping and pull string installation completed for communication ducts in upper and lower faregate arrays; video scoping also completed in respective power ducts. Video scoping and pull string installation was completed in duct between Kiosk, Handhole 1 and Handhole 2. Pull string installation was also completed in conduit between AFC Panel and Junction Box on ceiling in Room N104 at platform level. Although video scoping was attempted and partially completed, it was not possible to complete pull string installation between Handhole 2 and Junction Box due to an obstruction caused by a vertical 90-degree bend under the mezzanine floor where the duct goes down to platform level. Scanning of the mezzanine was conducted to identify a power route between the Kiosk and AFC Panel. The results of the scanning confirmed that there are multiple ducts running from the Kiosk - an alternate duct running parallel to existing power duct was also identified.

Recommendation: It is recommended to utilize the alternate duct for the installation of new wires. Although there is pull string installed in both existing and alternate ducts/ conduit between Kiosk and AFC Panel, it is preferred to use the alternate duct because the duct has more capacity. Refer to attached photos and drawings for further information.
